Mission Canyon Stream Habitat Restoration Project
Initial Study/Mitigated Negative Declaration

Mission Creek Habitat Restoration Project: Cultural Resources Technical Report

NOVEMBER 2023

SWCA Environmental Consultants

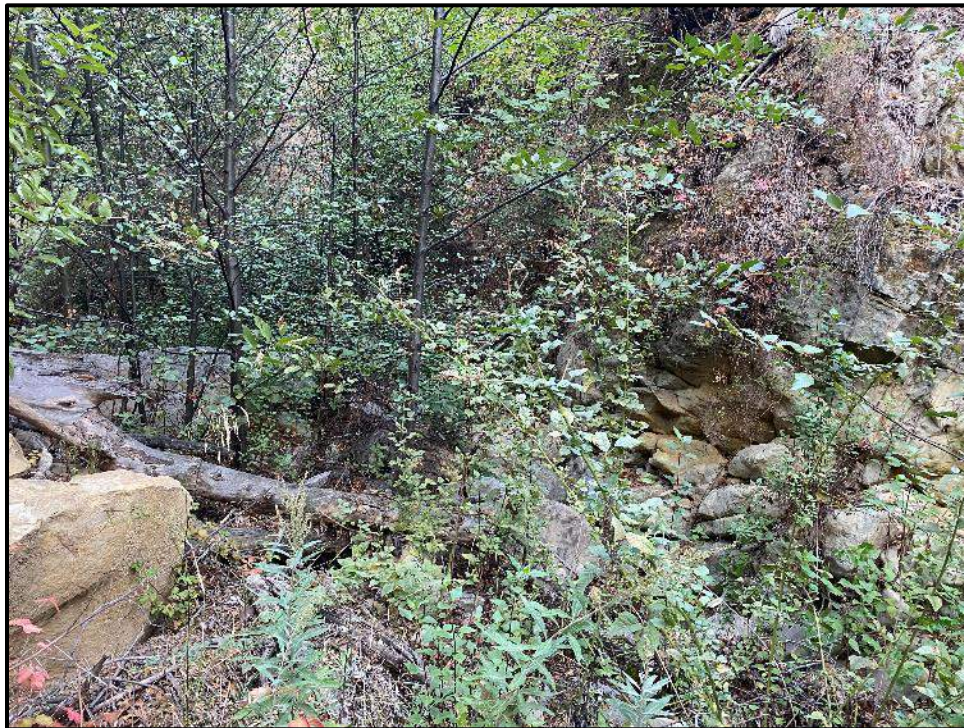
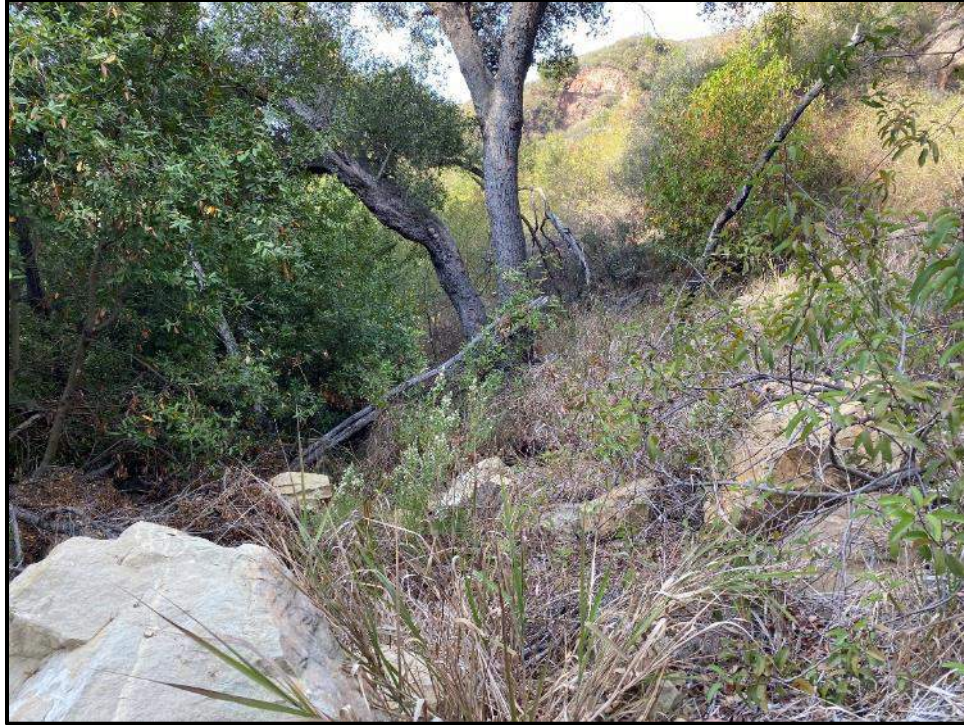
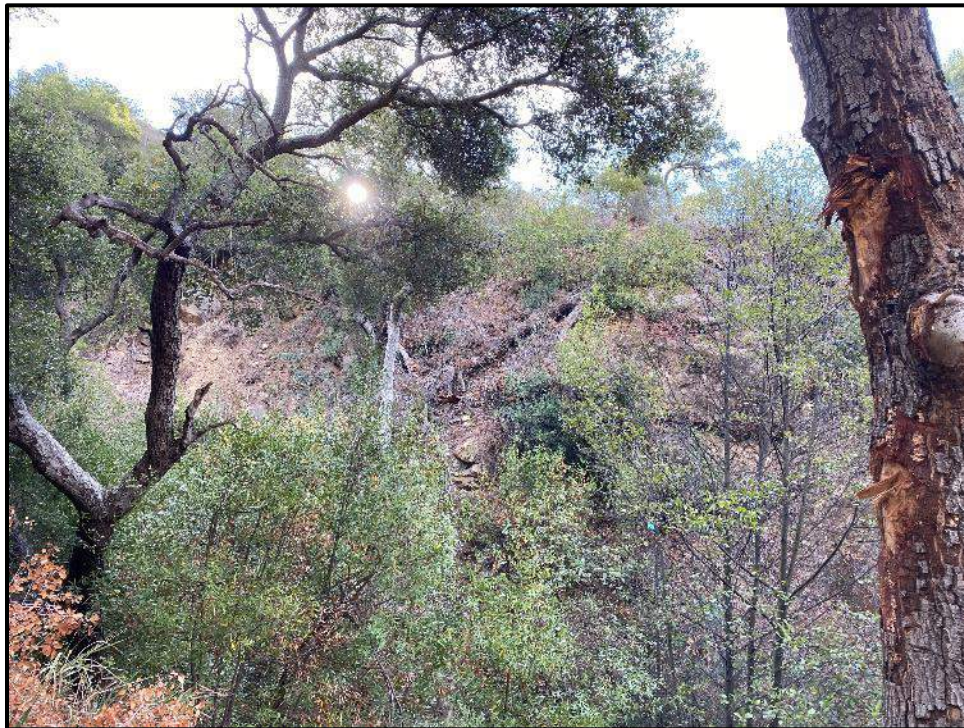
Figure C-4. Overview of the Sidecast Addition Outlier (surveyed in October 2021), direction facing unknown.

Figure C-5. Overview of the Sidecast Addition Outlier (surveyed in October 2021), direction facing unknown.

Figure C-6. Overview of the Sidecast Addition Outlier (surveyed in October 2021), direction facing unknown.

The ground surface was covered with rocks and boulders and dense vegetation, which included coast live oak woodland, coastal sage scrub, grasses, and chaparral. Visibility of the ground surface ranged from poor to fair. No cultural resources were observed during the survey. Photographs from this field survey are included in Appendix C (Figures C-4 through C-6).
