Mitigated Negative Declaration

San Juan School Reconstruction

January 31, 2024

Prepared by
EMC Planning Group

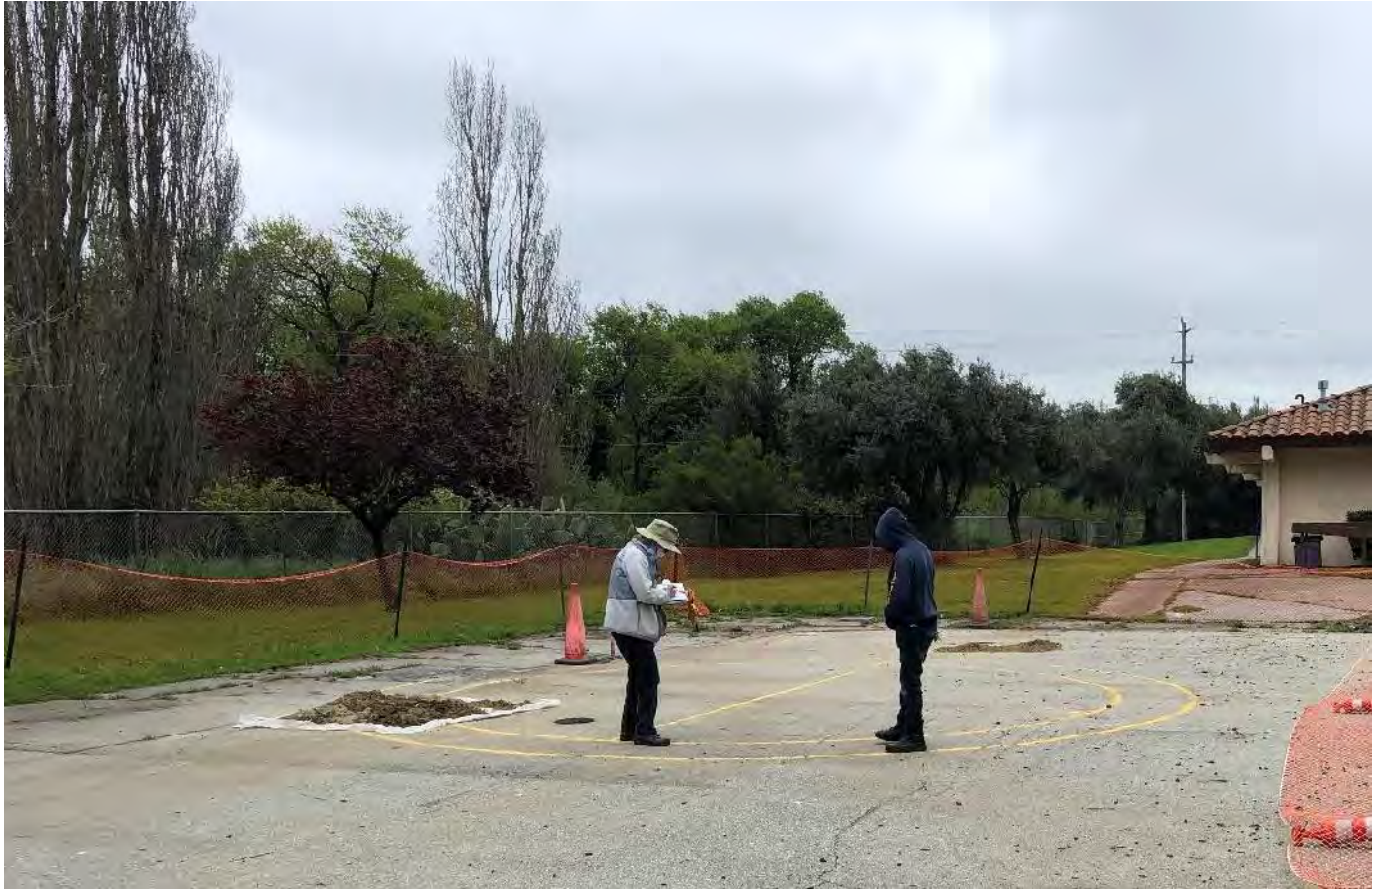
Fault Rupture Hazard Update for San Juan School

Proposed building site, April 8, 2020
