**Phase II Environmental Site
Assessment**

**225 North Las Posas Road
San Marcos, California 92069**

March 23, 2021

Project No.: 185805035

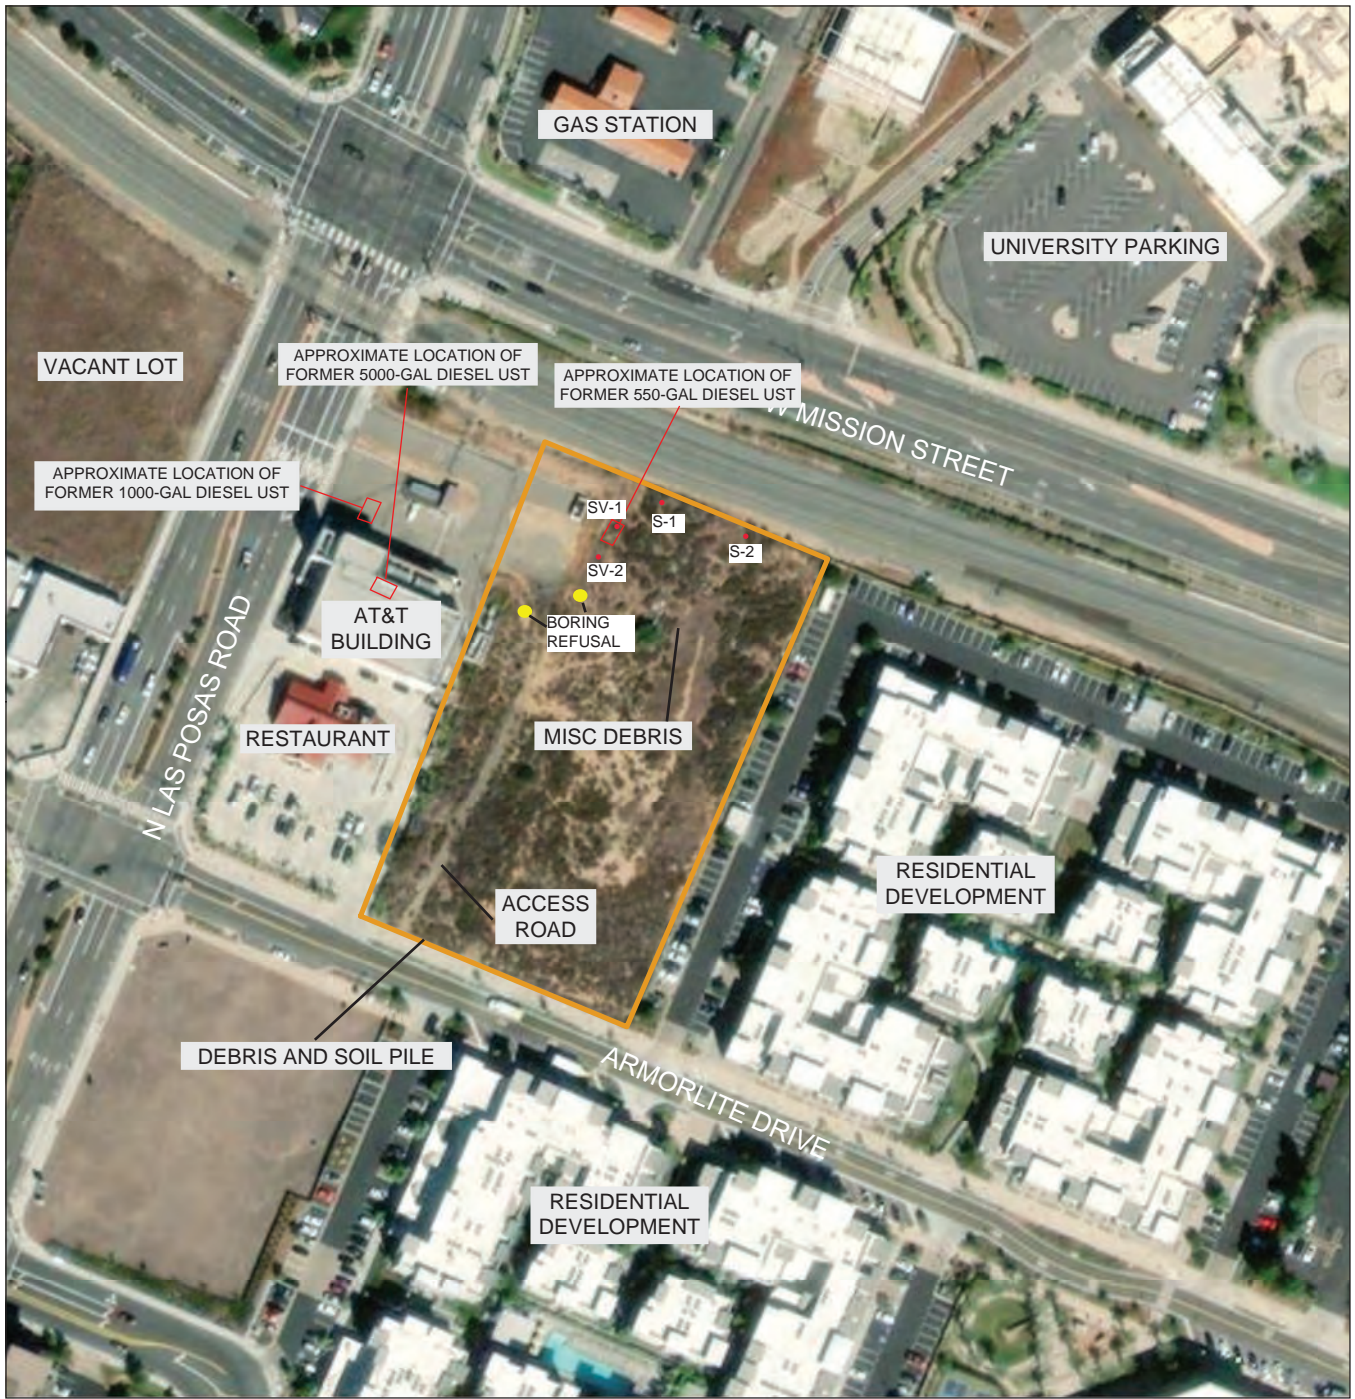
detected in the northwest portion of the Property at approximately 2 to 4-feet in depth. The location is shown on Figure 2 and the geophysical survey results attached in Appendix A.

- Property Boundary
- Soil Sample Location
- Soil Vapor Location

The GPR Survey identified an anomaly which may be the 550-gallon UST in the northwest portion of the Property at approximately 2 to 4-feet in depth. Stantec recommends removing and disposing of the UST in accordance with all applicable laws.

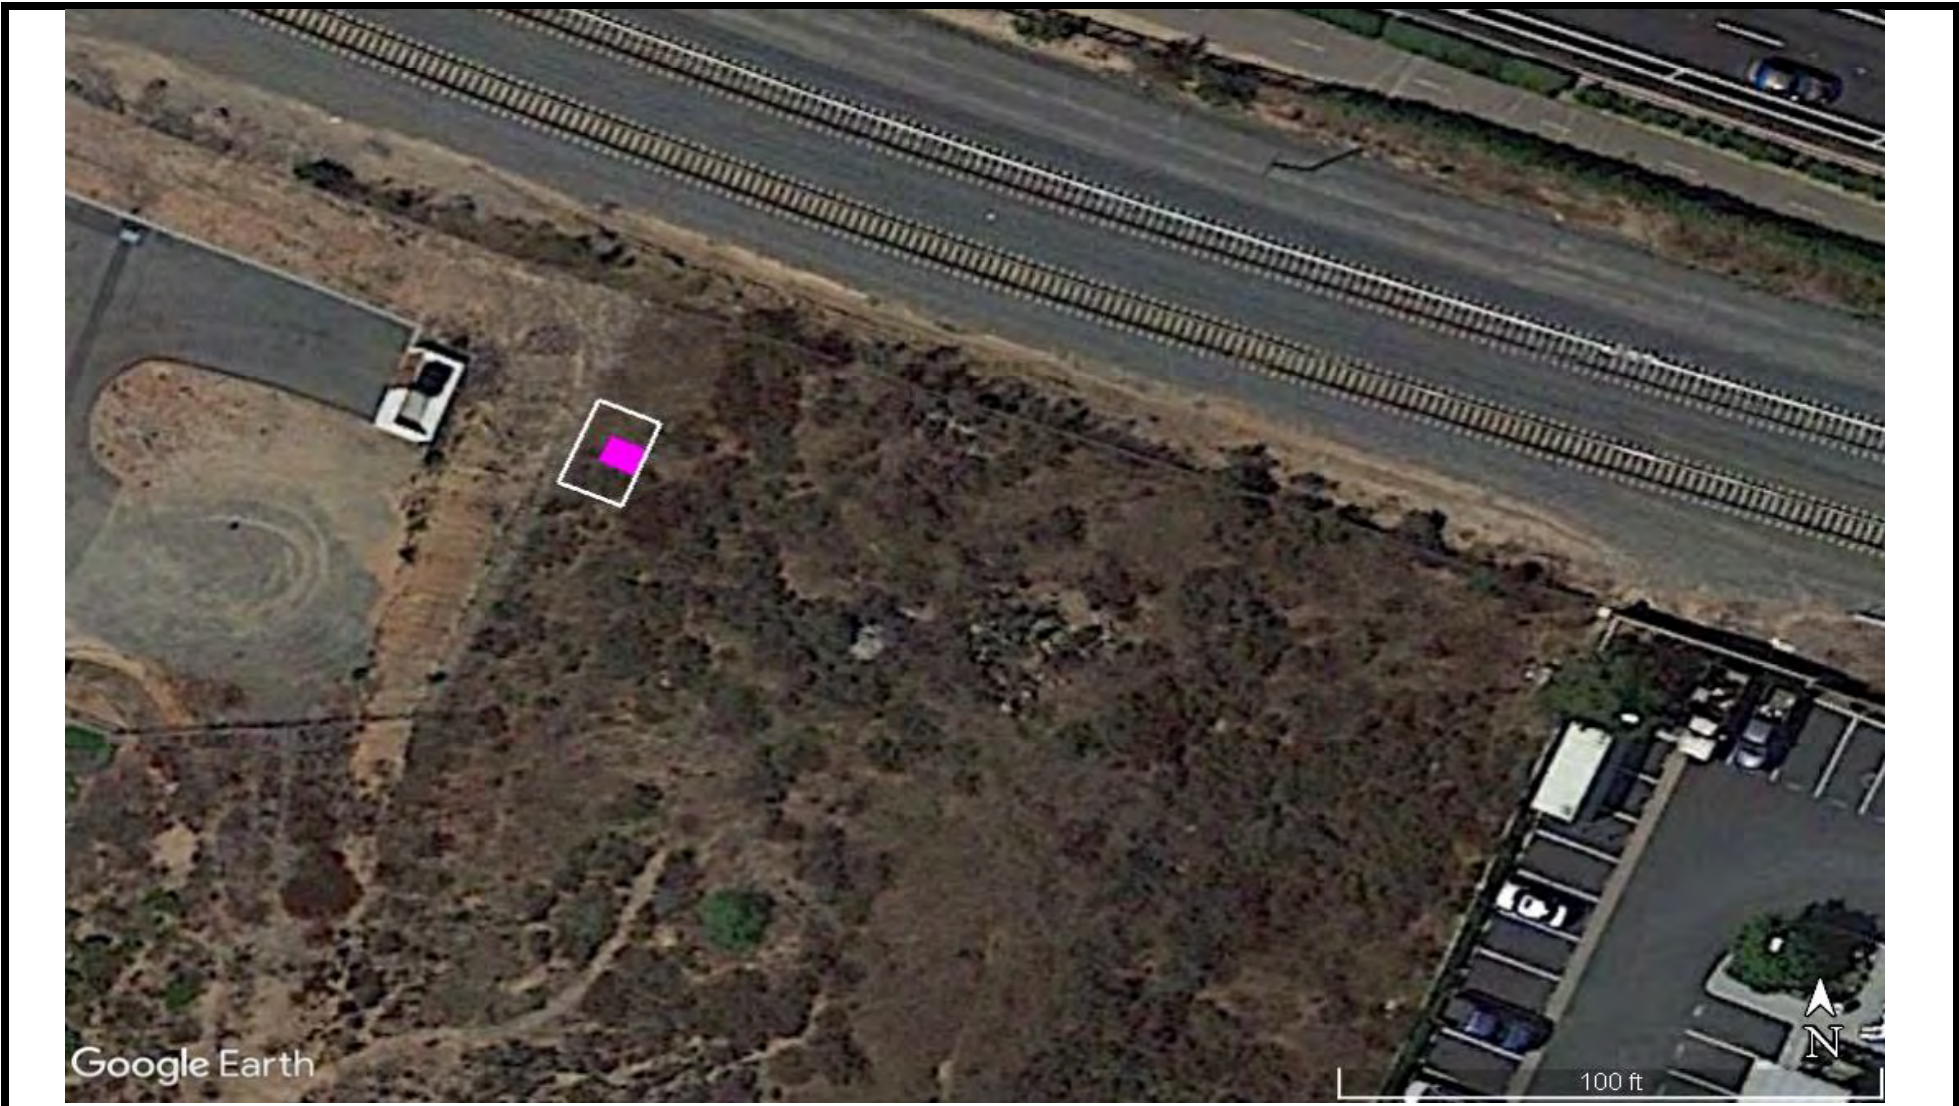
The subsurface conditions at the time of the scanning allowed for maximum GPR depth penetration of 4' in most areas. The equipment and methods used did detect reactions from potential UST's. Possible UST detected north-west of property lot at approximate 2'-4' in depth. The following pages will provide further explanation of the findings.

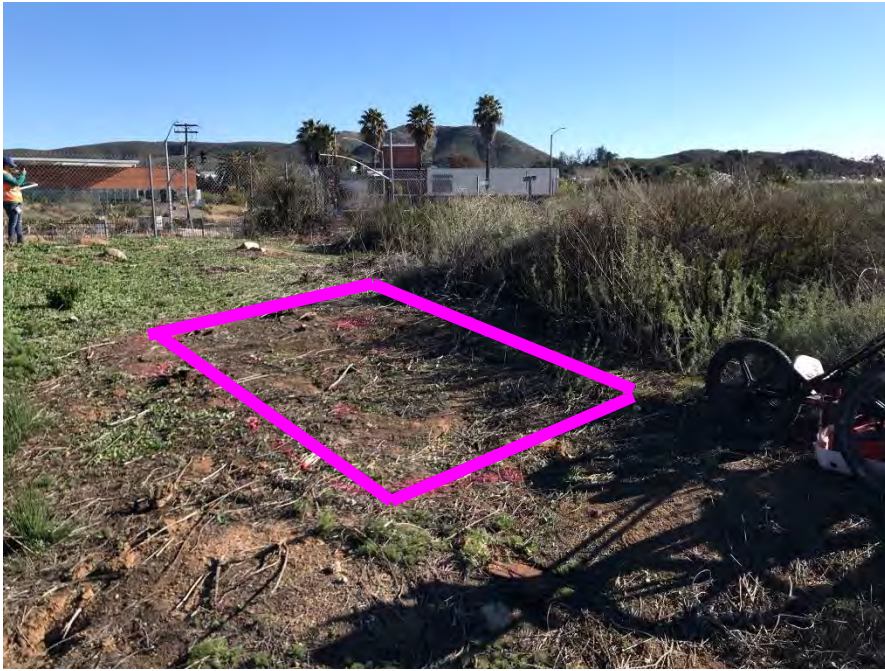
Pink outline shows location of possible UST. Thick vegetation prevented GPR from scanning additional area.

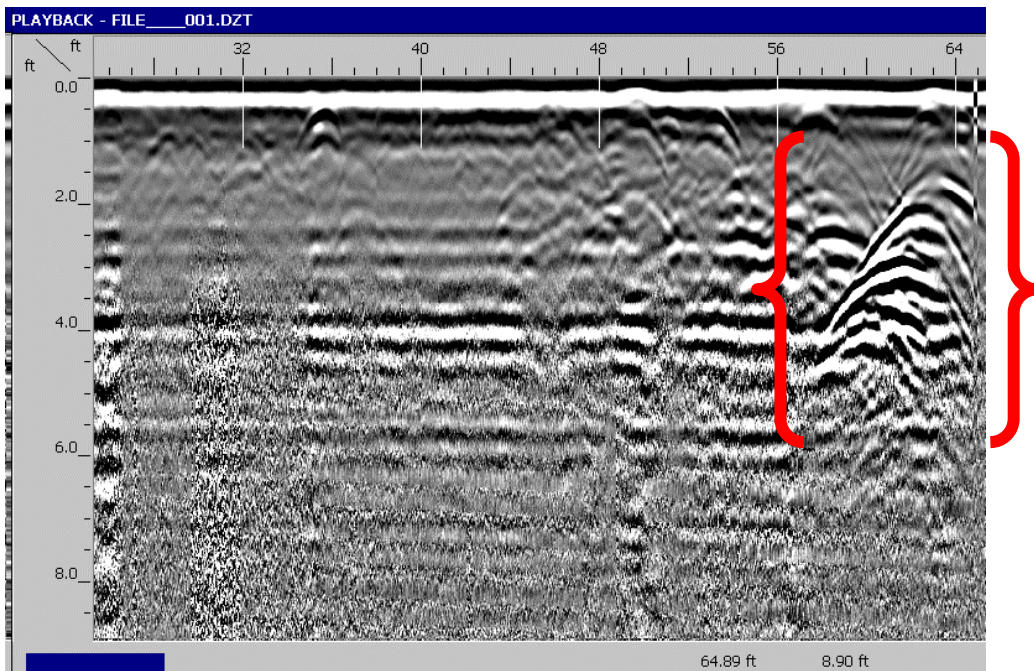
GPR Data Screenshot and Photo

Red brackets highlight anomaly detected in the field, potential UST.

The GPR Survey identified an anomaly which may be the 550-gallon UST in the northwest portion of the Property at approximately 2 to 4-feet in depth. Stantec recommends removing and disposing of the UST in accordance with all applicable laws.

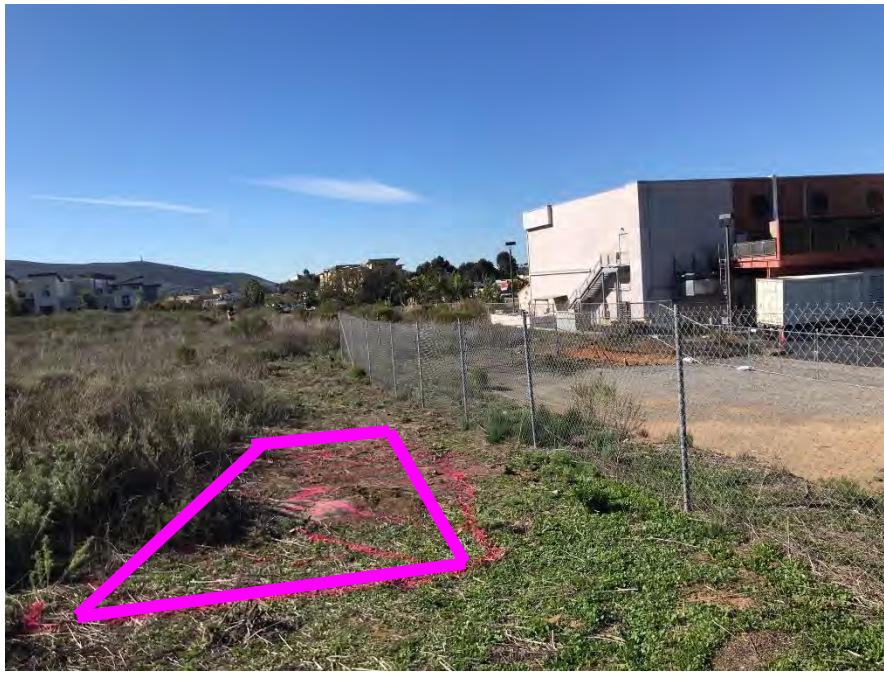
Possible location of UST marked in pink. Fence and vegetation limited GPR scan length.
