Draft Initial Study & Mitigated Negative Declaration
Chualar Canyon Road Bridge Replacements Project
February 2024

Replacements four different bridges (Nos. 302, 303, 304, and 305) along Chualar Canyon Road in the County of Monterey.

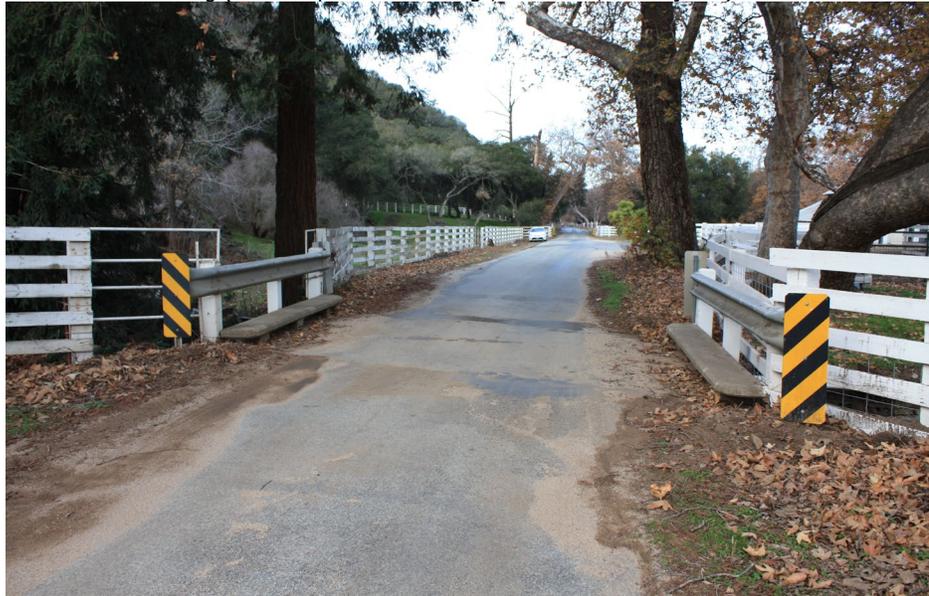
P5b. Description of Photo: (View, date, accession #) **Photograph 1: Bridge 305 with Bridge 304 in the background; camera facing west; December 19, 2022.**

*P6. Date Constructed/Age and Sources: Historic Prehistoric Both
c. 1901-1936 Salinas Californian; deck and span structure replaced 1940 and 1948.

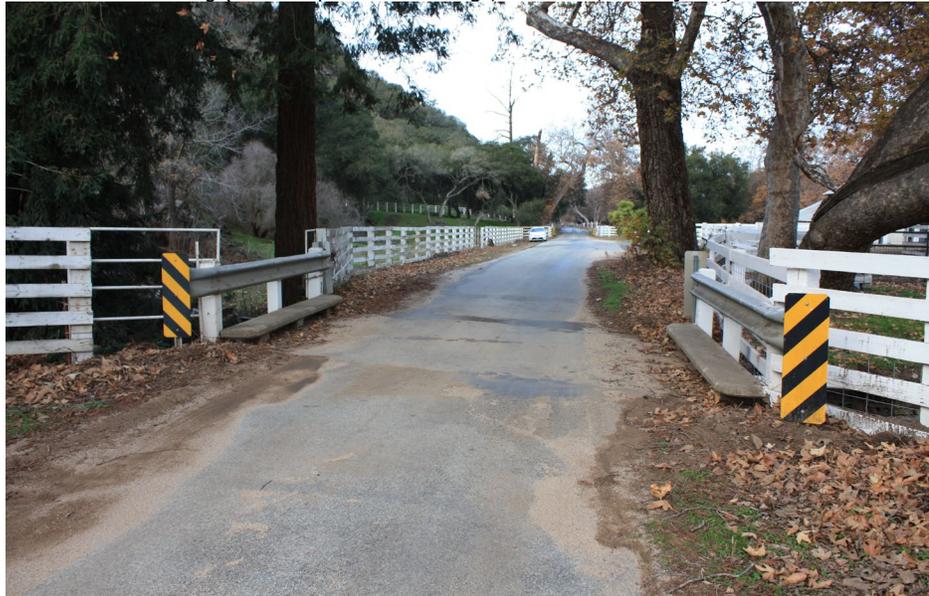
P5b. Description of Photo: (View, date, accession #) **Photograph 1: Bridge 305 with Bridge 304 in the background; camera facing west; December 19, 2022.**

*P6. Date Constructed/Age and Sources: Historic Prehistoric Both
c. 1901-1936 Salinas Californian; deck and span structure replaced 1940 and 1948.
