Spring Plant Survey Report

Addendum to the **Revised Biological Survey Report**

for the **Proposed Truck Rack Project Lompoc Oil Field Santa Barbara County, California**

July 2023

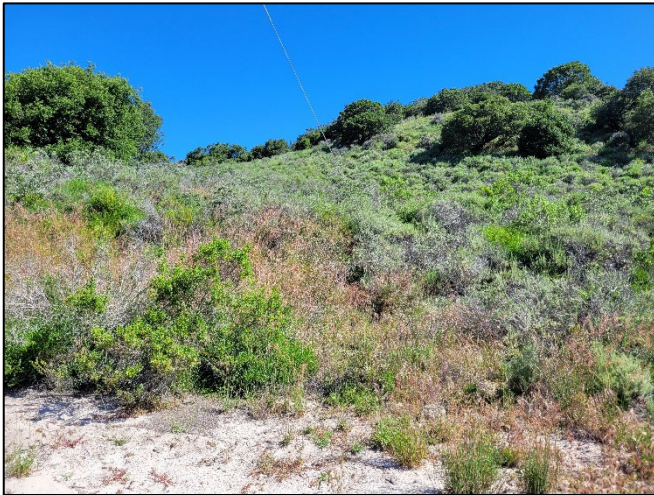
Photograph 1. View shrubland north of Pad Purisima 33, facing north from the production pad.

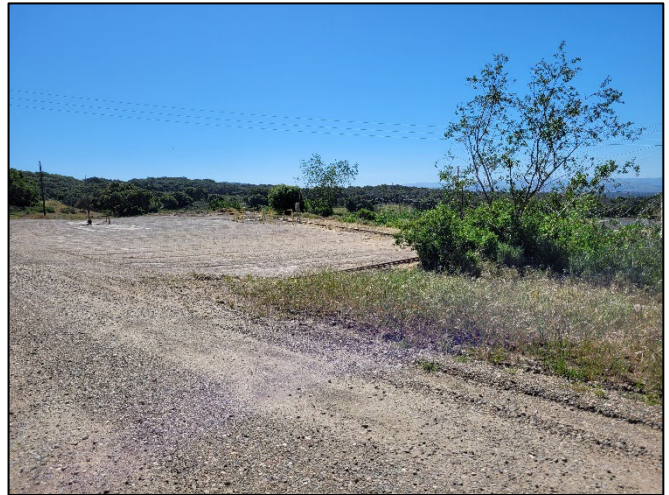
Photograph 2. View of the existing production pad Purisima 33, facing southeast from the access road.

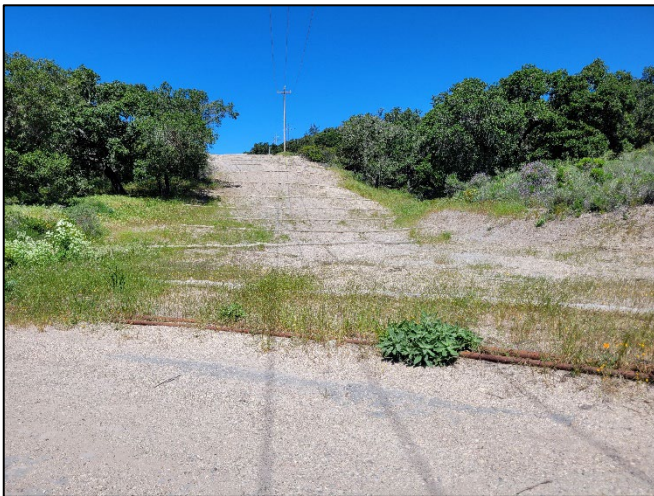
Photograph 3. View of the existing cleared area associated with the SoCal Edison utility corridor, facing northwest from the access road. Vegetation removal was not associated with the Project or SPR.

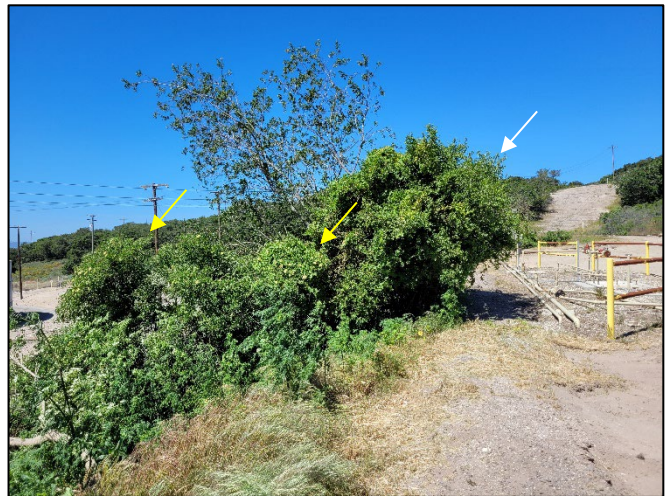
Photograph 4. View of the southern boundary of Pad Purisima 33. Quag-31 is shown with a white arrow, blue elderberry (*Sambucus nigra*) with a yellow arrow.

Four blue elderberry shrubs were observed in the scrubland south of Purisima 33 in December 2022 (**Figure 3**). All were in a senescent condition during the survey, with limited to no foliage, due to the season. These shrubs were visited in April 2023 and all were found to be alive, with blooms, and in good condition. One shrub is located near the edge of the production pad but is outside the proposed secondary containment berms and will not be disturbed. One shrub is located south of the proposed storm drain pipeline; this shrub will also be avoided during construction. The other shrubs are downslope within the scrubland.

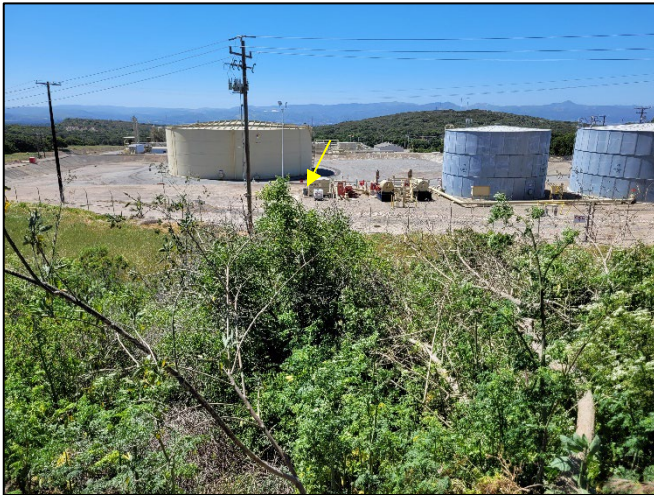
Photograph 5. View south from Pad Purisima 33. Blue elderberry shrub in shrubland is indicated with yellow arrow.

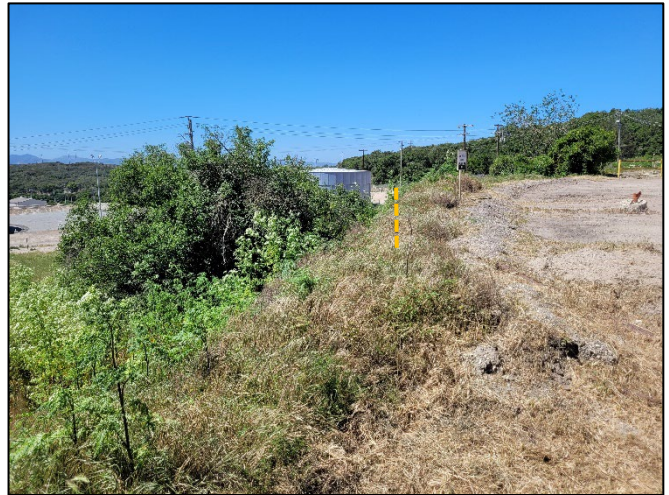
Photograph 6. View of large blue elderberry on east slope of Pad Purisima 33, in the vicinity of the proposed storm drain feature.

There will be no trimming or removal of any blue elderberry shrubs.

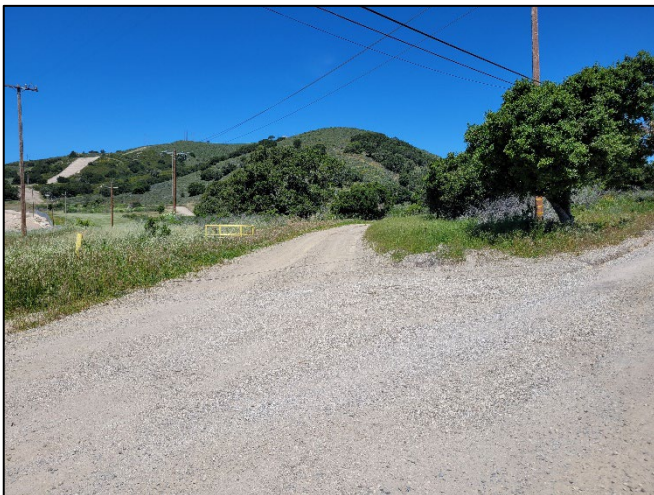
Photograph 7. View from the start of the eastern access road, facing north-northwest along the road.

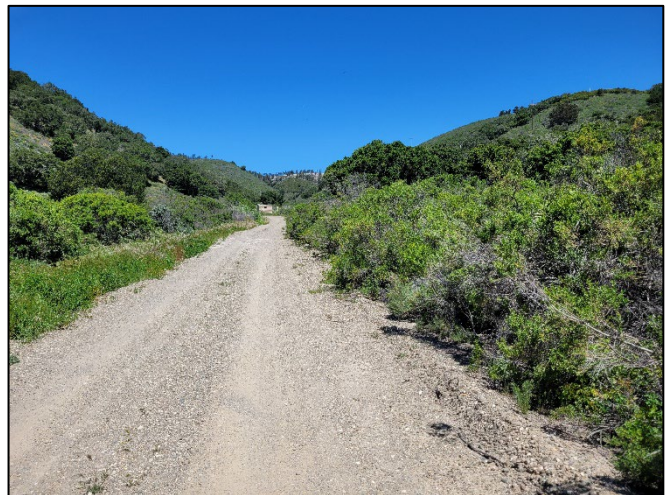
Photograph 8. View west along the eastern access road from with coyote bush (*Baccharis pilularis*) dominated shrubland on both sides of the road.

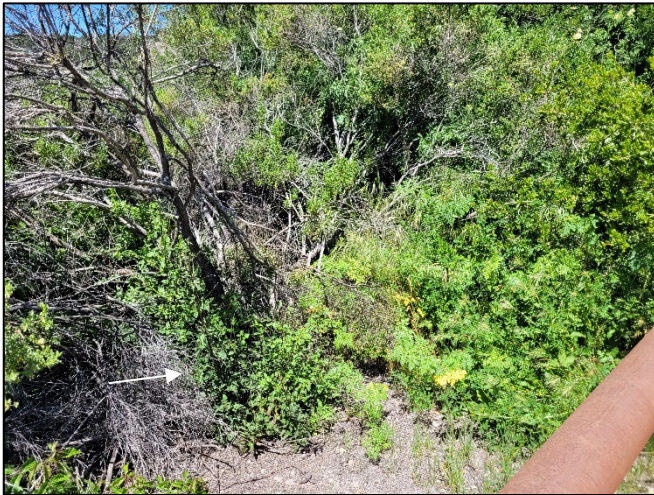
Photograph 9. View of black-flowered figwort (*Scrophularia atrata*) in flower (white arrow), with existing aboveground pipeline on right.

Although basal leaves are present year-round, no black-flowered figworts were identified during the December 2022 survey. However, a total of 12 individuals were observed in April 2023 (**Figure 3**). All individuals occurred in dense stands of coyote bush and poison oak along the eastern access road and were identified from the road edge by their tall inflorescences. Plants on the western edge of the road occurred behind the existing aboveground pipeline. Plants on the eastern side of the road are set back in the shrubland. No black-flowered figworts were observed along the western access road or in the shrubland north or south of Purisima 33.

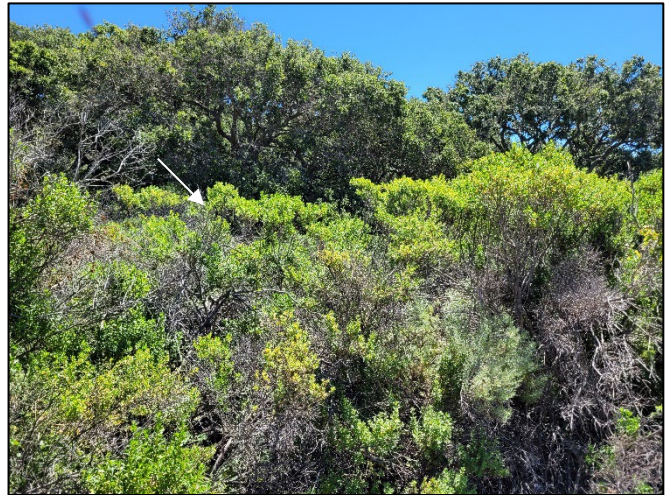
Photograph 10. View of dense shrubland east of the eastern access road. Black-flowered figwort inflorescence indicated with white arrow.

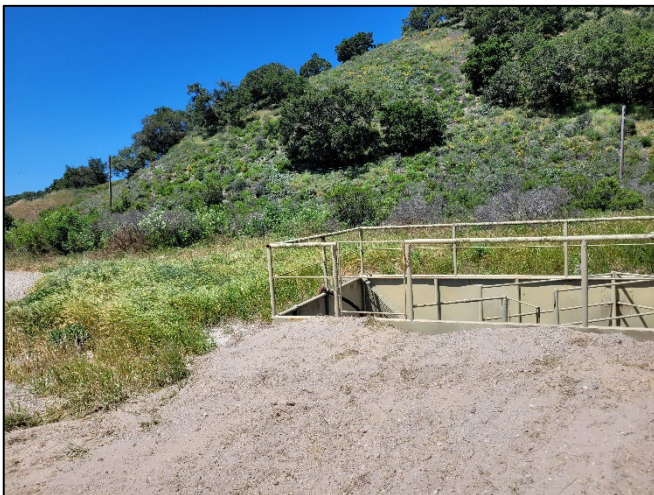
Photograph 11. View of disturbed, weed-dominated area around existing infrastructure north of the eastern access road, with native shrubland on slope in the background.

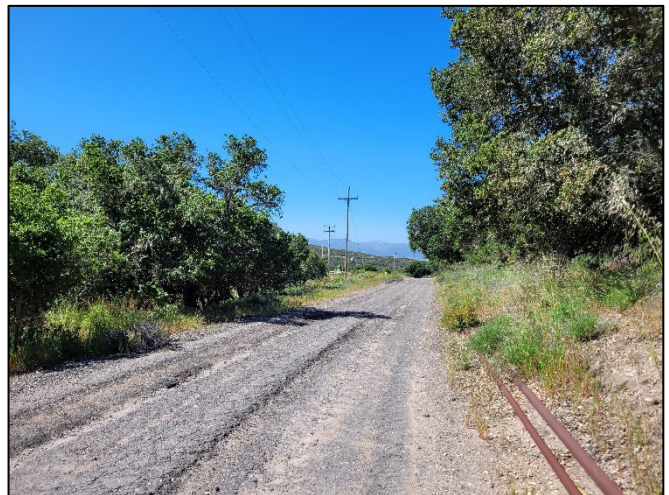
Photograph 12. View along the western access road during the April 2023 survey, facing south.

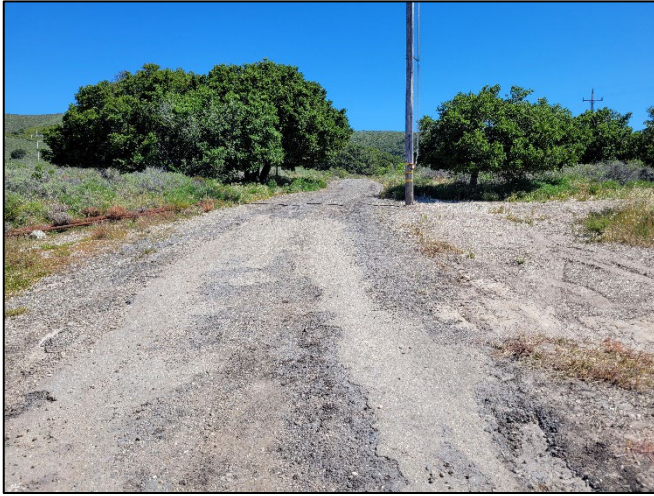
Photograph 13. View north from the end of the western access road.
