LETTER OF MAP REVISION FLOODWAY DETERMINATION DOCUMENT

U.S. COAST GUARD HOUSING FACILITY, COMMUNICATIONS AREA MASTER STATION PACIFIC
(CAMSPAC), POINT REYES STATION, CALIFORNIA

POINT REYES COAST GUARD HOUSING
100 COMMODORE WEBSTER DRIVE
 Point Reyes Station, California

**FORMER COAST GUARD SITE
POINT REYES STATION**

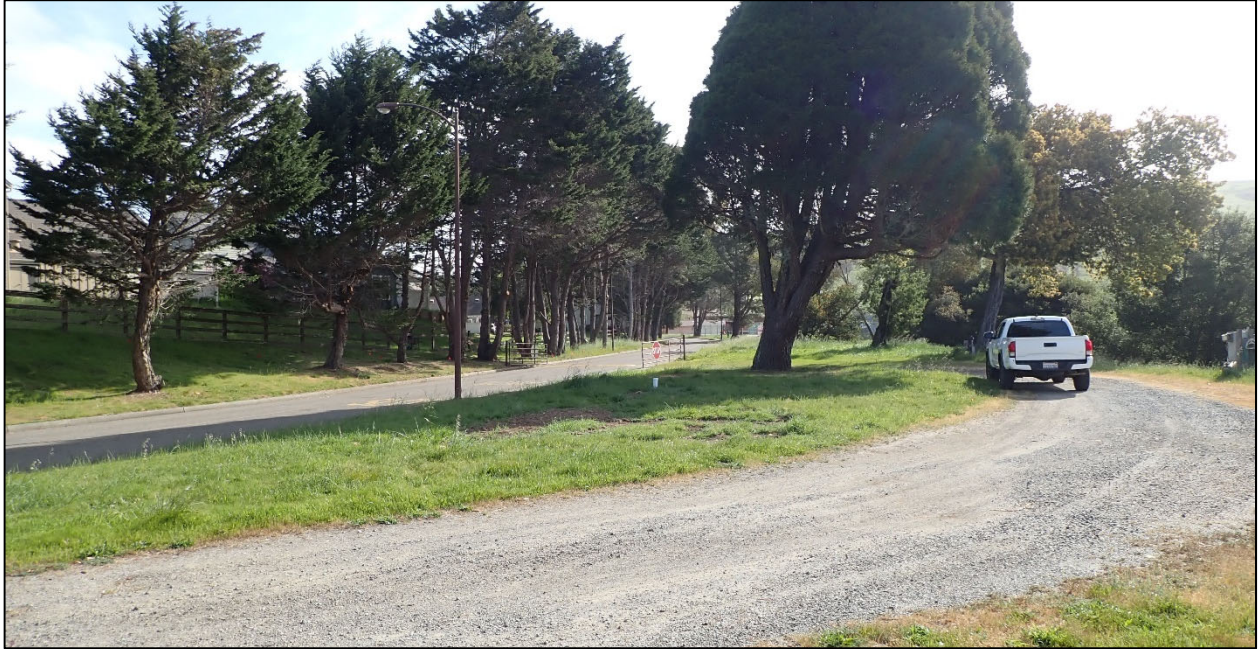
Photograph 1. Photograph depicting developed/landscaped area including the entry road at left and existing gravel parking area in the Project Area. Photograph taken April 9, 2021.

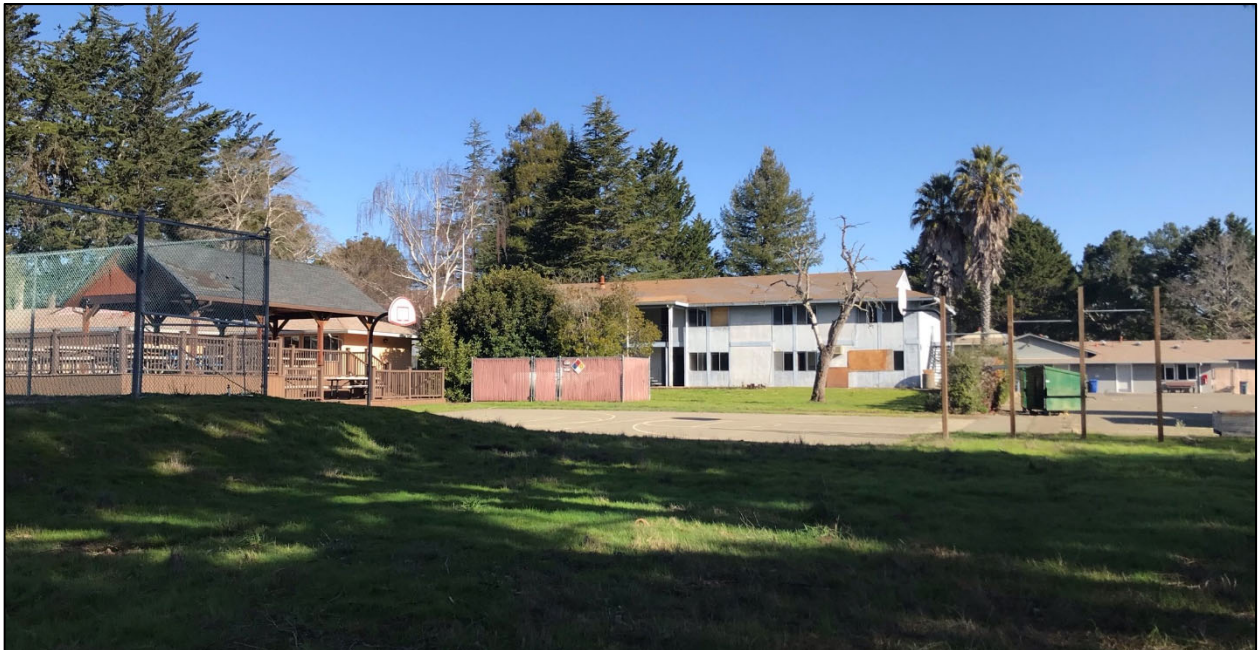
Photograph 2. Photograph depicting developed/landscaped area consisting of the previously developed USCG housing site. Photograph taken April 9, 2021.

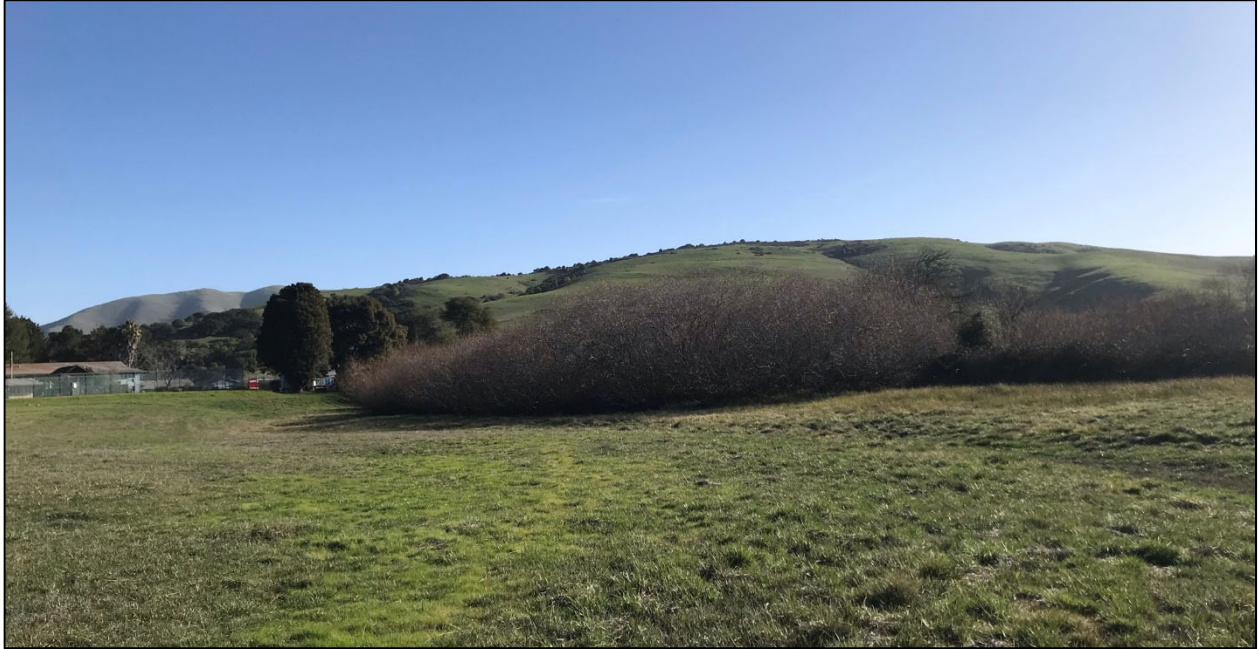
Photograph 3. Photograph depicting low-lying CCC seasonal wetland and Corps seasonal wetland area (aquatic ESHAs) in foreground in southwest portion of Study Area, outside of Project Area. Riparian arroyo willow thicket (aquatic ESHA) seen in the background. Photograph taken January 20, 2021.

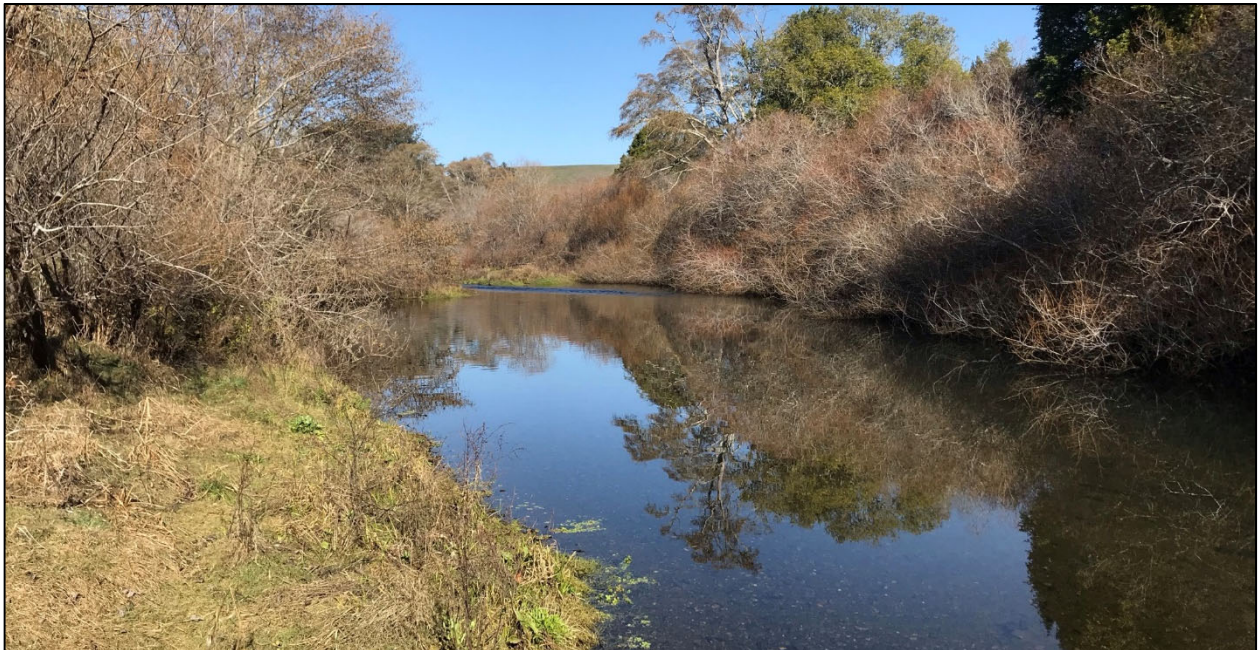
Photograph 4. Photograph a representative portion of Lagunitas Creek, an aquatic ESHA, within the Study Area (left bank and riparian are in the Study Area; area across creek outside of Study Area). Photograph taken January 20, 2021.

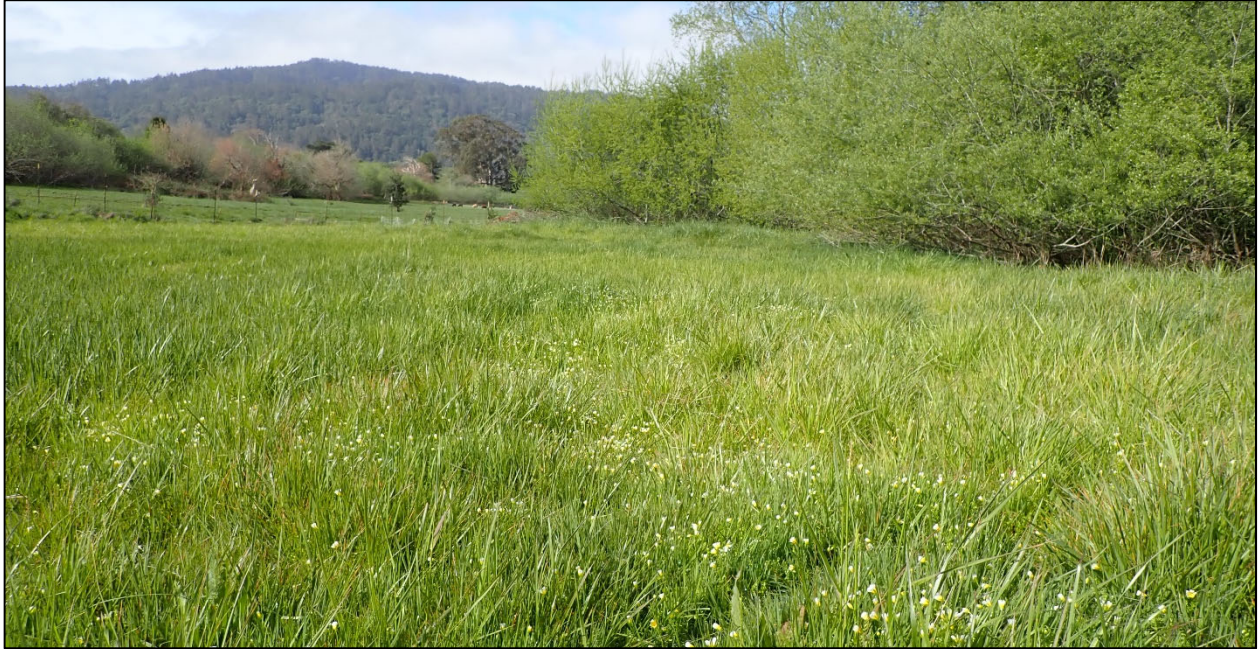
Photograph 5. Photograph depicting a Corps seasonal wetland, an aquatic ESHA, in the southwestern portion of the Study Area. Photograph taken April 9, 2021.

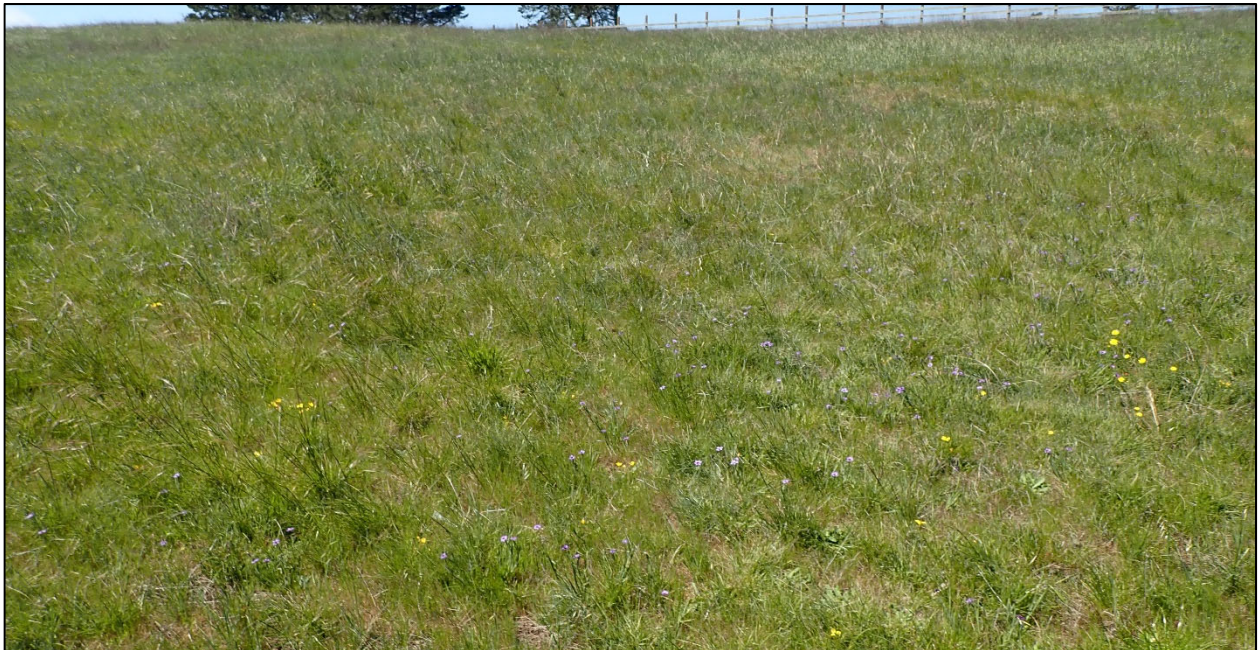
Photograph 6. Photograph depicting purple needlegrass grassland, a terrestrial ESHA in the northeast portion of the Study Area on a slope above the developed/landscaped area. Photograph taken April 9, 2021.

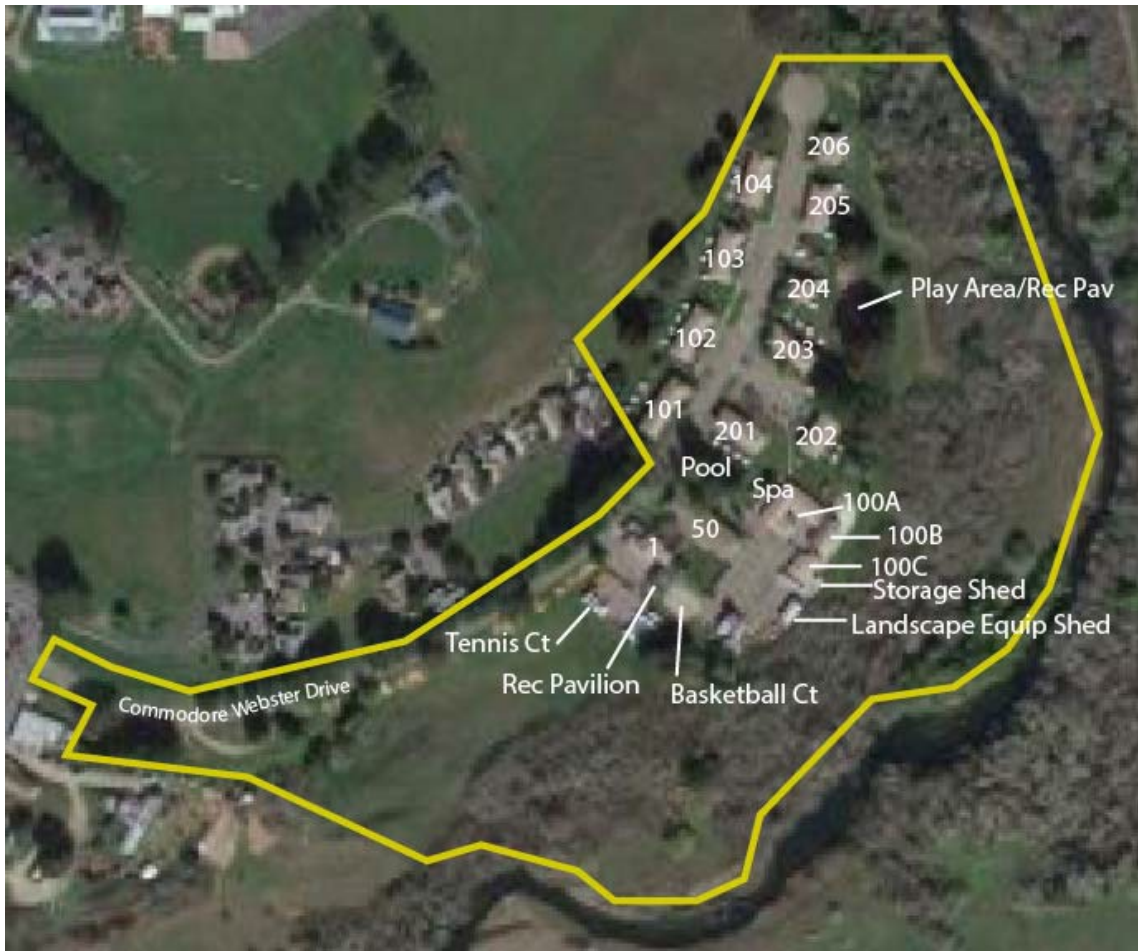
Figure B: Site Plan prepared by Groundwork Planning & Preservation. Base: Google Earth aerial, 2023.

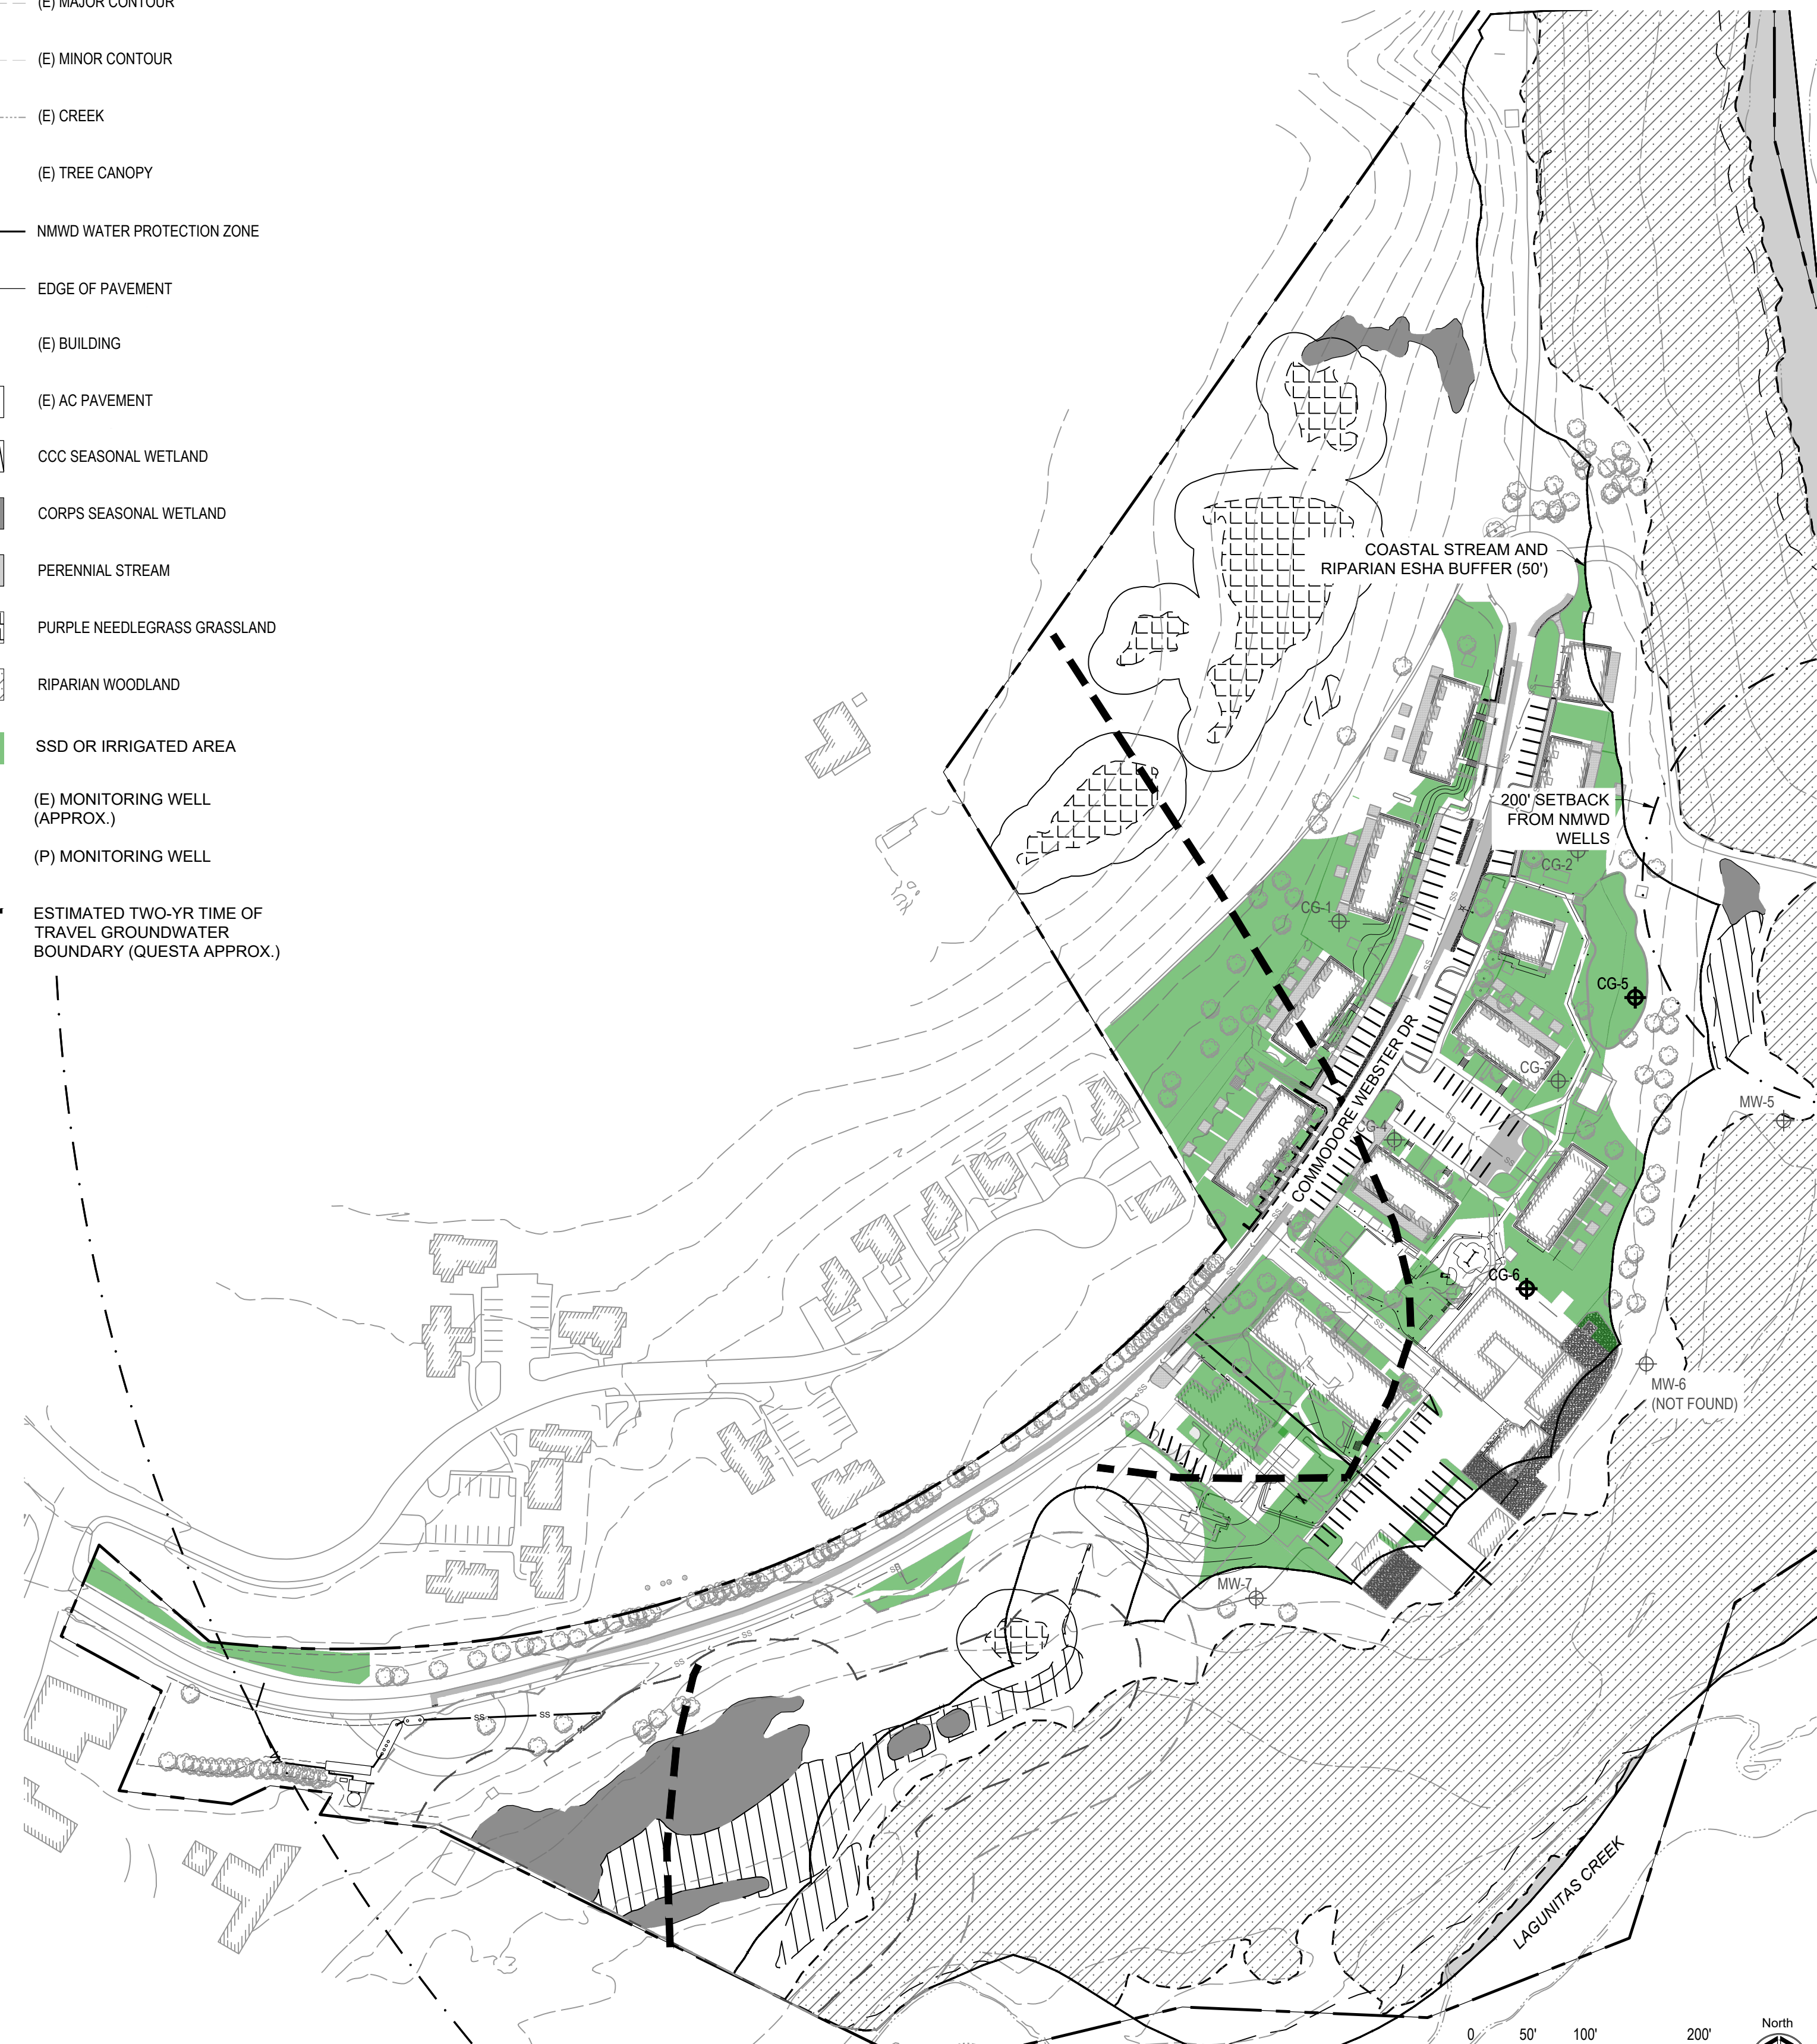
NOTES
 1. PROPOSED IRRIGATED AREAS PROVIDED BY BAY TREE DESIGN ON 3/29/22 AND SHOULD ONLY BE INTERPRETED AS CONCEPTUAL.

3 IRRIGATED AREAS (121,000 SF, CONCEPTUAL)

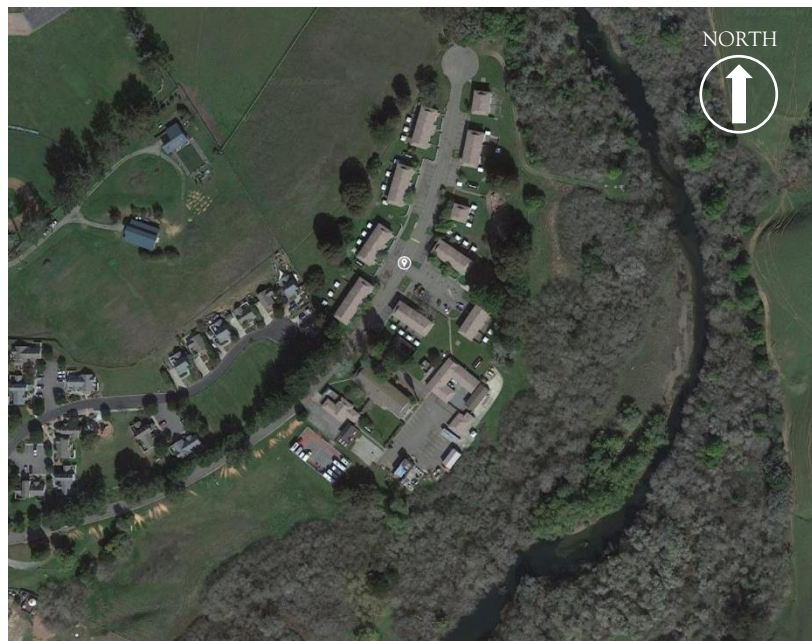
Figure 2: Existing Site Conditions

The soil is approximately 60% xerorthents and 40% Cortina, which is a gravelly sandy loam. It has a hydrologic rating of A, meaning that it has a low runoff potential, and very good infiltration. The Cortina unit is primarily located north of Commodore Webster Drive, where only minor work is taking place. The majority of work will occur on xerorthents.
