Draft Mitigated Negative Declaration 23NGD-00007

PLSB, LLC Residence & Accessory Structures

20CDH-00000-00022 & 23CUP-00001

March 2024

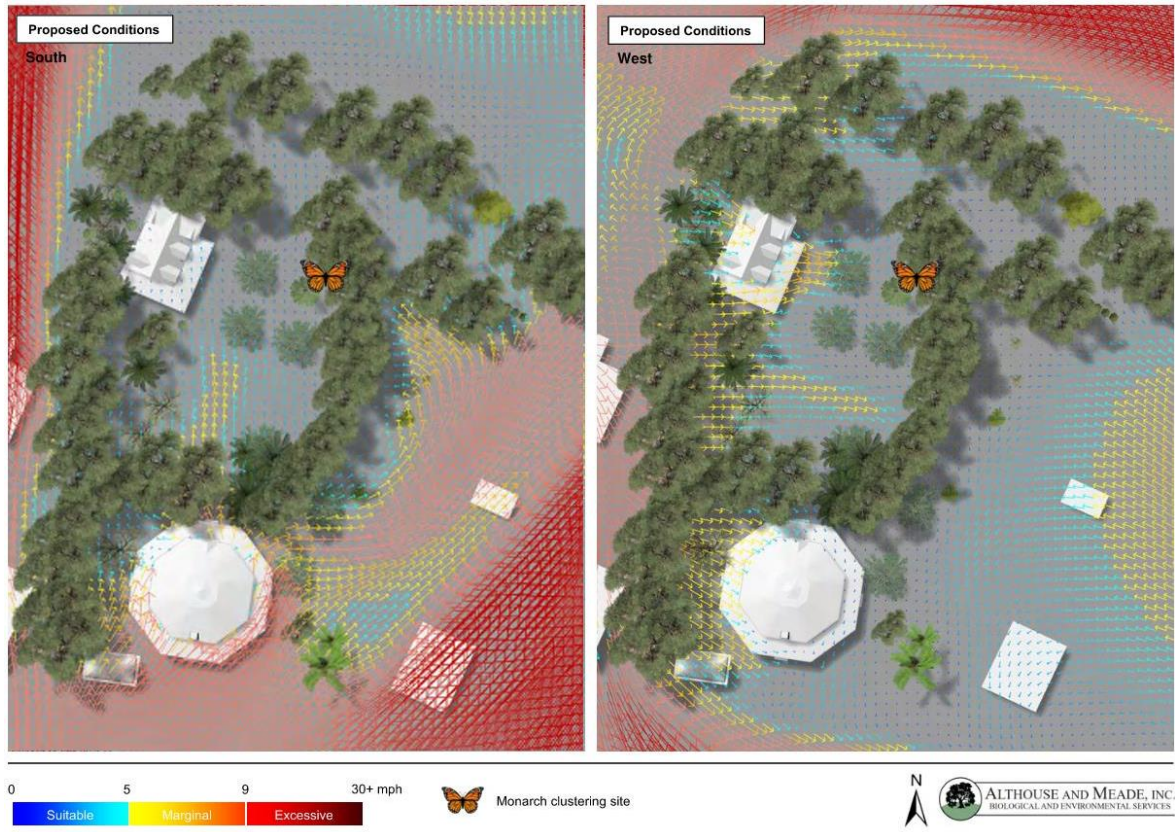
FIGURE 8. SOUTH AND WEST GAP OVERVIEW, PROPOSED CONDITIONS.

To assess changes in sheltering dynamics around the monarch aggregation site, the Monarch Butterfly Habitat Conservation and Enactment Plan (HCEP) modeled existing and proposed wind conditions using microclimate airflow simulations. Current conditions identify two locations of “gaps” which allow wind to hit the overwintering site: the South and West Gap. For proposed conditions, site plans for the proposed buildings were georeferenced to the Study Area model. As a result of the models, the proposed additional trees and main house height, bulk and scale contribute to greater wind protection in the proposed condition, “plugging” the South Gap, therefore improving habitat quality by reducing wind speeds under storm conditions where the butterflies aggregate. The size of proposed buildings create advantageous wind breaks that help reduce strong winds, and the locations are placed strategically in the most vulnerable gaps identified in existing canopy. Construction of the proposed ancillary building on the west side of the property would provide wind blockage equivalent to or better than the current wind protection from the west at the West Gap. The two story building fills the West Gap and reduces wind speeds around the aggregation site. The additional plantings of island oak reinforce this wind protection, creating suitable conditions in and around the monarch clustering area (Figures 8 & 9).

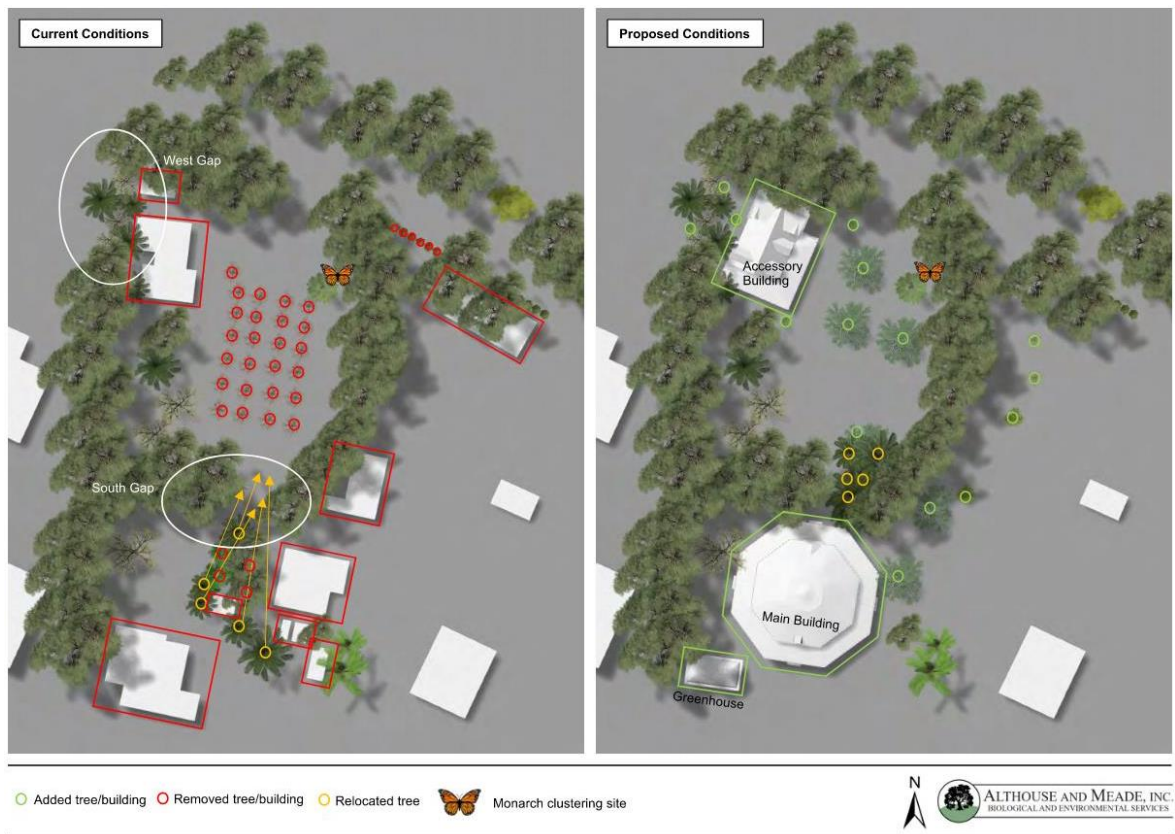
FIGURE 9. CHANGES FROM CURRENT TO PROPOSED CONDITIONS.

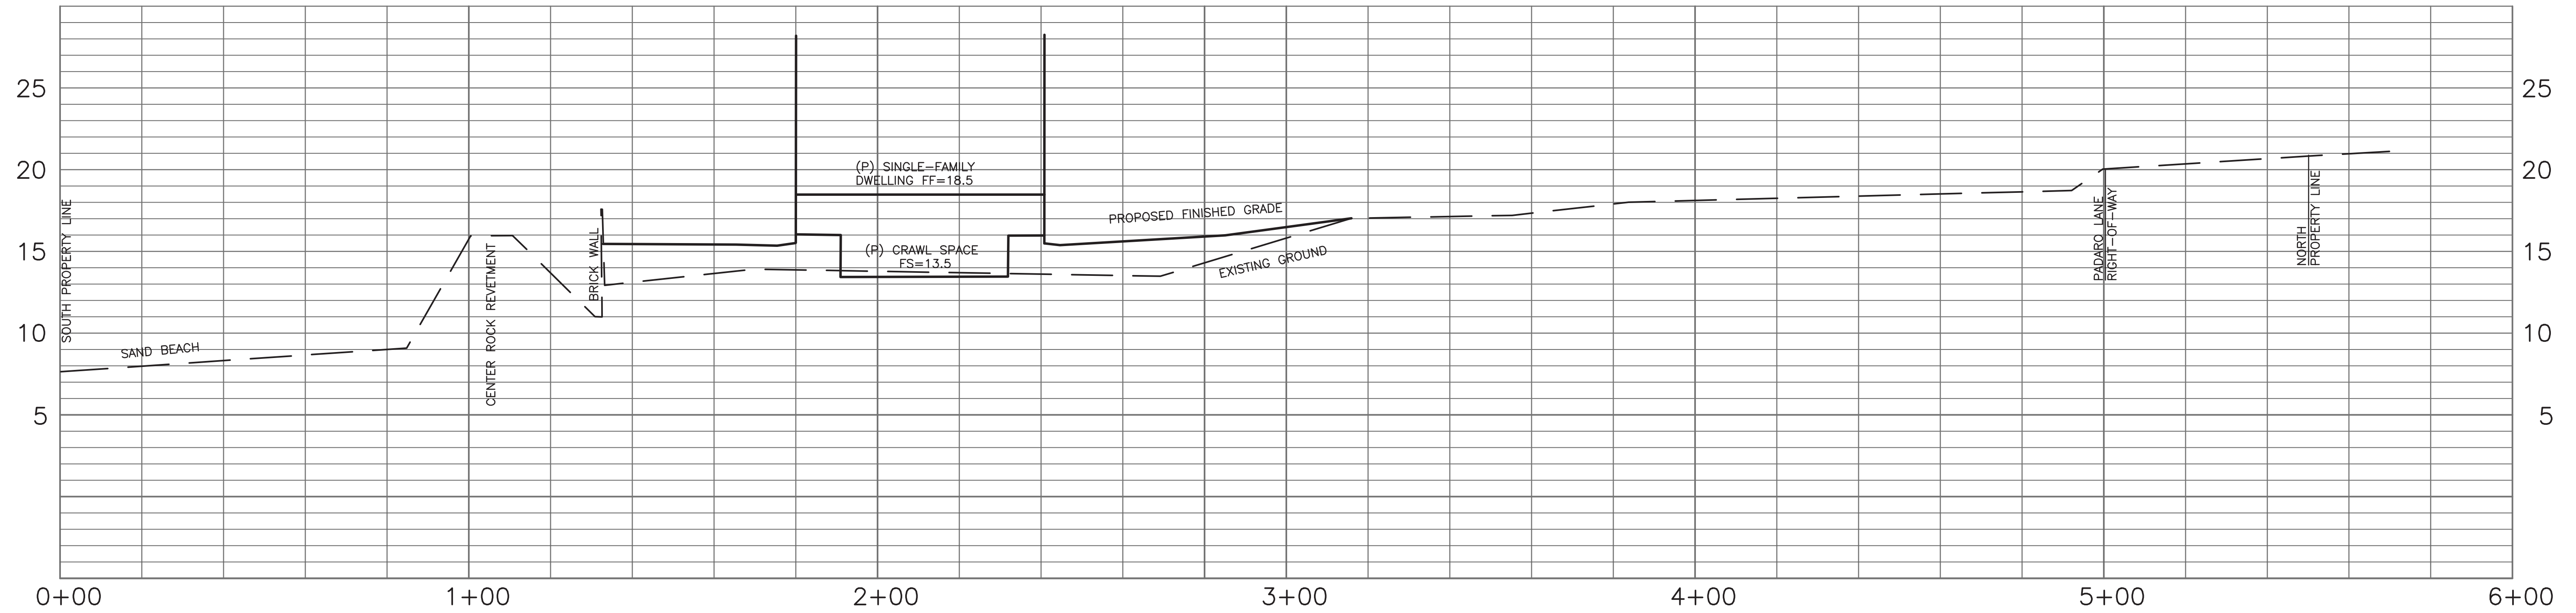
SECTION "A-A"

SCALE: HORIZONTAL - 1"=20' ; VERTICAL - 1"= 5'

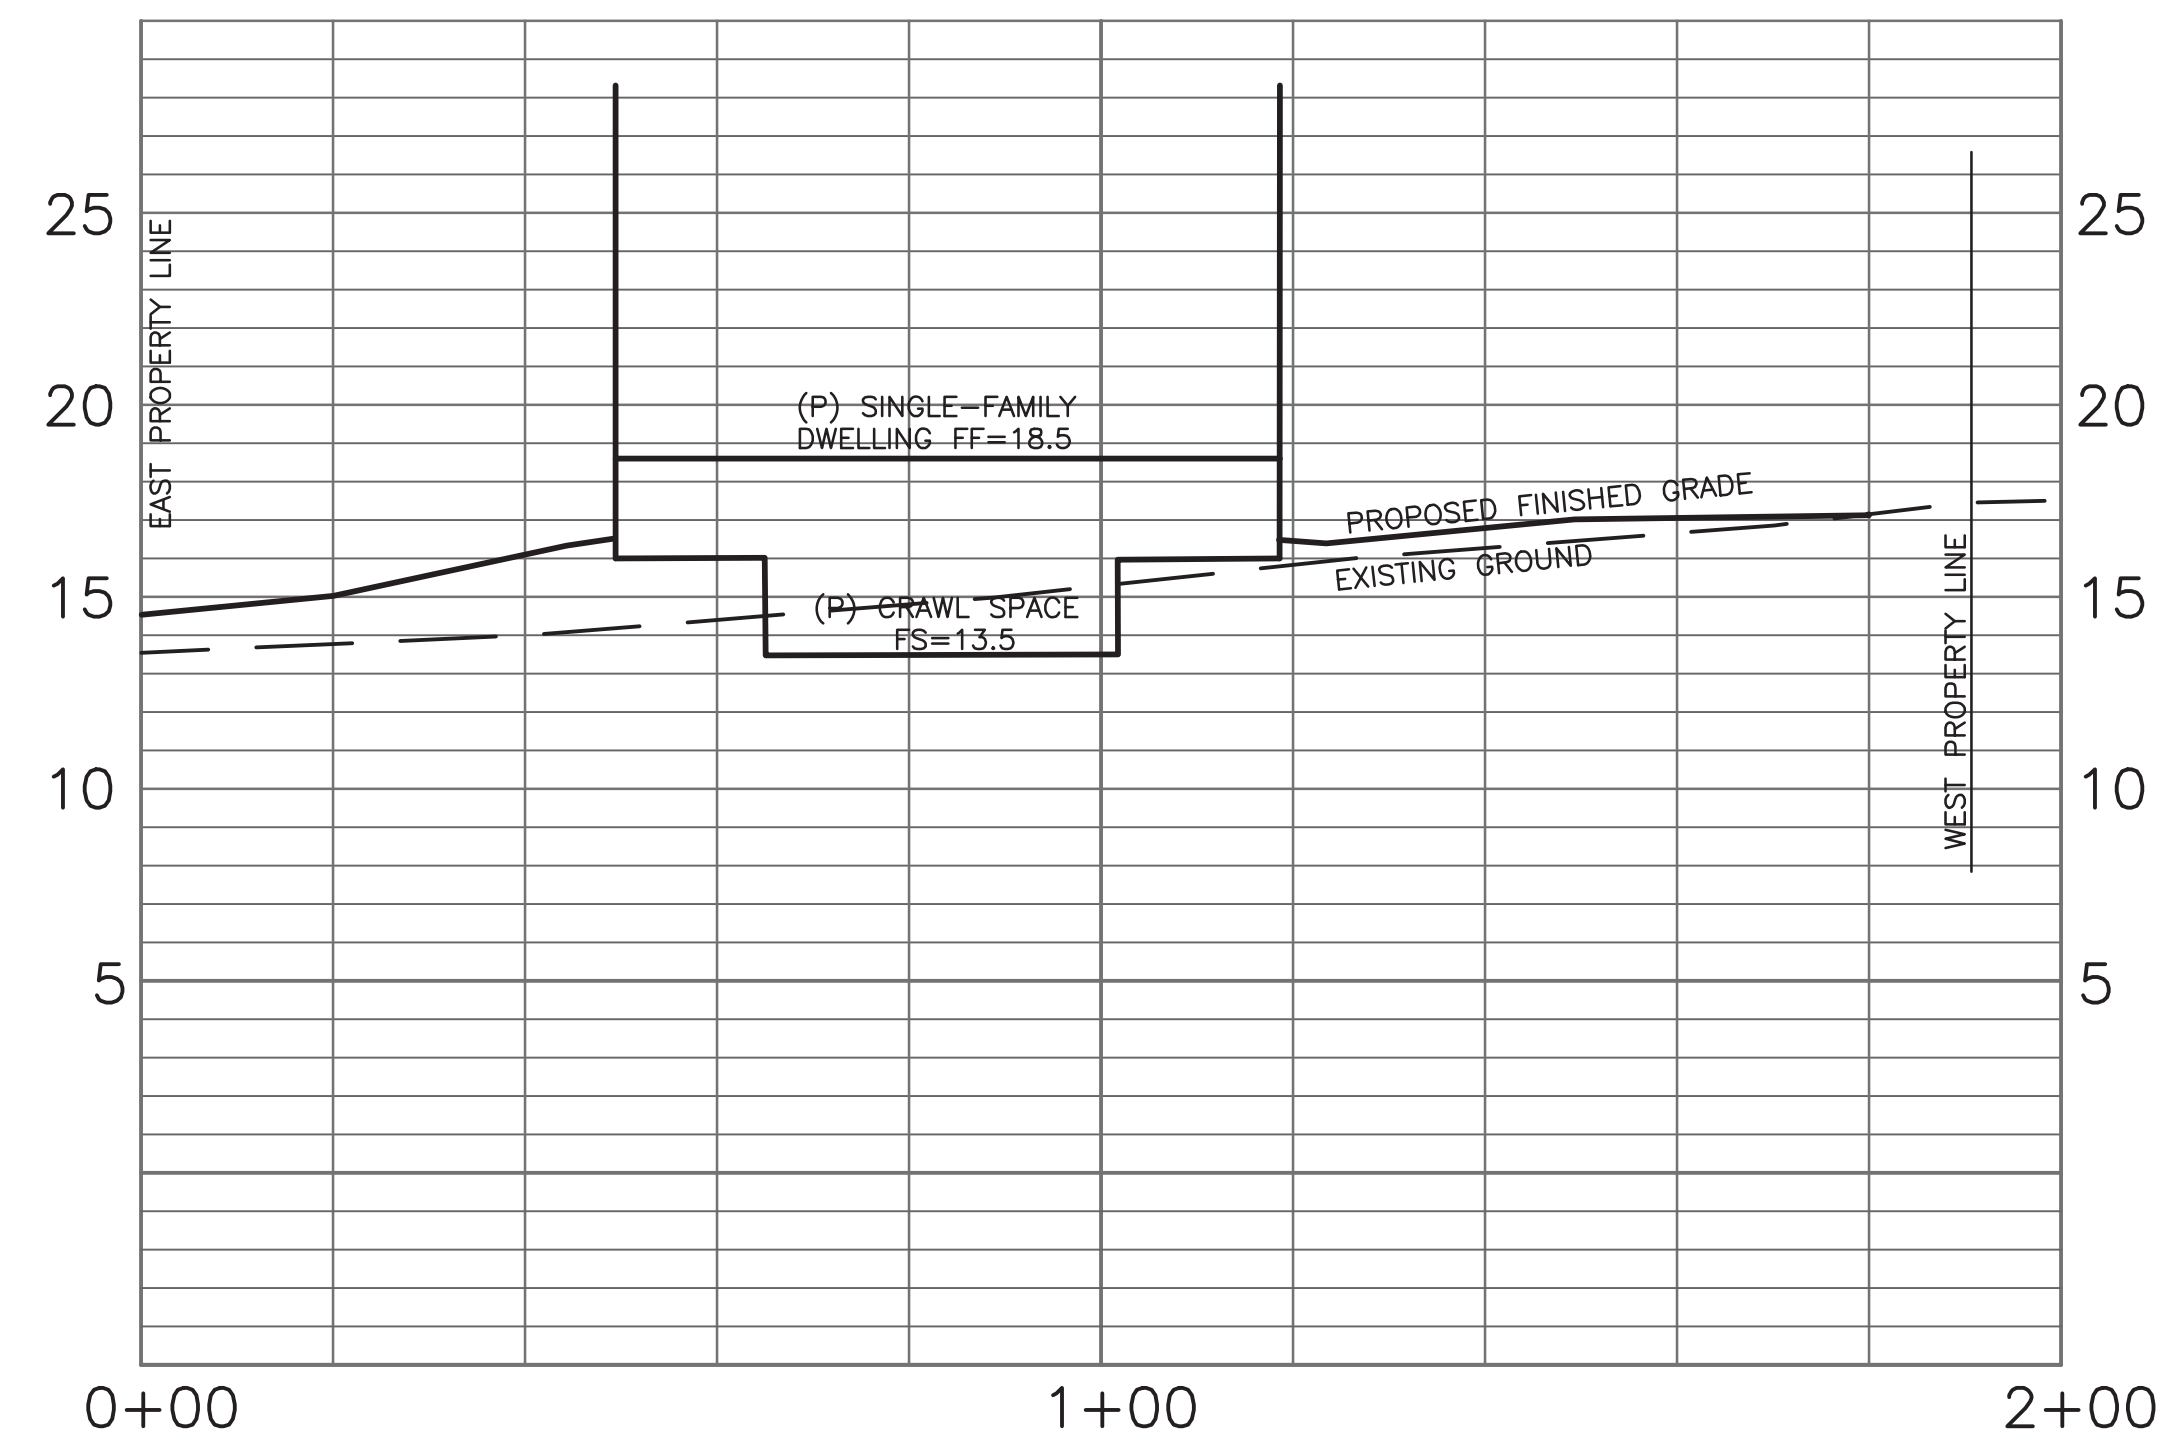
SECTION "B-B"

SCALE: HORIZONTAL - 1"=20' ; VERTICAL - 1"= 5'

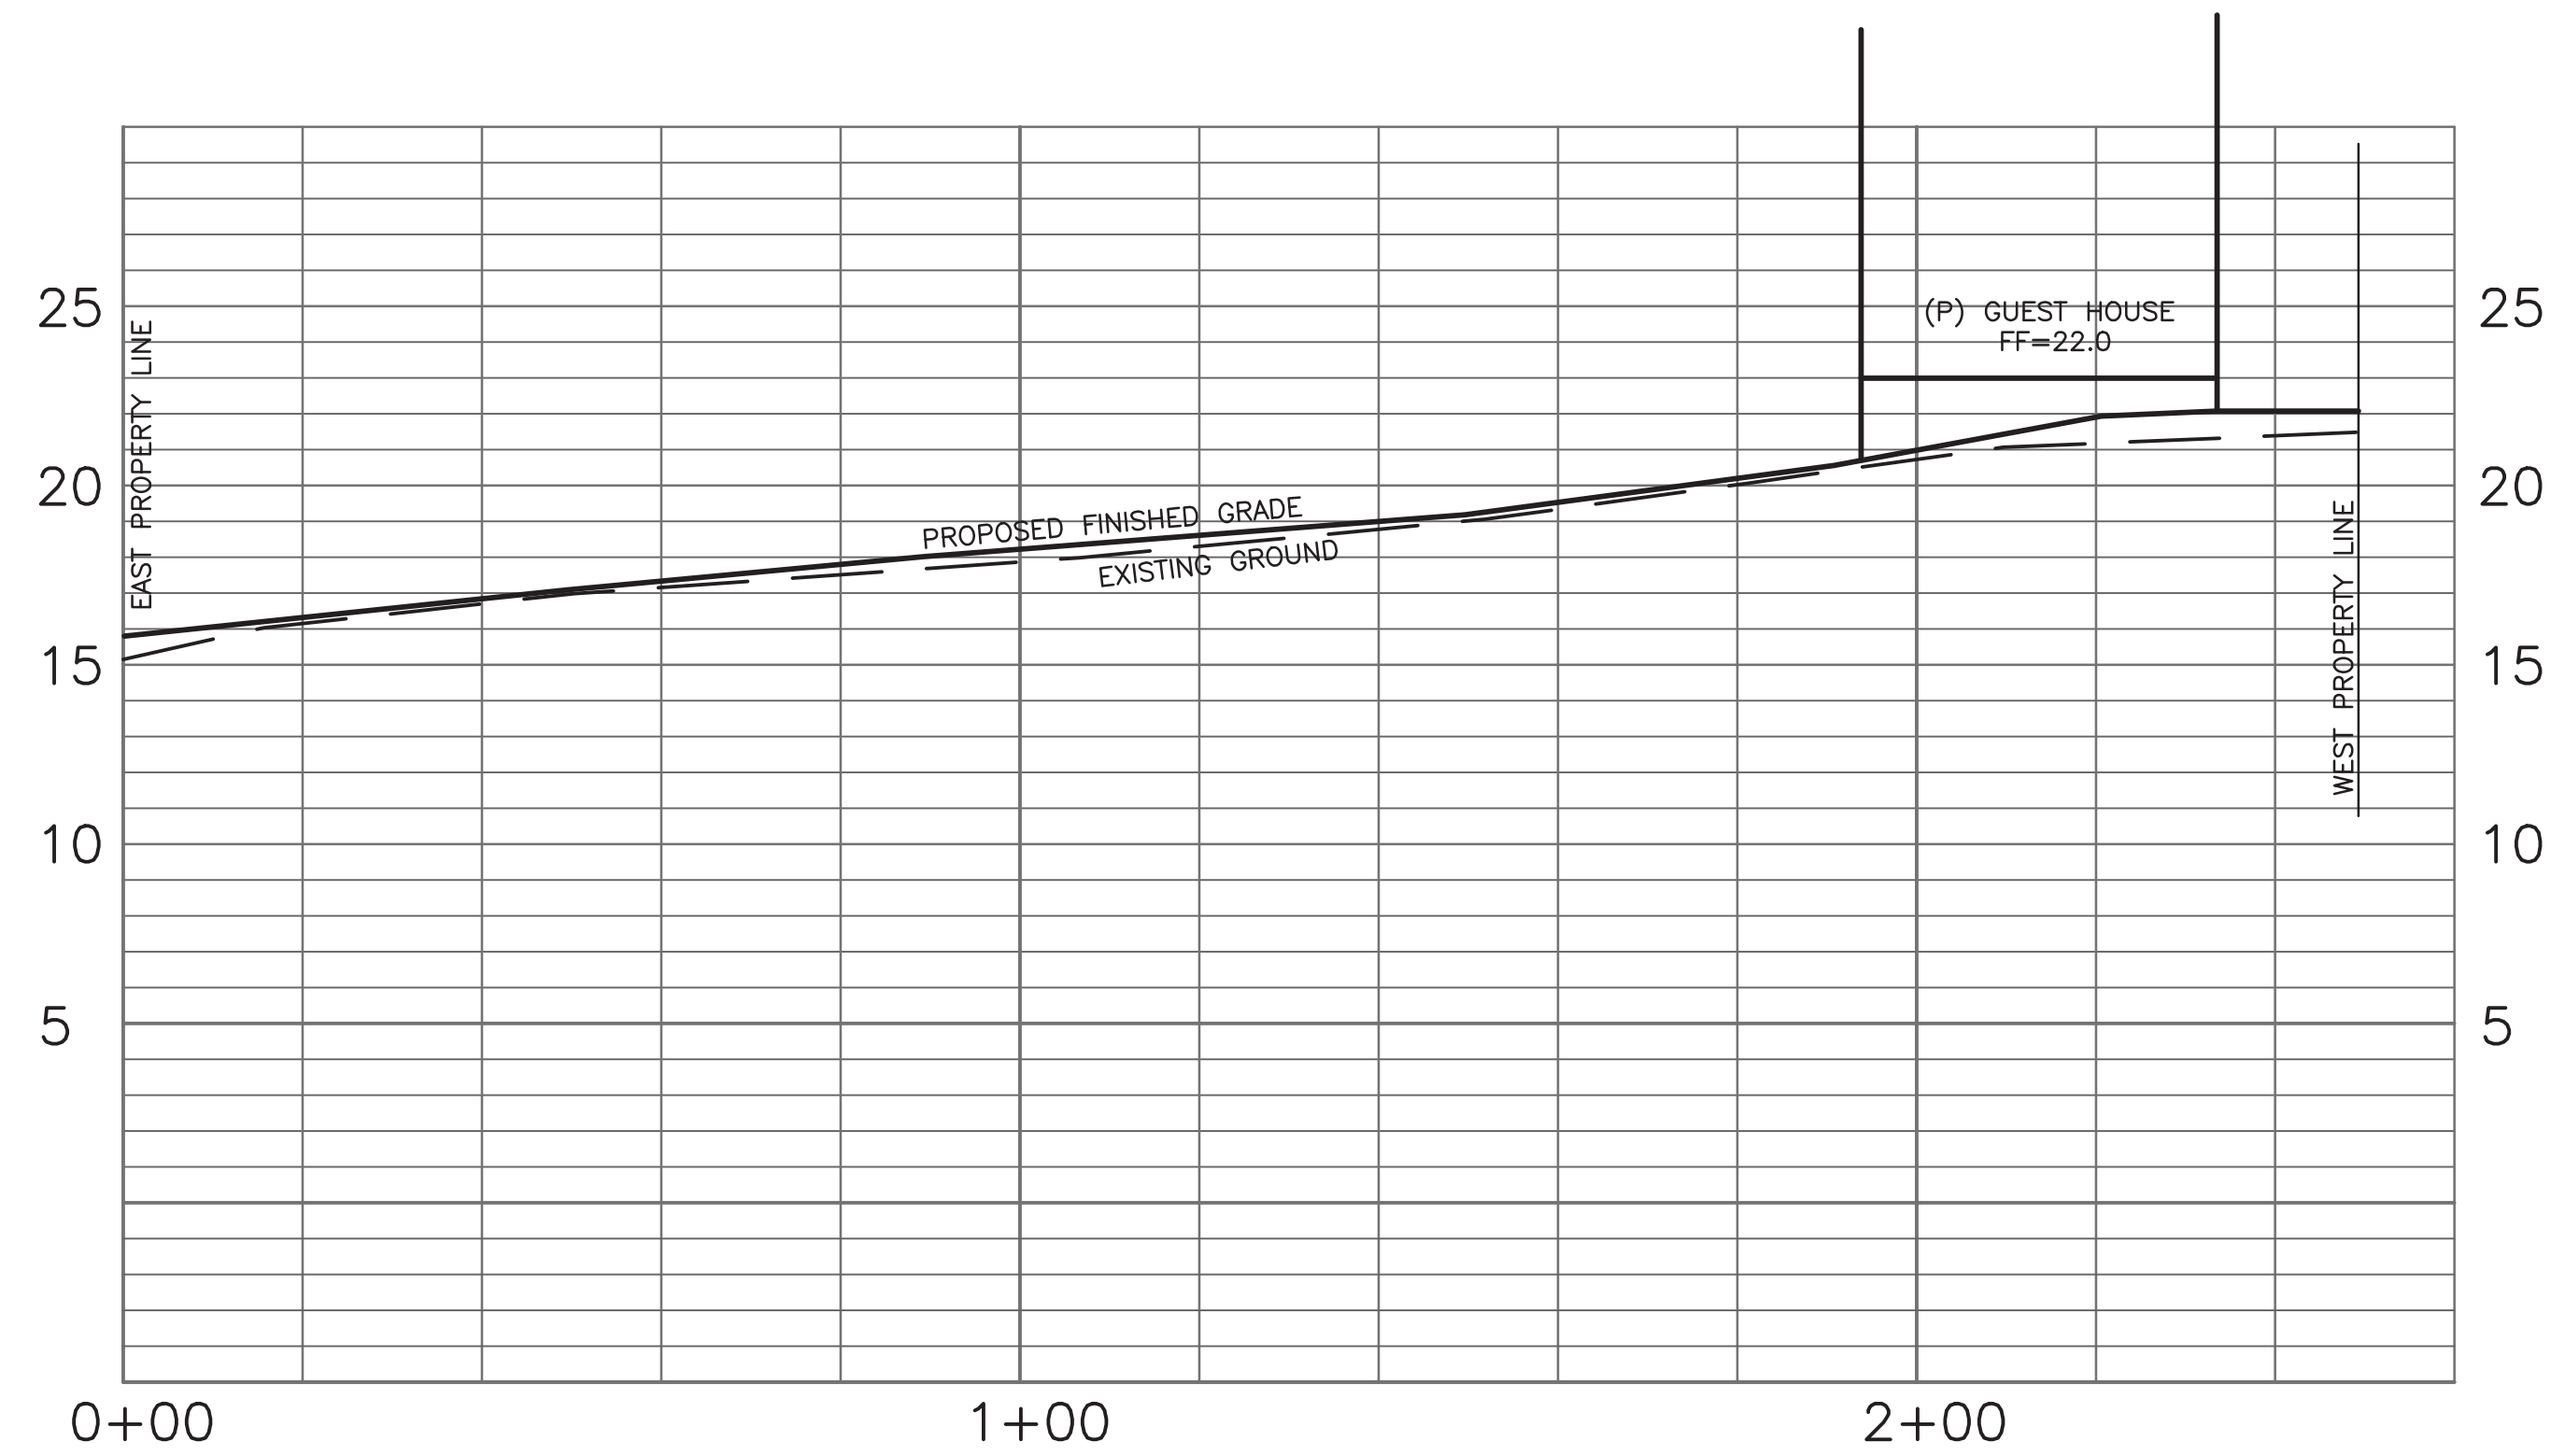
SECTION "C-C"

SCALE: HORIZONTAL - 1"=20' ; VERTICAL - 1"= 5'

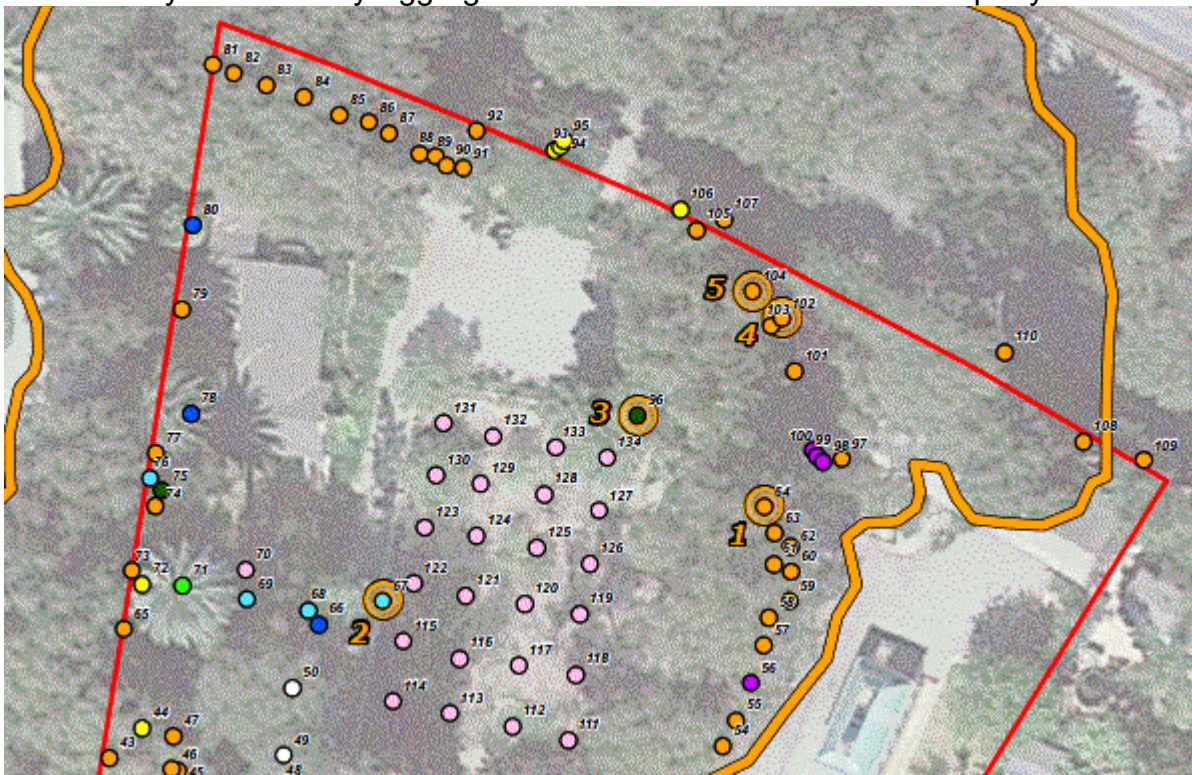
Tree Inventory and Butterfly Aggregation Sites Northern Section of Property

Figure 1. An aerial view of the north half of the property with all trees numbered and highlighted in designated colors (refer to the color key in Figure 2, page 3 below). The irregular orange line represents the outline of potential roosting sites. Five aggregation sites are noted. Graphic is courtesy of Watershed Environmental, Inc., the organization which performed the survey. A key to the colored tree representations can be found in Figure 2, page 3.

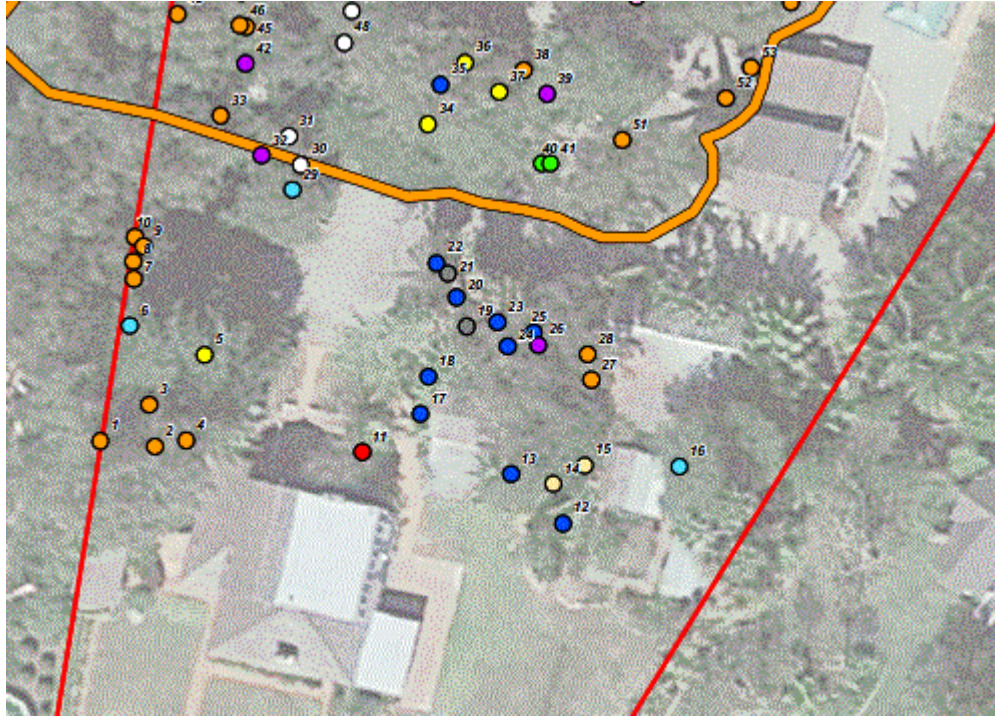
Tree Inventory Showing the Southern Section of the Property

Figure 2. Graphic shows the south half of the property. No current butterfly roosting sites are found here. Potentially, there may be future sites within the irregular orange line.

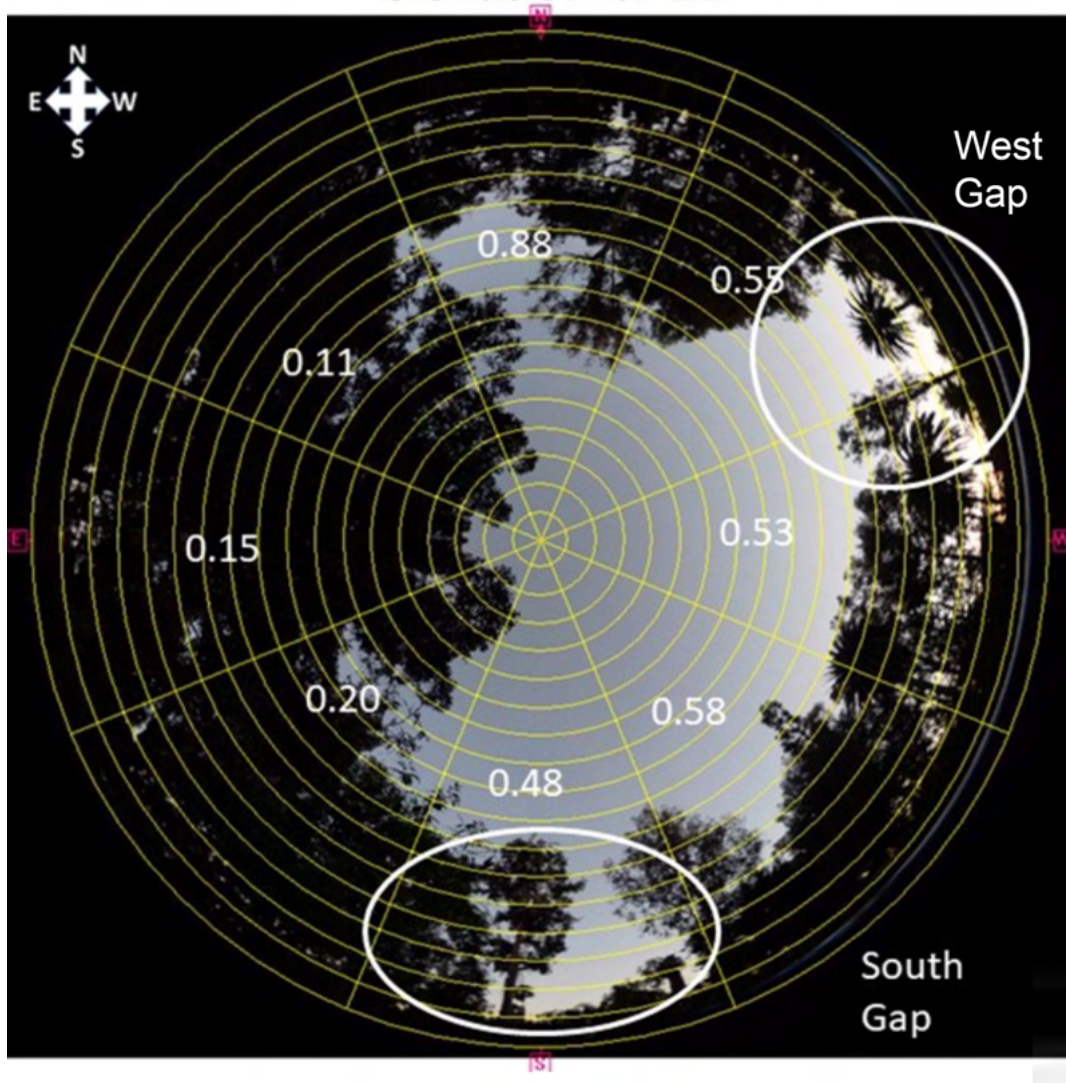
EXHIBIT 1. HEMIPHOTO AT CLUSTER TREE

The sun paths are divided into monthly bands going E to W (left to right) across the photo, divided into half-hour time slices (Exhibit 3). Fully shaded is when a sector is totally blocked, dappled light of varying intensities is where many small holes in the canopy are visible, and full sun when the sky is open. Apparent sunpaths are quite sensitive to the height of observation – sites that are completely shaded at ground level may be in bright sun 20 ft up in the canopy, depending on the exact configuration of branches and canopy gaps.

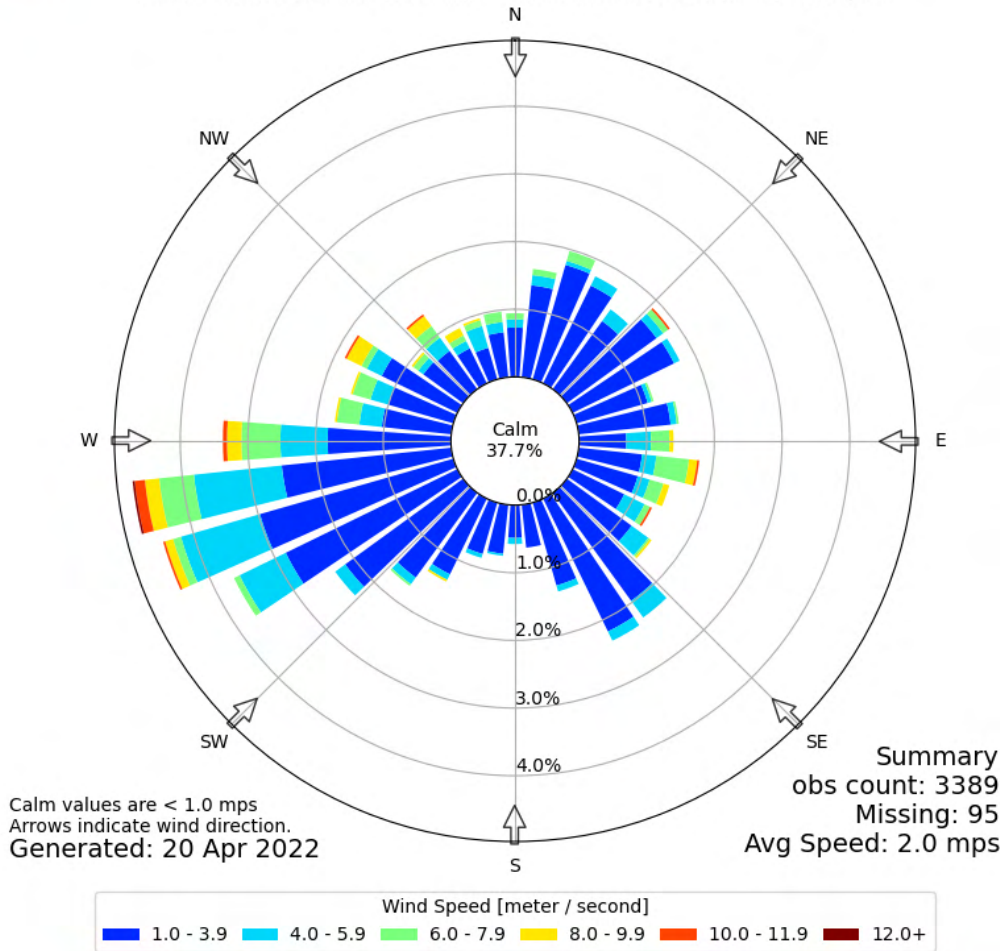
EXHIBIT 2. WIND DATA

[SBA] SANTA BARBARA MUNI
 Windrose Plot
 Time Bounds: 05 Oct 2020 08:02 PM - 18 Feb 2021 11:53 PM America/Los_Angeles

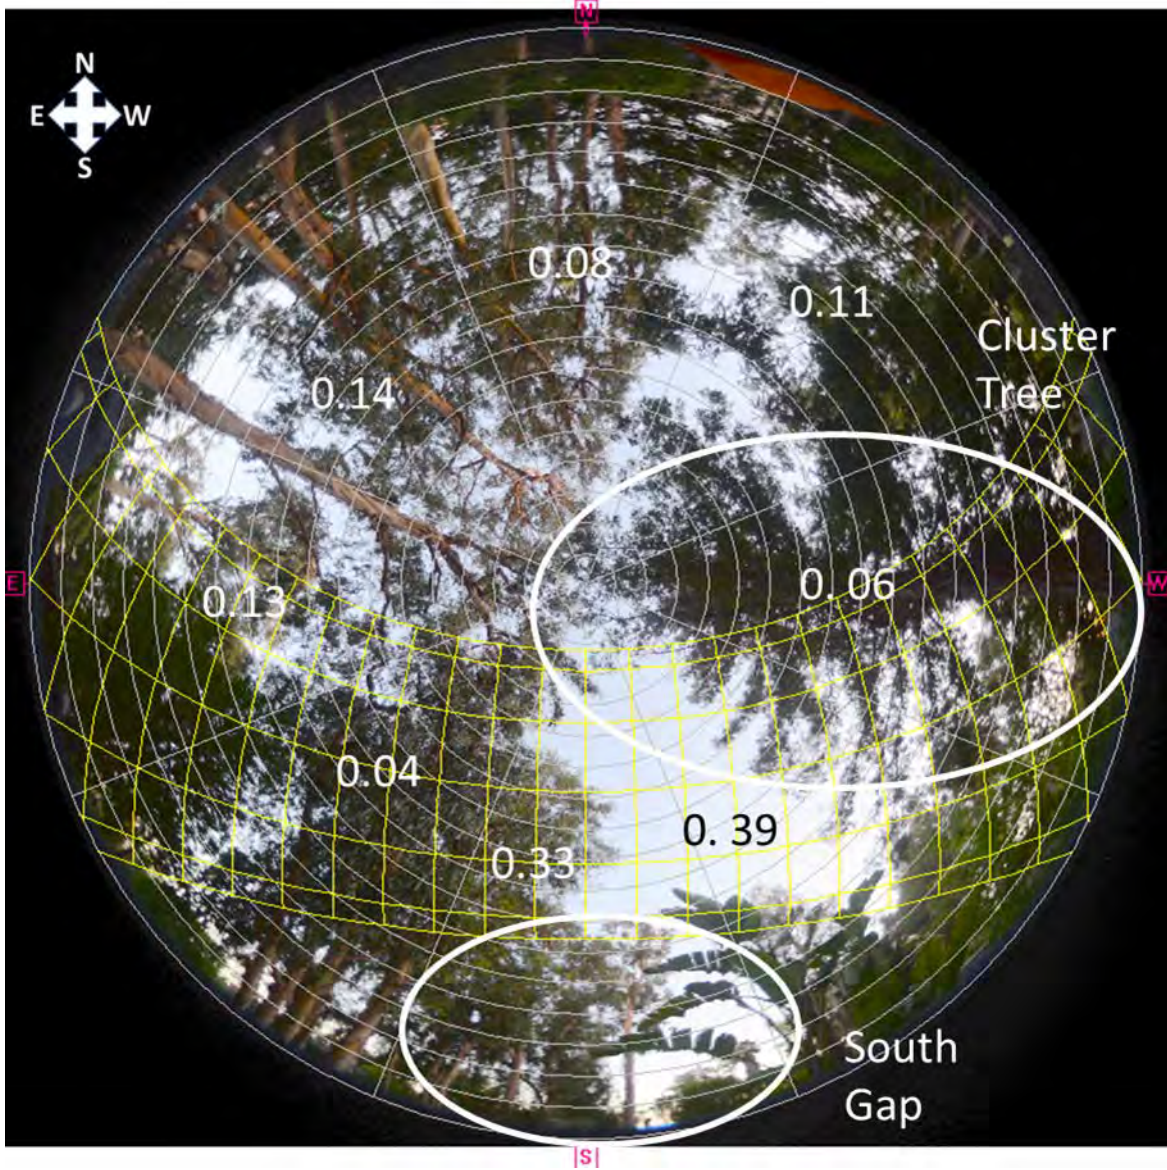
EXHIBIT 4. HEMISPHERICAL PHOTO AT THE ENE SIDE OF THE PRIMARY CLUSTERING TREE

Wind vulnerabilities are circled. Percent of open sky is given in each octant. This photo was taken SW of the cluster tree, at an elevation of 11' (3.5 m), to obtain a view unobstructed by the short trees in the orchard. Exposure factors are posted in each azimuth octant. The West Gap is a wind vulnerability. The palms on the adjacent property provide the primary wind shelter in that gap above 10' elevation. The South Gap is a wind vulnerability. The clump of trees in that gap (including the palm just visible) provides the only wind shelter for the cluster tree from that direction, and the shelter does not extend to higher elevations. Plugging this gap with the building itself and tall trees would improve wind protection.

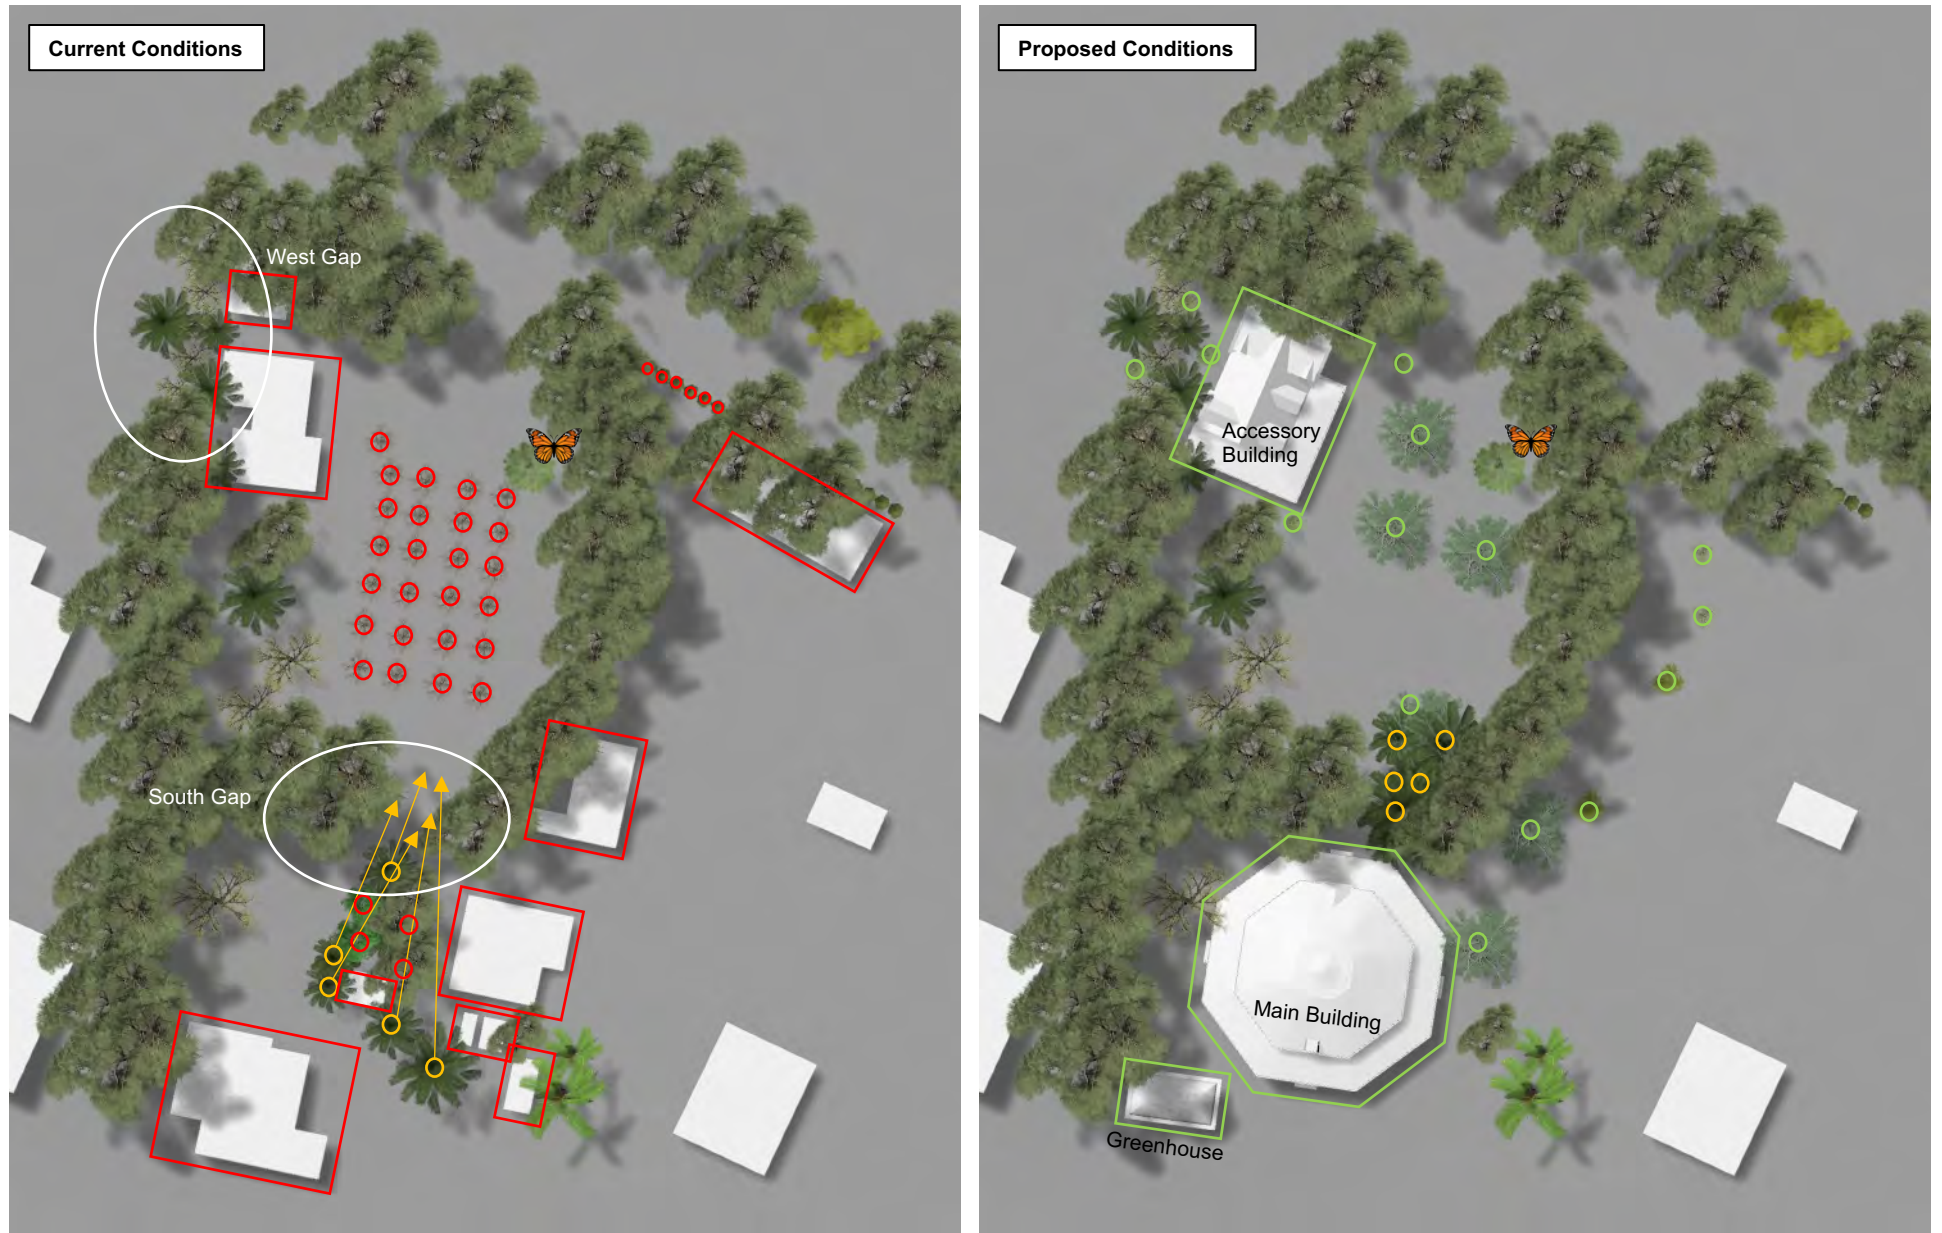
Figure 5. Changes from Current to Proposed Conditions

○ Added tree/building ○ Removed tree/building ○ Relocated tree 🦋 Monarch clustering site

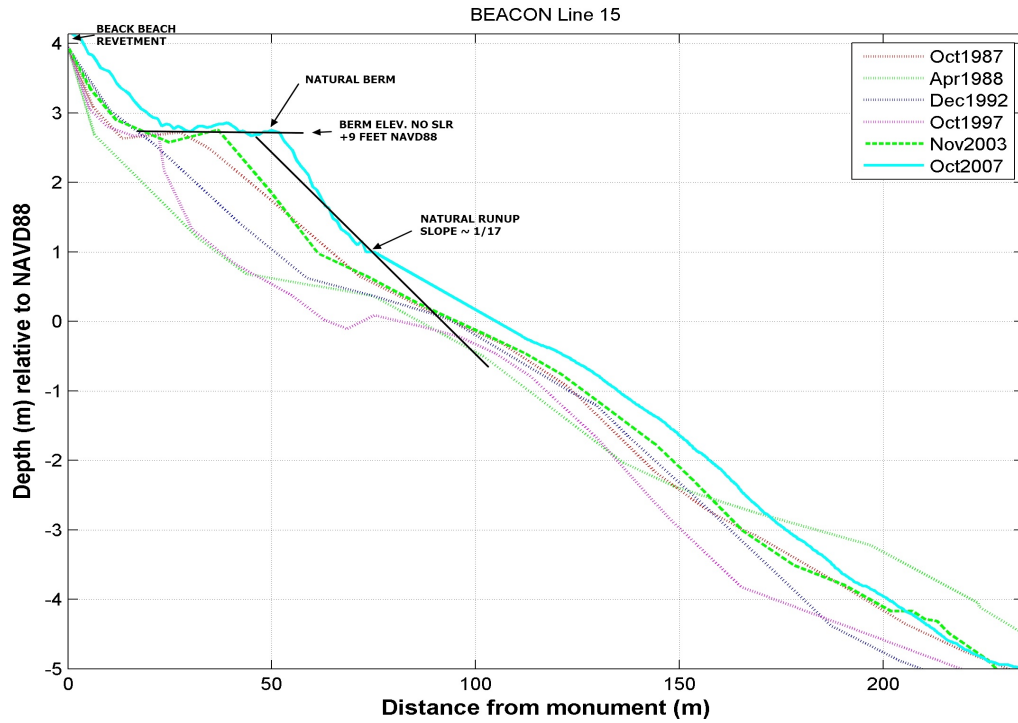
Tides are taken from the National Oceanic and Atmospheric Administration (NOAA) tidal station at Santa Barbara, see Figure 3. The historical design ocean water level will be 7.6 feet NAVD88, the “100 Year” water level. Site topography, attached as APPENDIX I, shows site elevations from the beach at ~+10 feet NAVD88 through the site from about +14 feet NAVD88 to about ~+11 feet NAVD88, with Padaro Lane at about elevation +10.5 feet NAVD88. The “natural” beach slope is taken from the closest BEACON beach profile monitoring range line at Padaro Lane, see Figure 4. While there may be some additional profile data taken by USGS, the information is not ready for public use (Dan Hover, USGS, personal communication). The Design Beach Profile (DBP) for both the current condition and “natural beach” (no revetment) analysis is provided in APPENDIX II.

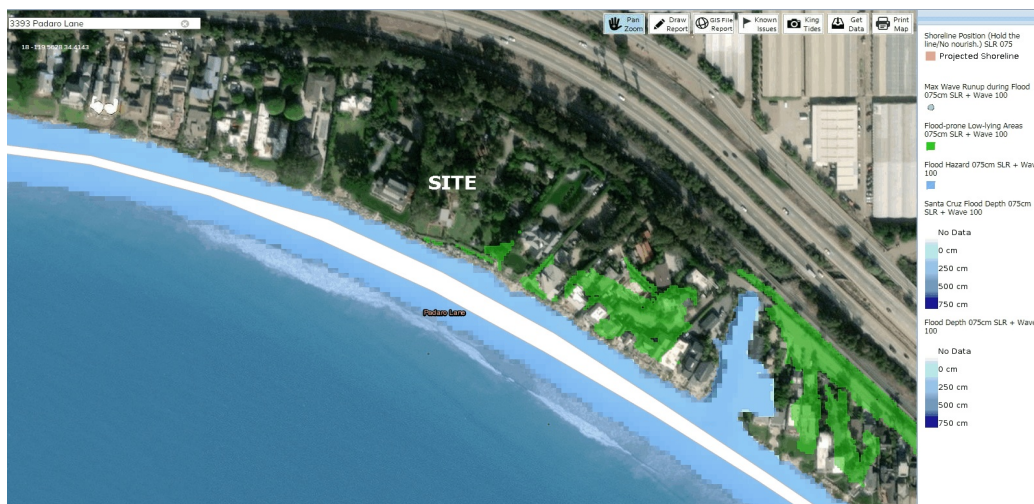
Figure 10 and Figure 11 below are the output of the CoSMoS program for the site for 75 cm SLR and 150 cm SLR under extreme design conditions. The modeling shows that offsite portions of the road, with 75 cm (2.5 feet) of SLR, are flood prone. However, the site proper is safe from wave runup, flooding, and shoreline erosion. The modeling also shows that a portion of the site will flood during the 100-year event with 150 centimeters (~4.9 feet) of SLR. In addition, Figure 11 shows that the shoreline will retreat to a location that is seaward of the proposed structure as shown on the DBP (APPENDIX II). This conservative analysis verifies that the GSI analysis and conclusions are reasonable and justified.

Figure 10. CoSMoS output at the site for the 100-year storm, 2.5 feet SLR and erosion.
