Draft Mitigated Negative Declaration 23NGD-00007

PLSB, LLC Residence & Accessory Structures

20CDH-00000-00022 & 23CUP-00001

March 2024

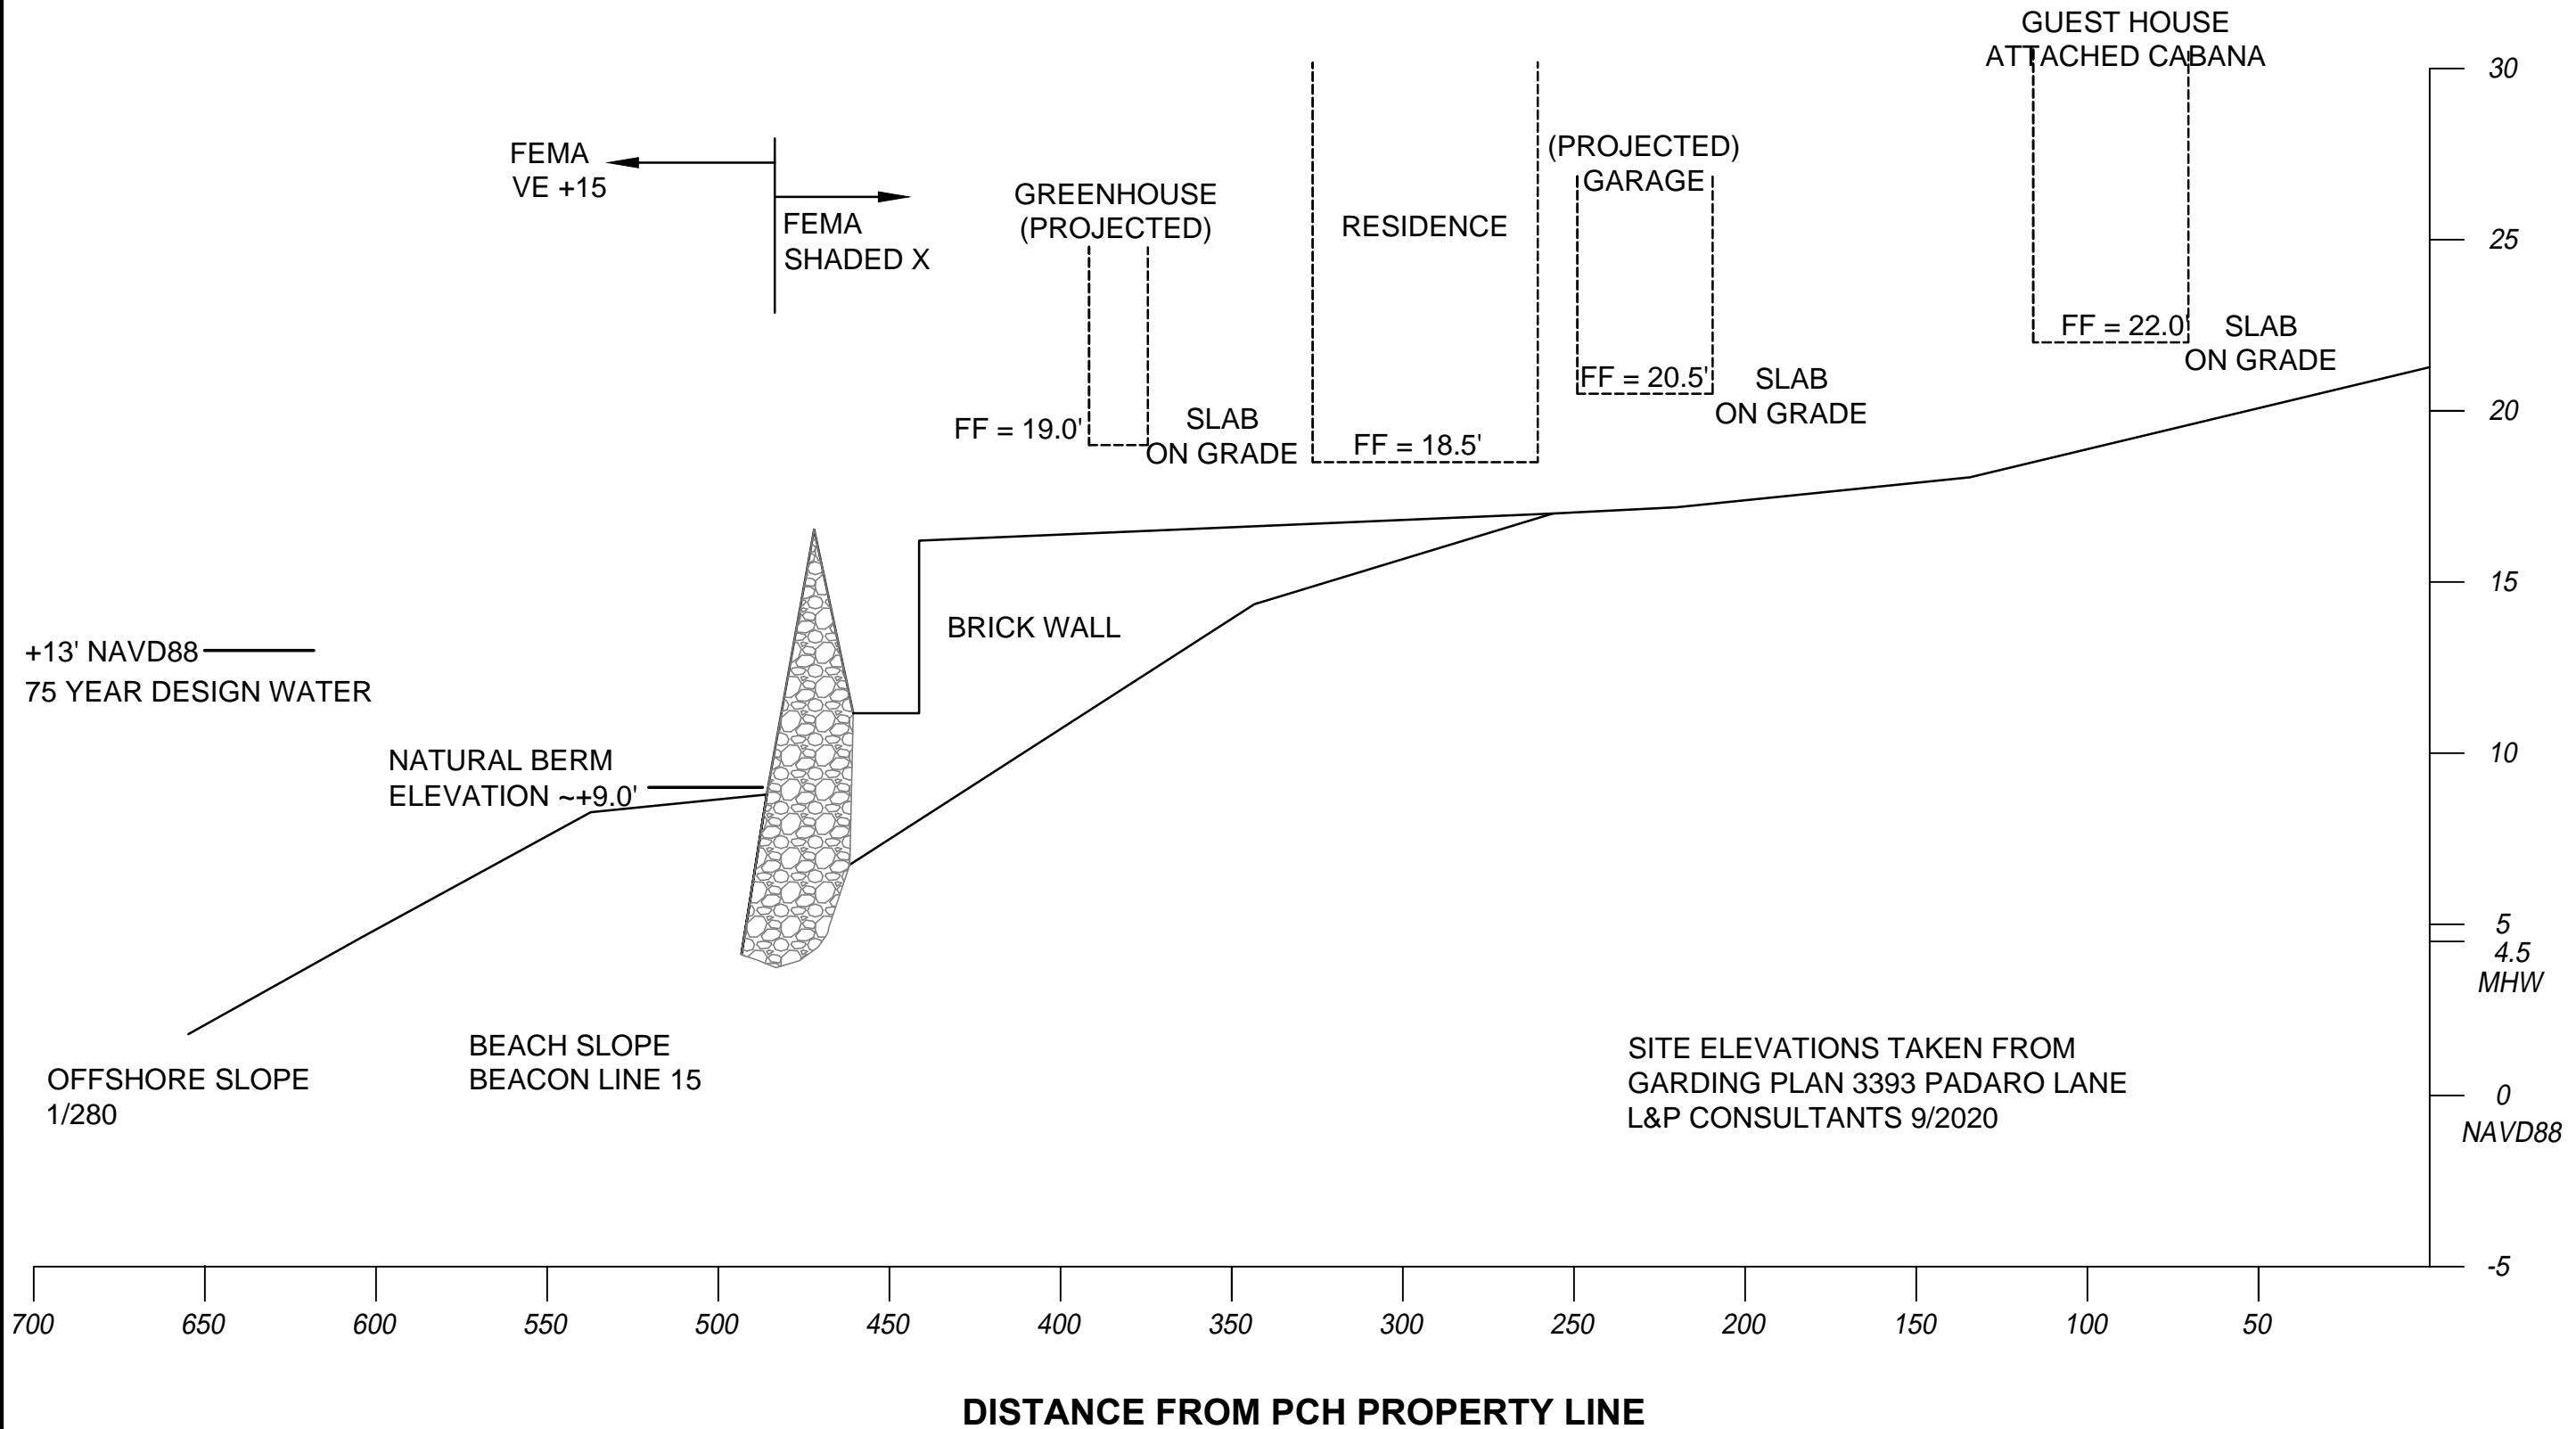
3393 PADARO LANE DESIGN BEACH PROFILE

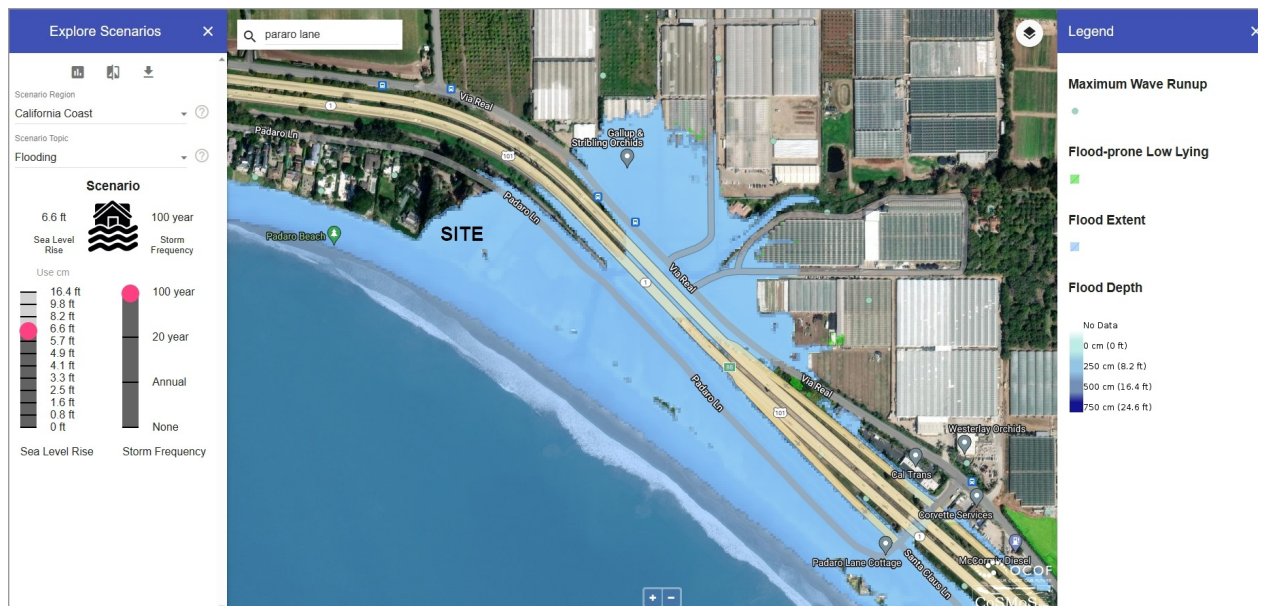
For a conservative potential flooding analysis with 6.6 feet of SLR and the 100-year wave the USGS CoSMoS model can be used. The figure below is the output from the CoSMoS model. It shows the partial flooding of the site, total flooding of many adjacent properties, flooding of the entire southern portion of Padaro Lane, the railroad, Highway 101, and development inland of Highway 101 and Via Real. It should also be noted that the properties to the north and west of the site are not modeled to be impacted by 6.6 feet of SLR and wave runup. Understanding that CoSMoS is a simple elevation driven conservative model and does not account for elevated development (as is proposed), it is not unreasonable to opine that even with 6.6 feet of SLR the proposed development is safe. The site can flood and not have the flooding significantly impact the structures. As far as changes in the coastal hazard design forces it is GSI’s opinion that as currently designed (specifically including potential seismic forces) the proposed structure is adequate to resist coastal hazard forces with 6.6 feet of SLR.

If SLR is higher, and occurs more rapidly than currently modeled, the associated coastal hazards could be devastating to most of the nearby existing development in the area (southeast) much sooner than the proposed development at this site. With over 6 feet of SLR access along Padaro Lane may be lost, the railroad and Highway 101 will be subject to wave runup, flooding, and erosion. Access to a portion of the community will likely be lost. However, due to the elevation, the residence pile foundation, and the project design, the building proper may not be significantly impacted by coastal hazards. As stated before, the proposed structure is reasonably safe from coastal hazards due to the elevated structure, the pile foundation, and building structural design. The owner through conditions of acceptance of the permit will acknowledge that the development is in a high coastal hazard area. In addition, this will be on the property title warning future owners.
