HISTORIC STRUCTURE ASSESSMENT FOR 19543 PATTERSON AVENUE

**PPT220024; CEQ22048; GEO220011
RIVERSIDE COUNTY, CALIFORNIA**

***Report Summary: Historic structure evaluation; residence, detached garage, and storage structure
not historically or architecturally significant; no mitigation measures recommended.***

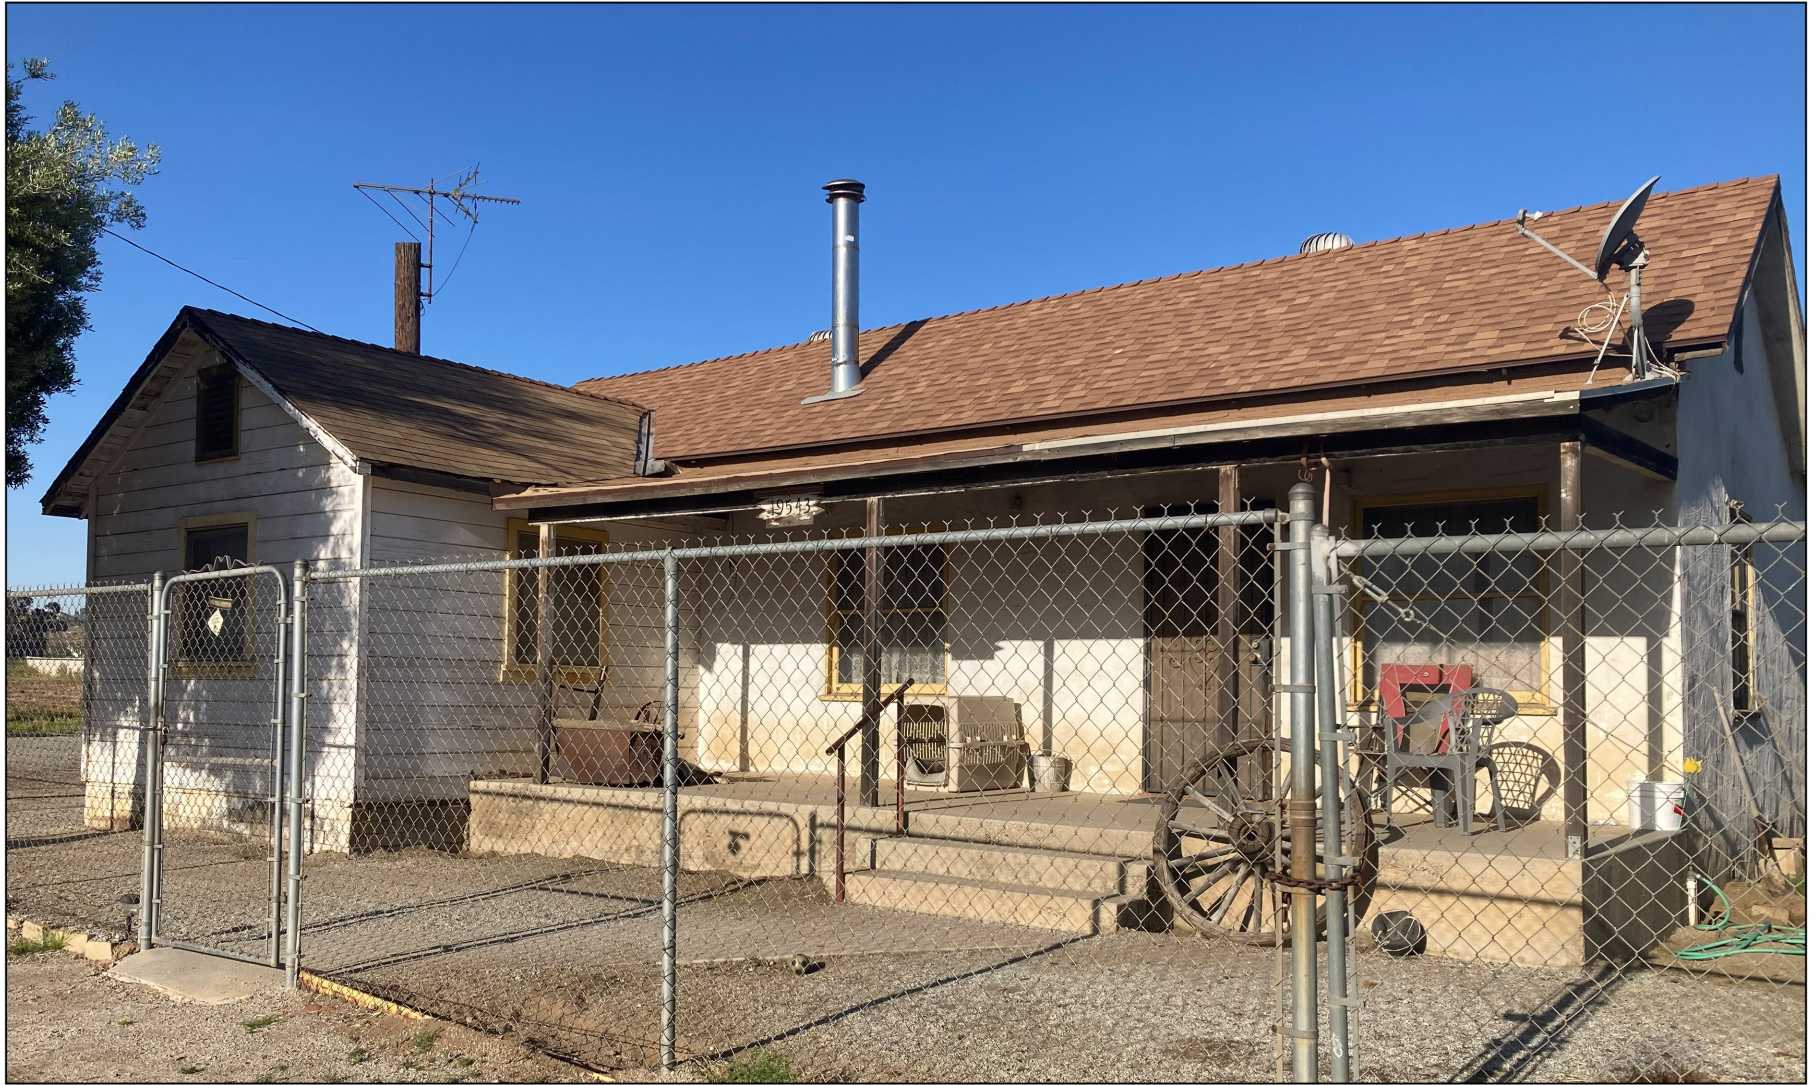
Plate 5
East Façade of the Residence, Facing Southwest
19543 Patterson Avenue

The primary (east) façade of the residence faces Patterson Avenue, separated with a chain-link fence. Access to the residence is provided directly from the street. The front porch features a shed roof and wood supports. The main entrance door is located at the center of the porch, on the east façade. Two large double-hung windows are located on either side of the entrance door. The southern end of the east façade features the gable wall of the east wing and features a double-hung window. The north façade of the east wing faces the front porch and features another double-hung window (Plate 5).

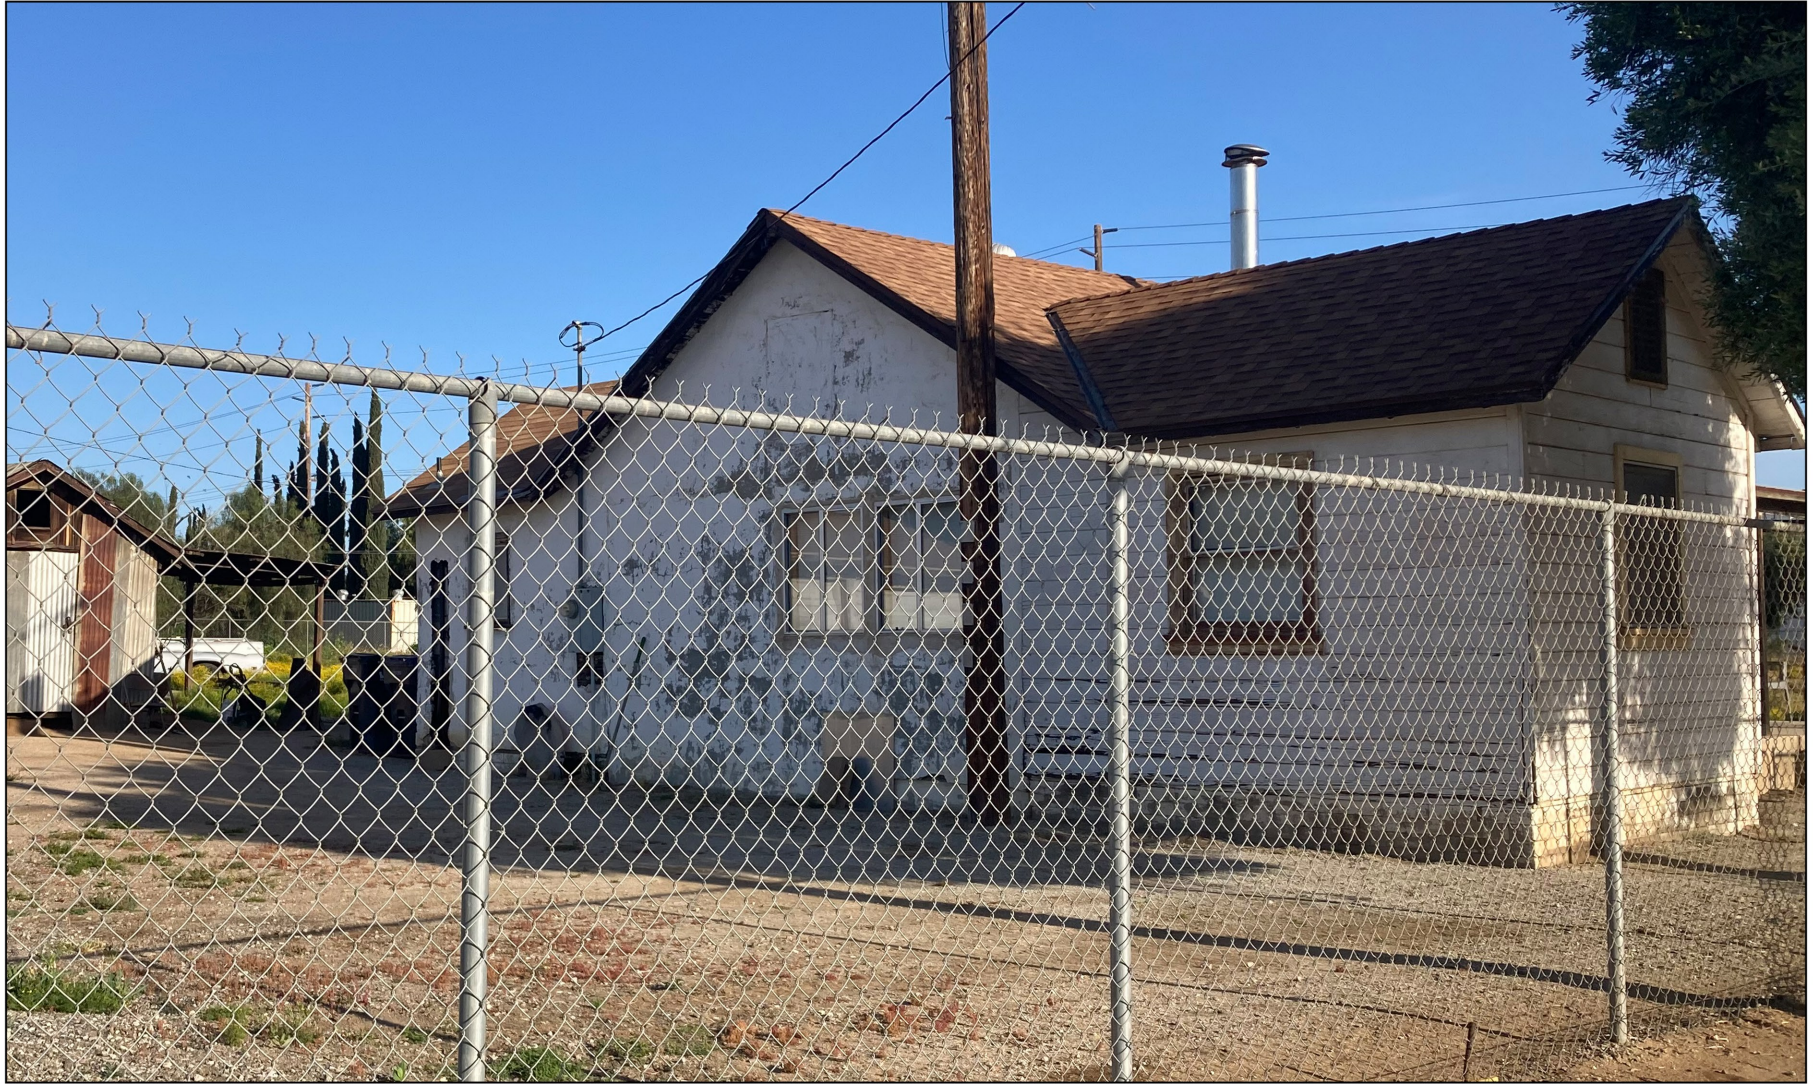
Plate 6
South Façade of the Residence, Facing Northwest
19543 Patterson Avenue

The south façade of the residence faces the detached garage and features the gable wall of the main structure at its center and non-gable walls of the east and west wings on either side. The south façade features a double-hung window on its east side, a set of double vinyl-framed sliding windows on the gable wall, and a small, wood-framed picture window on its west end (Plates 6 and 7).

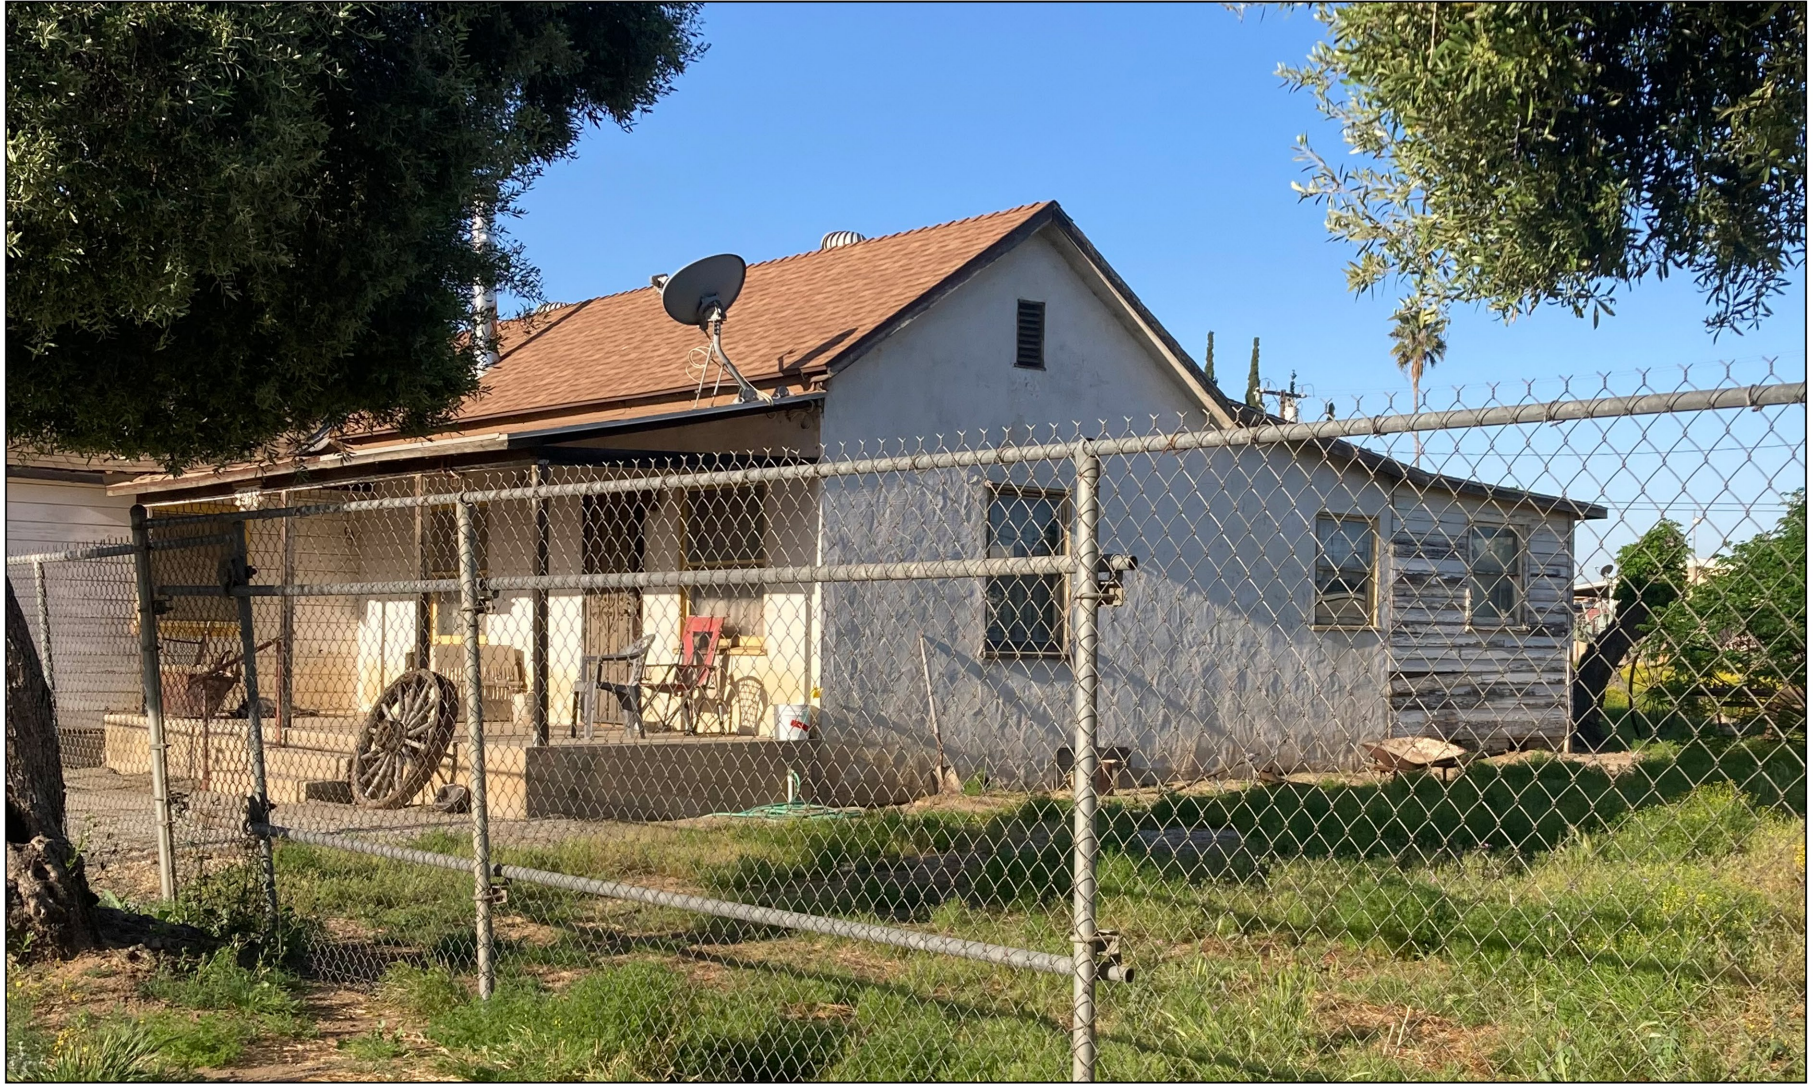
Plate 8

The north façade of the residence features the gable wall of the main structure on its east end and the north façade of the northwest wing. The northwest wing features a shed roof that runs parallel to the gable roof of the main house. This feature makes the roof look like a double-pitched roof from the northern point of view. The north façade features three double-hung windows of various sizes (Plates 8 and 9).

East (Left) and North (Right) Façades of the Residence, Facing Southwest

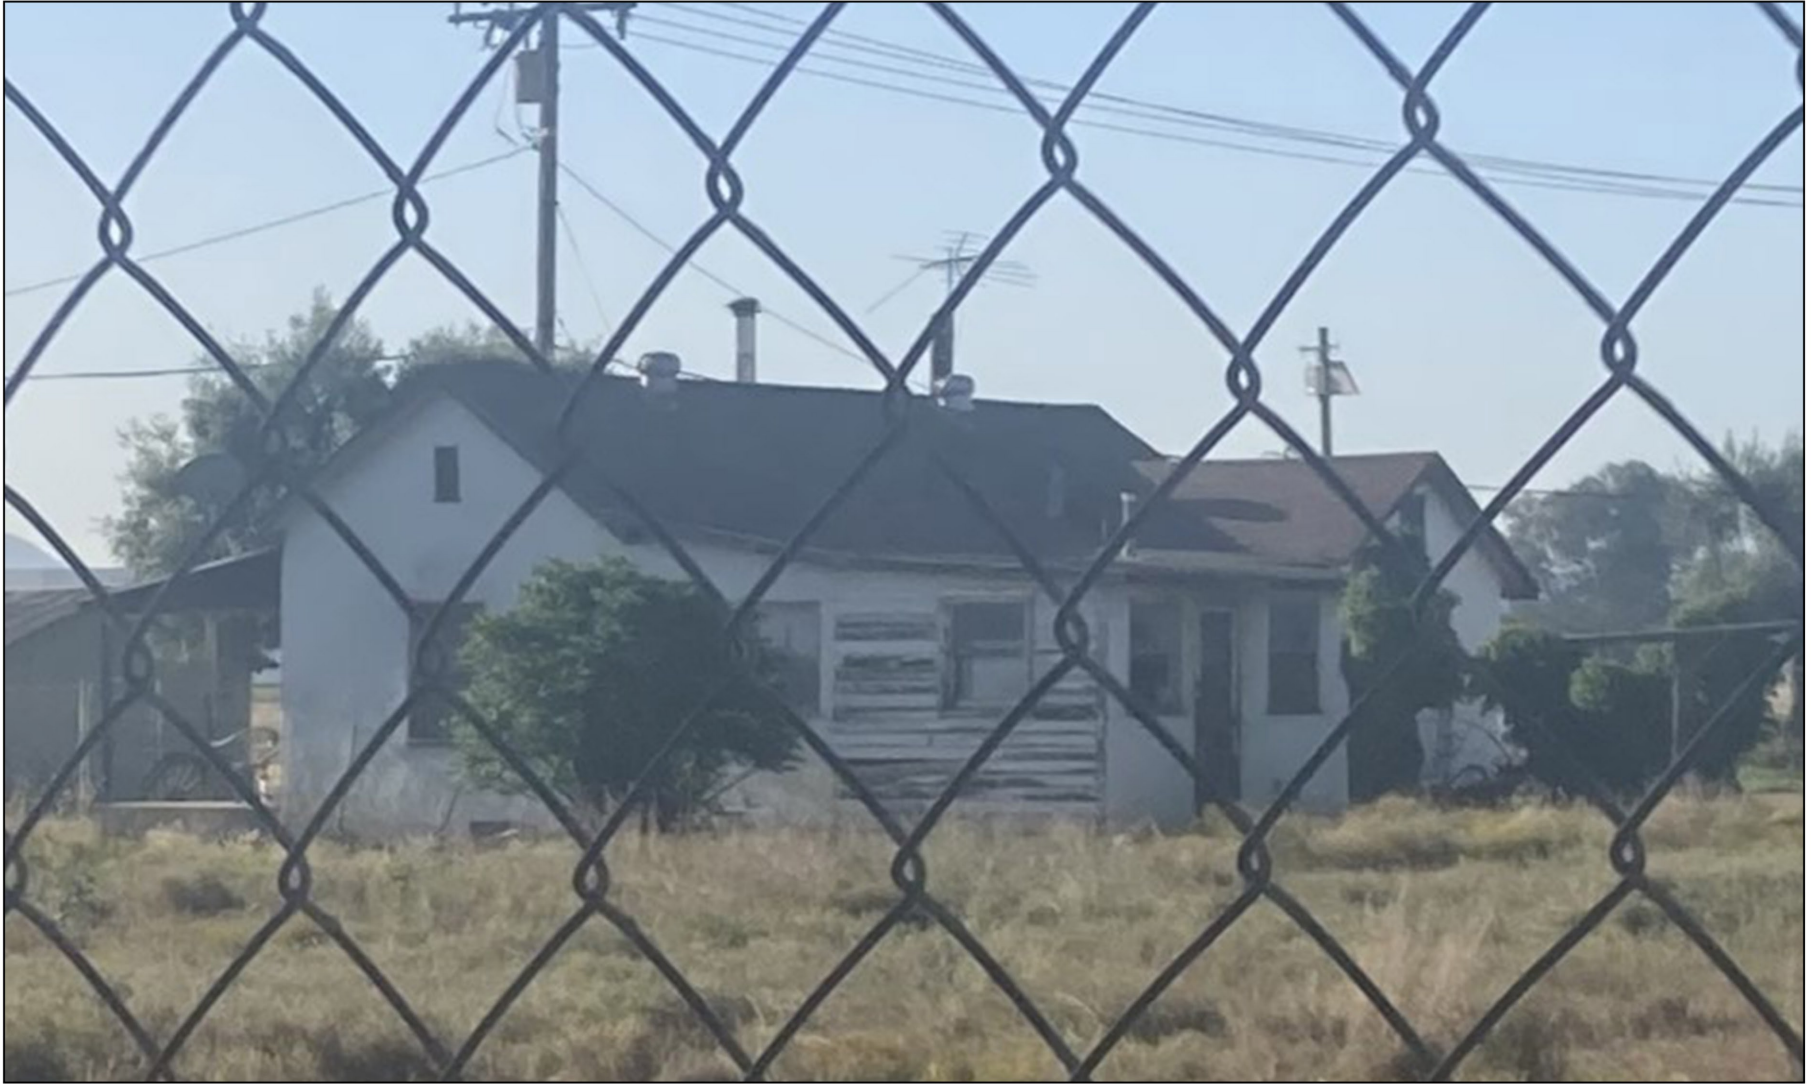
Plate 10
North (Left) and West (Right) Façades of the Residence, Facing Southeast
19543 Patterson Avenue

The west façade of the residence features another entrance door on its north end. Two double-hung windows are located on either side of the entrance door. The southern end of the west façade features the gable wall of the west wing (Plate 10). Research did not find any indication of applied changes that would alter the overall form, plan, space, structure, or style of the building since its initial construction.

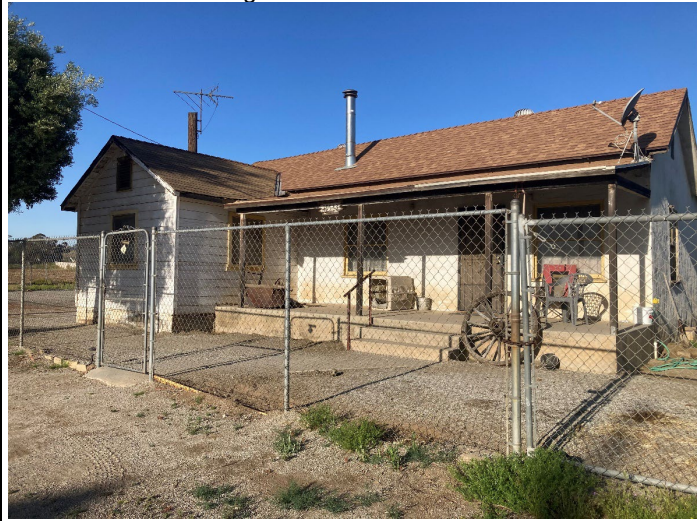
P5a. Photo or Drawing

The primary (east) façade of the residence faces Patterson Avenue, separated with a chain-link fence. Access to the residence is provided directly from the street. The front porch features a shed roof and wood supports. The main entrance door is located at the center of the porch, on the east façade. Two large double-hung windows are located on either side of the entrance door. The southern end of the east façade features the gable wall of the east wing and features a double-hung window. The north façade of the east wing faces the front porch and features another double-hung window. The south façade of the residence faces the detached garage and features the gable wall of the main structure at its center and non-gable walls of the east and west wings on either side. The south façade features a double-hung window on its east side, a set of double vinyl-framed sliding windows on the gable wall, and a small, wood-framed picture window on its west end.
