# AIR QUALITY REPORT

## JAMES A. GARFIELD HIGH SCHOOL MAJOR MODERNIZATION PROJECT

LOS ANGELES UNIFIED SCHOOL DISTRICT, OFFICE  
OF ENVIRONMENTAL HEALTH AND SAFETY

FEBRUARY 2024

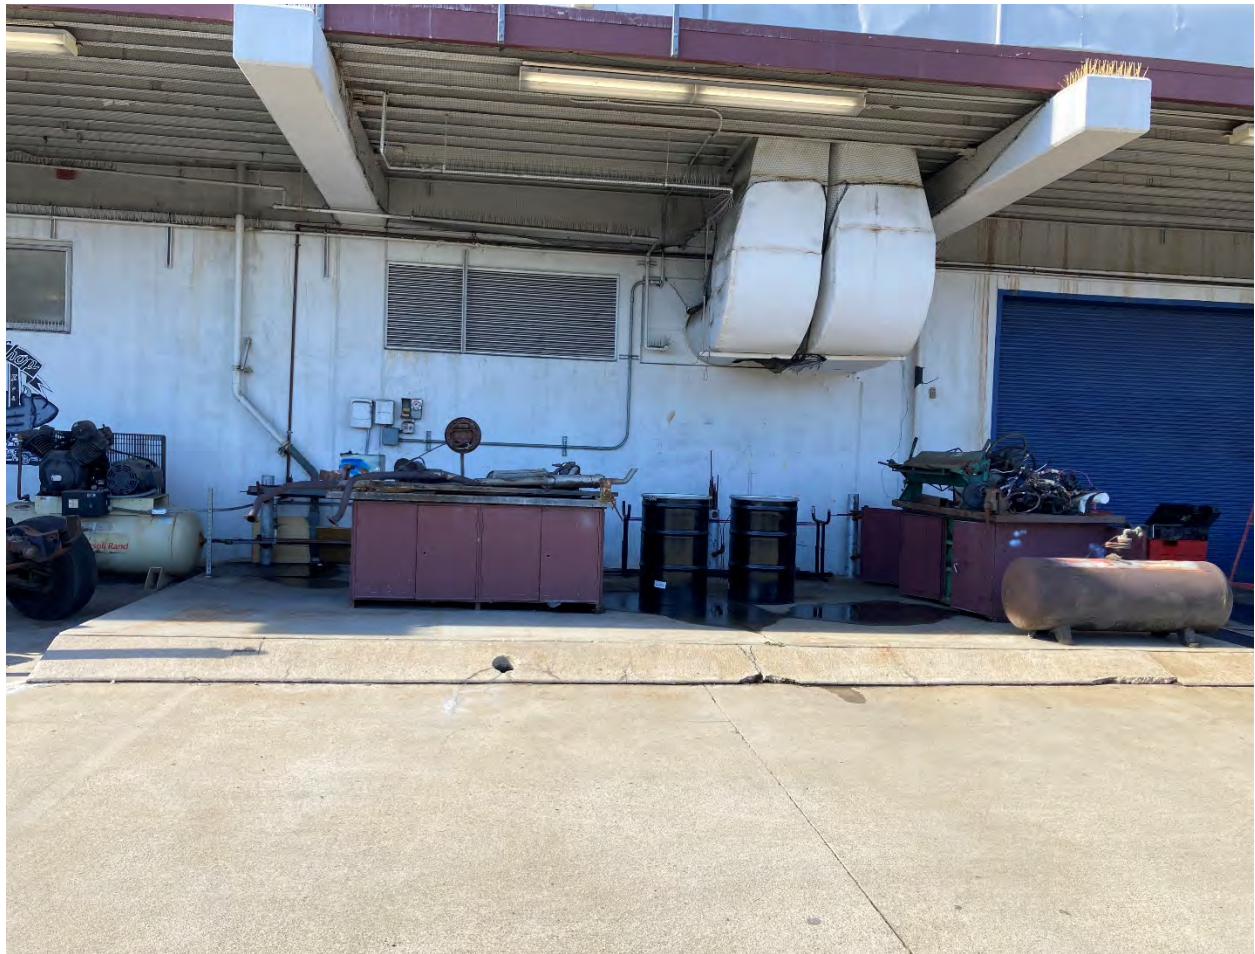
Northeast corner of Auto shop yard. 3-stage clarifier observed.

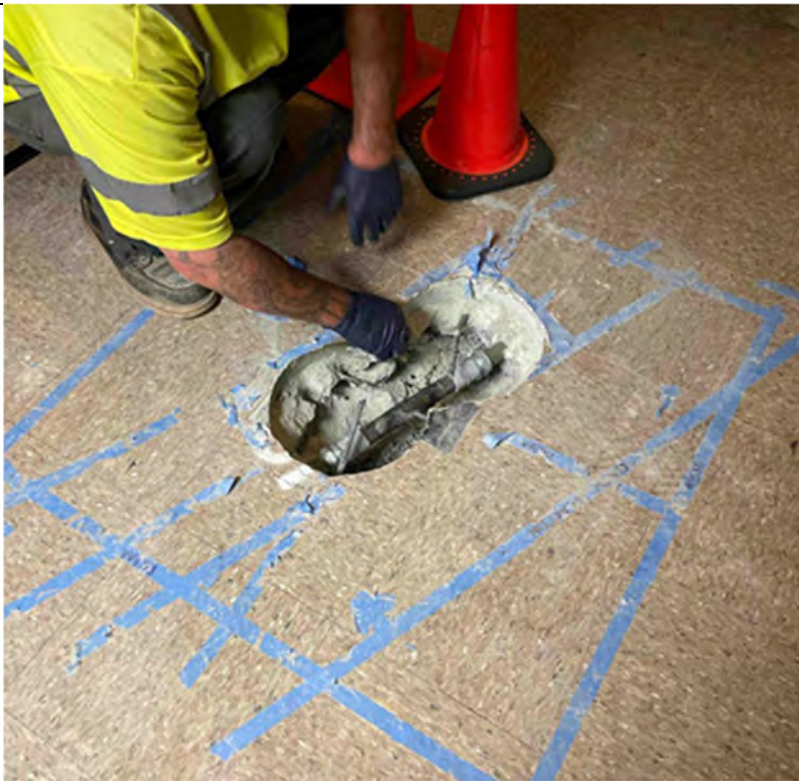
**Photograph 16:**  
Repaired utilities line, ready for concrete backfill.
