**Revised Biological Evaluation of Proposed  
Goerner Residential Construction Project,  
1017 Hot Springs Road (APN 011-010-008),  
Santa Barbara, California**

**20 June 2020**

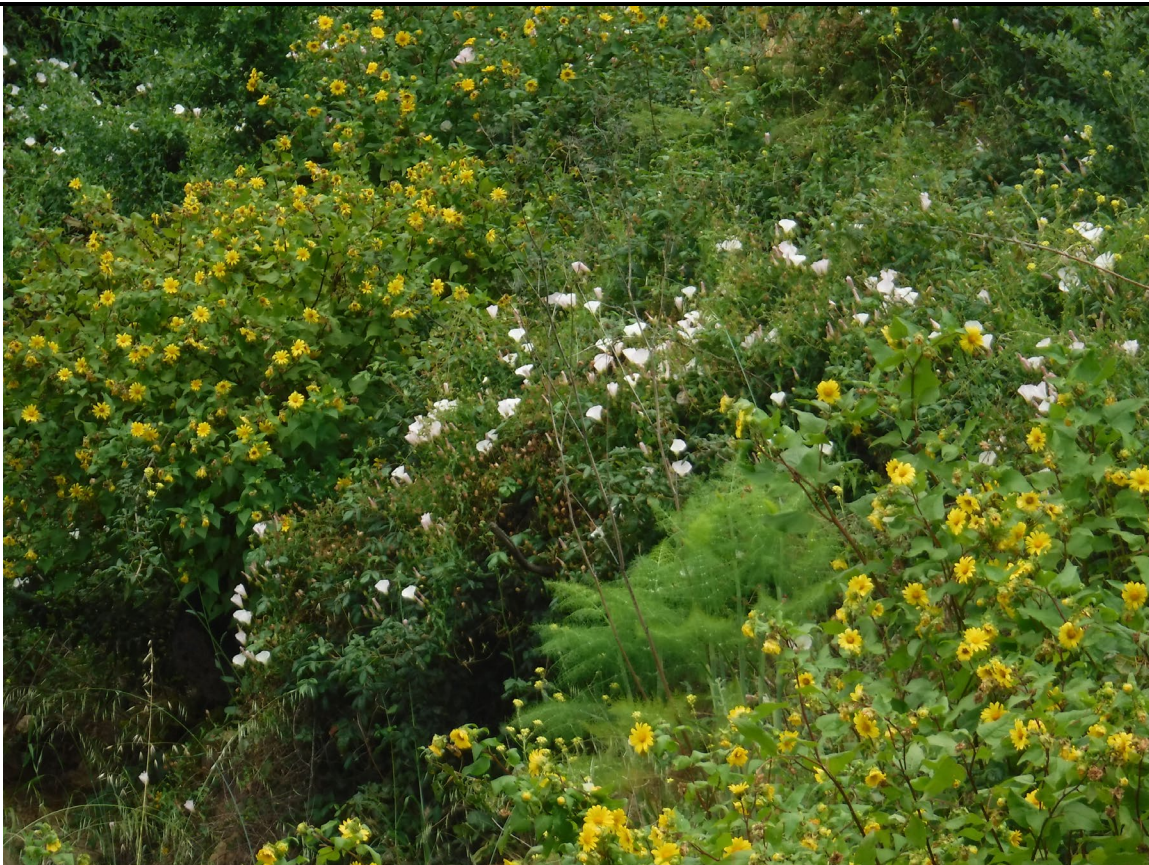
*Canyon sunflower and coastal morning-glory in coastal sage scrub and coast live oak woodland habitat proposed turnaround location. 12 May 2020.*

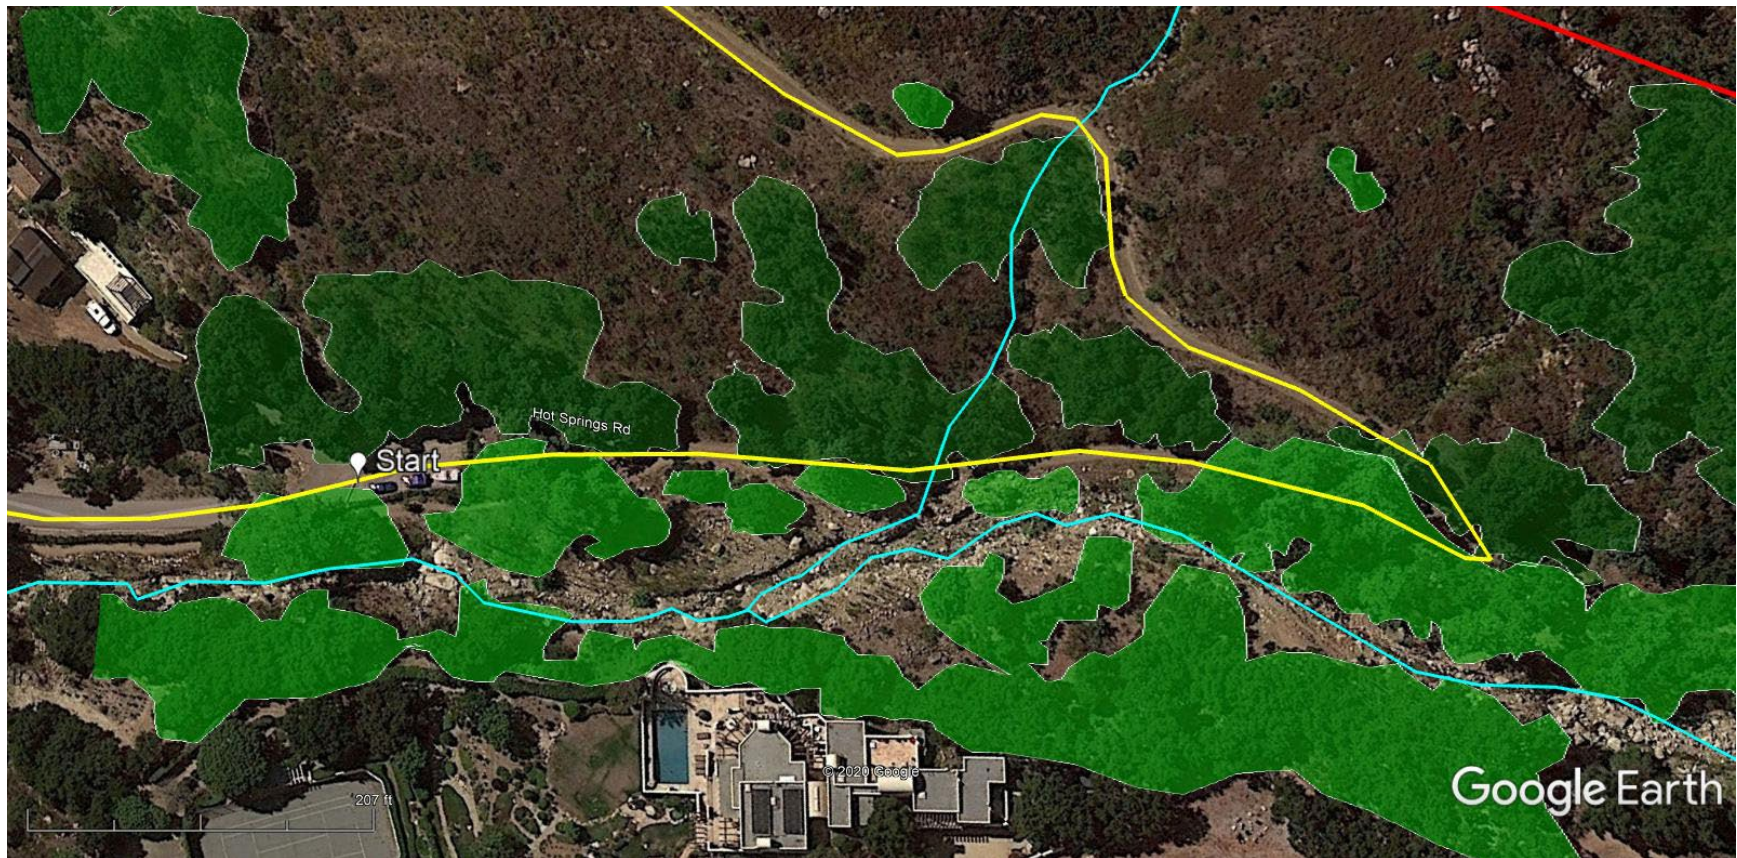
**Figure 5b. Current vegetation in access road portion of project area from start of project between road elevation 823 (at left) and road elevation 920 (Plan sheets C-1.4 through C-1.6). Hot Springs Creek runs through image from right to left; unnamed seasonal tributary east of subject parcel contacts main stem of creek in center of image. Western sycamore-coast live oak riparian woodland is shown in light green (ESHA); coast live oak woodland (ESHA) is shown in dark green. Uncolored areas on slopes outside of floodplain support coastal sage scrub and chaparral, which burned completely in the Thomas Fire in December 2017. Red line in upper right corner shows general transition from coastal sage scrub at lower elevations to chaparral at higher elevations. Yellow line shows approximate centerline of existing/proposed access road/driveway. Roadway improvements begin at label marked 'Start'. Ruderal vegetation occurs along both sides of the access road. North is towards upper right. Image dated 12 August 2019.**

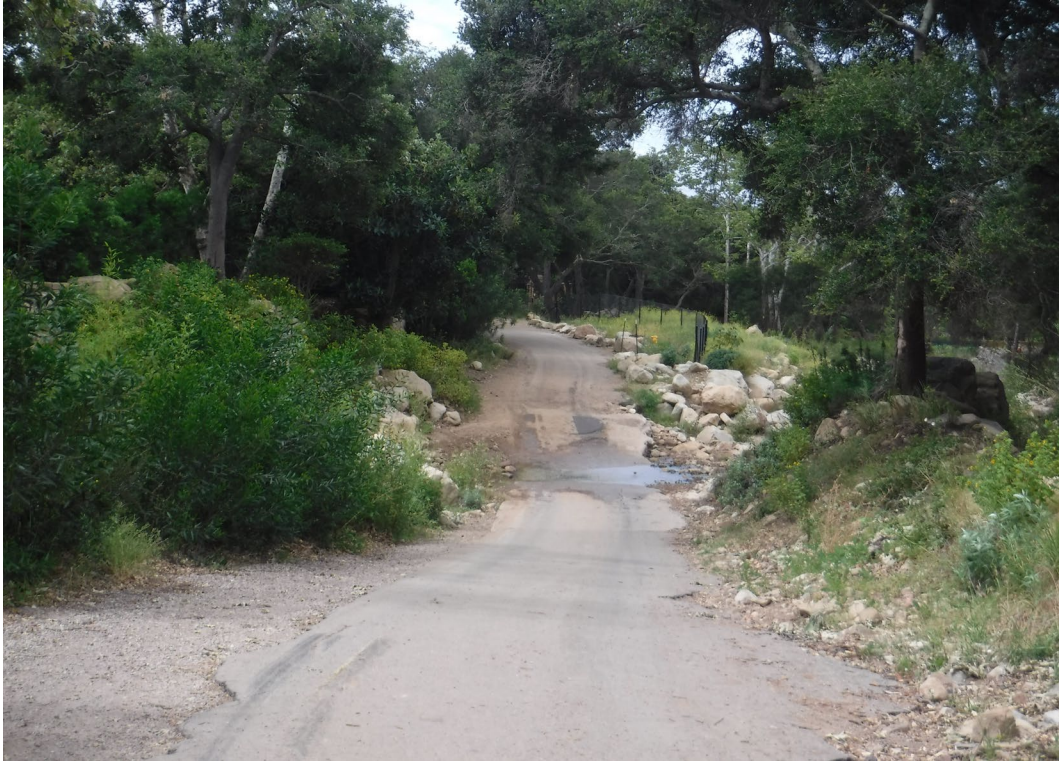
**At-grade crossing of Hot Springs Creek, looking south from access road.  
Creek is flowing from left to right.**

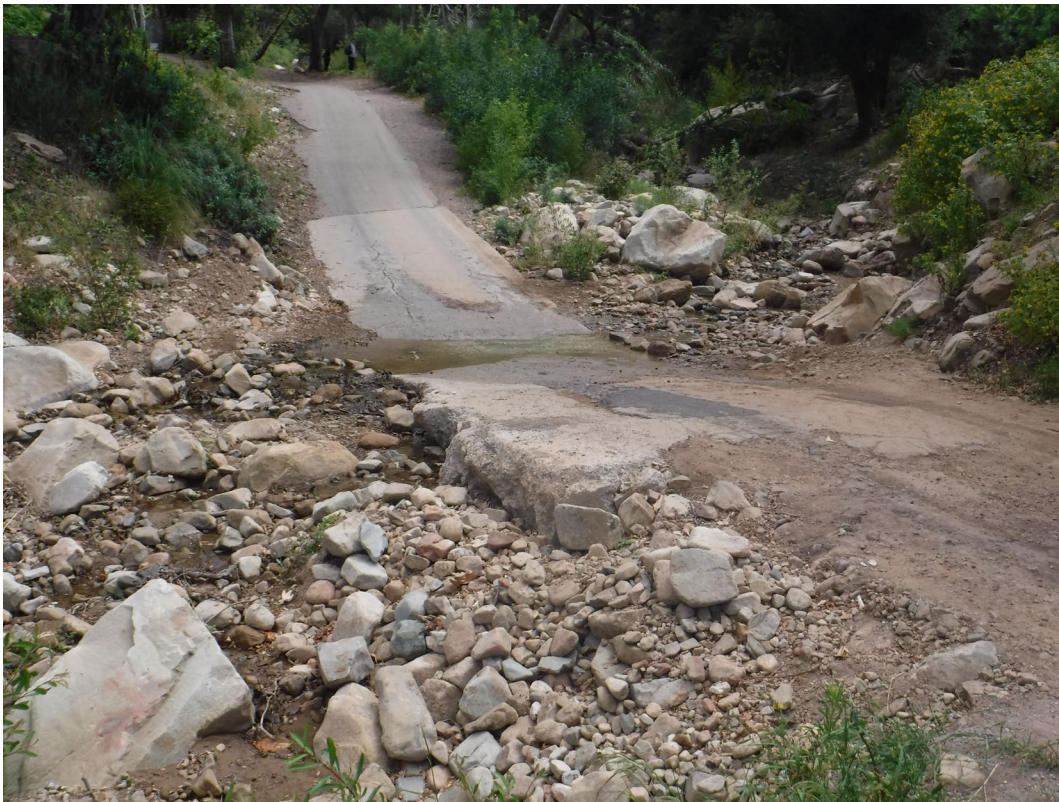
**At-grade crossing, looking upstream. Bed gradient steepens significantly immediately downstream  
of crossing (at left).**

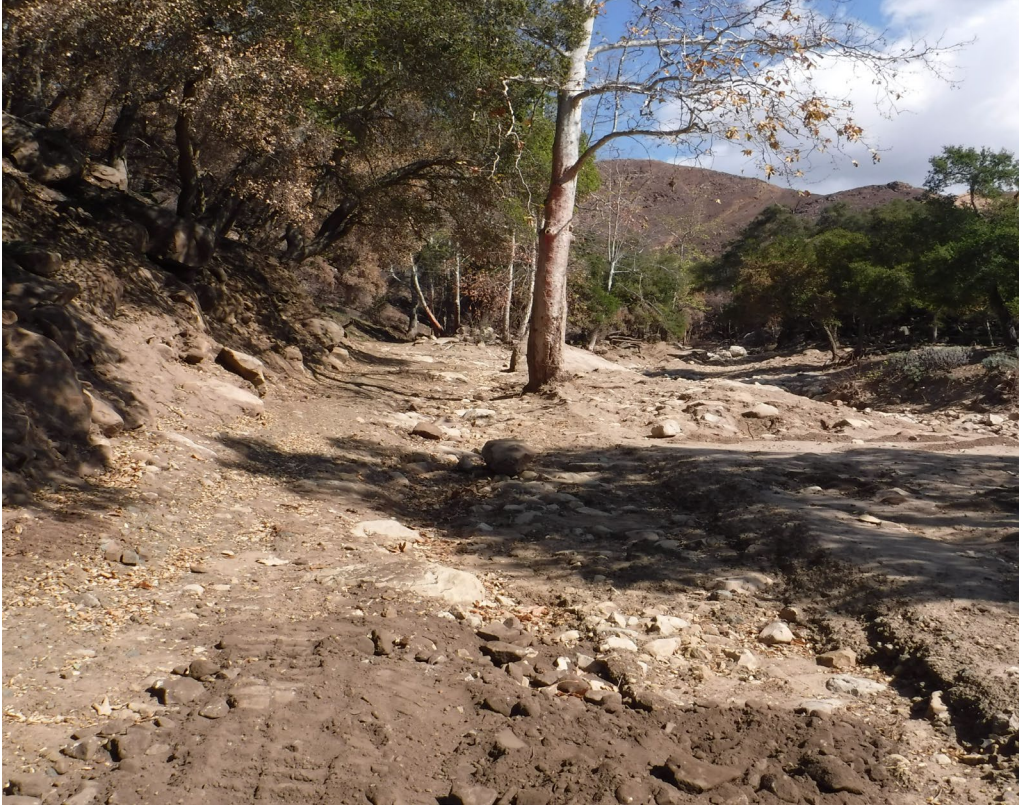
**Access road looking northeast from Station 11+00 at start of access road improvements following debris flow on 9 January 2018 that occupied the entire floodplain along this reach. Note proximity of channel (at right) to roadway. 22 February 2018.**

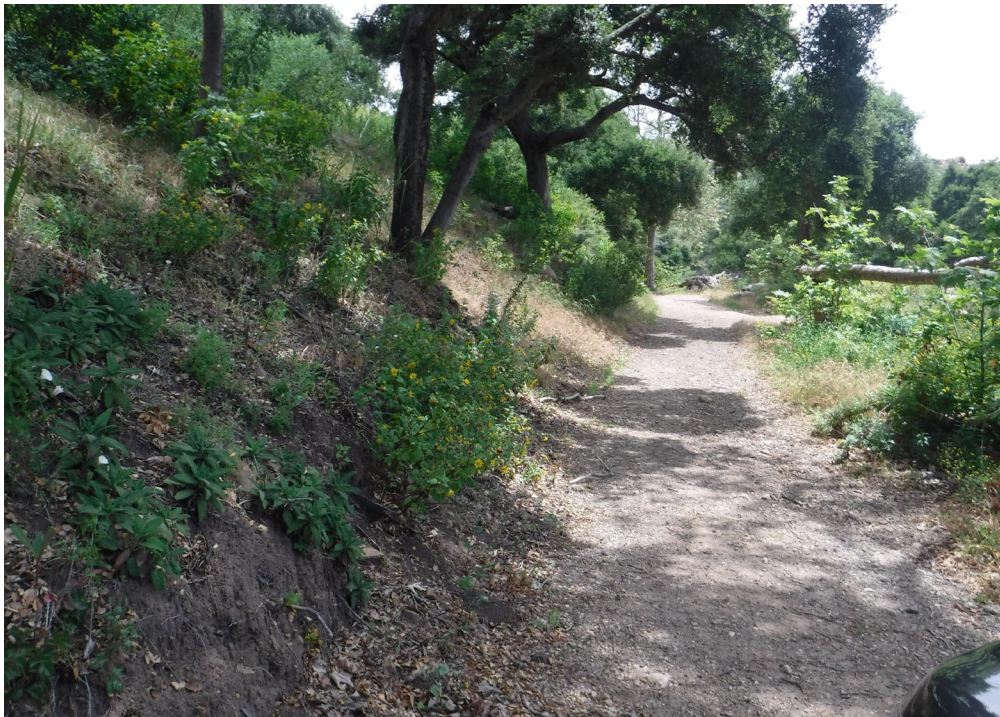
**Same view on 19 May 2020. Proposed road improvements will impact native understory vegetation on slope on left side of road.**

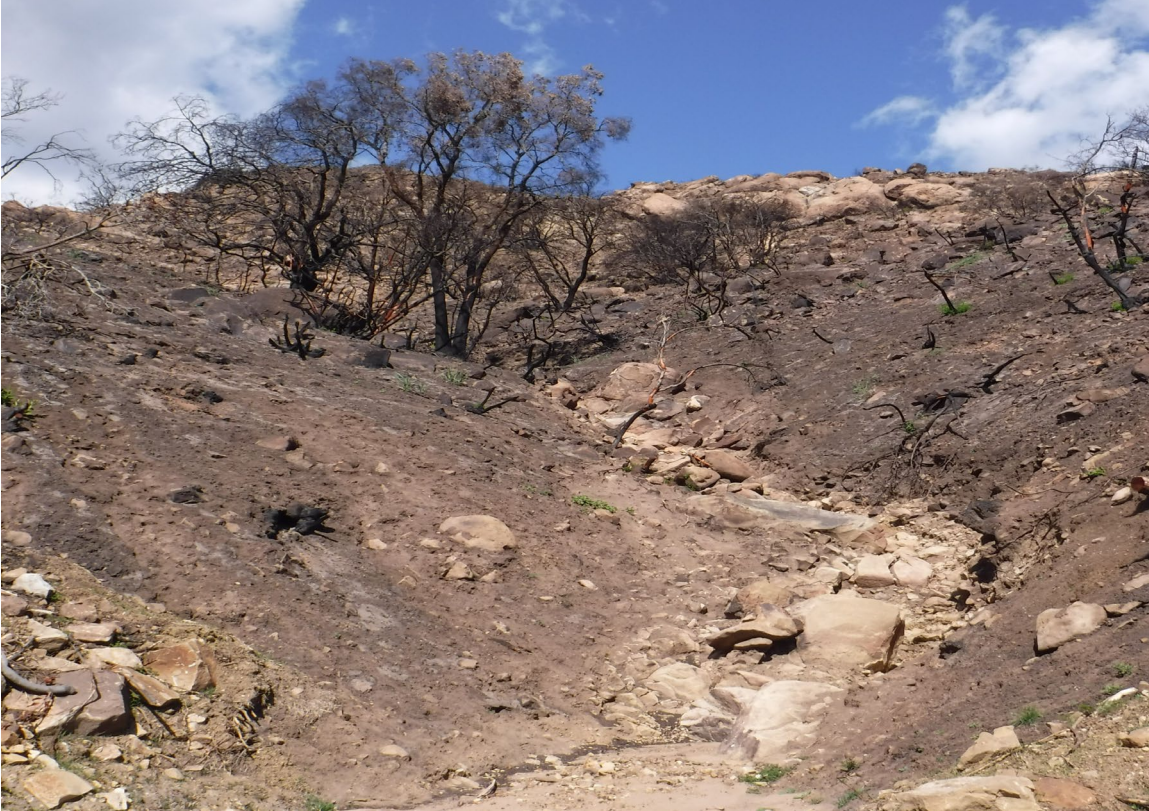
**Unnamed seasonal tributary of Hot Springs Creek, looking upslope from access road at Station 18+50 following Thomas Fire in Dec. 2017 and debris flow on 9-10 January 2018. 22 February 2018.**

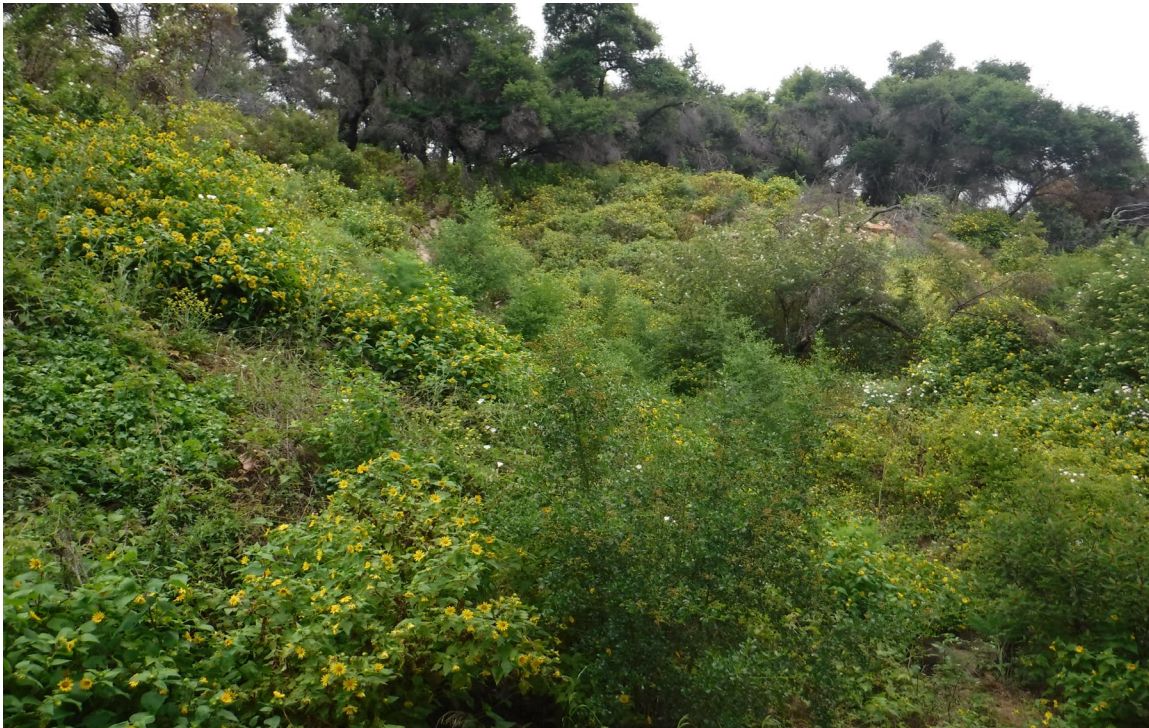
**Same view on 19 May 2020, showing massive re-growth of coastal sage scrub and oak woodland understory vegetation on slopes. Proposed turnaround and retaining walls along upslope side of access road here will impact vegetation on lower slope.**

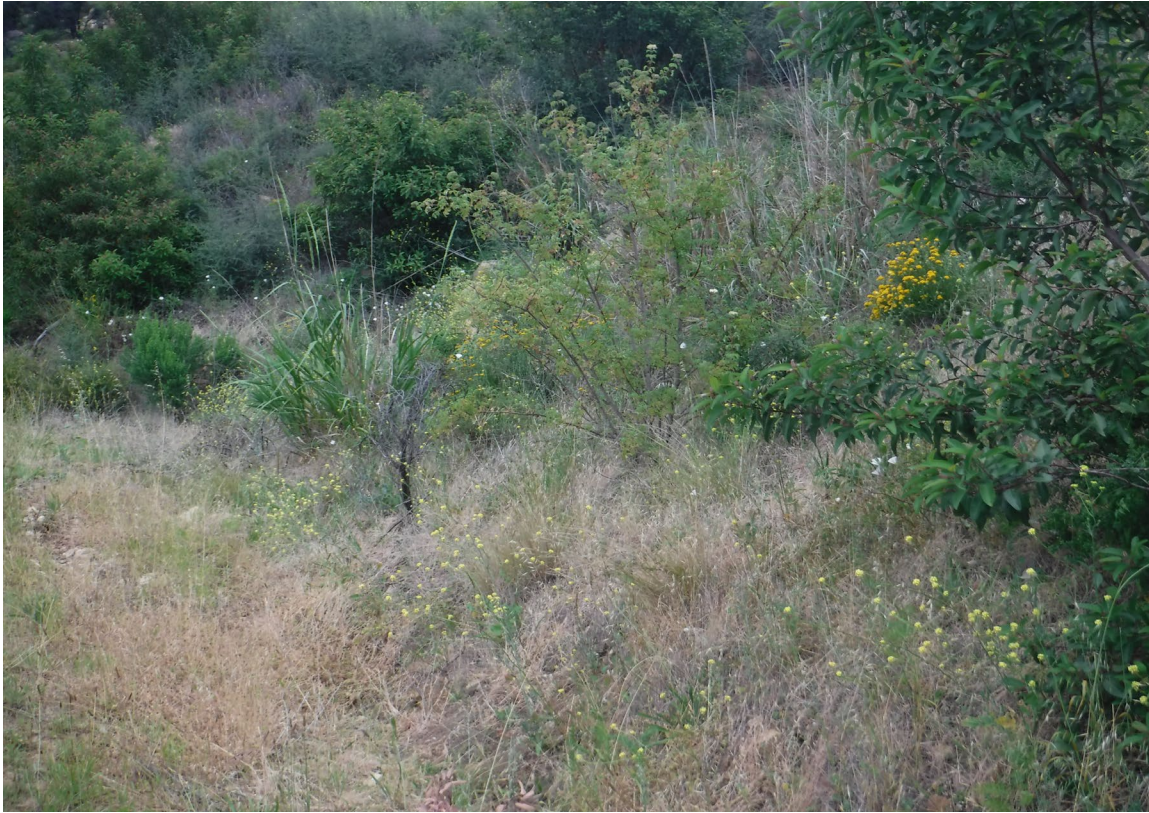
**Coastal sage scrub along access road at Station 23+00. Clumps of native foothill needlegrass are visible along lower slope and will be impacted by proposed roadway improvements.**

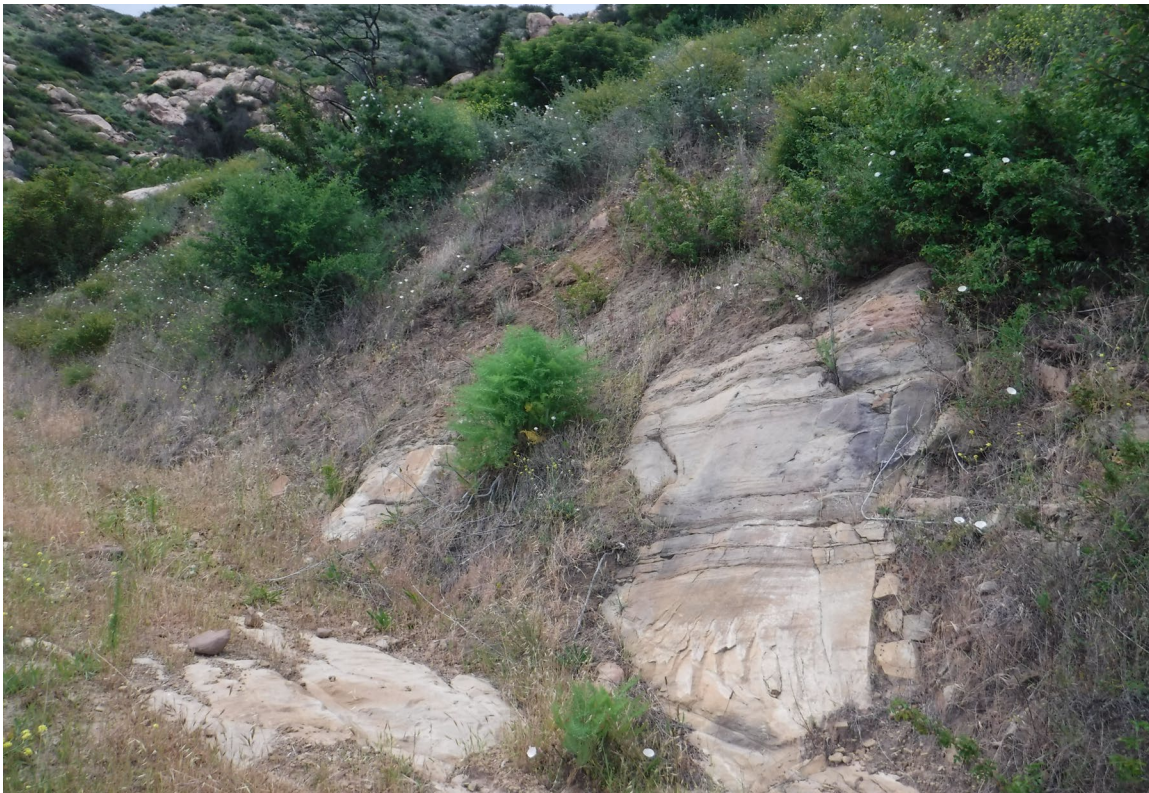
**Access road near Station 31+00, showing re-growth of diverse coastal sage scrub vegetation.**

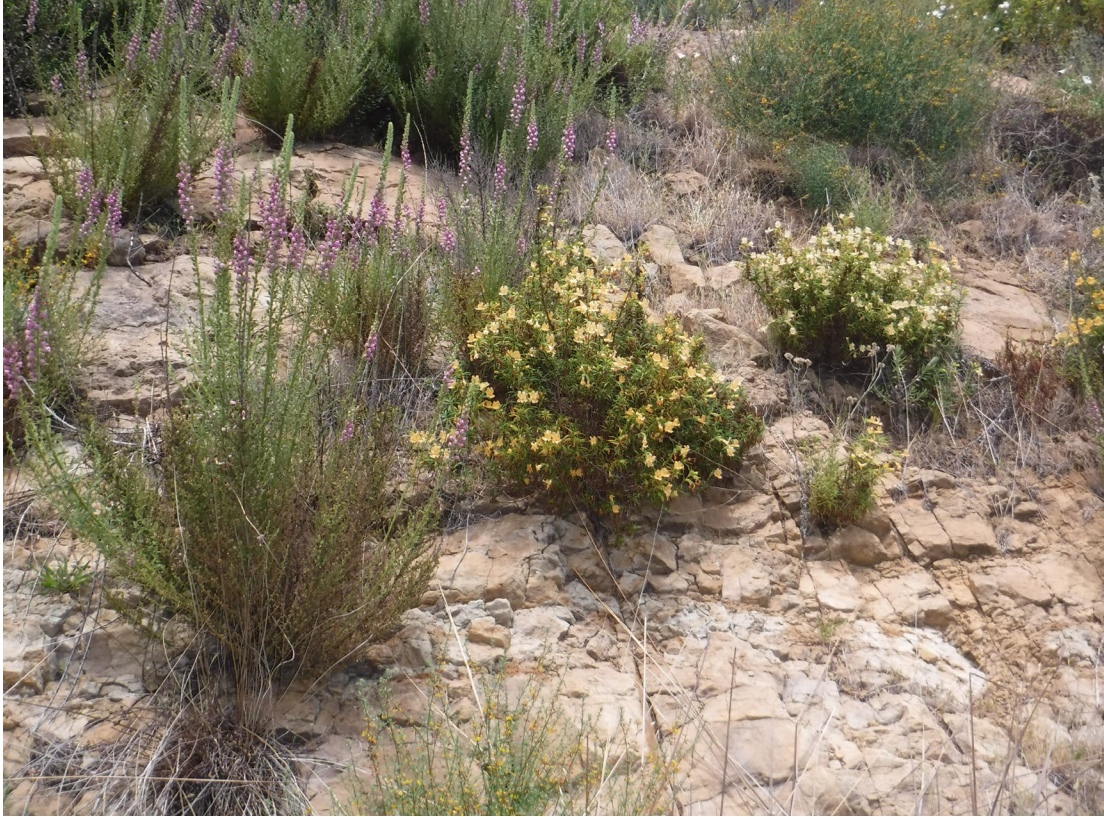
**Coastal sage scrub vegetation at Station 33+00, site of proposed hammerhead and turnaround. Native grasses and shrubs visible here include sticky snapdragon, deerweed, golden yarrow, and southern bush monkeyflower, and foothill needlegrass.**

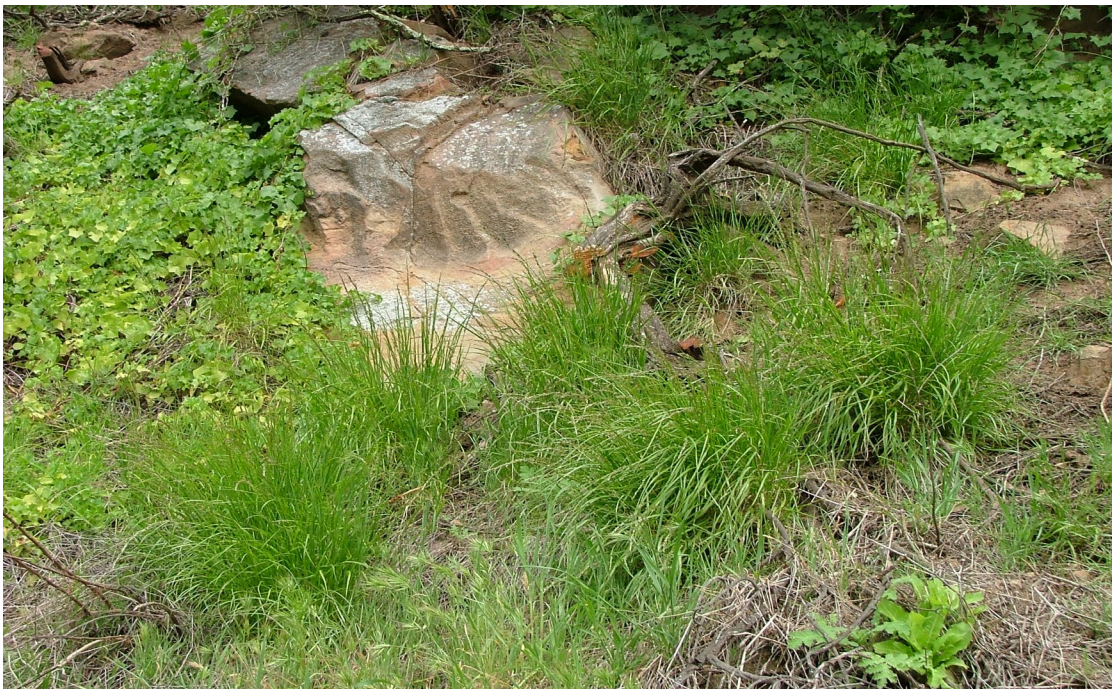
**Pre-fire example of native grass occurrence along access road at road elev. 945, pre-Thomas Fire. Clumps of small-flowered melic (*Melica imperfecta*) were growing along upslope edge of existing access road here. 11 March 2011.**

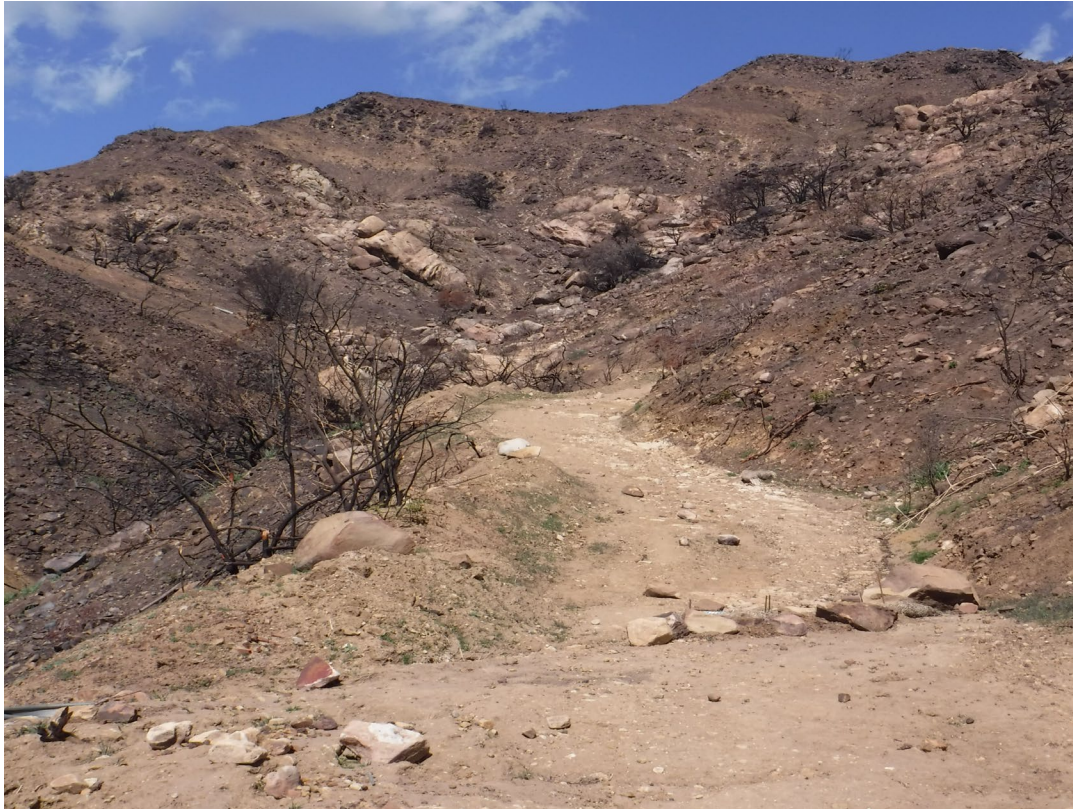
**Pre-Thomas Fire condition of access road and subject parcel (mostly to left), looking north from access road at about Station 28+40 (road elev. 1,000). Unnamed seasonal tributary of Hot Springs Creek is visible at left. 22 February 2018.**

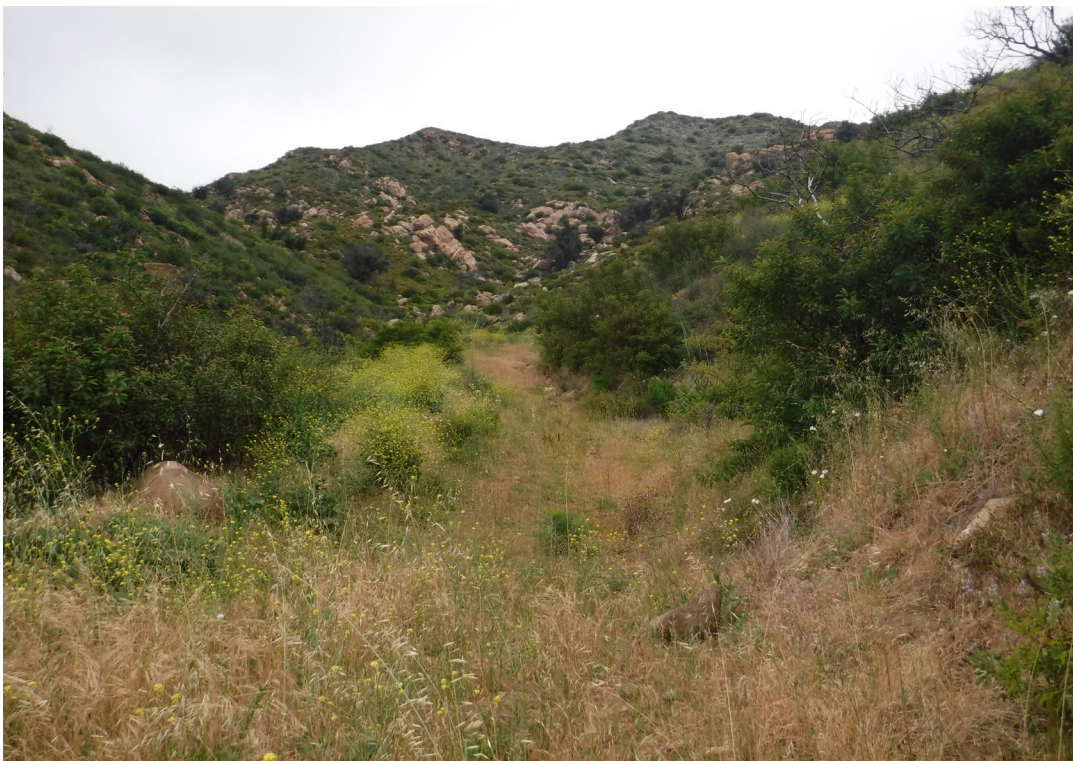
**Same view on 19 May 2020. Note recovery of coastal sage scrub and chaparral vegetation on slopes.**

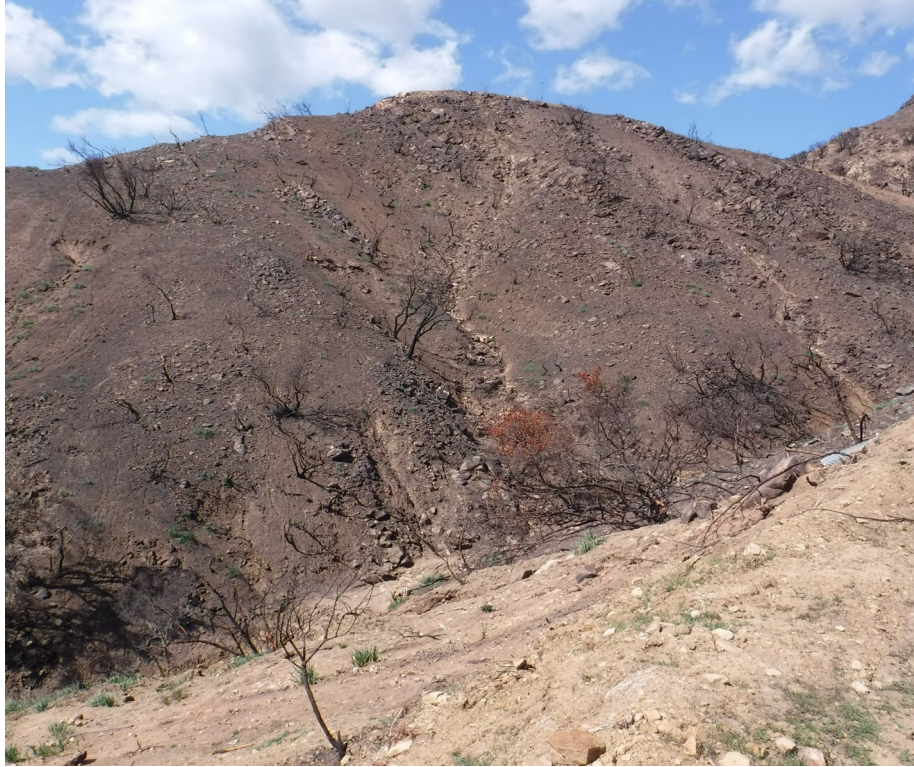
**East-facing slope below proposed house site (to be constructed on ridgeline), post-Thomas Fire, looking west from access road about Station 28+40 (road elev. 1,000). Slopes below access road are highly erosive. Drainage in center of photo is an unnamed tributary of Hot Springs Creek. Large portions of this slope are in the 200-foot fire fuel management zone around the proposed house site (Appendix 4). 22 February 2018.**

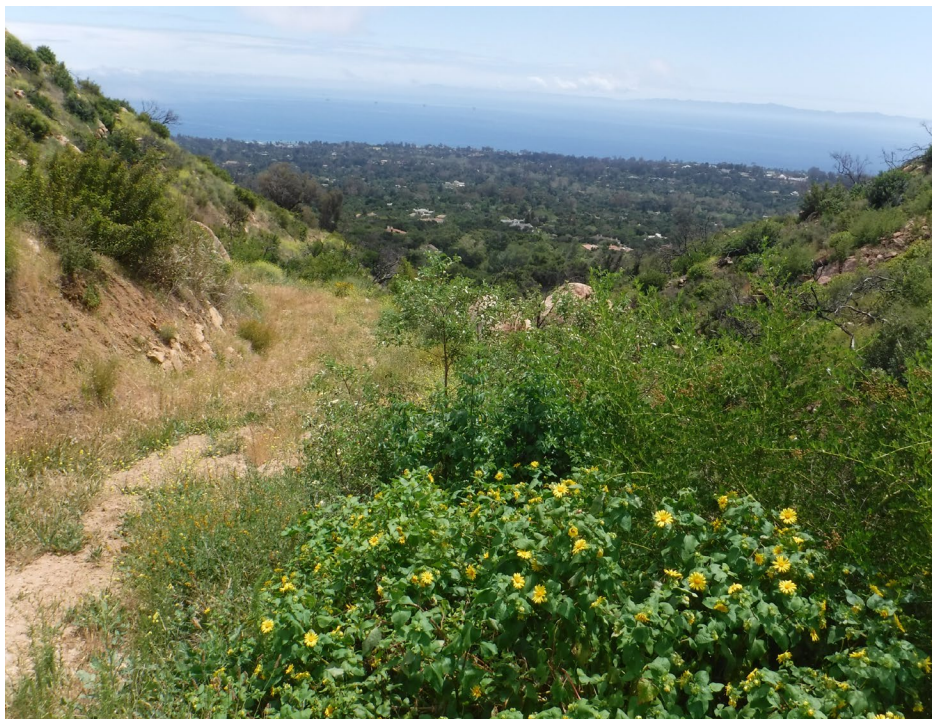
**Unnamed tributary of Hot Springs Creek, looking south, on 19 May 2020. Portion of slope in previous photograph is visible at right. Note amount of re-growth of native shrub cover.**
