Project 00949.00004.001

**Subject: Aquatic Resources Delineation and Preliminary Jurisdictional Determination Addendum for the Holesapple (Crestview) Property Project (also known as Winding Ranch) in Carmichael, California**

# Delineation of Waters of the United States For the Crestview Property

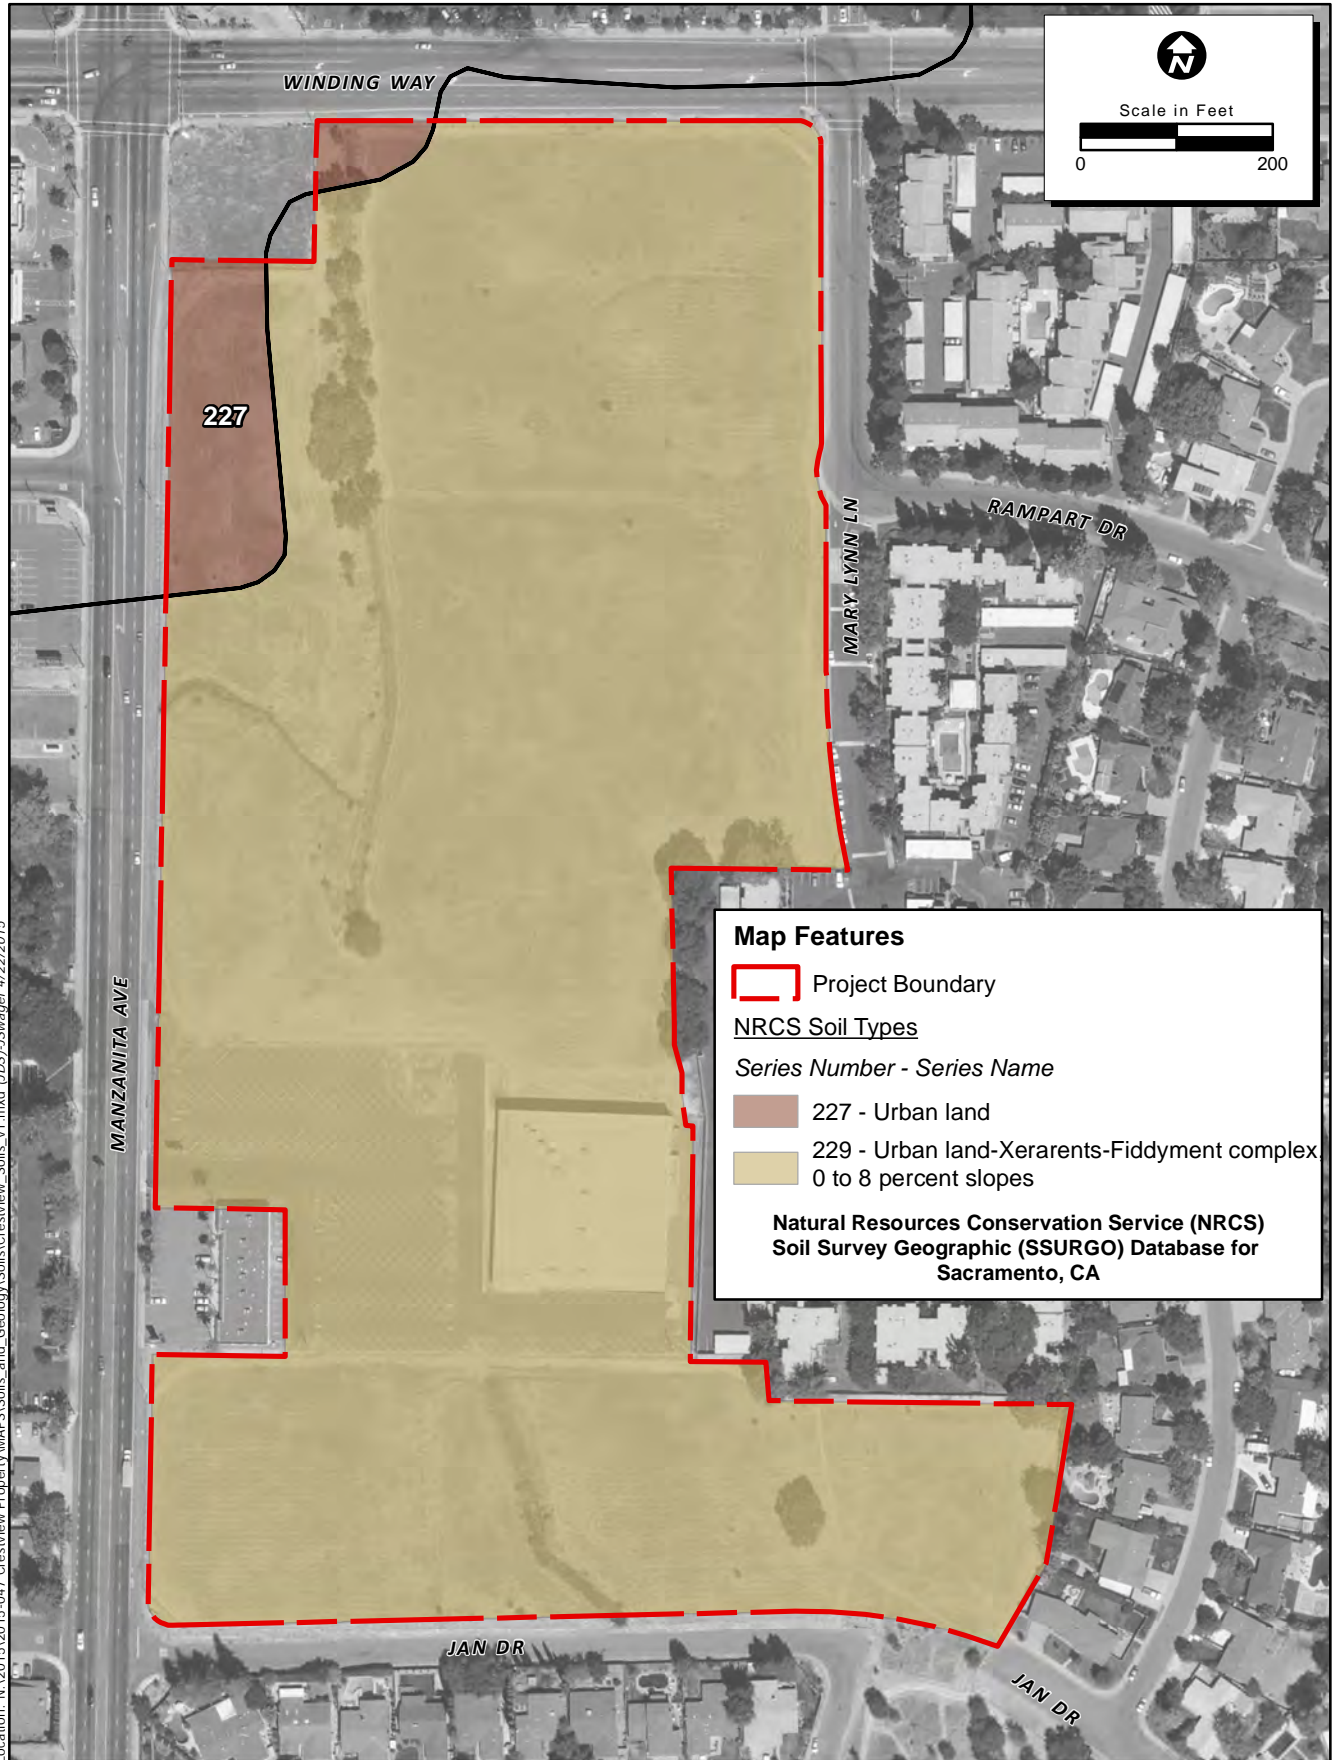
**Figure 2. Natural Resources Conservation Service Soil Types**

According to the Web Soil Survey (NRCS 2015), two soil units, or types, have been mapped within the Property (Table 2 and Figure 2. *Natural Resources Conservation Service Soil Types*). These include: (227) Urban Land; and (229) Urban land – Xerarents-Fiddyment complex, 0 to 8 percent slopes. Both of these soil units are not considered hydric (NRCS 2006).

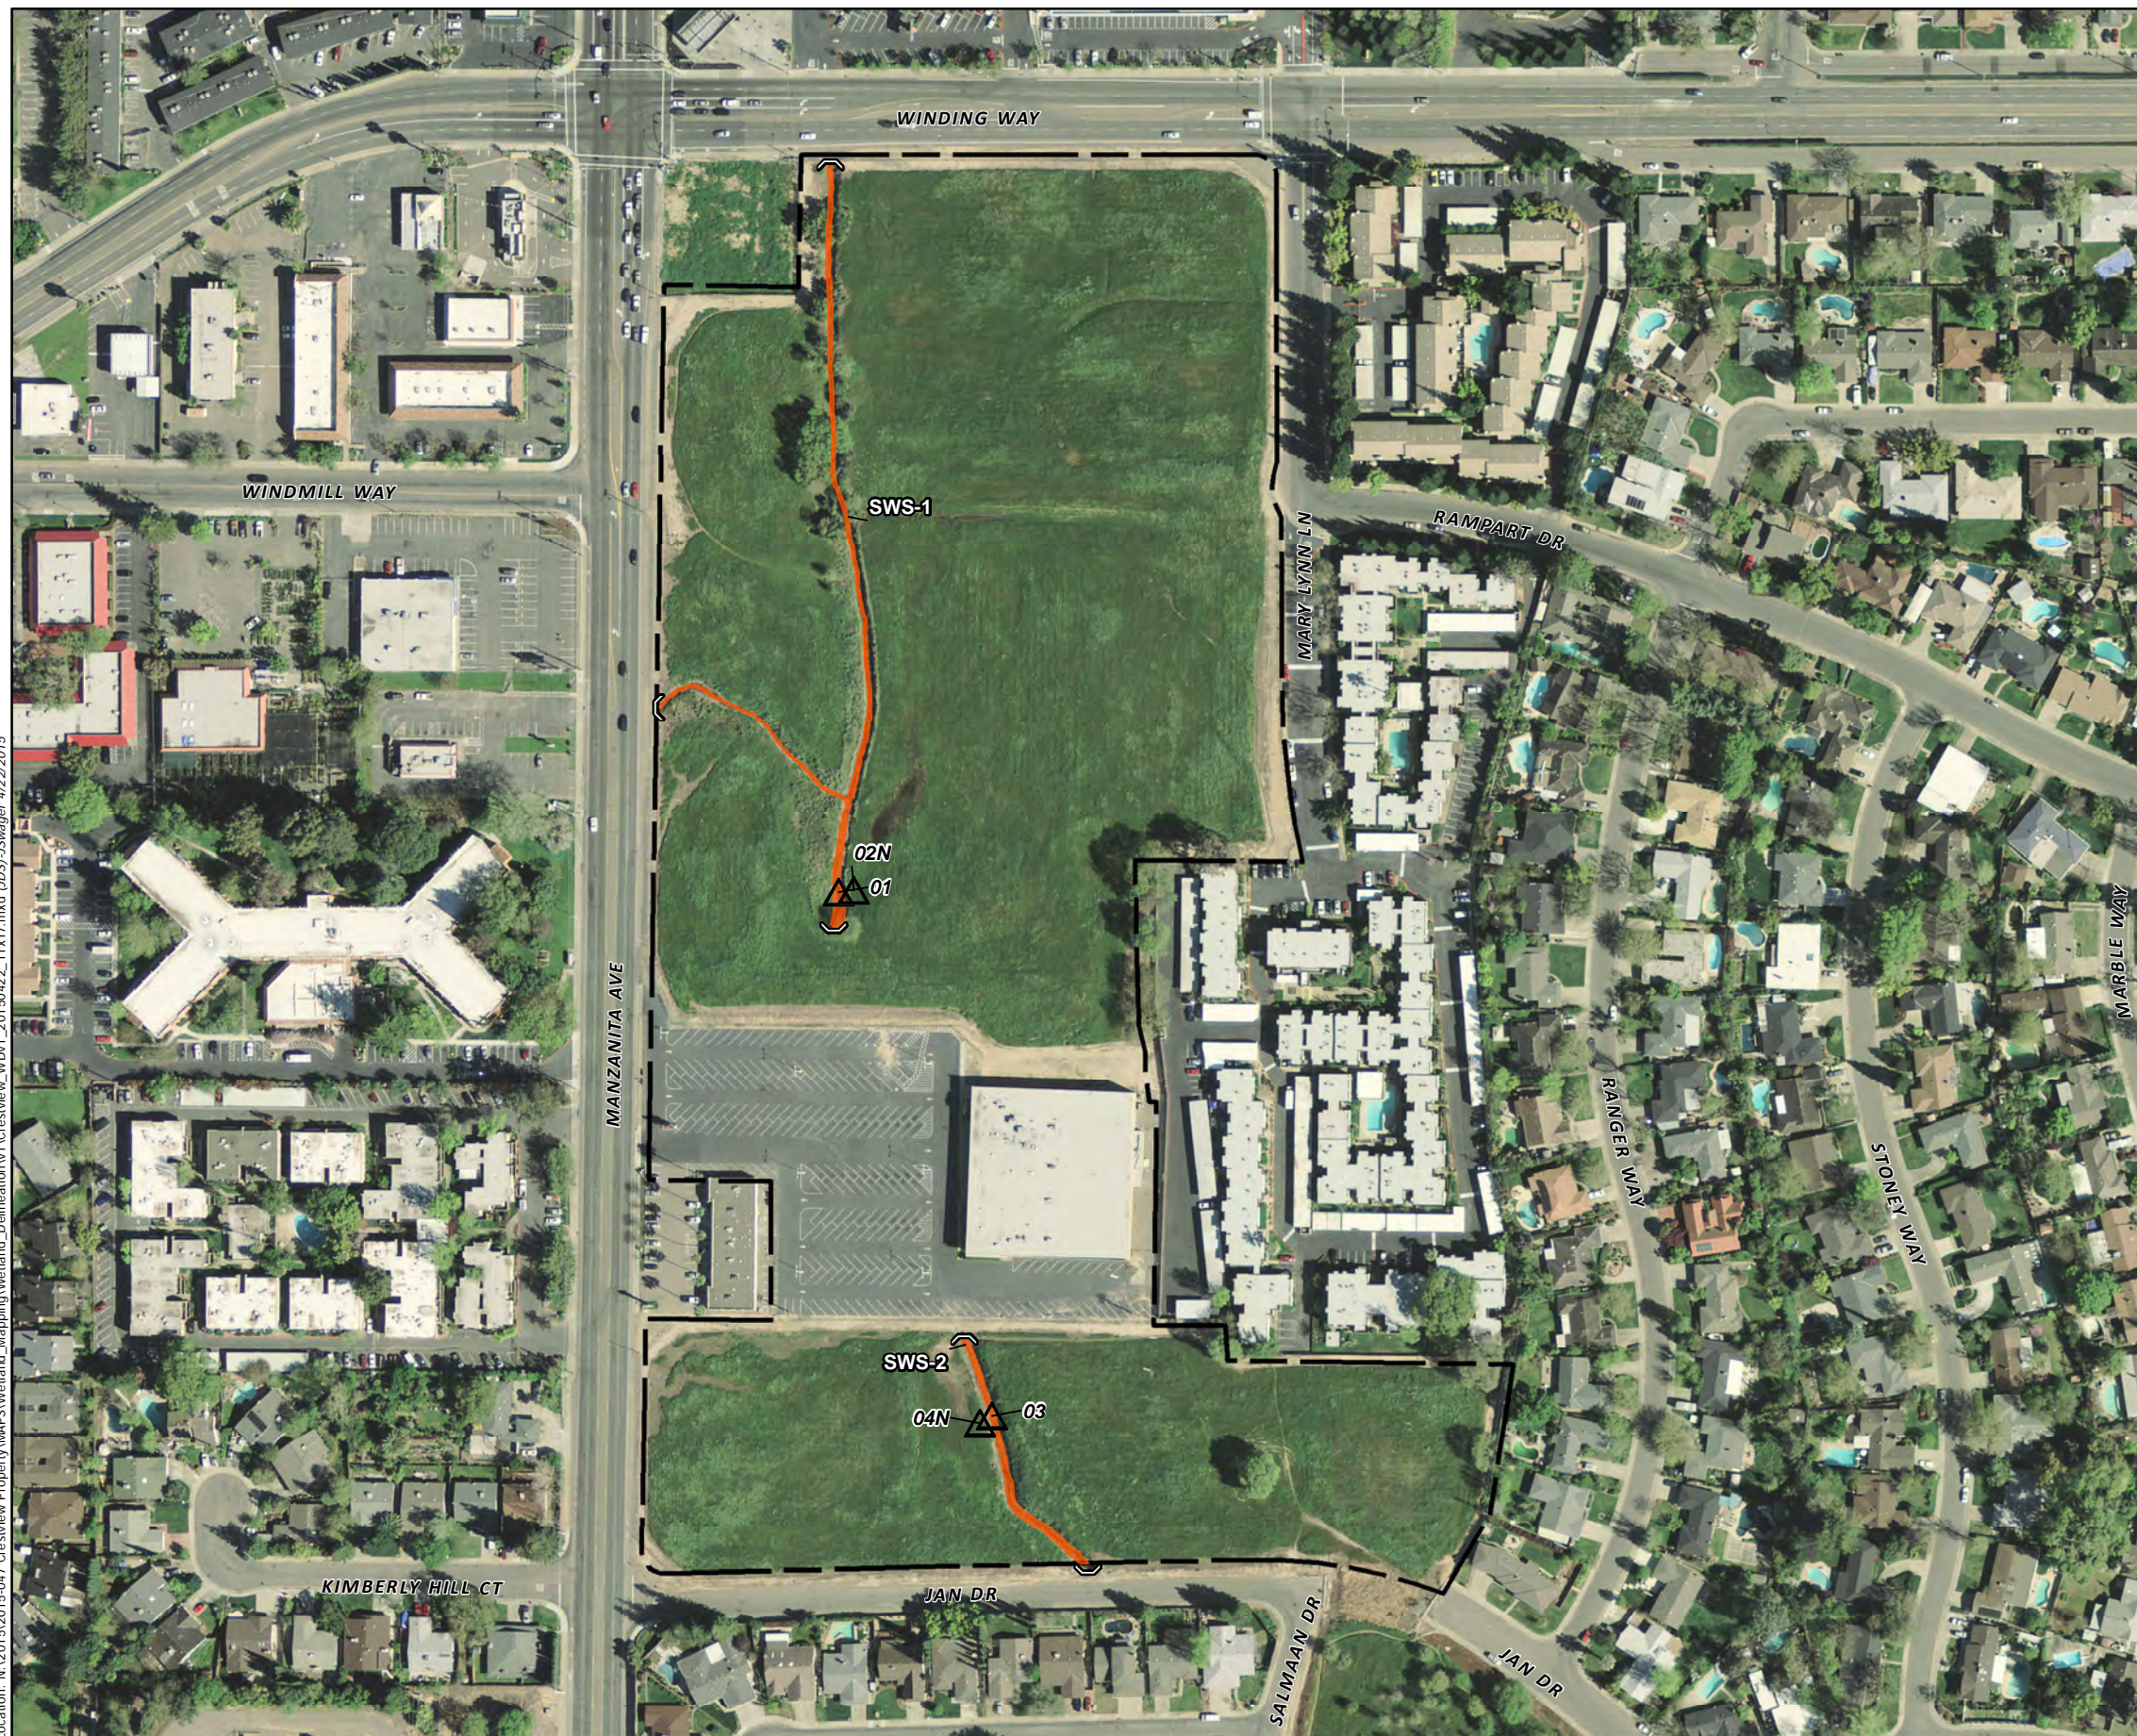
**Figure 3.**  
**Jurisdictional Delineation** <sup>2</sup>

A total of 0.164 acre of seasonal wetland swale was mapped on the Property (Figure 3. *Jurisdictional Delineation*). The Arid West wetland determination data forms are included as Attachment A, an aerial photograph of the site is included in Attachment B, and a list of plant species observed on-site is included in Attachment C. A discussion of the wetlands is presented below.

The dominant plant species found within the seasonal wetland swale included swamp smartweed (*Persicaria hydropiperoides*) (see Attachment A). Other plants found within the seasonal wetland swale included common cattail (*Typha latifolia*), cut-leaf geranium (*Geranium dissectum*), goose grass (*Galium aparine*), harding grass (*Phalaris aquatic*), soft brome (*Bromus hodeaceus*), wild grape (*Vitis californica*), wild radish (*Raphanus raphanistrum*), common fig (*Ficus carica*), valley oak (*Quercus lobata*), and cork oak (*Quercus suber*). Hydrophytic vegetation was determined to be present in both of the sampling points (01 and 03) within seasonal wetland swales due to the passage of the dominance test.

The soil matrix color from the surface to a depth of 4 inches within sampling point 01 was 10YR 2/1 (without redox features). The soil matrix color from a depth of 4 inches to a depth 16 inches was 10YR 3/3 with 15% redox concentrations located in pore linings colored 7.5YR 4/6. Soils within sampling point 01 were not determined to be hydric based on hydric soil indicators; however, because there is so much urban runoff (e.g., asphalt) these soil are problematic and assumed hydric because there is an obvious seasonal wetland swale in this location. The soil matrix color from the surface to a depth of 6 inches in the upland area (02N) adjacent to sampling point 01 was 10YR3/6 (without redox features); refusal was encountered at greater than 6 inches in depth (Attachment A). Soils within this upland sampling point (02N) were determined not to be hydric.

Wetland hydrology indicators observed within the seasonal wetland swale included Saturation (A3), sediment deposits (B2, nonriverine), drift deposits (B3, nonriverine), and oxidized rhizospheres along living roots (C3) (Attachment A). Wetland hydrology indicators were not found in the upland areas adjacent to the seasonal wetland swales.

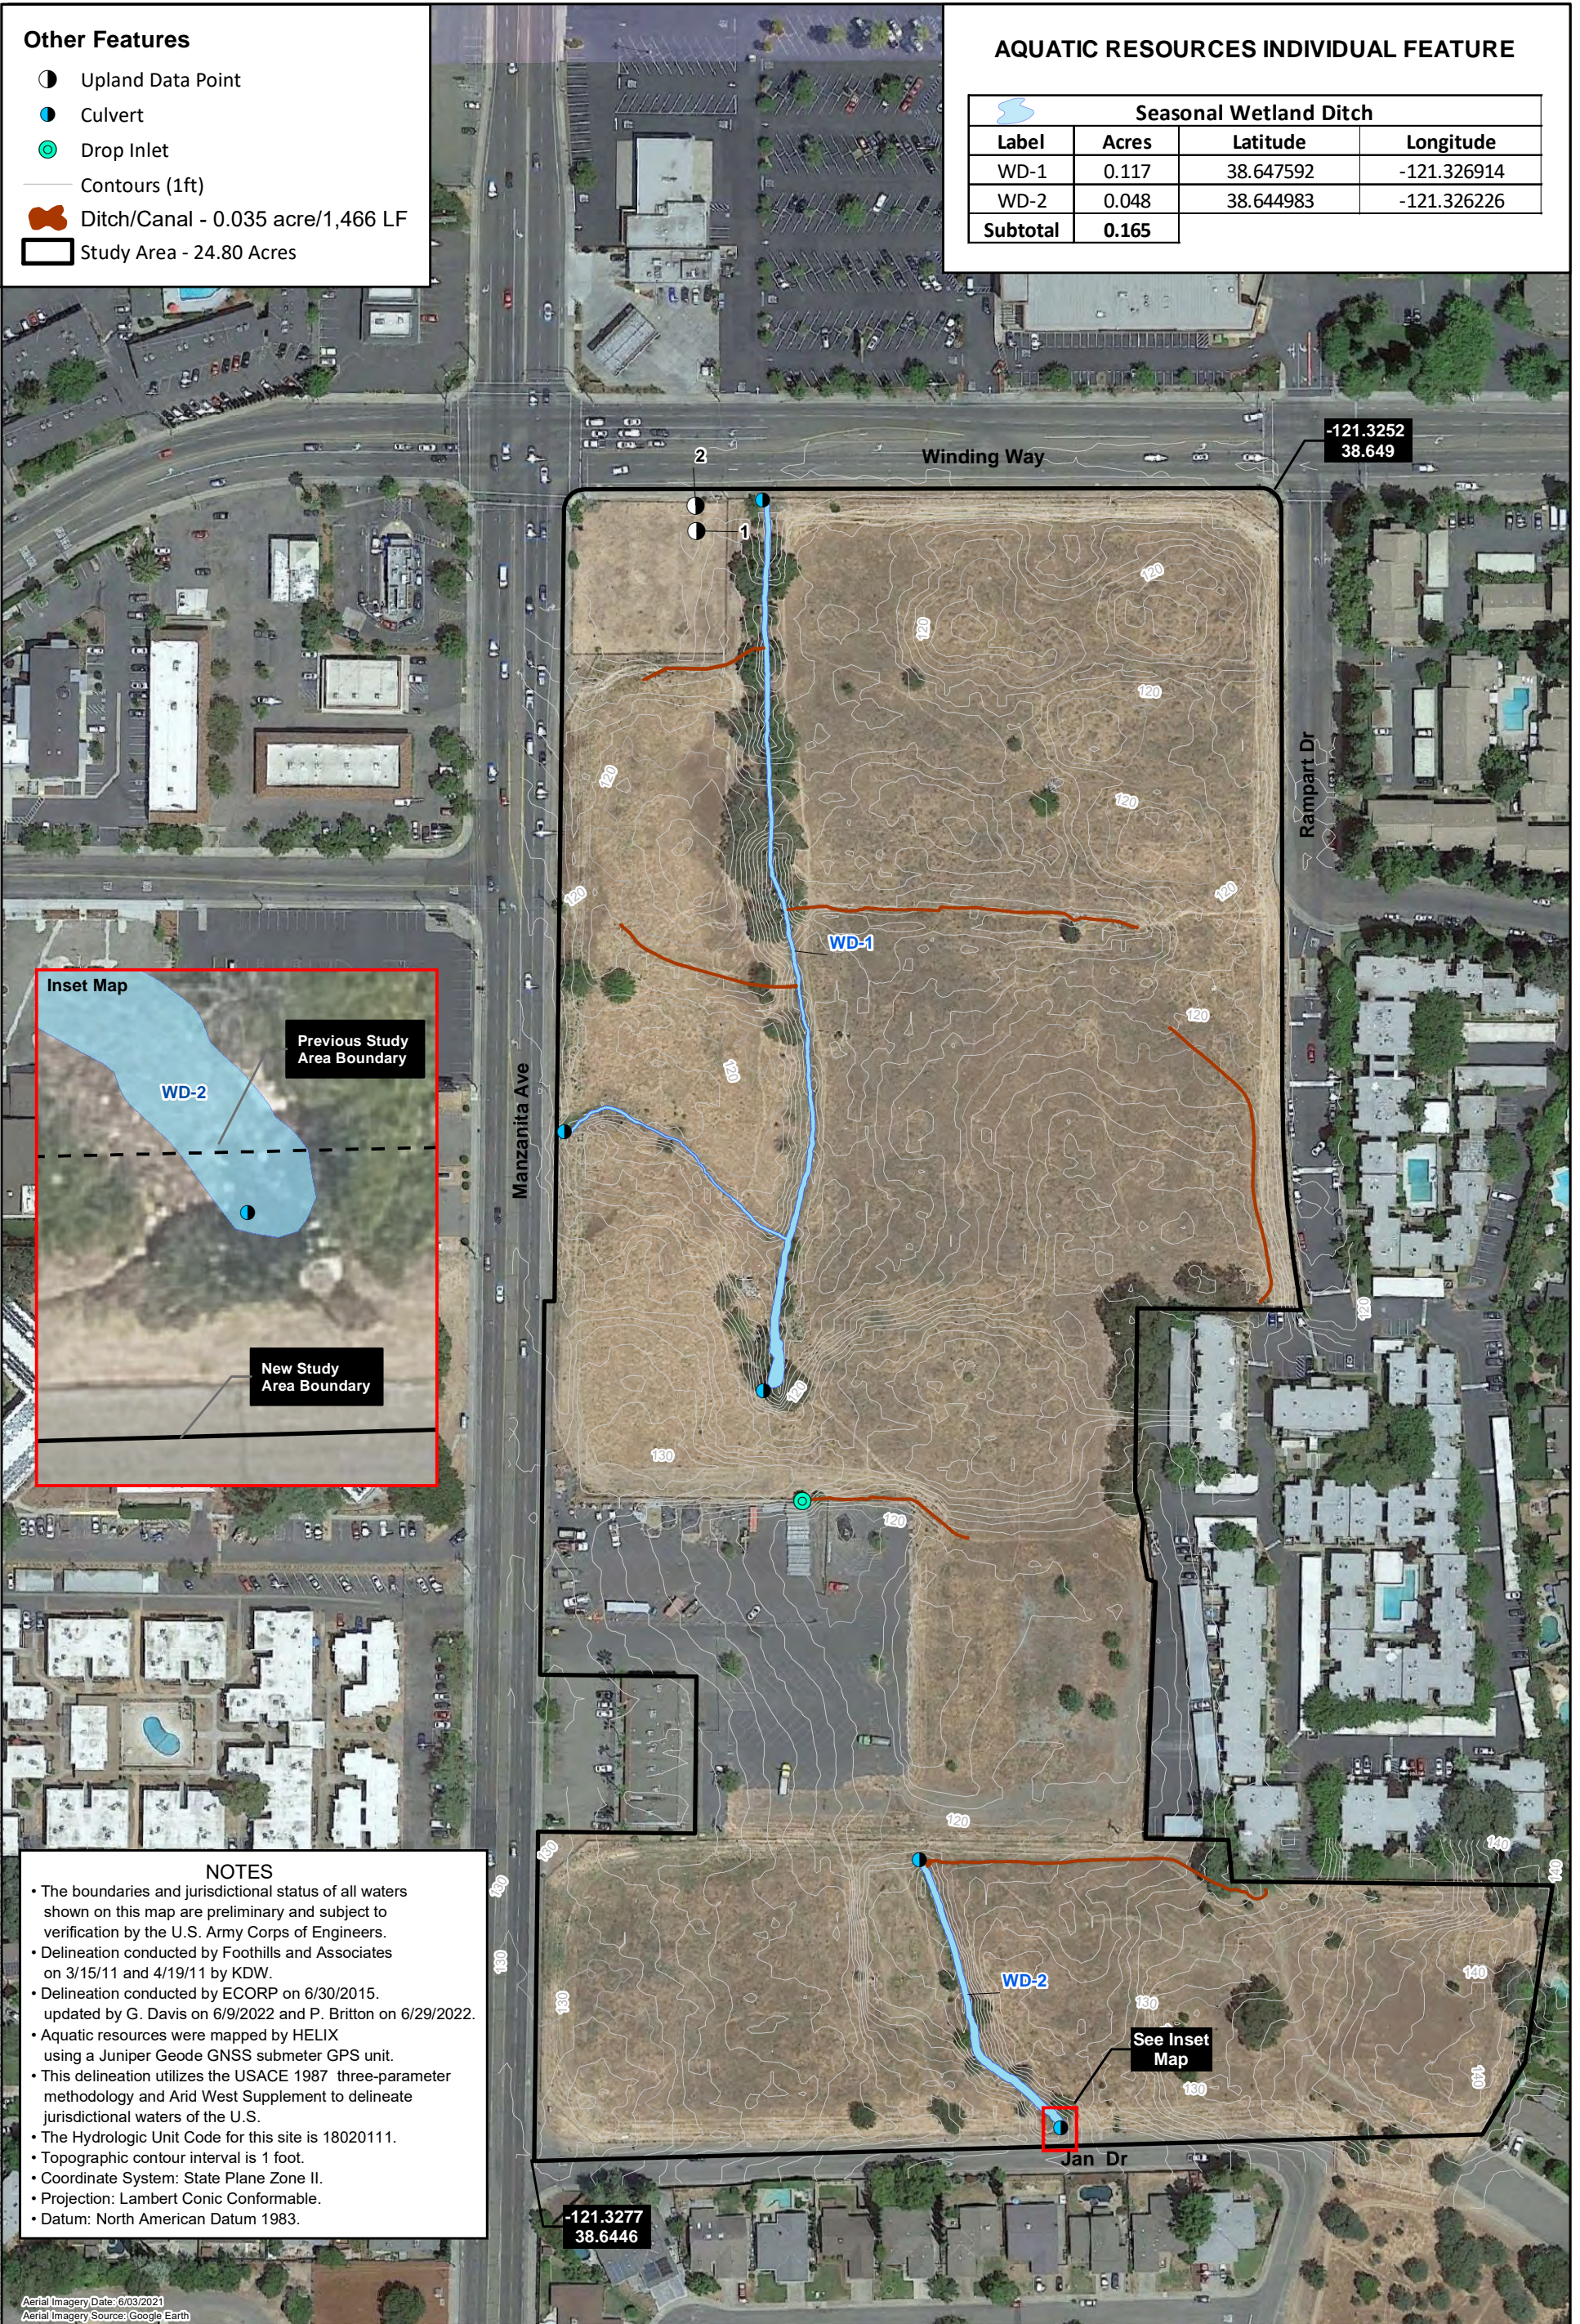
**AQUATIC RESOURCES INDIVIDUAL FEATURE**

No aquatic resources were observed within the 0.5-acre parcel during the survey conducted on June 8, 2022. Wetland Ditch (WD)-1 was expanded from 0.047-acre to 0.048-acre in the southern portion of the new Study Area boundary during the survey conducted on June 29, 2022. The aquatic resources delineation map from ECORP has been modified to include the 0.5-acre parcel, as well as other expansion areas (see HELIX's Aquatic Resources Delineation Map in Attachment B).

Seasonal Wetland Ditch			
Label	Acres	Latitude	Longitude
WD-1	0.117	38.647592	-121.326914
WD-2	0.048	38.644983	-121.326226
<b>Subtotal</b>	<b>0.165</b>
