**DRAFT PHASE I AND LIMITED PHASE II
ENVIRONMENTAL SITE ASSESSMENT
PROPOSED COMMERCIAL DEVELOPMENT
516 LA COSTA AVENUE
ENCINITAS, CALIFORNIA 92024**

Project No. 11823.001

November 30, 2017

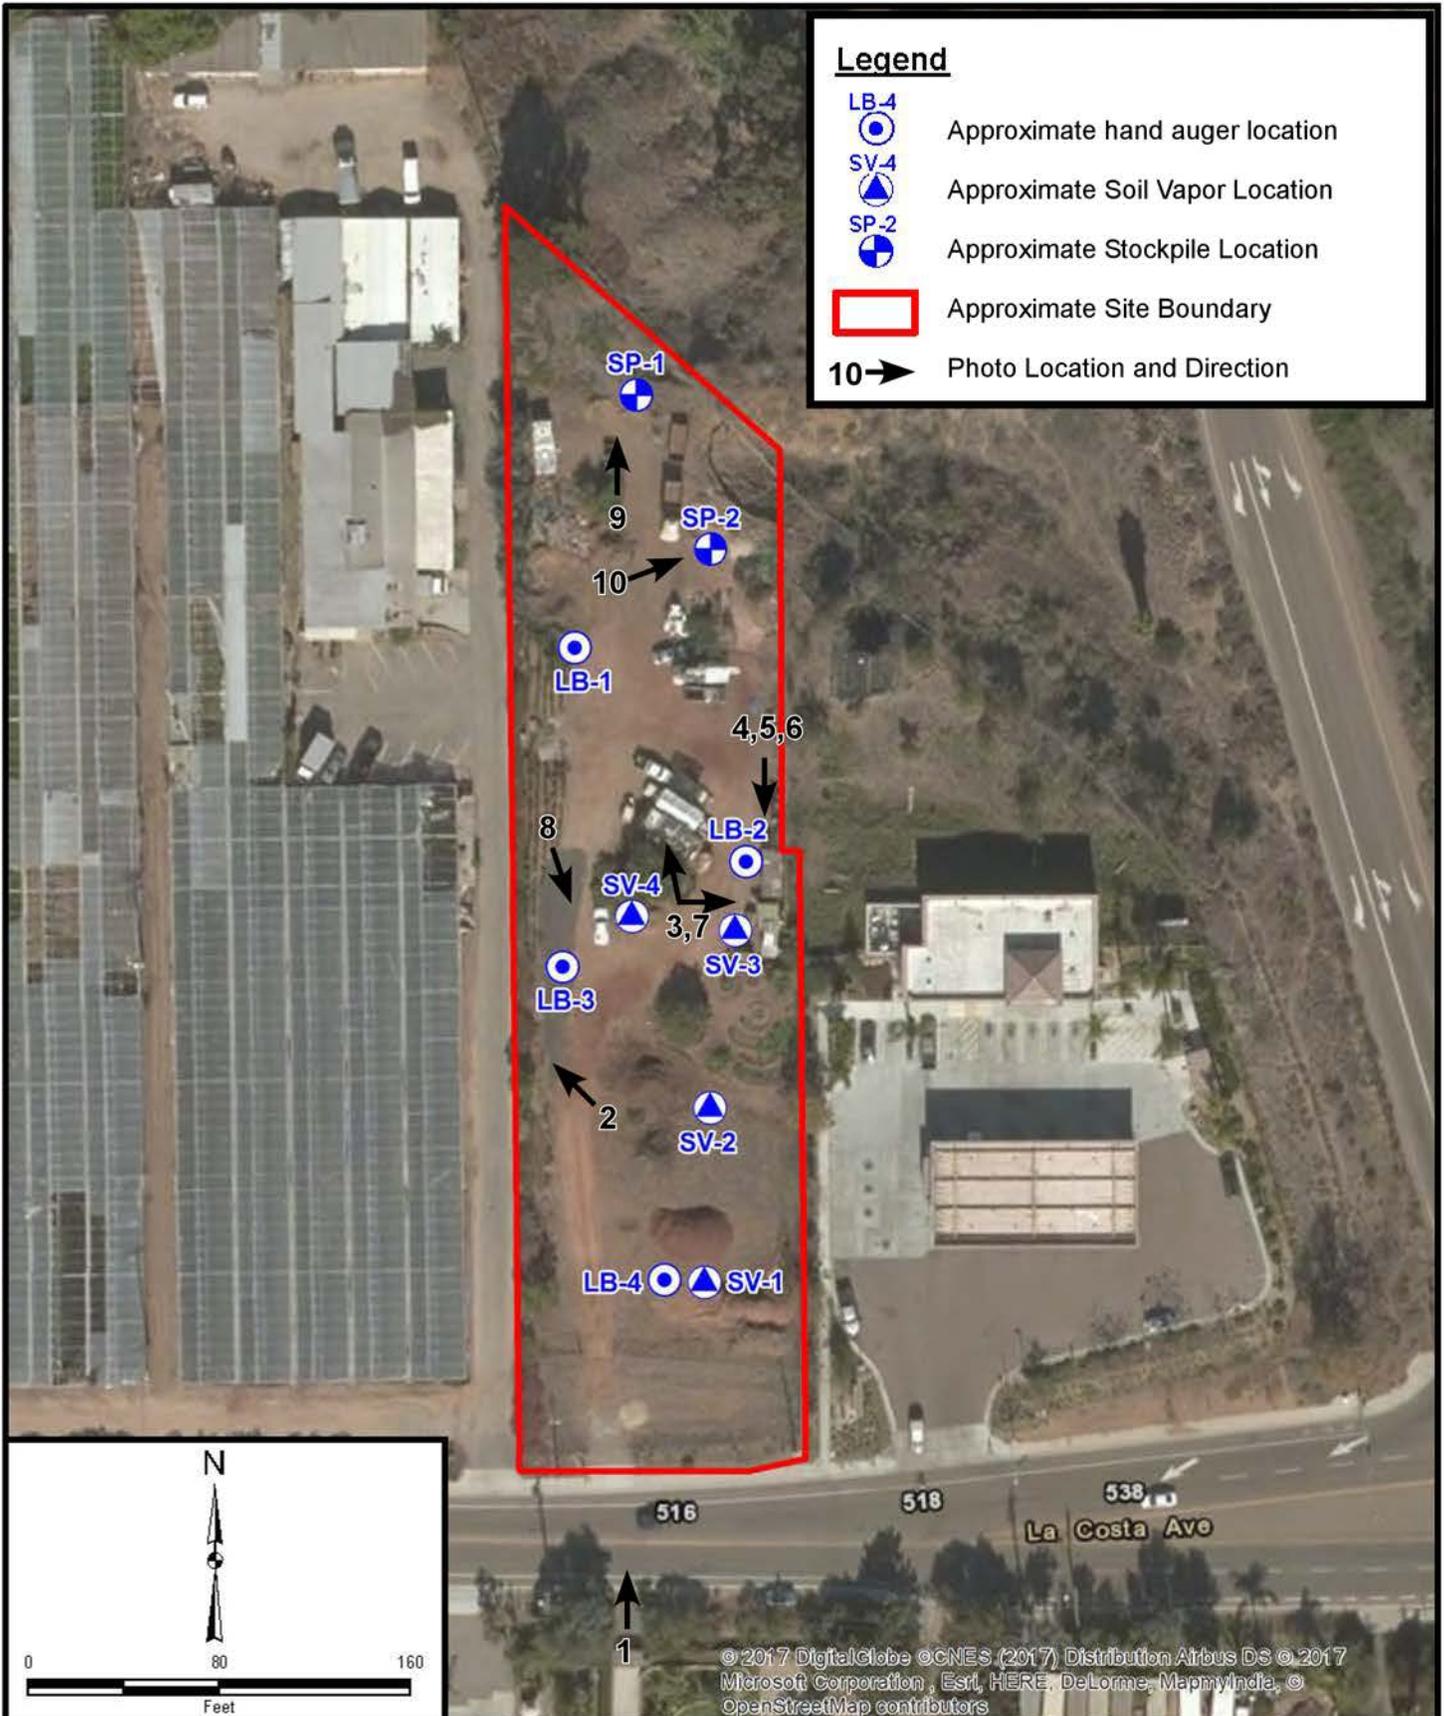
- LB-4 Approximate hand auger location
- SV-4 Approximate Soil Vapor Location
- SP-2 Approximate Stockpile Location
- Approximate Site Boundary
- 10 → Photo Location and Direction

On November 16, 2017, a representative of Leighton, conducted a reconnaissance-level assessment of the Site. The site reconnaissance consisted of the observation and documentation of existing site conditions and nature of the neighboring property development within ¼ mile of the Site. Photographs of the Site are presented in Appendix B and their view directions are noted on Figure 2. Items noted during the site reconnaissance are also noted on Figure 2.

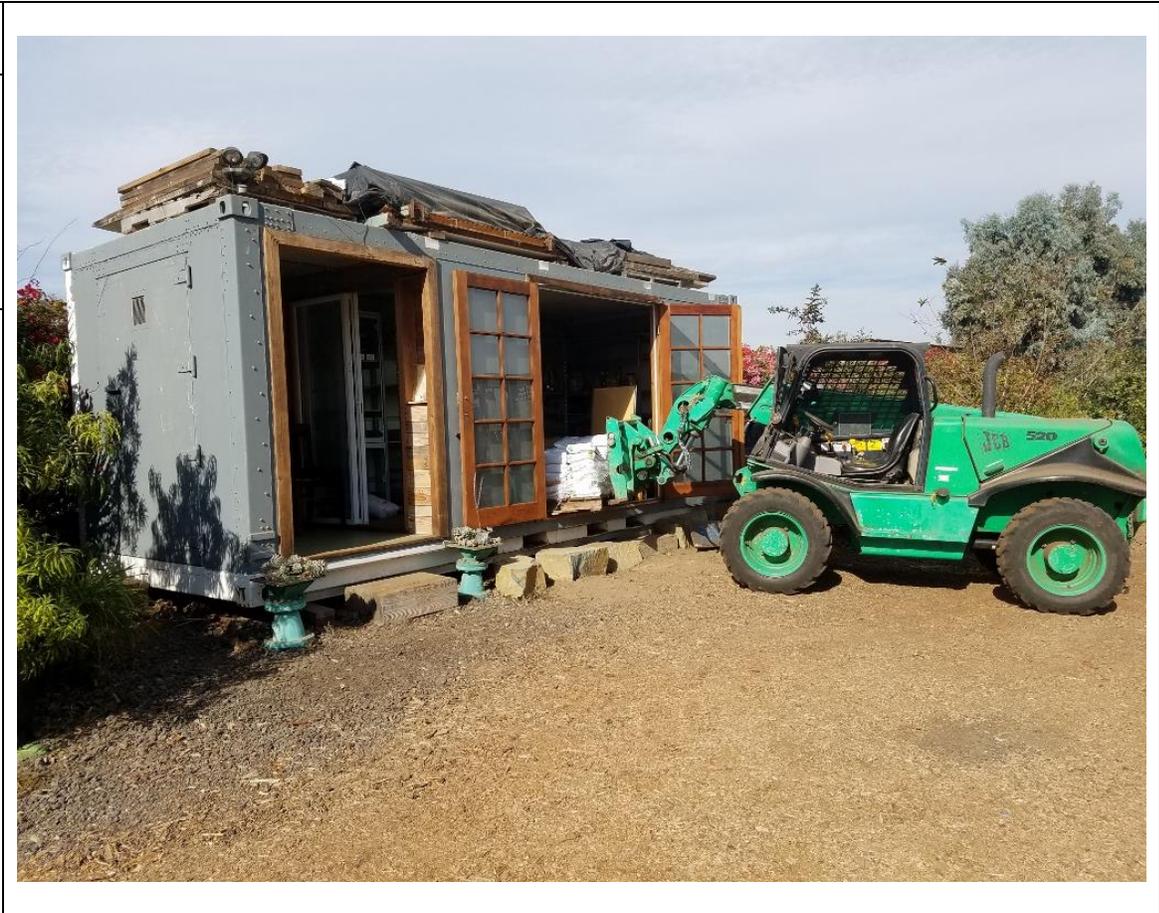
View Direction of Photo:
East

Description:
View of tree trimming contractor's shop area.

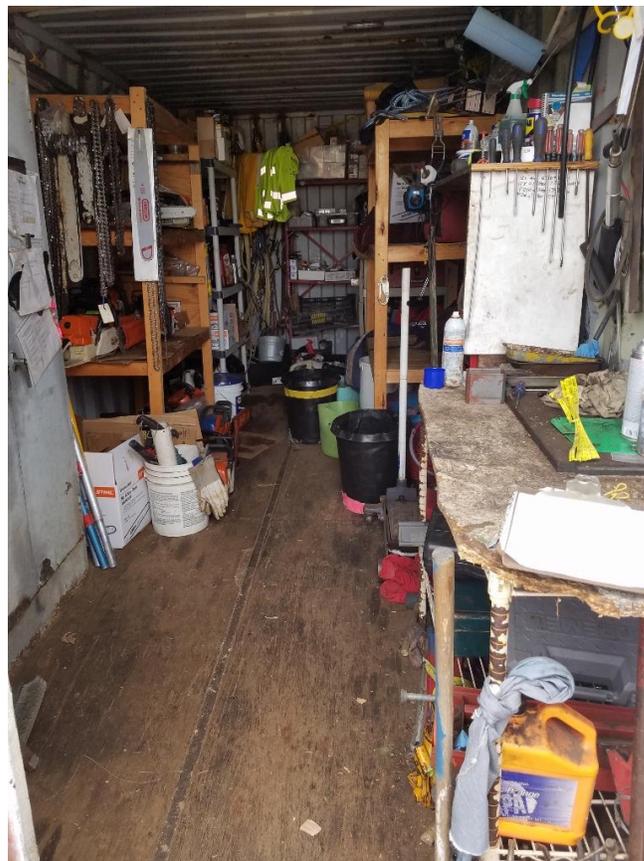
View Direction of Photo:
N/A

Description:
Closeup of equipment maintenance chemicals inside the shop storage container.

Paint cans, oil, fuel, and other equipment maintenance products were observed in the storage containers at the Site (Photos 3 through 7 – Appendix B). Organic fertilizers and pesticides were also observed in a storage container on-site (Photo 2 – Appendix B). Staining or corrosion indicative of a release of hazardous materials was not observed in these areas. The presence of small quantities of hazardous and regulated wastes is considered a *de minimis* condition for the Site.

Paint cans, oil, fuel, and other equipment maintenance products were observed in the storage containers at the Site. Organic fertilizers and pesticides were also observed in a storage container on-site. Staining or corrosion indicative of a release of hazardous materials was not observed in these areas. During future property redevelopment, all regulated wastes should be properly disposed of in accordance with local, state, and federal regulations.

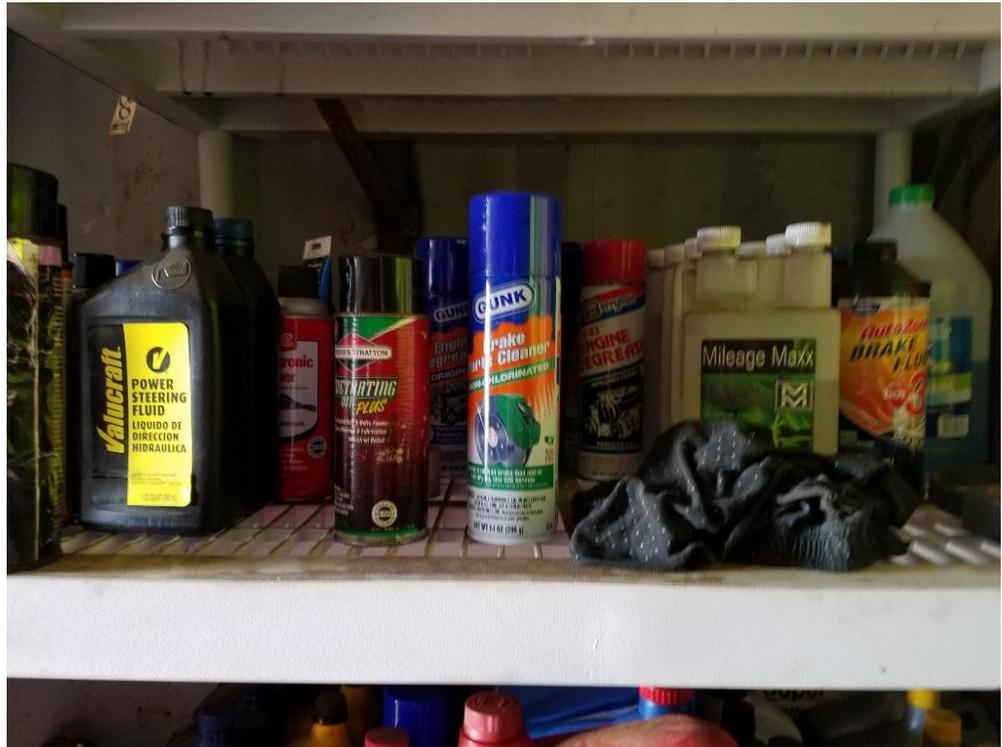
Photo No. 6

View Direction of Photo:
N/A

Description:
Closeup of a storage container with fuel and oil stored inside.

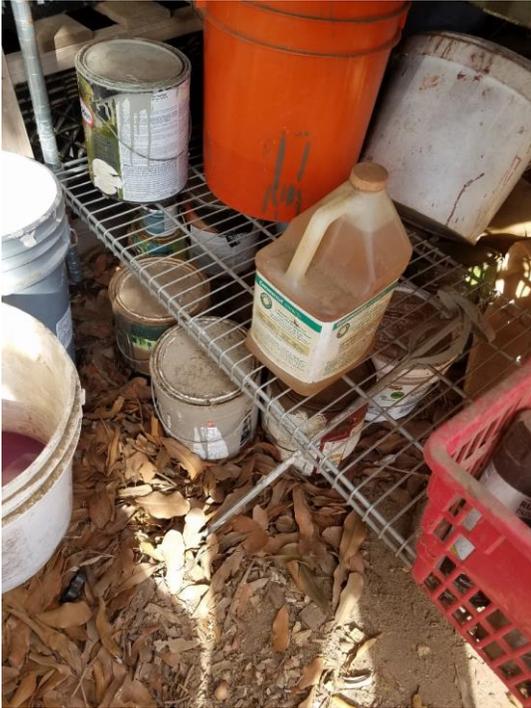
Photo No. 7

View Direction of Photo: N/A	
Description: View of paint and other chemicals in the central portion of the Site.

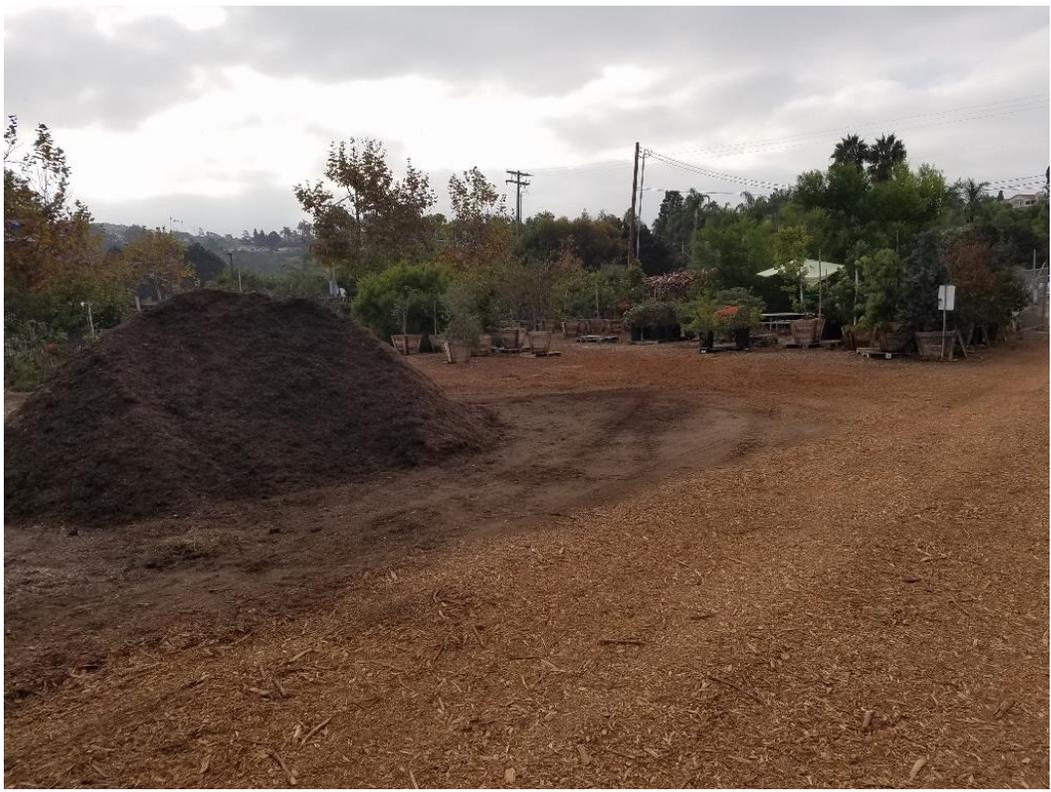
Photo No. 8

View Direction of Photo: Southeast	
Description: General view of the Site. Plants, trees, and mulch are sold at the nursery operating on-site.

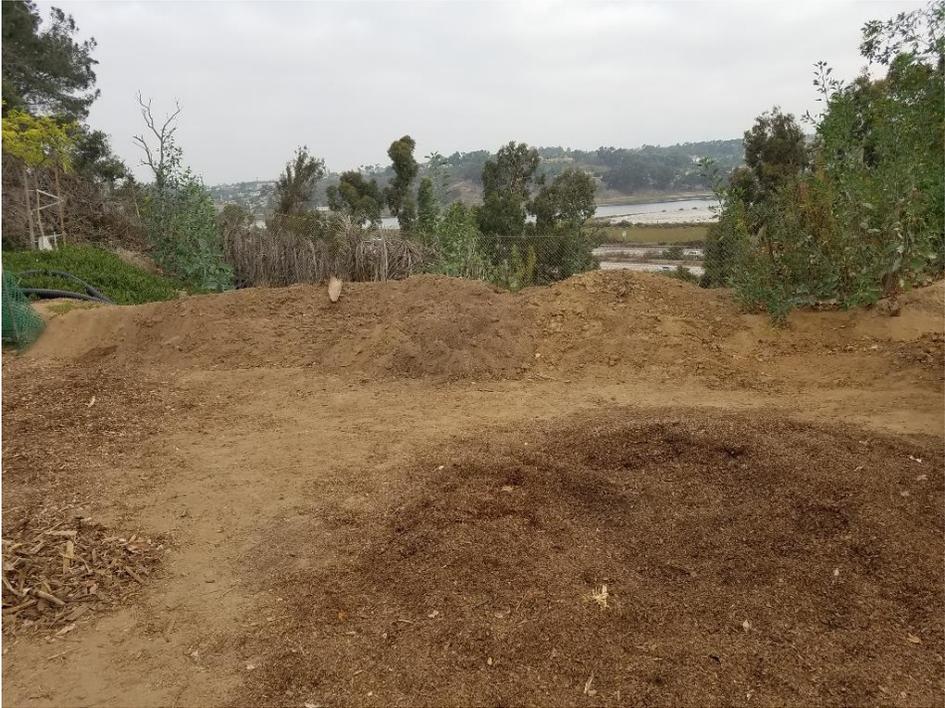
Photo No. 9

View Direction of Photo: North	
Description: View of stockpiled import soils at the northern margin of the Site. Batiquitos Lagoon is visible in the background.

Currently, the Site consists of a 1.19-acre parcel of commercial land that is occupied by a tree trimming contractor and a nursery (Photos 1 through 10 – Appendix B). Undocumented import soils were observed at the northern margin of the Site (Photos 9 and 10 – Appendix B).

In addition, two soil samples collected from the northern margin of the Site where imported soil stockpiles were observed. These samples were also analyzed for TPH and Title 22 Metals.

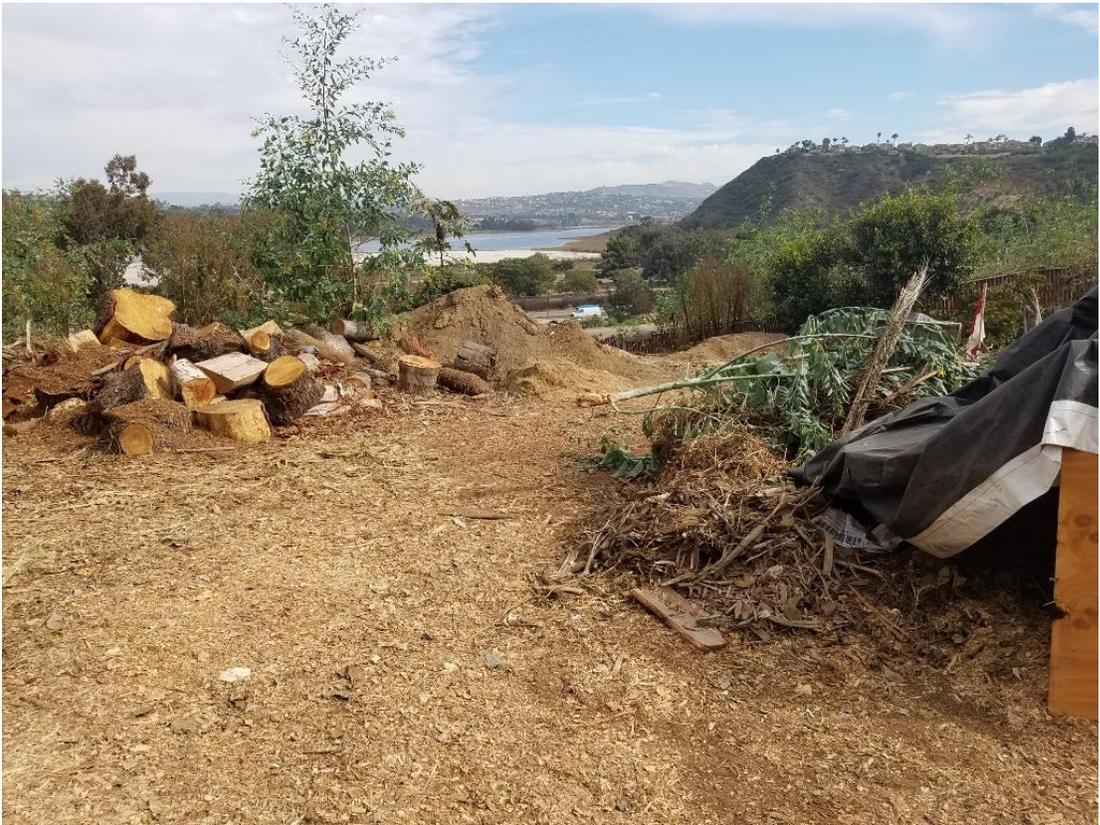
Photo No. 10

View Direction of Photo: Northeast	
Description: View of stockpiled import soils at the northern margin of the Site. Batiquitos Lagoon is visible in the background.
