Subject: Phase I Environmental Site Assessment and Limited Subsurface Investigation
455 Hickey Boulevard
Daly City, California

***Phase I
Environmental Site Assessment***

455 Hickey Boulevard
Daly City, California

July 24, 2015
Project Number 15-0030.00

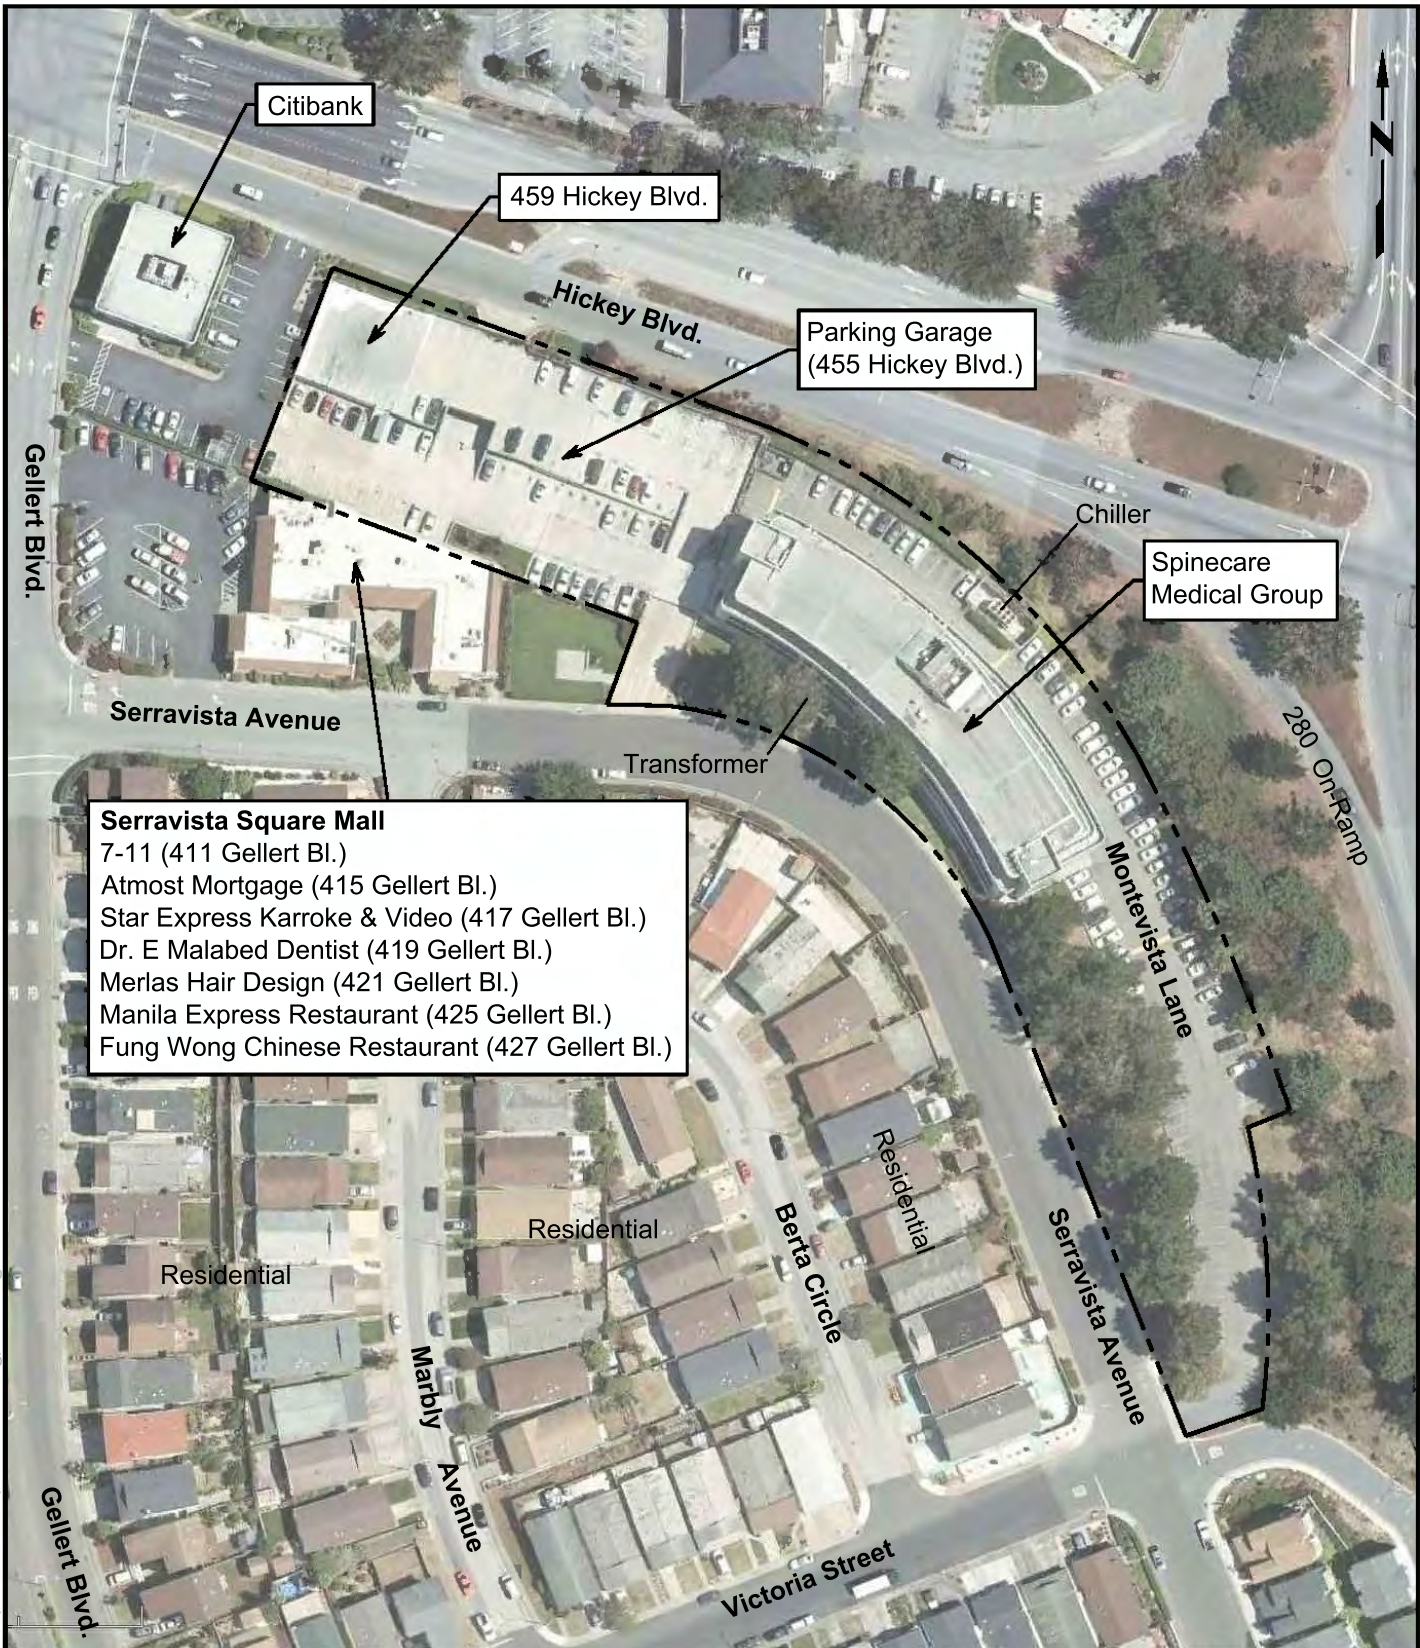
ROSSO ENVIRONMENTAL, INC.	Figure 2

The approximately 3.2-acre kidney-shaped subject property is located on a hillside (sloping down to the northeast), and is improved with a five-story administrative and medical office building, and a three-level parking garage with small annex located in the western portion of the parking garage. Telecommunications equipment are located on the roof of the building. Remaining portions of the subject property include landscaping, an exterior chiller pad, and paved parking. The subject property is bordered to the north by Hickey Boulevard, and is accessed by Serravista Avenue to the south; Montevista Lane, which is accessed from Serravista Avenue, runs on the subject property along the eastern border. Because of the hillside location, the 3rd floor of the building is approximately at street level with Serravista Avenue. Figure 2 shows the Site plan.

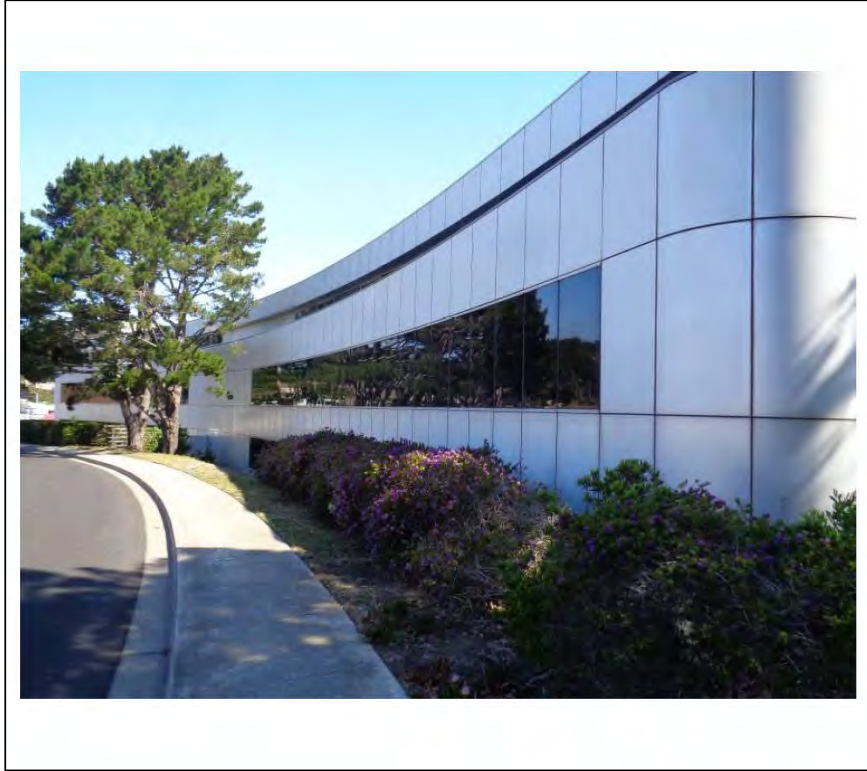
Project No. 2015-0030.00	Description	Subject property view from the southeast.	1
	Name	455 & 459 Hickey Boulevard, Daly City, California	Photo Date June 8, 2015

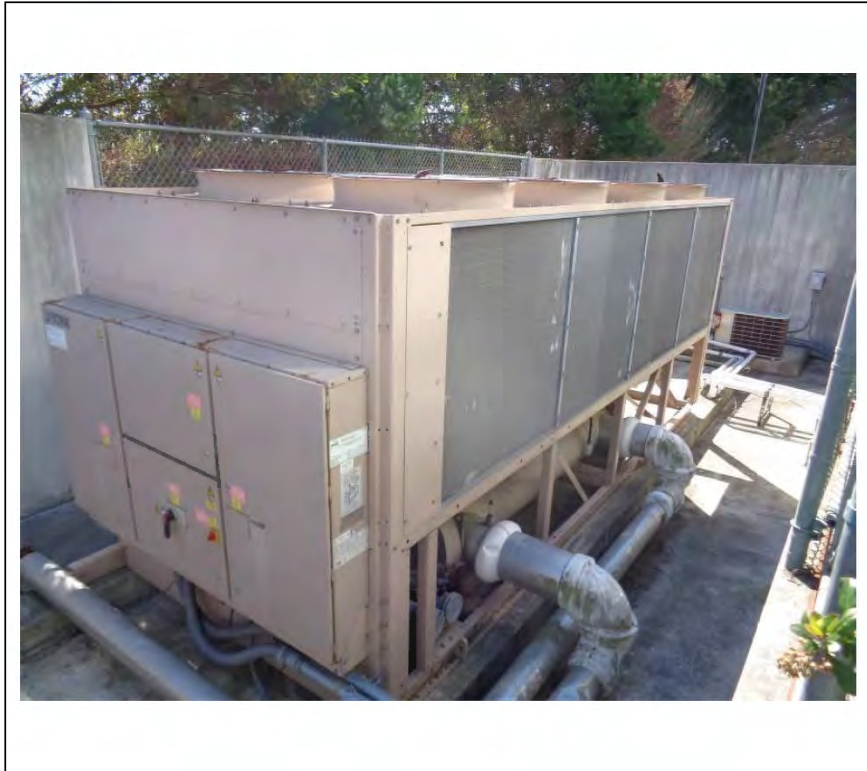
Project No. 2015-0030.00	Description	Chiller unit.	3
	Name	455 & 459 Hickey Boulevard, Daly City, California	Photo Date June 8, 2015

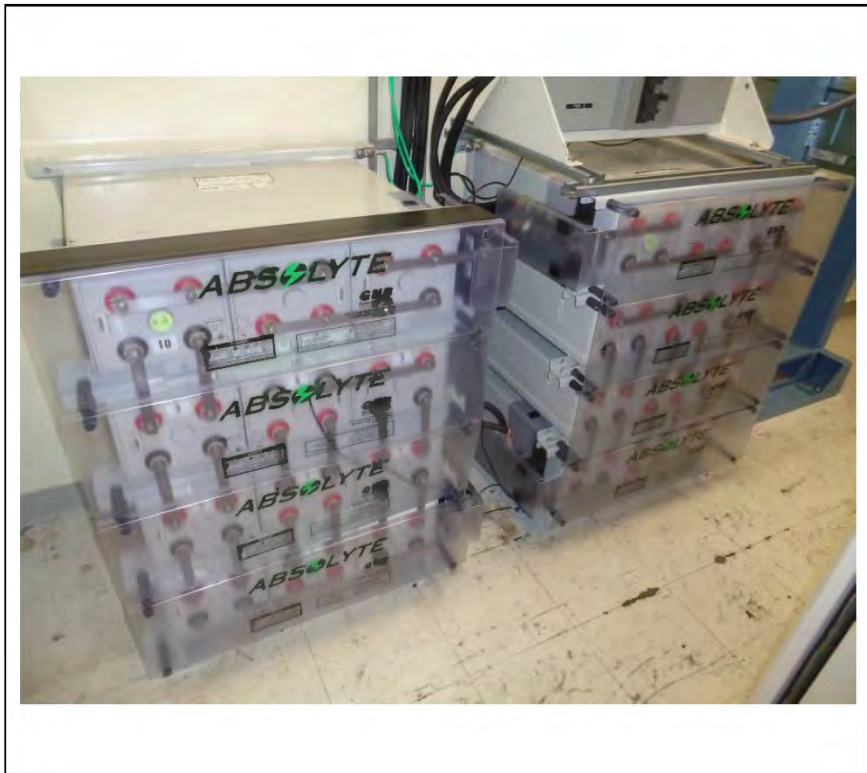
- 2005-2015: AT&T Mobility, permit to store hazardous materials (lead acid batteries). No material violations, USTs, or ASTs are noted.
- 2009-2014: T-Mobil, permit to store motor vehicle fuels or waste only. A 2011 email from T-Mobil to EH indicating that the amount of hazardous materials is below threshold amounts. According to Hazardous Materials facility information, hazardous materials are noted as the storage of batteries. No USTs or ASTs are noted.

Project No. 2015-0030.00	Description	Batteries associated with telecommunications equipment on the roof.	4
	Name	455 & 459 Hickey Boulevard, Daly City, California	Photo Date June 8, 2015

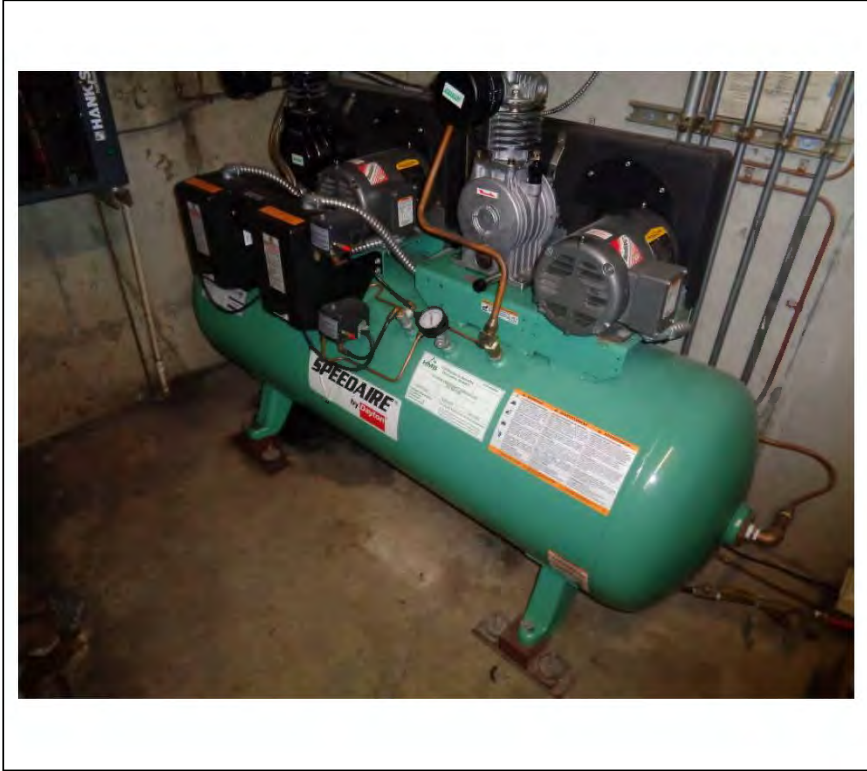
- Staining was observed within a maintenance room near a compressor in the vicinity of a drain. This finding was *de minimis*.
 - Records reviewed during this assessment indicated that a printing facility was to be developed in the annex by First Nationwide Bank. According to the 1991 Phase I ESA reviewed by AEI, Nationwide had been a tenant since the building was constructed, and interviewed Mr. Duncan Finlayson, who was present at the time of construction, and indicated that there was a photo processing area, but did not operate as a printing facility. In addition, no records regarding hazardous materials storage were reportedly available at the time from San Mateo County agencies.

Project No. 2015-0030.00	Description	Compressor in the maintenance room.	5
	Name	455 & 459 Hickey Boulevard, Daly City, California	Photo Date June 8, 2015

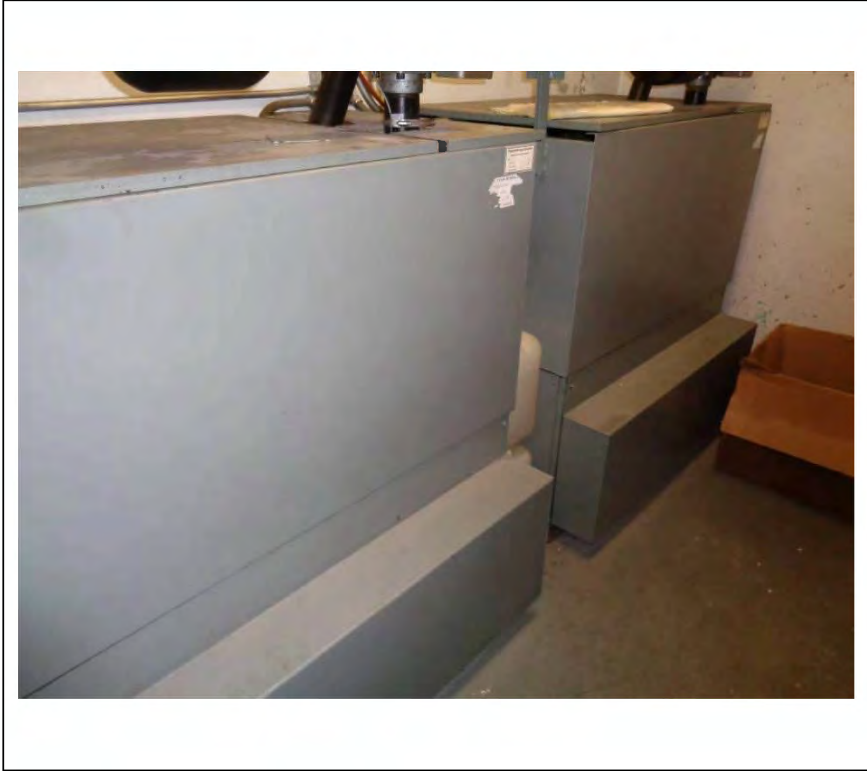
Thyssen Krupp Elevator. The elevator equipment was observed to be in good condition, with no evidence of spills noted.

Project No. 2015-0030.00	Description	Central elevator equipment	7
	Name	455 & 459 Hickey Boulevard, Daly City, California	Photo Date June 8, 2015

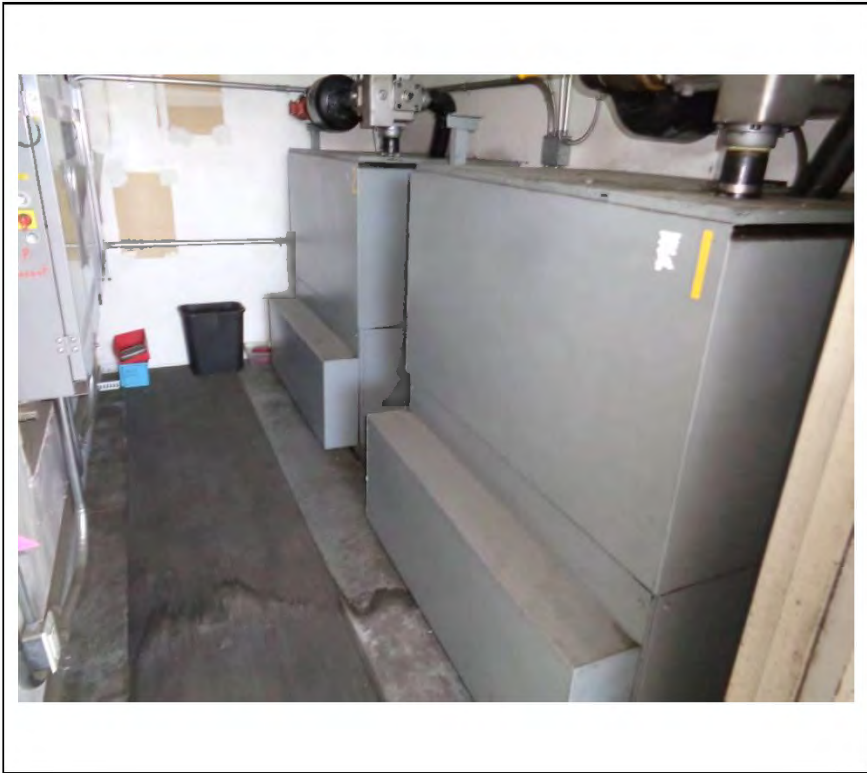
Project No. 2015-0030.00	Description	Northern elevator equipment room	8
	Name	455 & 459 Hickey Boulevard, Daly City, California	Photo Date June 8, 2015

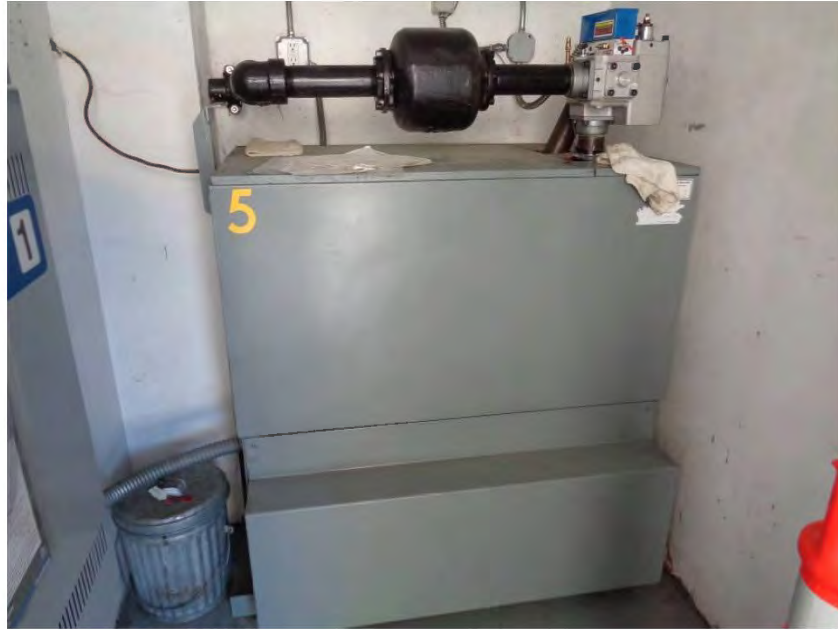
Project No. 2015-0030.00	Description	Southern elevator equipment room.	9
	Name	455 & 459 Hickey Boulevard, Daly City, California	Photo Date June 8, 2015

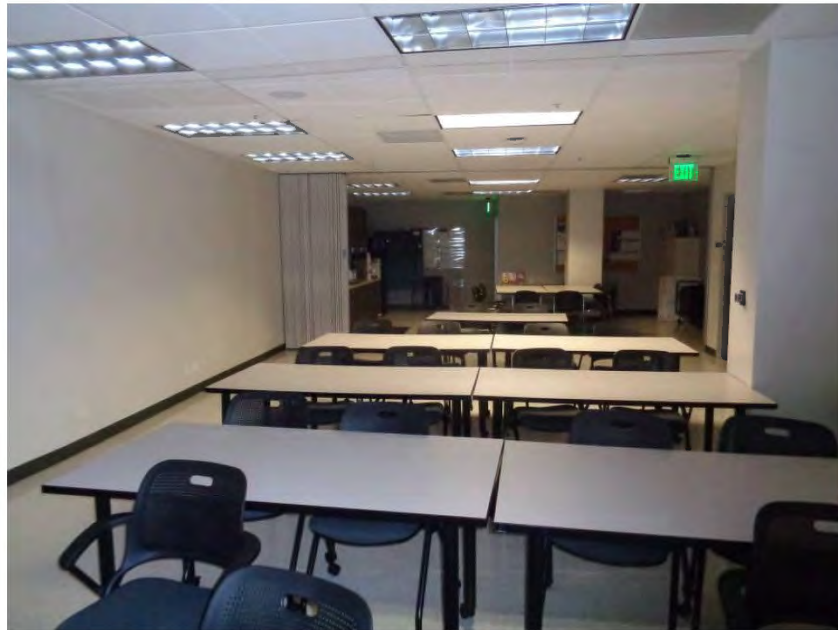
Project No. 2015-0030.00	Description	Typical office conference room on the first floor	10
	Name	455 & 459 Hickey Boulevard, Daly City, California	Photo Date June 8, 2015

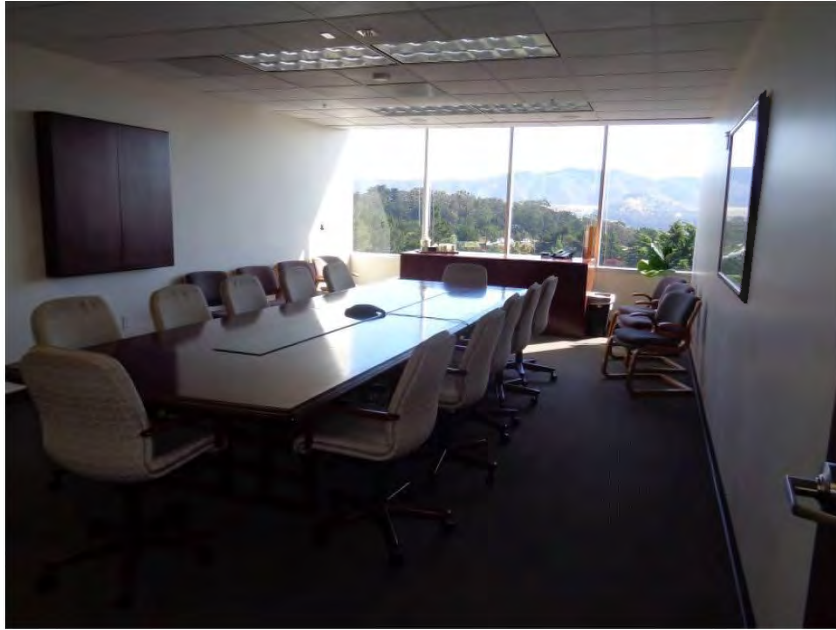
Project No. 2015-0030.00	Description	Typical office area.	13
	Name	455 & 459 Hickey Boulevard, Daly City, California	Photo Date June 8, 2015

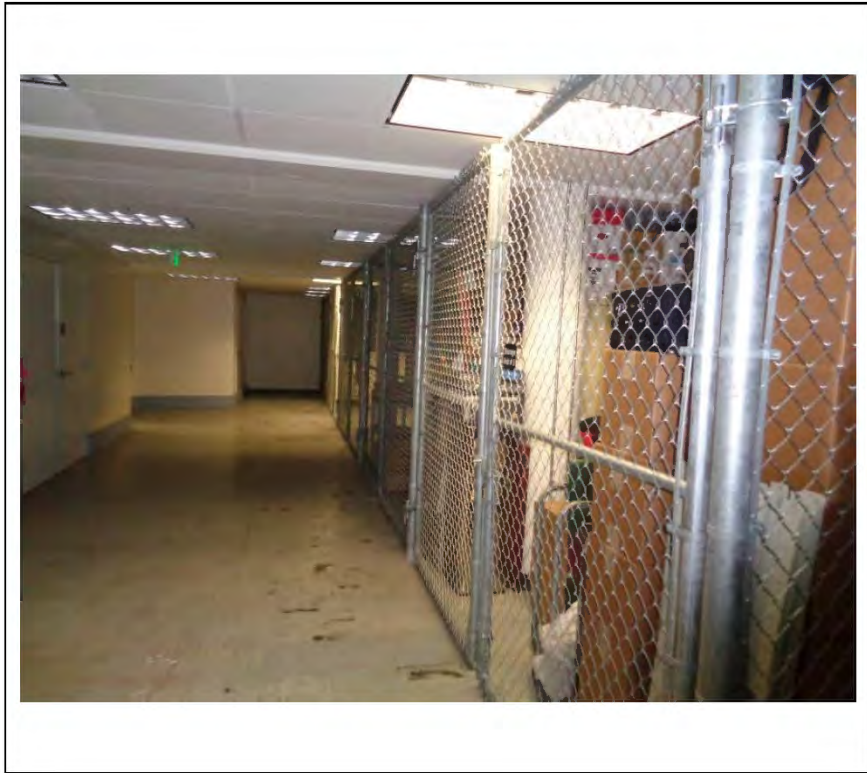
- The lower floor of 459 Hickey Boulevard is used for storage by various tenants, portions of which were fenced and locked, and thus inaccessible during reconnaissance; stored materials (eg, office equipment, furniture, and holiday decorations) observed through the fence obscured visual observation of the floor. This is a limitation to the reconnaissance; however, does not appear to be significant as Mr. Rudy Mahan indicated hazardous materials are not stored in the area.

Project No. 2015-0030.00	Description	Storage area (inaccessible fence), bottom floor 459 Hickey Boulevard.	16
	Name	455 & 459 Hickey Boulevard, Daly City, California	Photo Date June 8, 2015

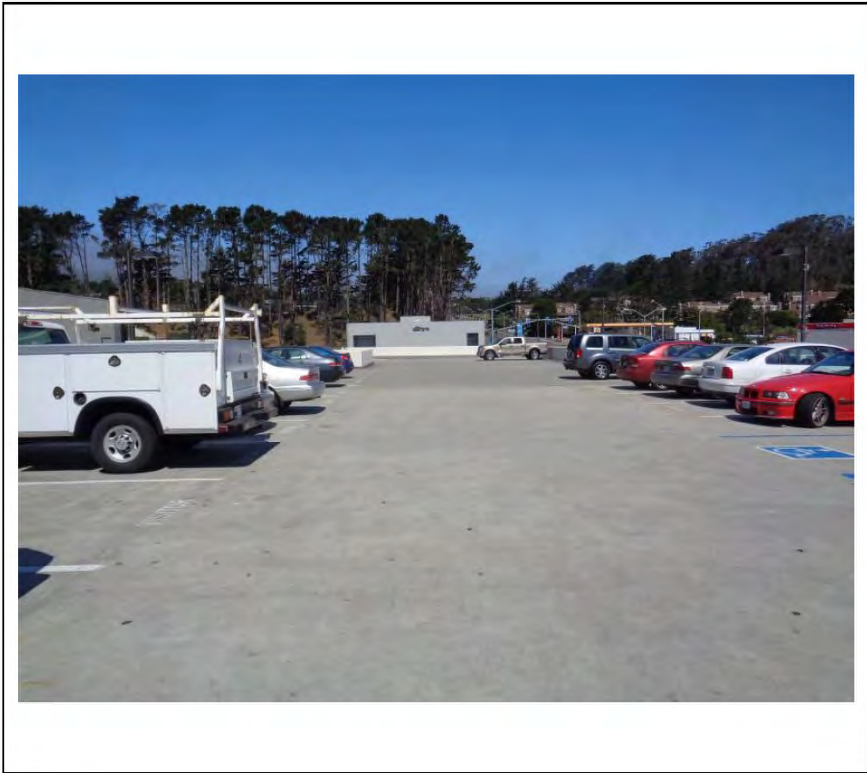
Project No. 2015-0030.00	Description	Parking structure exterior.	18
	Name	455 & 459 Hickey Boulevard, Daly City, California	Photo Date June 8, 2015

The construction of the current on-Site parking garage involved a relatively deep (approximately 16 foot) excavation into the hillside that likely would have removed recirculation system features associated with the former carwash. The former gas station / carwash was removed 35 years ago and present for less than 10 years, which generally reduces the opportunity for releases of hazardous substances and petroleum products.

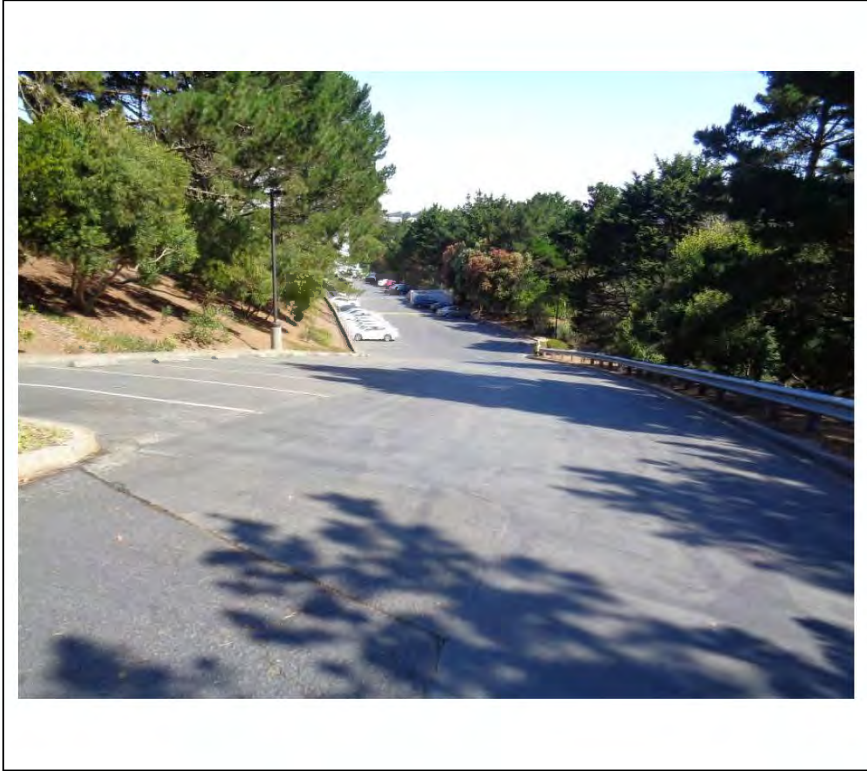
Project No. 2015-0030.00	Description	Southeastern portion of subject property.	19
	Name	455 & 459 Hickey Boulevard, Daly City, California	Photo Date June 8, 2015

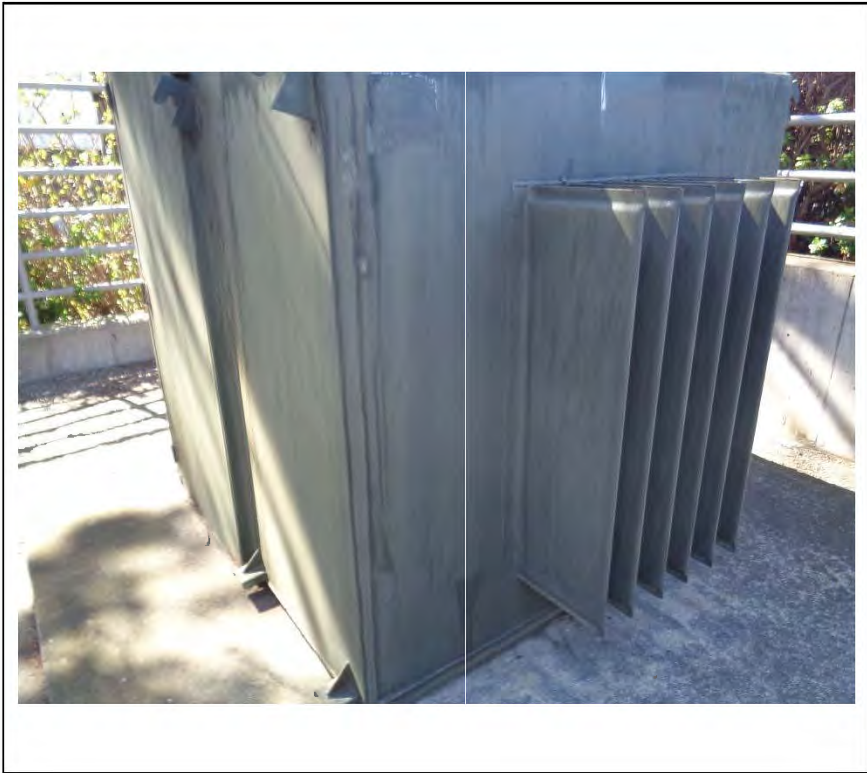
- One Pacific Gas and Electric (PG&E) pad-mounted transformer was observed in the southern portion of the subject property. The transformer appeared to be in good condition, with no evidence of leaks or spills observed.

Project No. 2015-0030.00	Description	Pad mounted transformer south of the building.	20
	Name	455 & 459 Hickey Boulevard, Daly City, California	Photo Date June 8, 2015

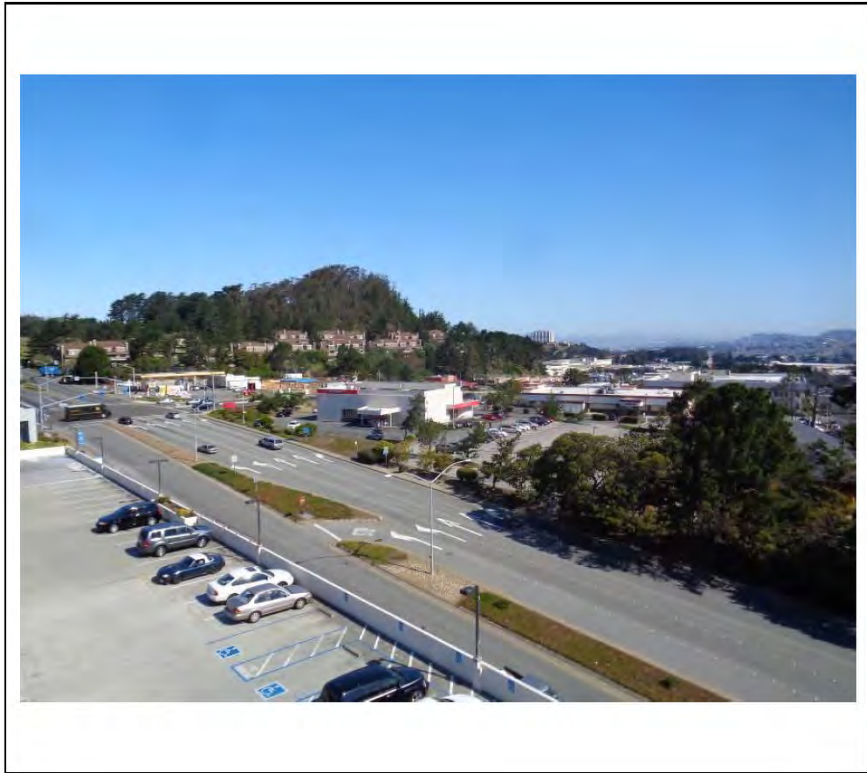
Project No. 2015-0030.00	Description	Northern adjoining property	22
	Name	455 & 459 Hickey Boulevard, Daly City, California	Photo Date June 8, 2015

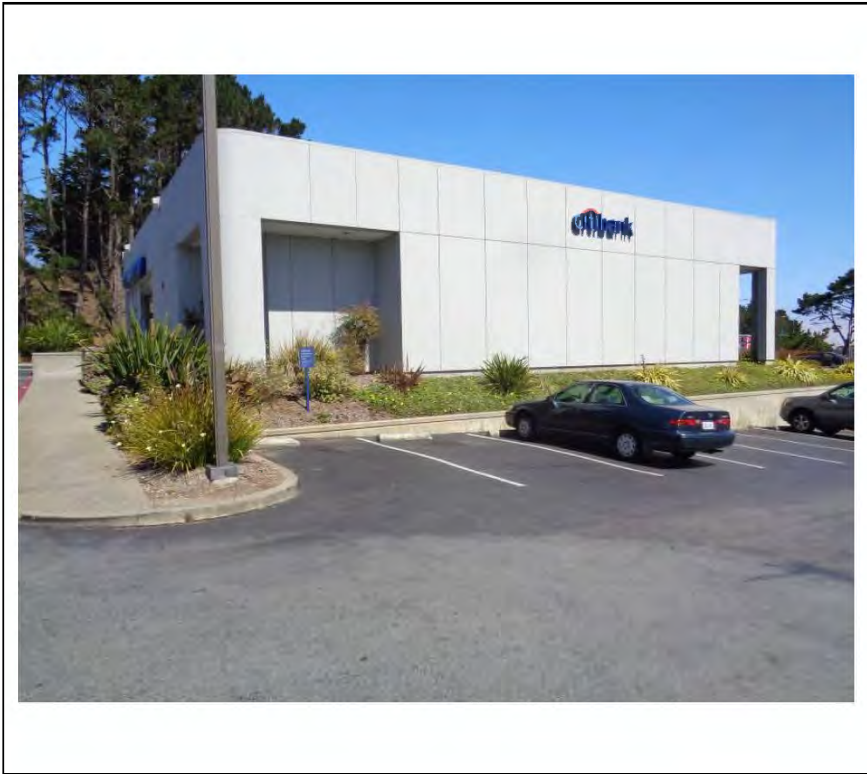
Project No. 2015-0030.00	Description	Western adjoining property.	23
	Name	455 & 459 Hickey Boulevard, Daly City, California	Photo Date June 8, 2015
