**HAZARDOUS WASTE
INITIAL SITE ASSESSMENT**

**PSR#TD004 BAKER BOULEVARD OVER MOJAVE RIVER
BRIDGE REPLACEMENT PROJECT
County of San Bernardino, California
District 8 - SBD**

Federal Project Number: STPL-5954(193)

February 2025

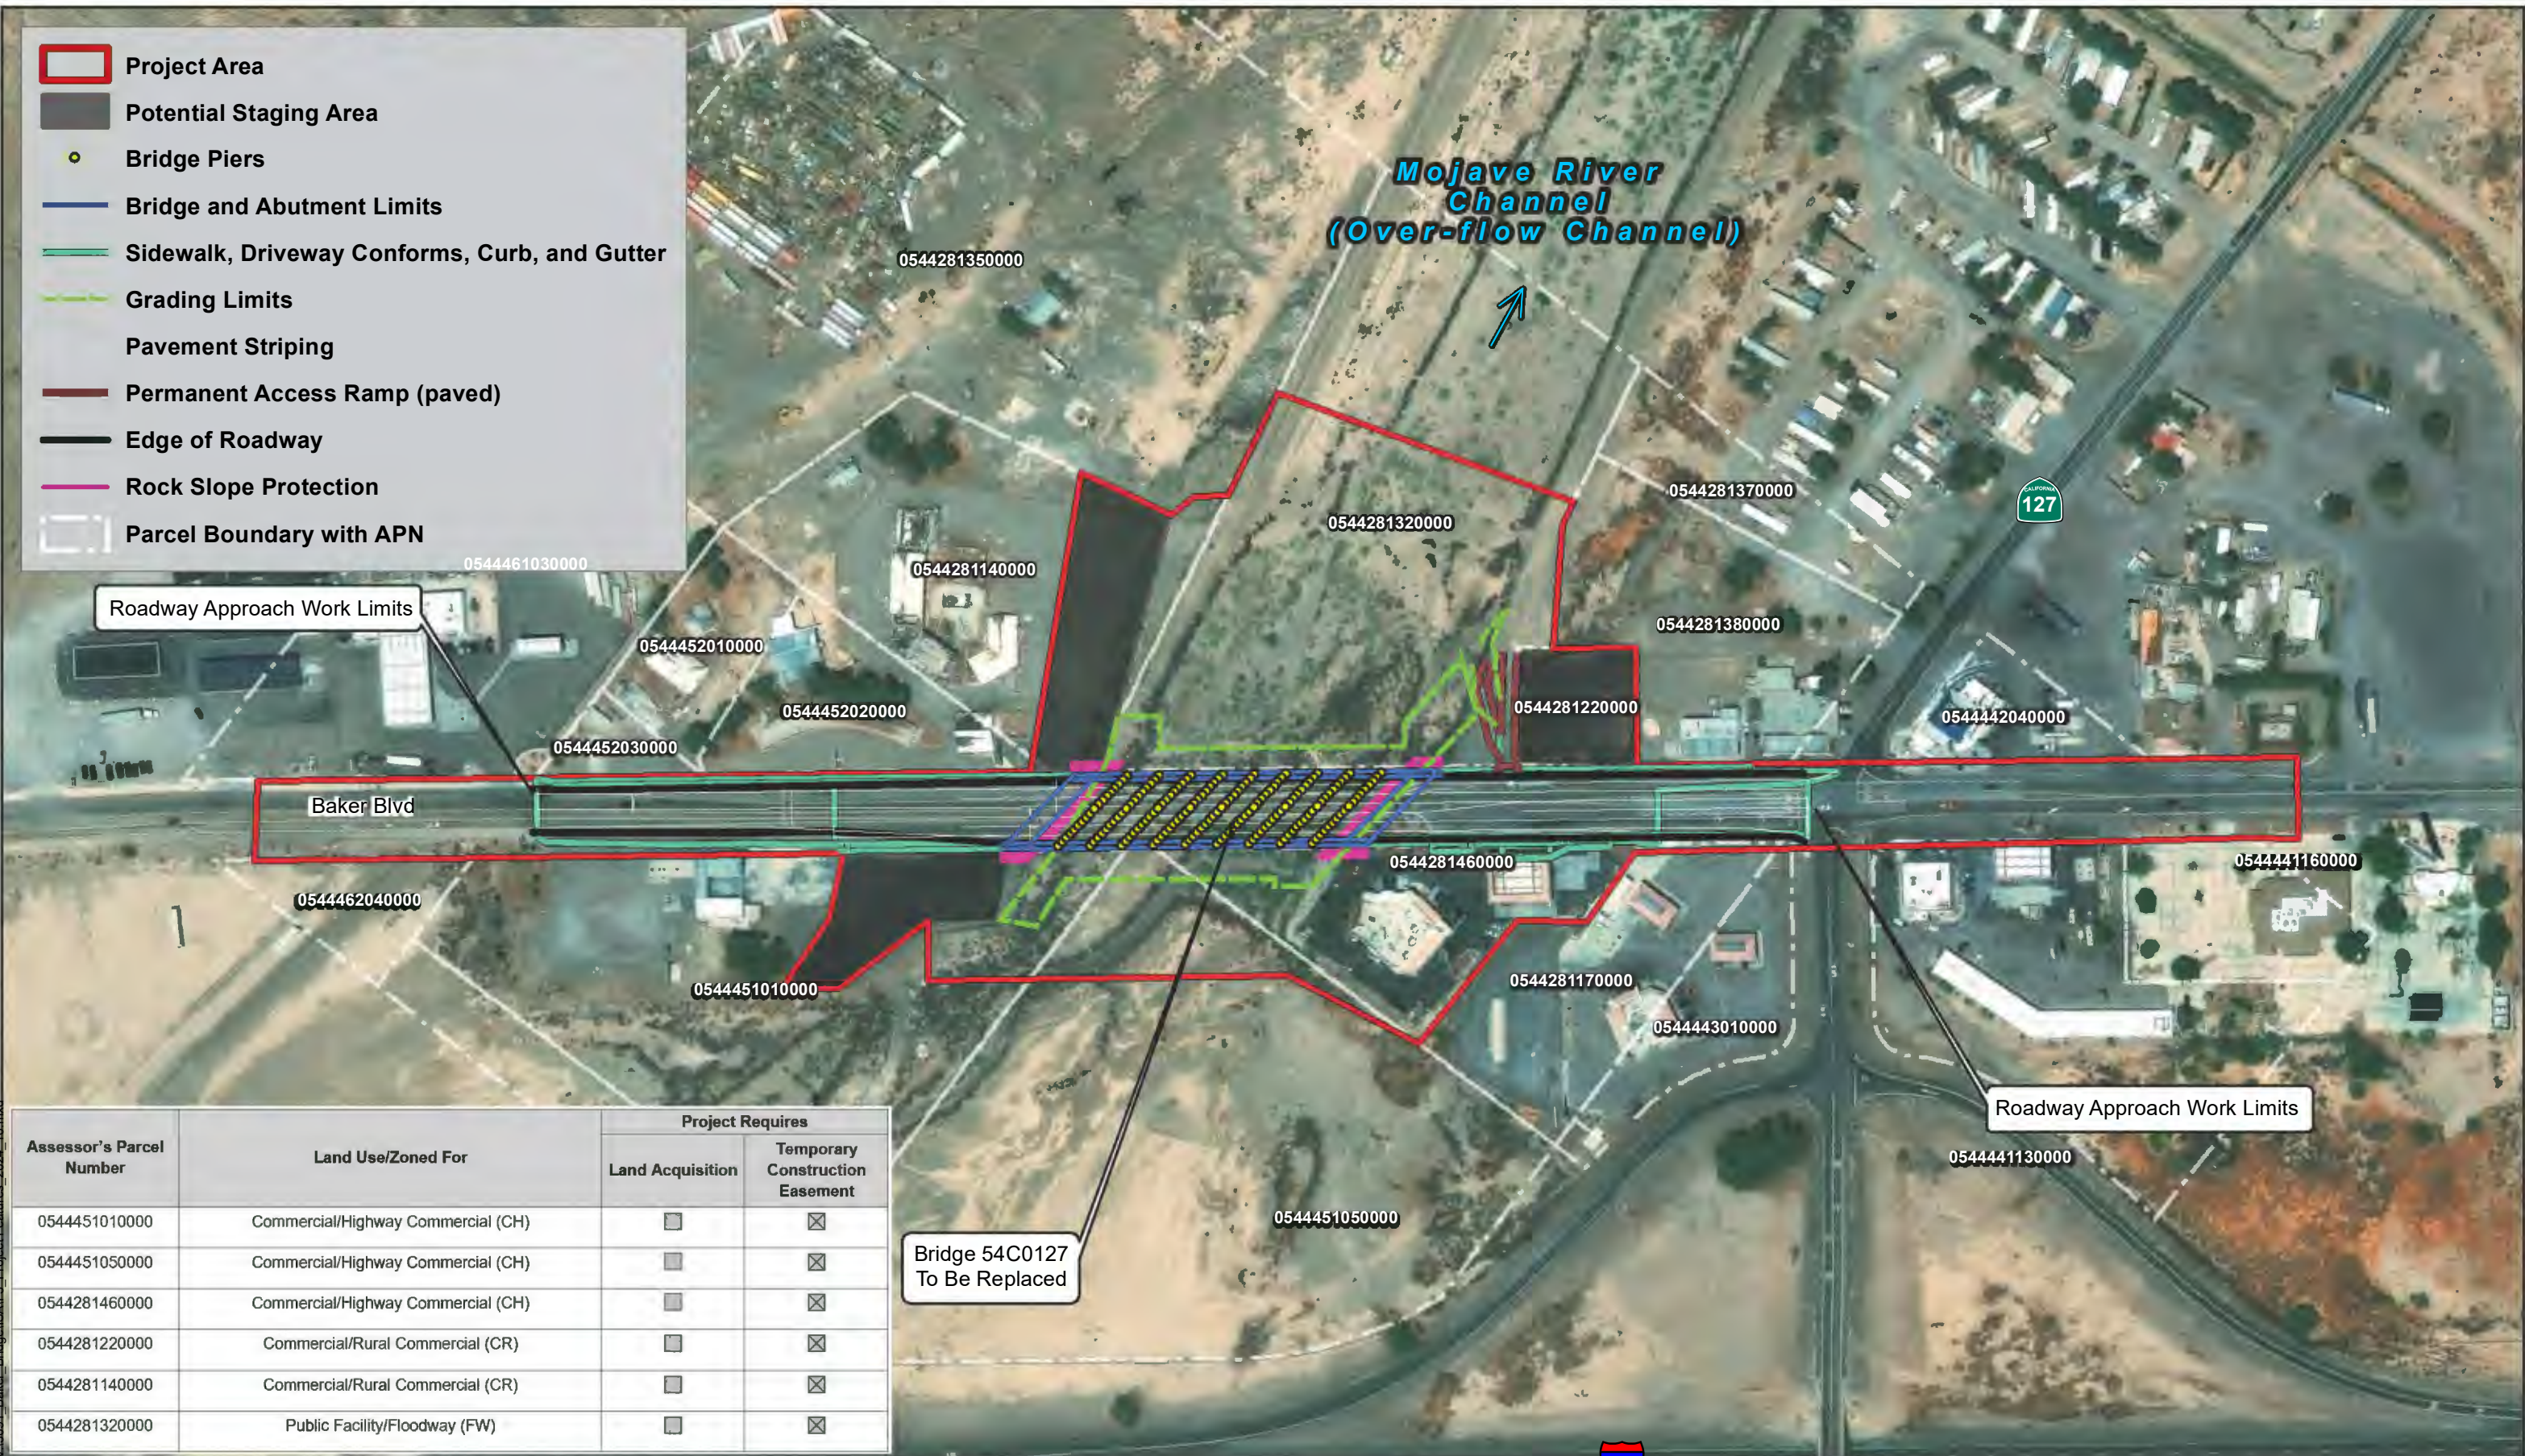
Figure 3
Project Features

- Project Area
- Potential Staging Area
- Bridge Piers
- Bridge and Abutment Limits
- Sidewalk, Driveway Conformers, Curb, and Gutter
- Grading Limits
- Pavement Striping
- Permanent Access Ramp (paved)
- Edge of Roadway
- Rock Slope Protection
- Parcel Boundary with APN

As the Project involves improvements to County-owned infrastructure, there will be no ROW acquisition required. There may be temporary construction easements (TCEs) obtained to complete construction. There will also be maintenance easements obtained for upkeep of the rock slope protection. All easements are identified in the below **Table 2** and in **Figure 3. Project Features**.

The Project will occur within existing County ROW but may need several TCEs from adjacent private property parcels, as noted in **Table 2** and in **Figure 3. Project Features**.
