Pond Management and Enhancement Project

Categorical Exemption Report

Santa Clara Valley Open Space Authority

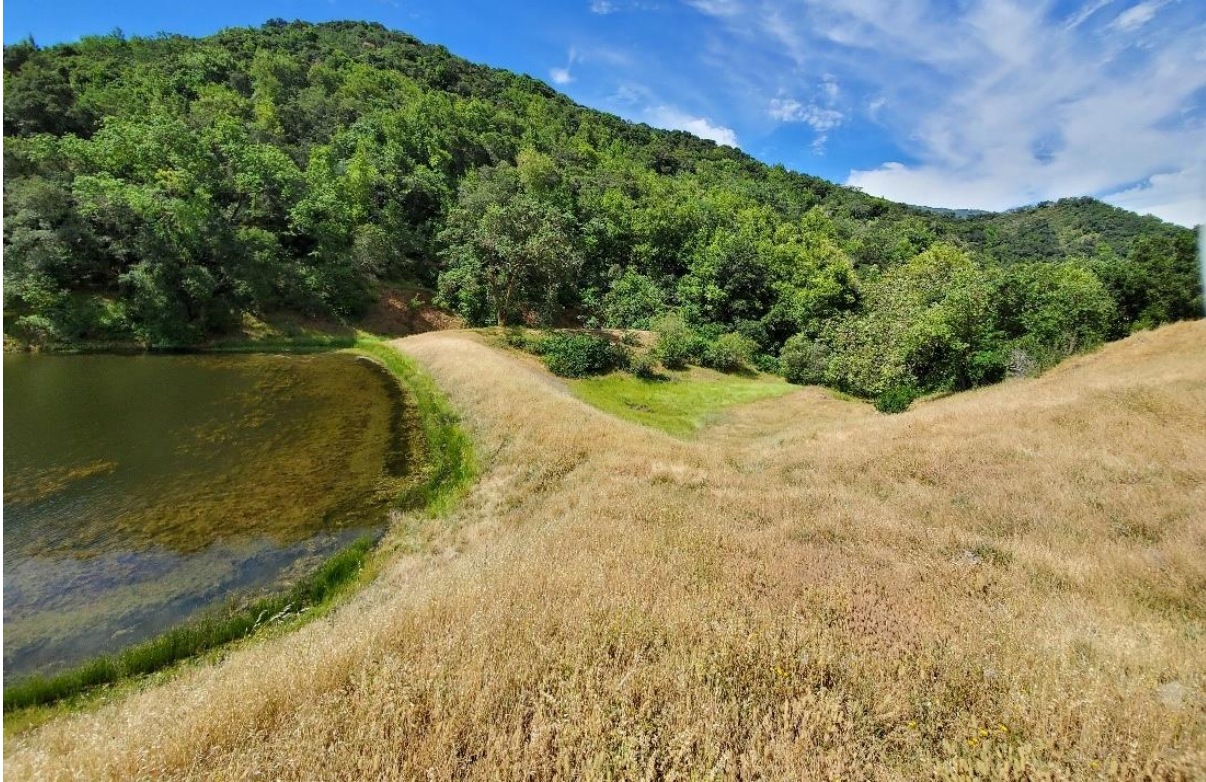
Photograph 1. The berm at the west end of RC-01, facing south.

Pond RC-01 is a perennial pond that holds water throughout the year and is a man-made stock pond. Pond RC-01 is located approximately 0.5 mile south east of Casa Loma Road at the bottom of Limpkin Canyon approximately 0.5 mile east of the confluence with Llagas Creek. The pond is approximately 1.34 acres measuring 170 feet from north to south and 370 feet from east to west. The western side of the pond has been modified with the construction of an earthen berm. The pond is classified in the National Wetlands Inventory (NWI) as ‘permanently flooded’ and has been created or modified by a man-made barrier or dam that obstructs inflow and outflow of water (USGS 2020, USFWS 2020a).

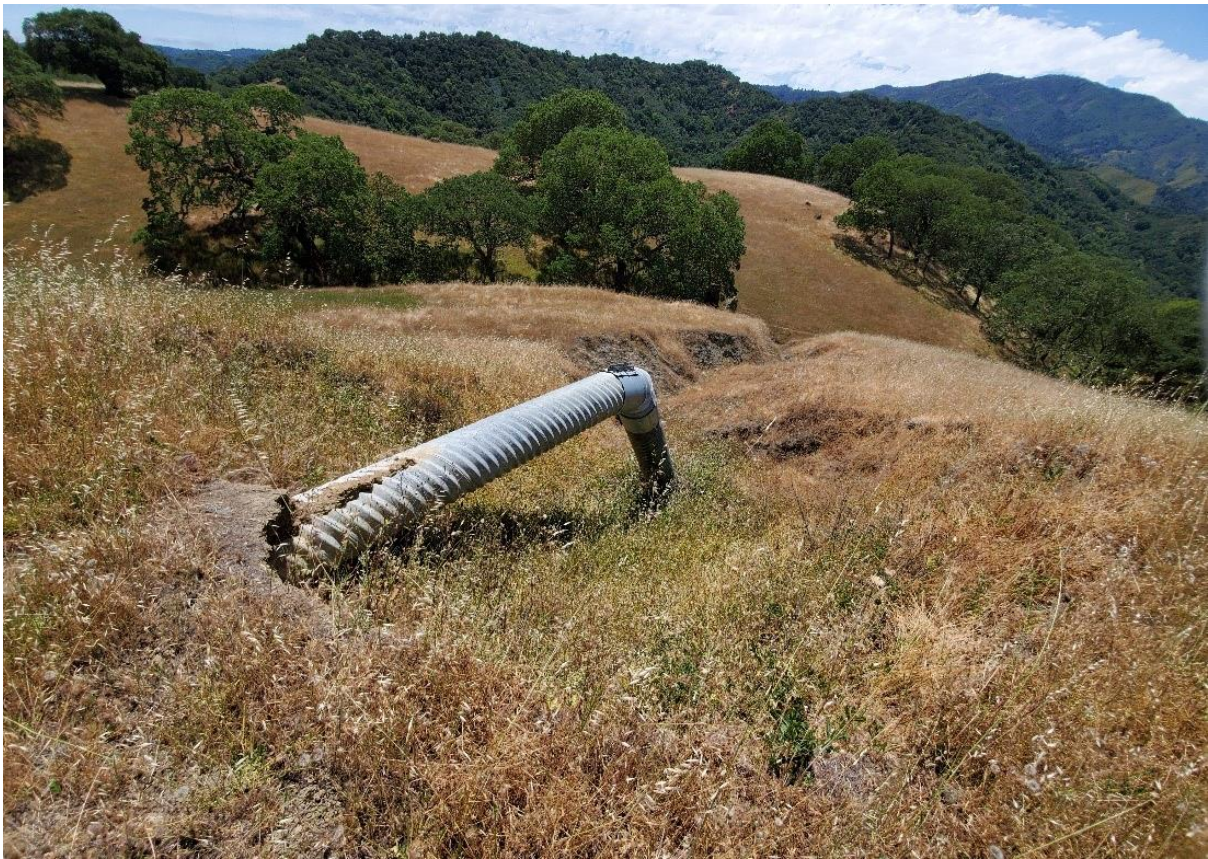
Photograph 4. The existing outfall at the west side of RC-07, facing southeast.

Three ephemeral drainages were observed within the study areas. Ephemeral Drainage 1 begins from an outfall corrugated pipe culvert below Pond RC-07. The drainage flows in a southern direction downslope. The incised channel, approximately 20 feet in height, contains an approximately one-foot-wide bed and is vegetated with upland annual grasses, Italian thistle (*Carduus pycnocephalus*), fiddle dock (*Rumex pulcher*) and mountain dandelion (*Agoseris heterophylla*). The top of the bank spans approximately 12 feet across. Ephemeral Drainage 1 is classified by NWI as a 'seasonally flooded, intermittent riverine' (USFWS 2020a); however, in-channel upland vegetation and the lack of defining OHWM indicators of intermittent flow characterize this drainage as ephemeral.

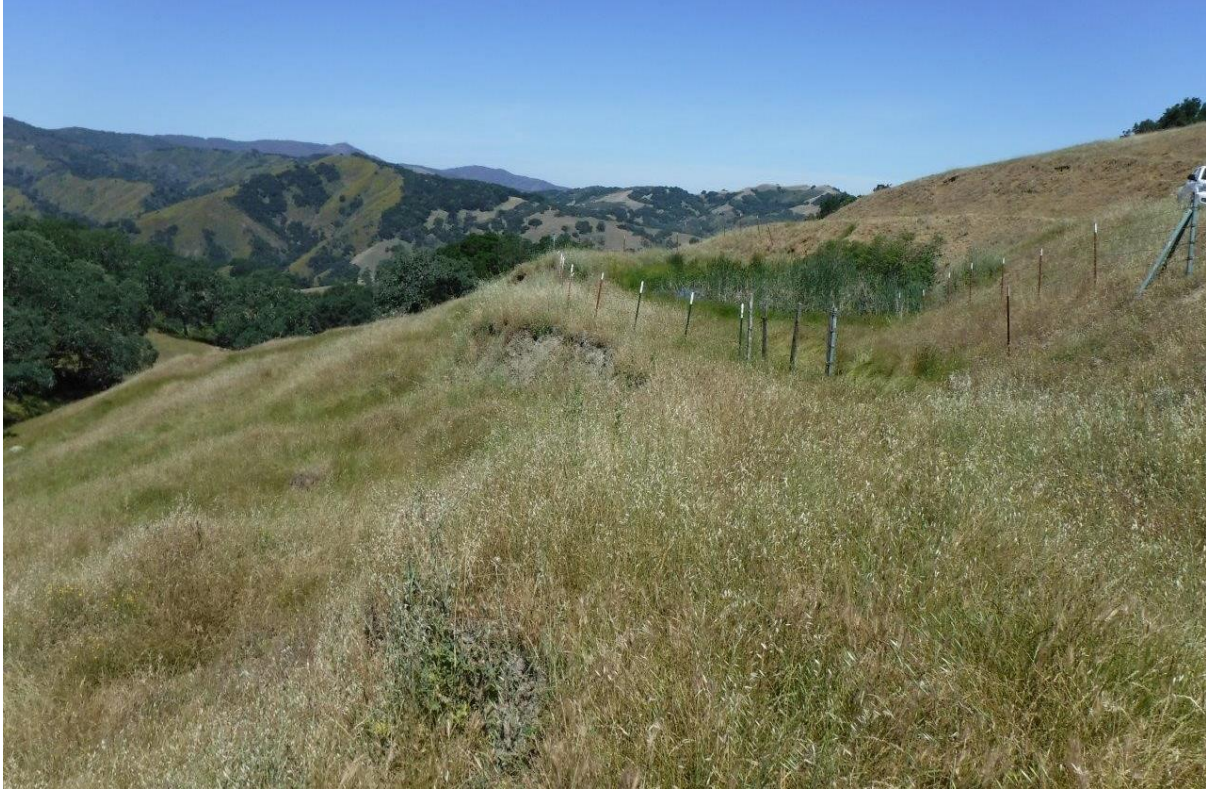
Photograph 5. The eroding berm below the fence at RC-07, facing west.

Isolated wetland 1 is located downstream of the break in Pond RC-07 wall, where a patch of dominant hydrophytic vegetation was observed. All three USACE wetland parameters were observed at isolated wetland 1, with dominant common spikerush and annual beard grass, standing water and gleyed soils (Rincon 2020; Appendix B). Groundwater seepage from Pond RC-07 and water seeping from the break in the pond side may congregate along the hillslope to create Isolated Wetland 1.

The purpose of the proposed project is to restore and enhance three ponds in the Rancho Cañada Del Oro Open Space Preserve that have become degraded. The project would involve repairing the earthen embankments at Pond RC-07, adding or improving overflow spillways to Ponds RC-01 and RC-10, adding drains to Ponds RC-01 and RC-10 to control American bullfrog (*Lithobates catesbeianus*) populations, and deepening RC-10 to increase ponding duration. These project activities would increase habitat value for listed species and restore wetlands features, providing a long-term environmental benefit.

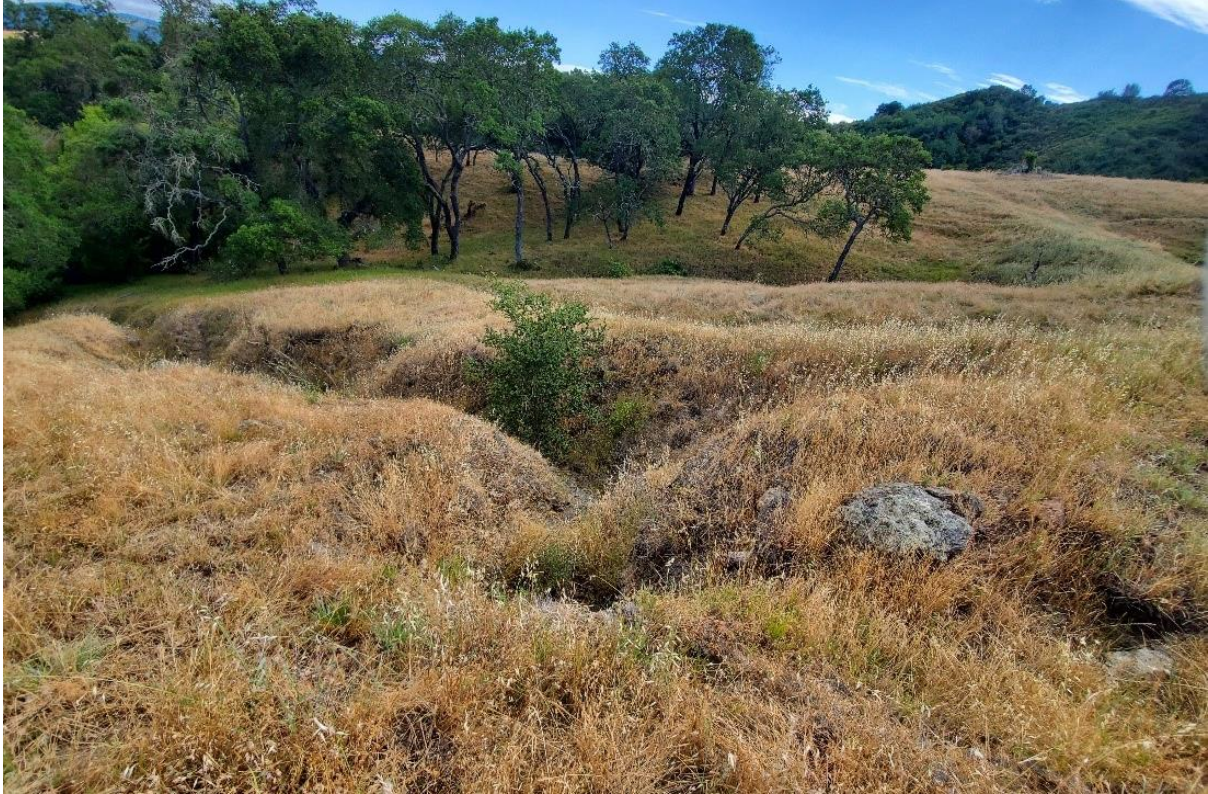
Photograph 7. The existing outfall at the west side of RC-07, facing southeast.
