Project No. E23228.000P
27 June 2023

Subject: **CITY OF PLACERVILLE CLAY STREET BRIDGE TESTING**
Clay Street north of Main Street, Placerville, CA
SUMMARY OF MATERIALS TESTING SERVICES

As requested, Youngdahl Consulting Group, Inc. has provided materials testing services from 16 June 2023 through 26 June 2023 for the above referenced project. We understand that material testing services for the subject Clay Street Bridge are complete. The structure for this project includes the Clay Street Bridge with abutment walls, retaining wall and sidewalk spanning over the top of the bridge.

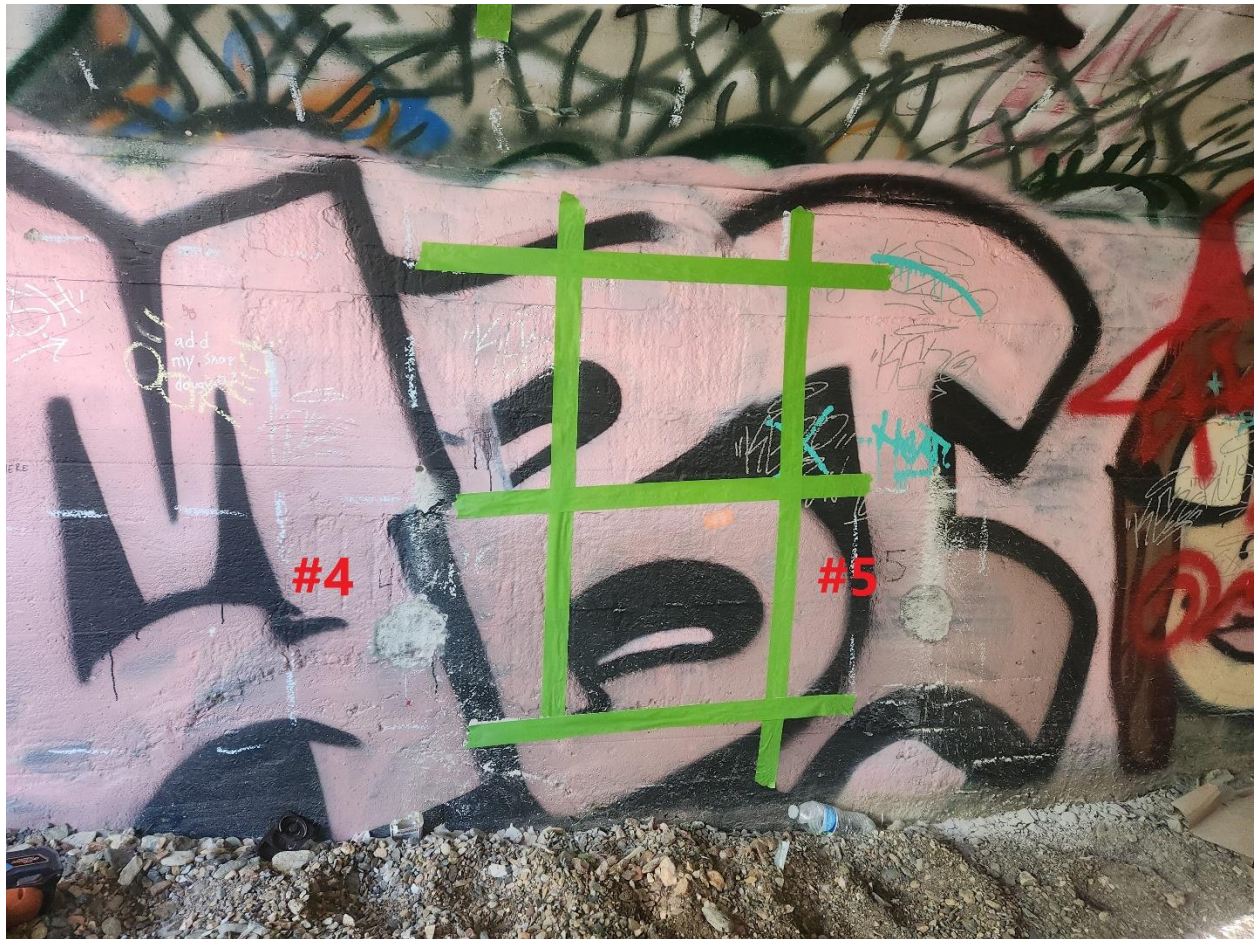
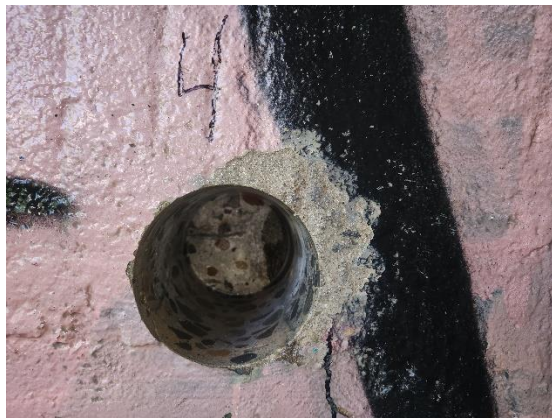
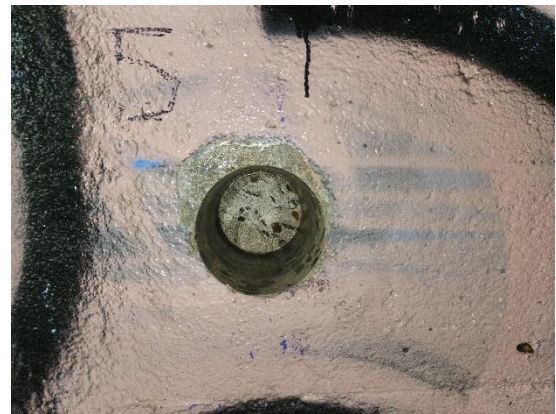
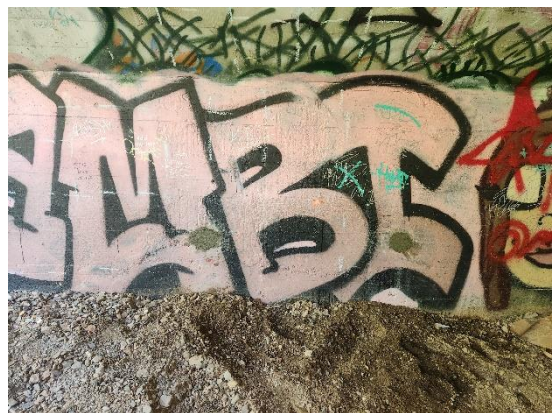
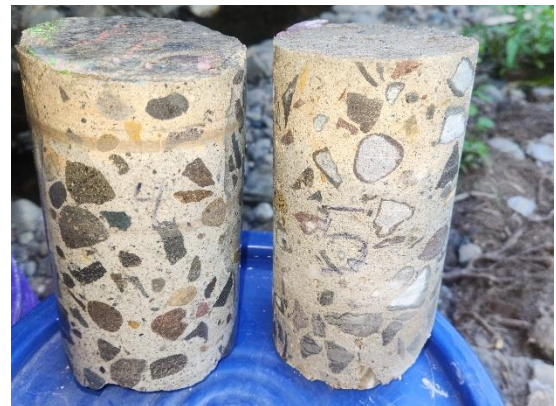
Three 4" diameter core samples were taken from north abutment wall and one from the sidewalk for compressive strength and to correlate with Schmidt Hammer testing results performed at same location. GPR was used on 6/19/23 to locate reinforcement and to make sure cores are taken without going through reinforcement. The core drill was only used to a depth of 7" inches in the abutment wall in order to not drill all the way through the wall. After samples were taken holes in wall were filled with Sakrete High-Strength Concrete Mix.

- #4 Compressive Strength of core 5,350 PSI
- #5 Compressive Strength of core 2,750 PSI **(Large rock in core may have affected the strength.)**
- #9 Compressive Strength of core 5,600 PSI

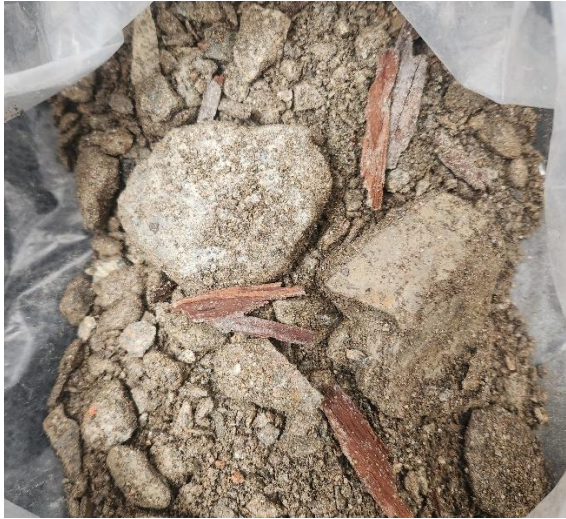
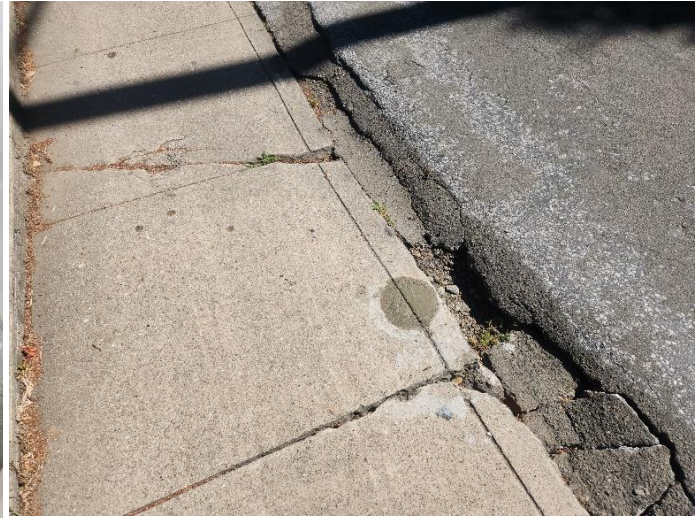
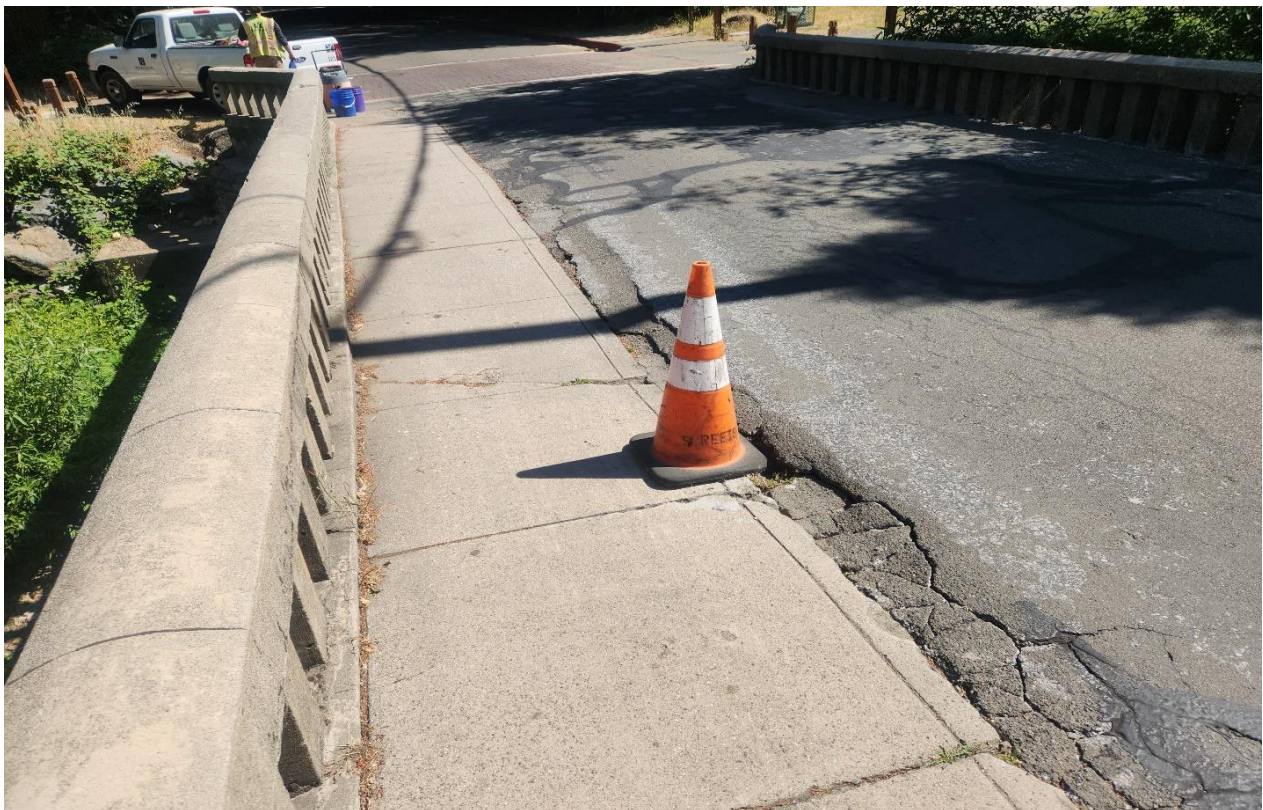
One 4" diameter core was taken from section of sidewalk above in order to observe material below (Compressive strength was also tested). Core was taken where there is a large amount of settlement and concrete was cracked. Material below sidewalk was observed to be moist and appears to be decomposed slate with pieces of wood (Material was easily obtained with hand auger and did not appear to be well compacted). Hole in sidewalk was filled with Sakrete High-Strength Concrete Mix and Orange cone placed over wet concrete.

Core compressive strength 5,600 PSI

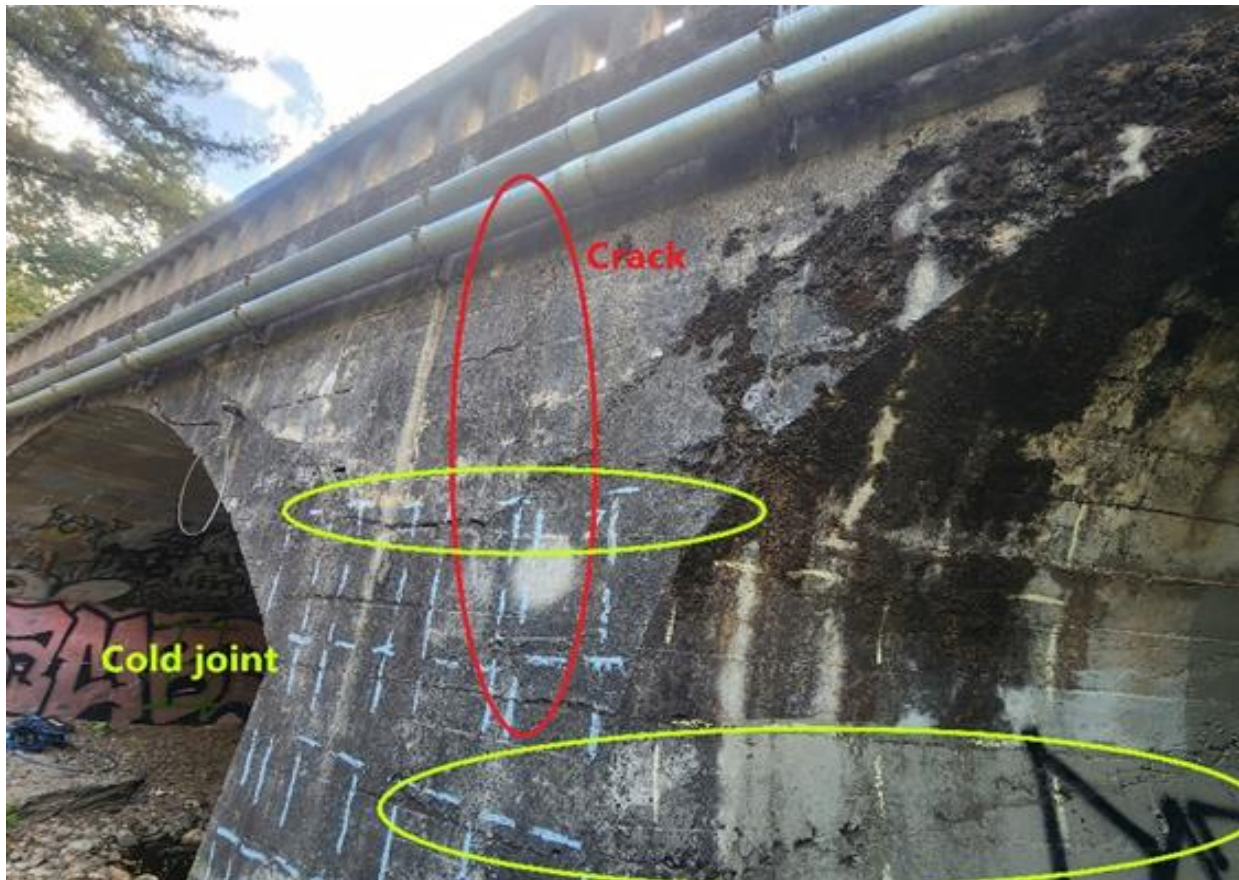
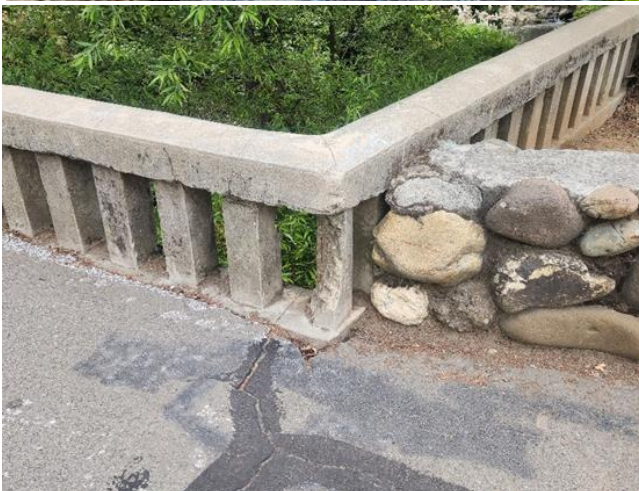
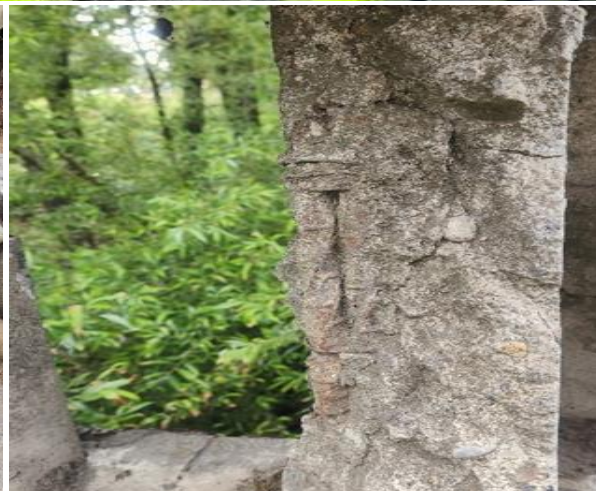
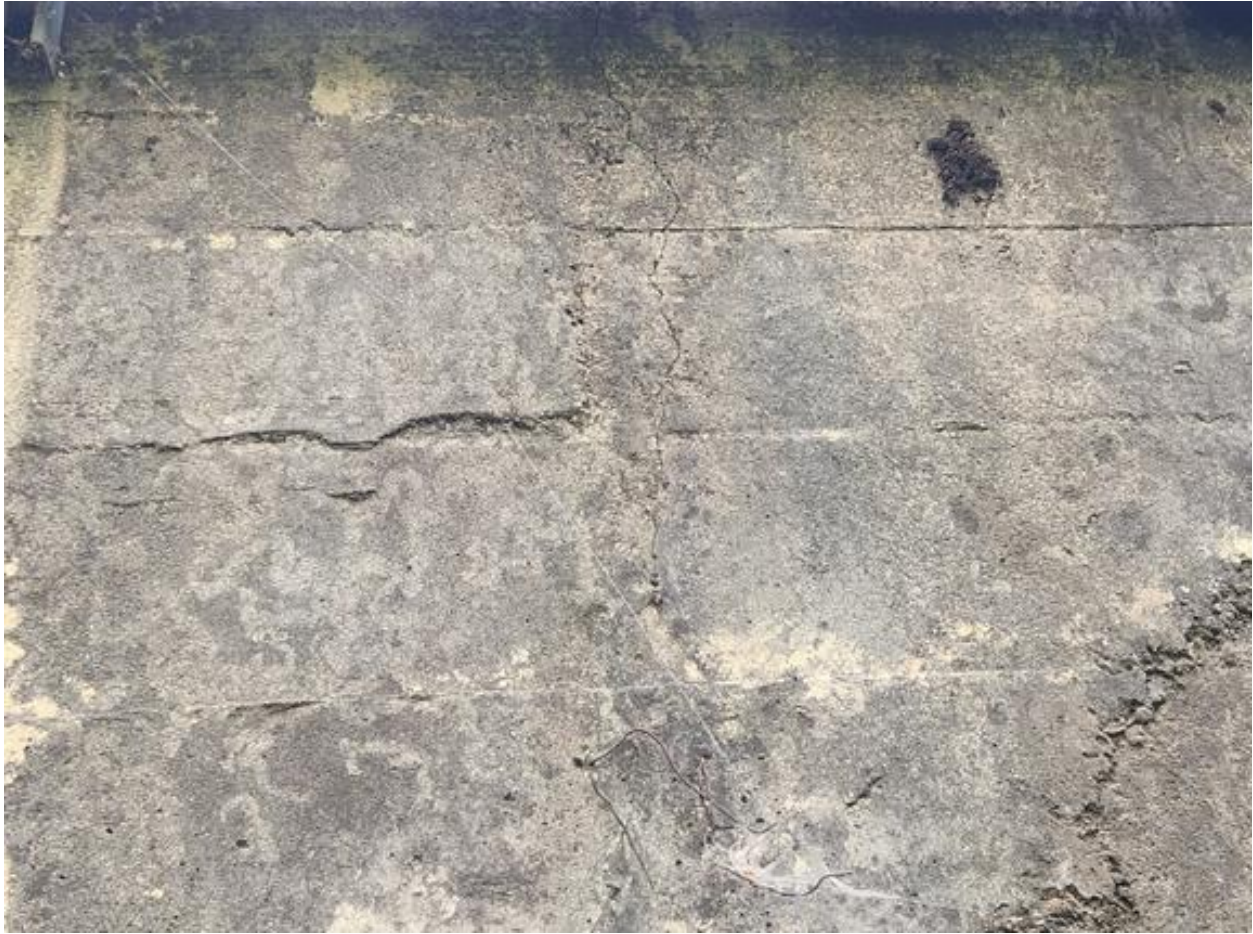
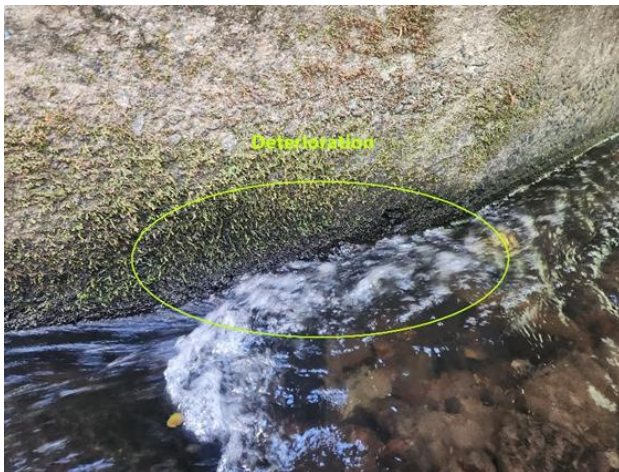
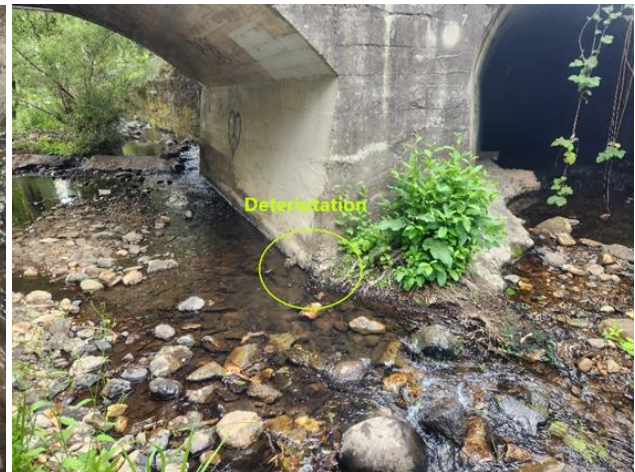
While on site areas of distress were observed and documented.

- 1) Crack on west side of center abutment
- 2) Cold Joint made during original concrete placement
- 3) Deterioration of concrete due to water flow and debris. South east corner of bridge (Transition of retaining wall and abutment) and north west corner of center abutment.
- 4) Chipping of concrete: Most likely due to being forcibly hit South east corner post of guard rail exposing reinforcement. Other posts have chipping throughout guard rails both sides of bridge
- 5) Sidewalk and asphalt depressions: Most likely due to deterioration and washing out of fill material below.
