BIOLOGICAL RESOURCES REPORT

SIXTH STREET PARK, ARTS, RIVER & CONNECTIVITY IMPROVEMENTS PROJECT

CITY OF LOS ANGELES, CALIFORNIA

April 2019

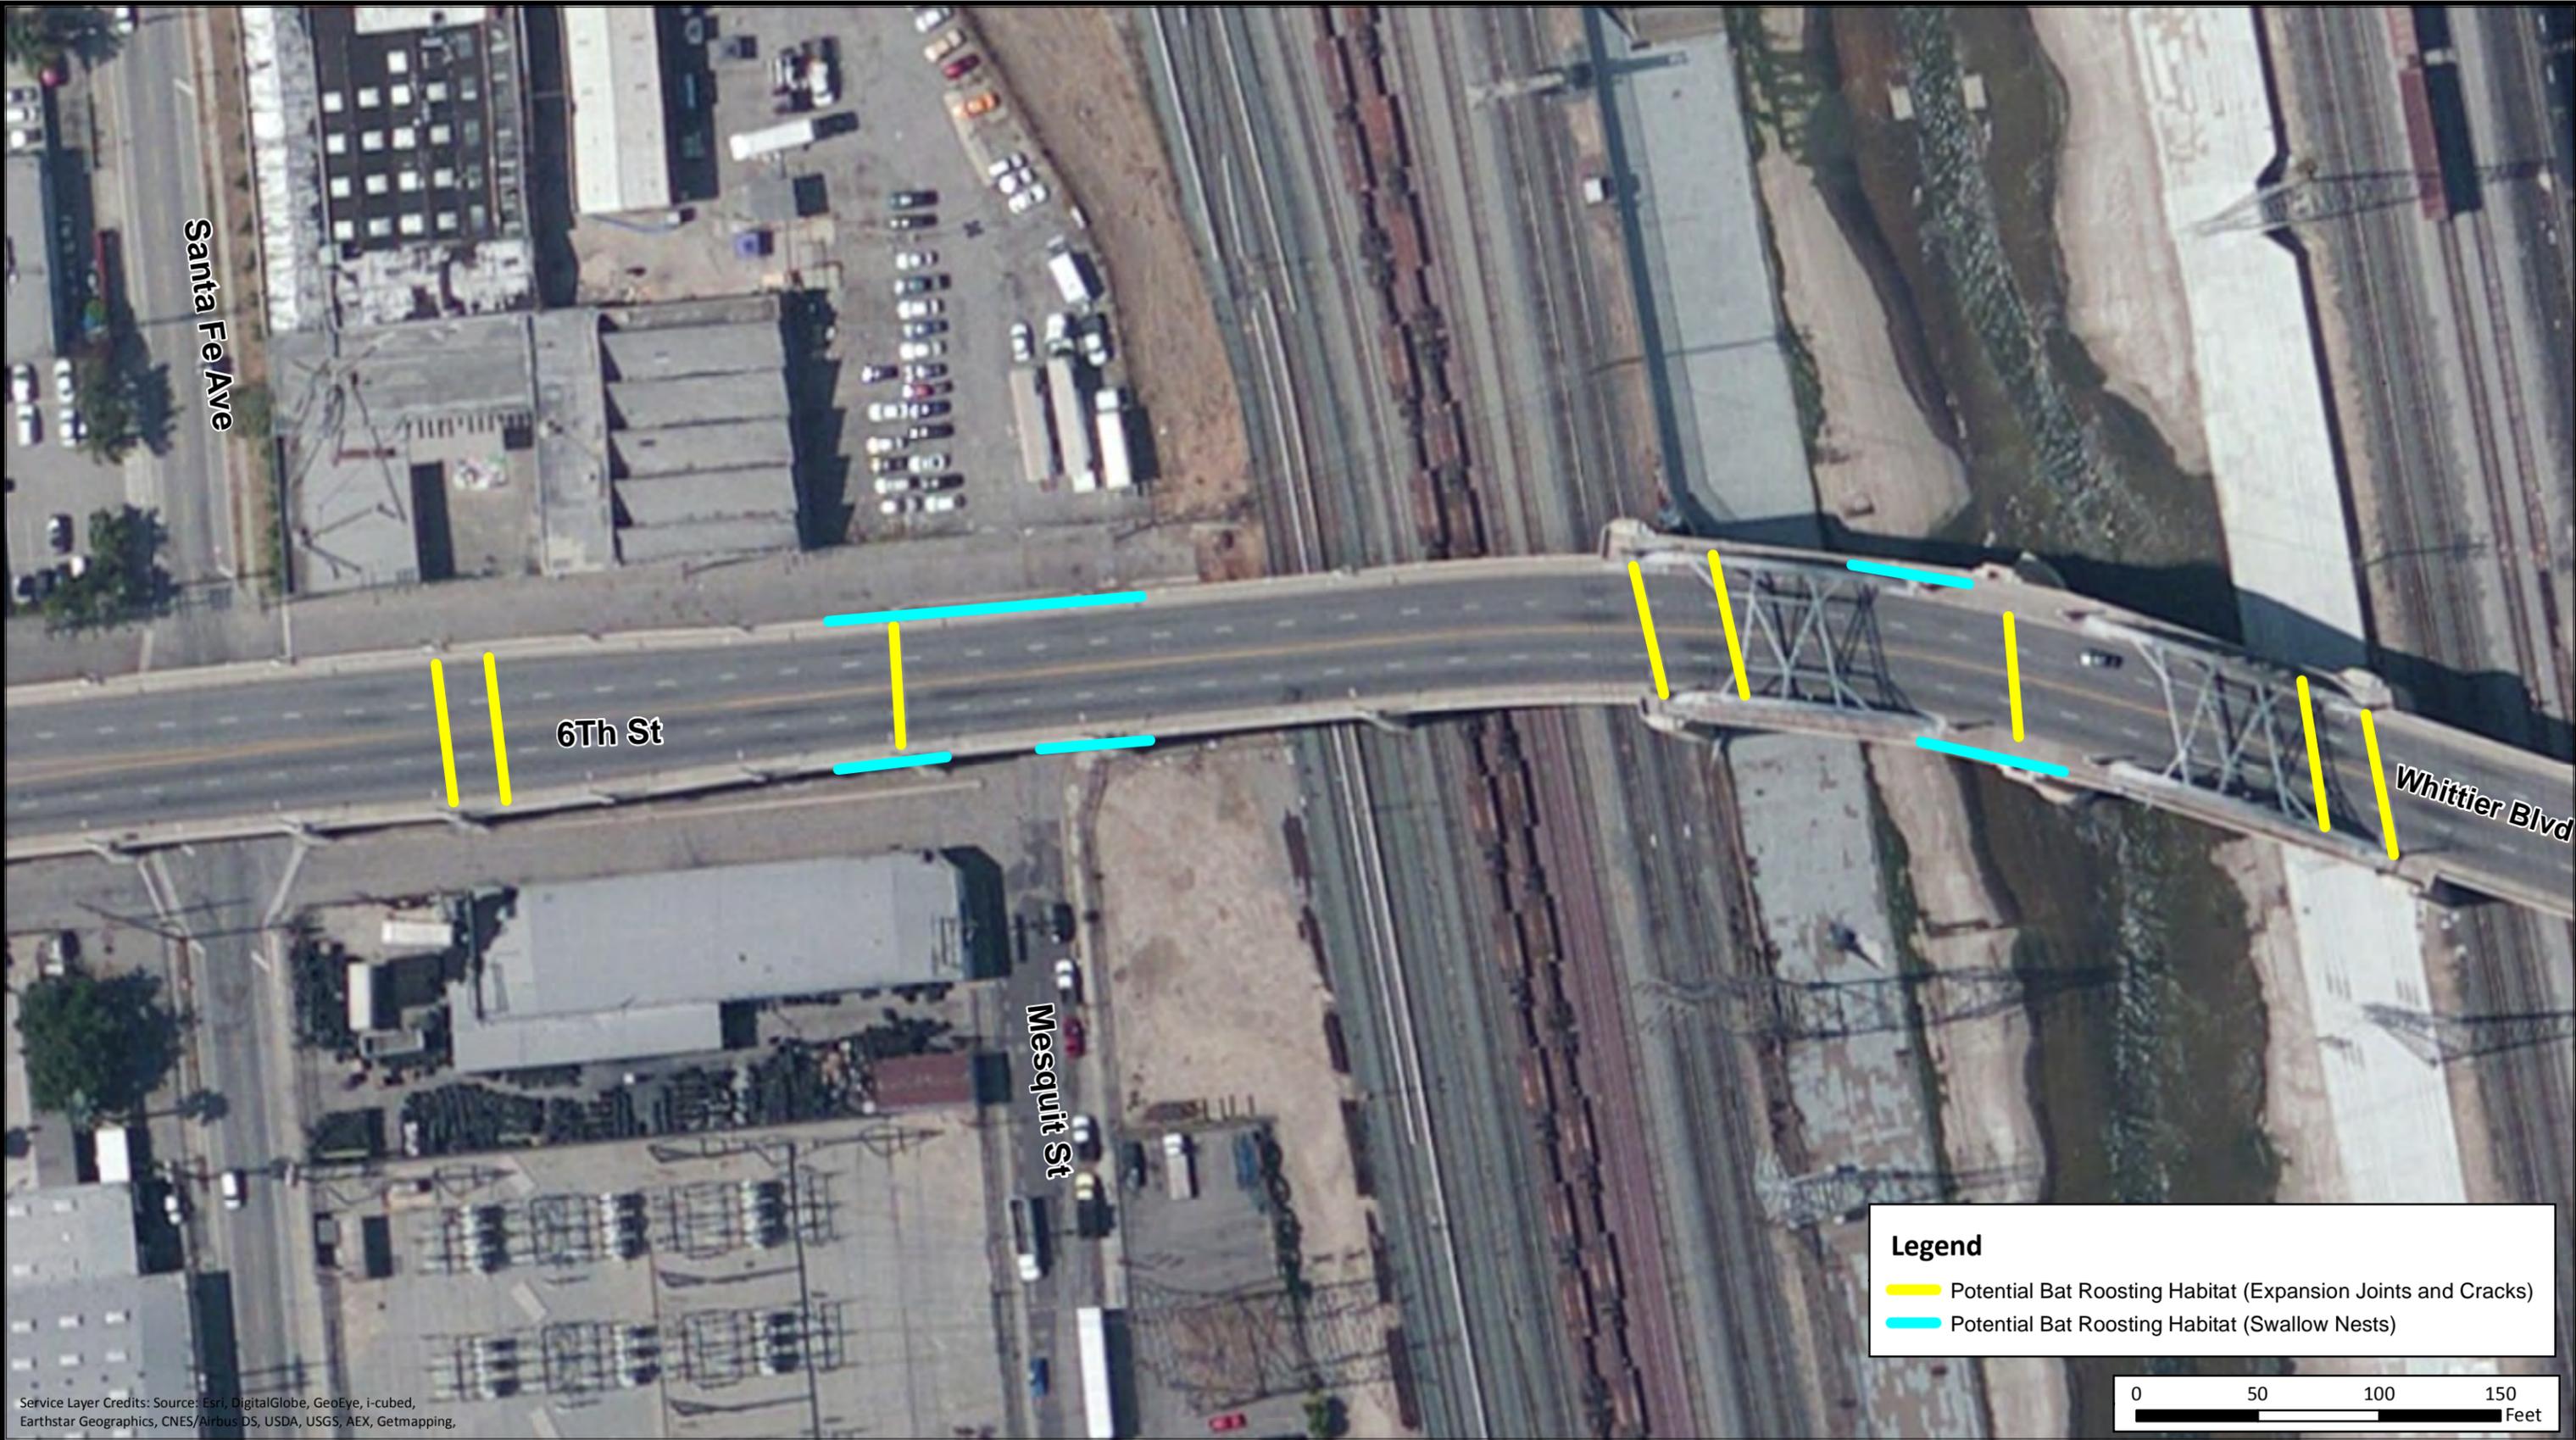
**FIGURE 3. BRIDGE SEGMENT 1 - POTENTIAL BAT ROOSTING HABITAT
6th Street Viaduct Replacement Project**

Suitable bat roosting habitat was identified in 16 expansion joints between Santa Fe Avenue and Clarence Street and in the central bridge pier over the Los Angeles River. Rubber foam filling placed in the expansion joints when the viaduct was built has deteriorated and is falling out in multiple locations; therefore, these joints are now open from the bottom and are wide enough for bats to enter and roost (see **Appendix A, Photo 7** and **Photo 8**). In addition, there are cracks along the edges of the structure wide enough to provide additional roosting habitat for bats (see **Appendix A, Photo 6**). Cracks suitable for bat roosting were identified in several locations between Santa Fe Avenue and Clarence Street (see **Figure 3, Figure 4, and Figure 5**).

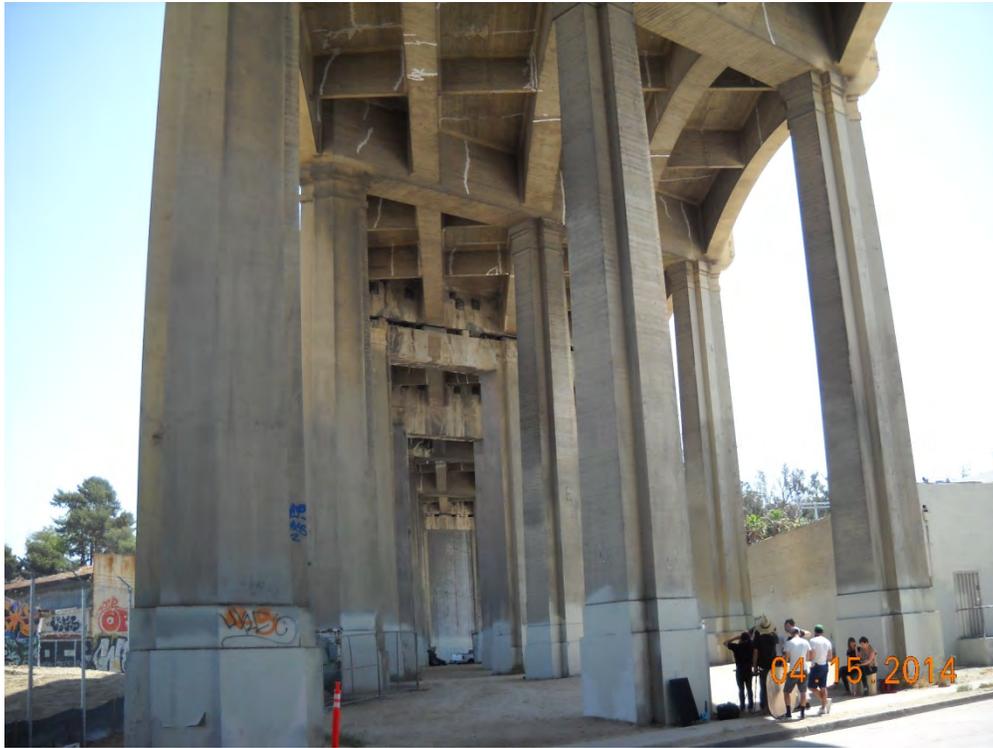
The viaduct is a solid structure made with concrete girders and metal arches. The viaduct is as high as 60 feet above the ground within the river corridor and east of the river (see **Appendix A, Photo 1** and **Photo 2**). Ongoing deterioration of the viaduct concrete from the Alkali-silica reaction has resulted in numerous cracks on the structure, most of which are less than 0.25 inch wide and have been sealed to slow the deterioration (see **Appendix A, Photo 3**). Expansion joints extend from the bridge deck to the lower girders and pier supports (see **Appendix A, Photo 4** and **Photo 5**), and there are multiple cracks along the edges of the structure that are wider than 0.75 inch) (see **Appendix A, Photo 6**).

Photo 1: Solid concrete piers and girder structure on viaduct; view facing east

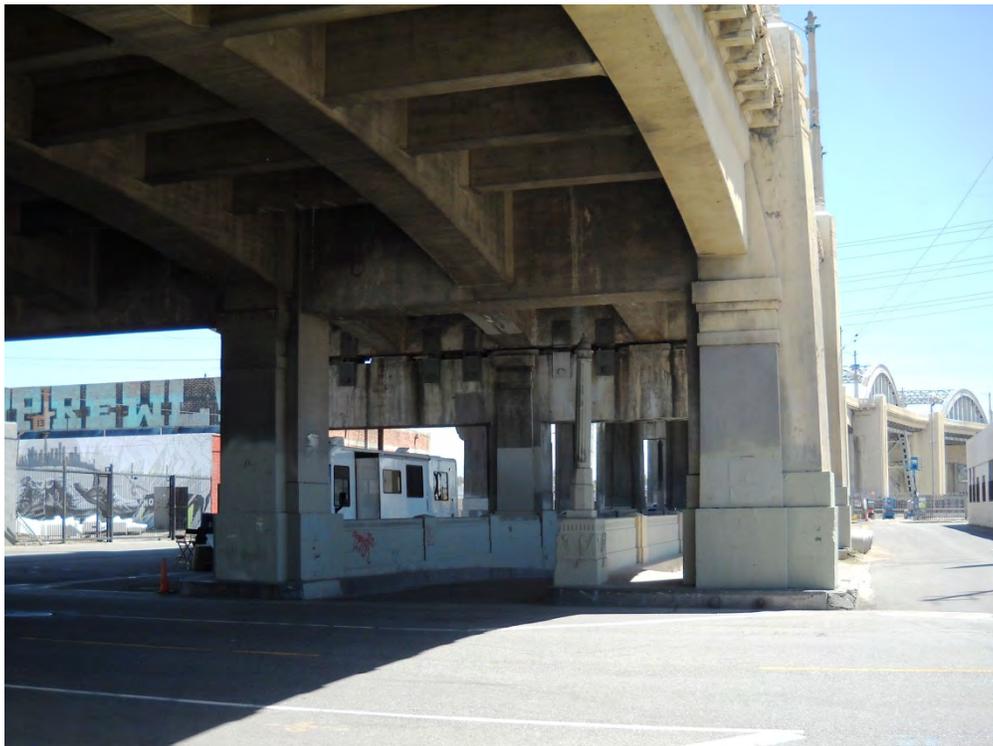
Photo 2: Solid concrete girders on viaduct with metal arches in the background; view facing east

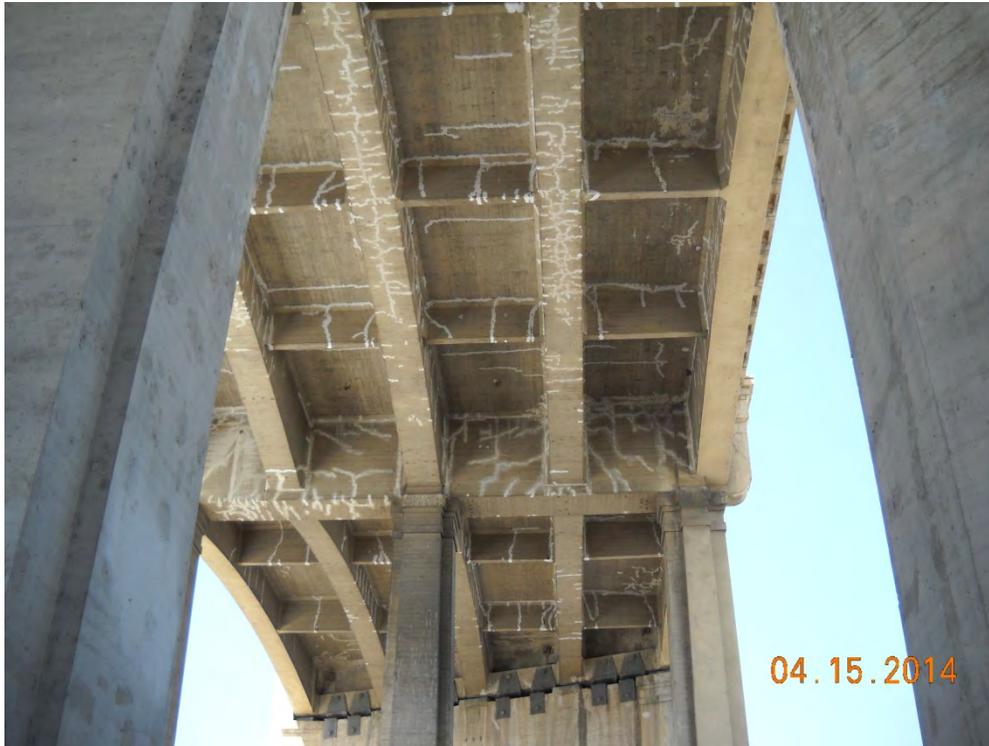
Twenty years after the viaduct was constructed, the cement supports began to disintegrate from a chemical reaction known as alkali-silica reaction, which has resulted in substantial deterioration of the structure. Restoration has been attempted, but has not been successful. In 2004, a seismic vulnerability study concluded that the viaduct is vulnerable to failure during a major seismic event. In addition, the viaduct also has geometric design and safety deficiencies.

Photo 3: Sealed cracks on viaduct, cracked from alkali-silica reaction; view facing west

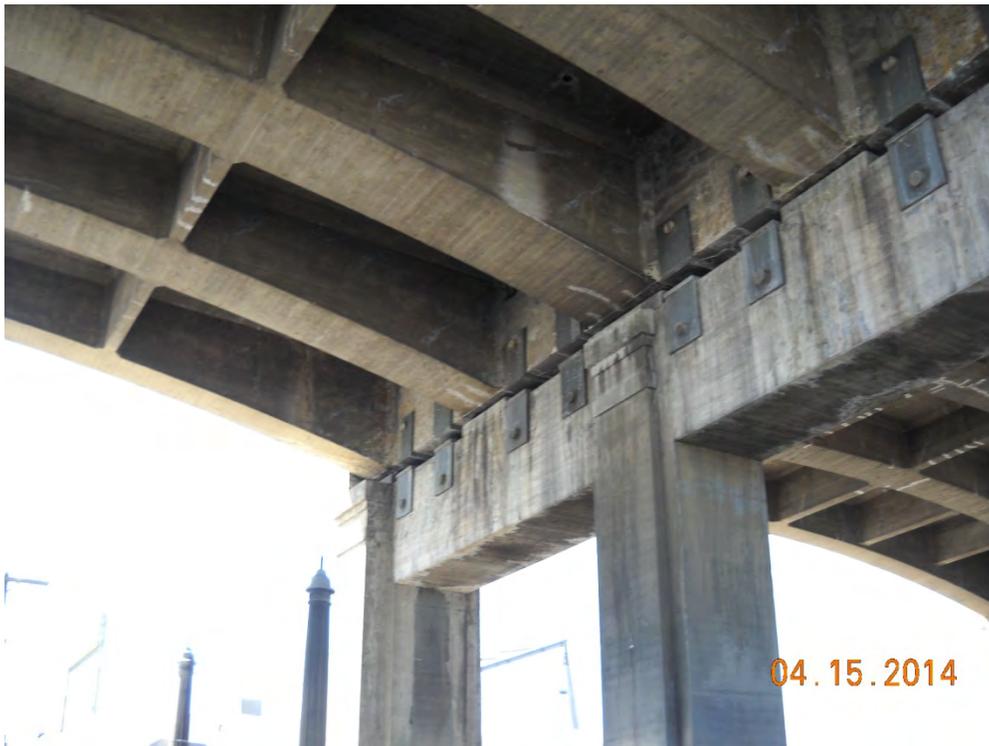
Photo 4: Pier support and metal bearings on viaduct, and an expansion joint providing suitable bat roosting habitat; view facing west

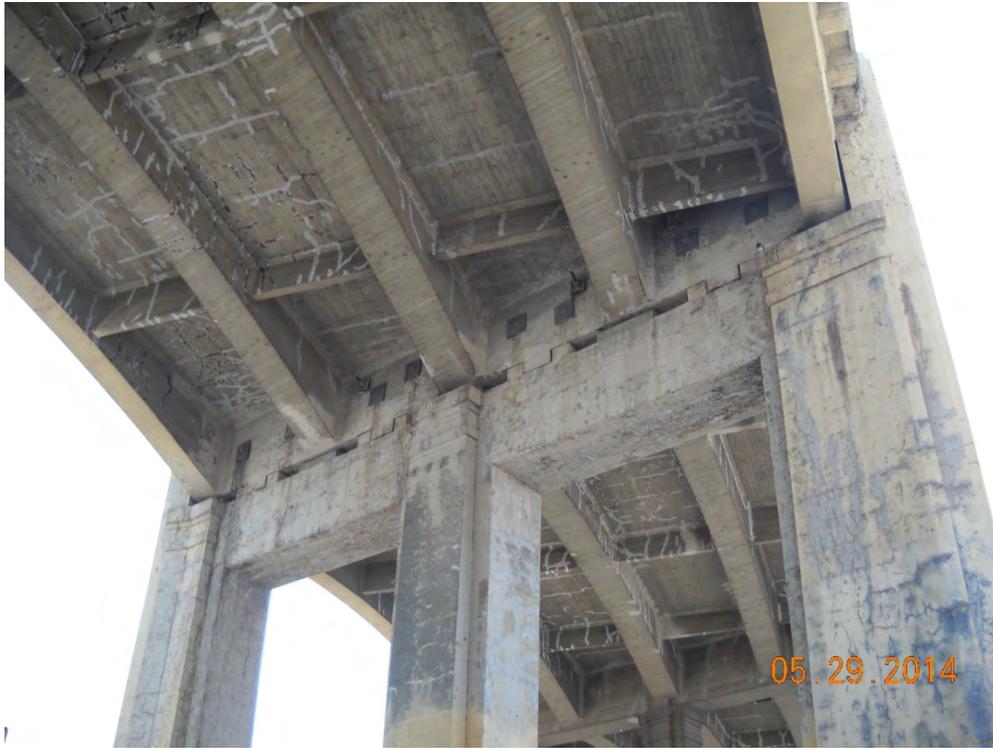
Photo 5: Pier support and bridge deck attachments on viaduct; and an expansion joint accessible to bats; view facing west

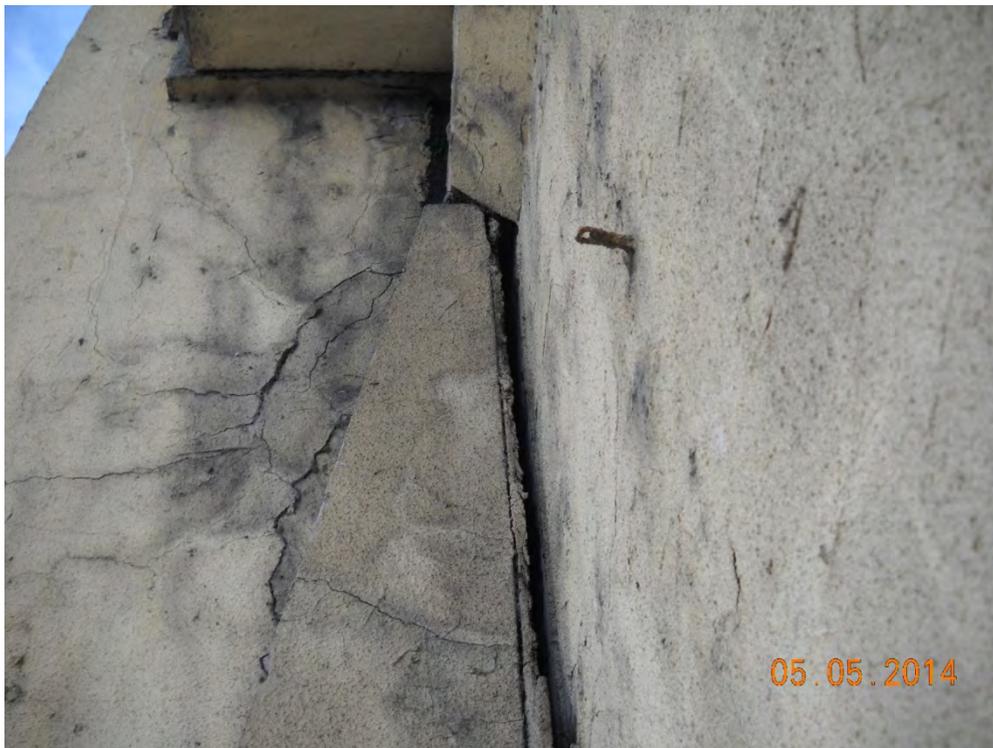
Photo 6: Crack on edge of viaduct near pier support wide enough (greater than 0.50 inch) to provide suitable bat roosting habitat; view facing west

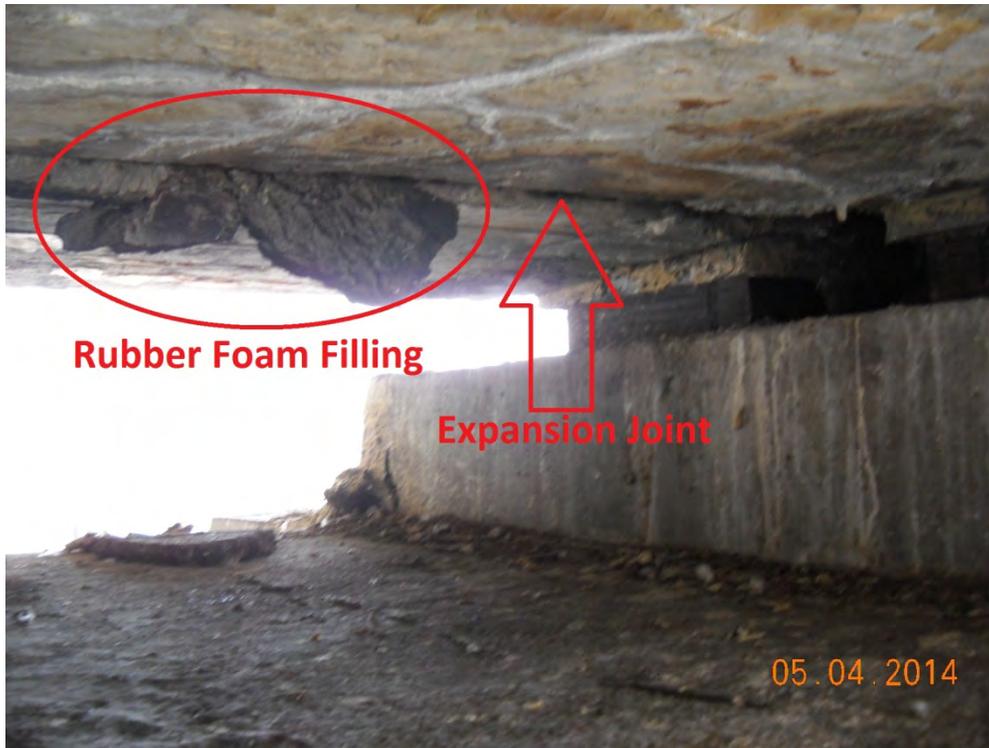
Photo 7: Falling rubber foam filling providing suitable bat roosting habitat within expansion joint; view facing west

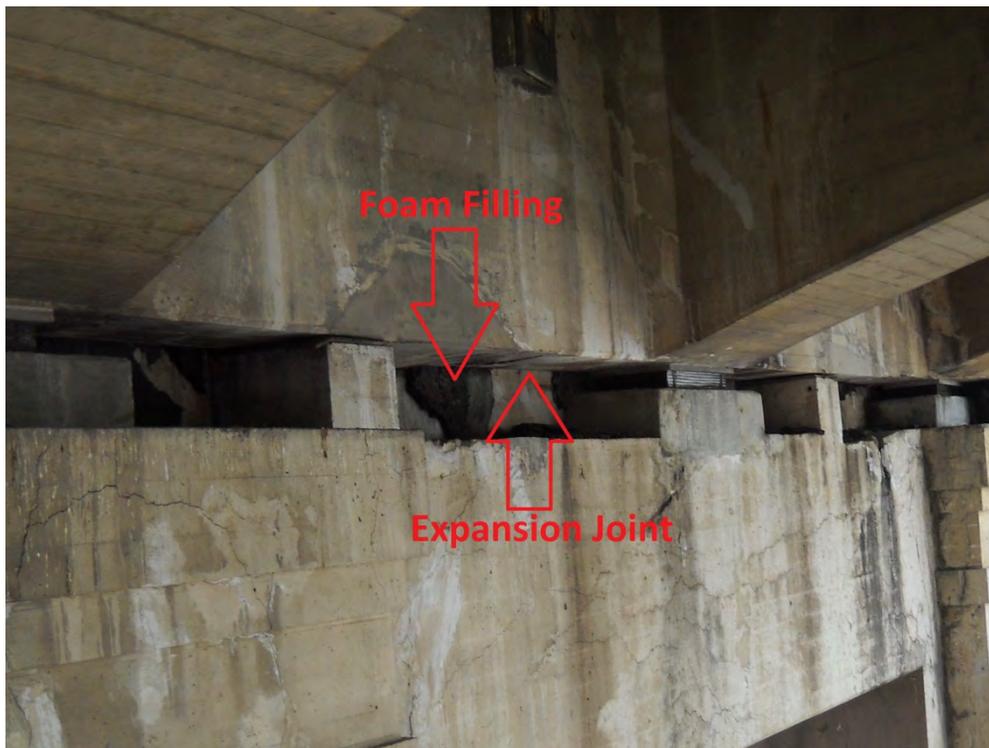
Photo 8: Rubber foam filling falling from expansion joint and providing suitable bat roosting habitat; view facing southeast

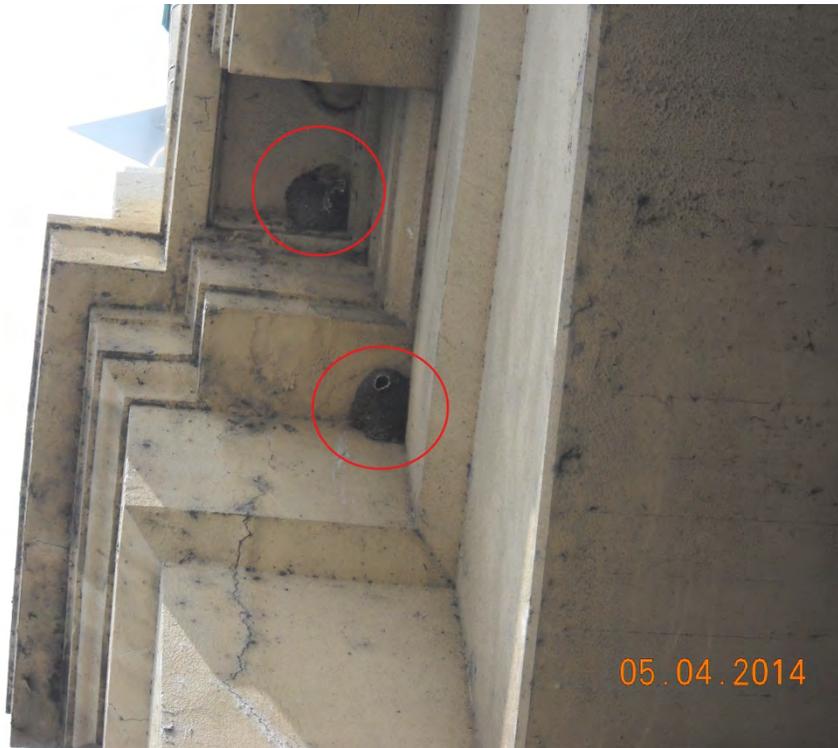
Photo 9: Active swallow nests observed on the Sixth Street Viaduct near Santa Fe Avenue; view facing east

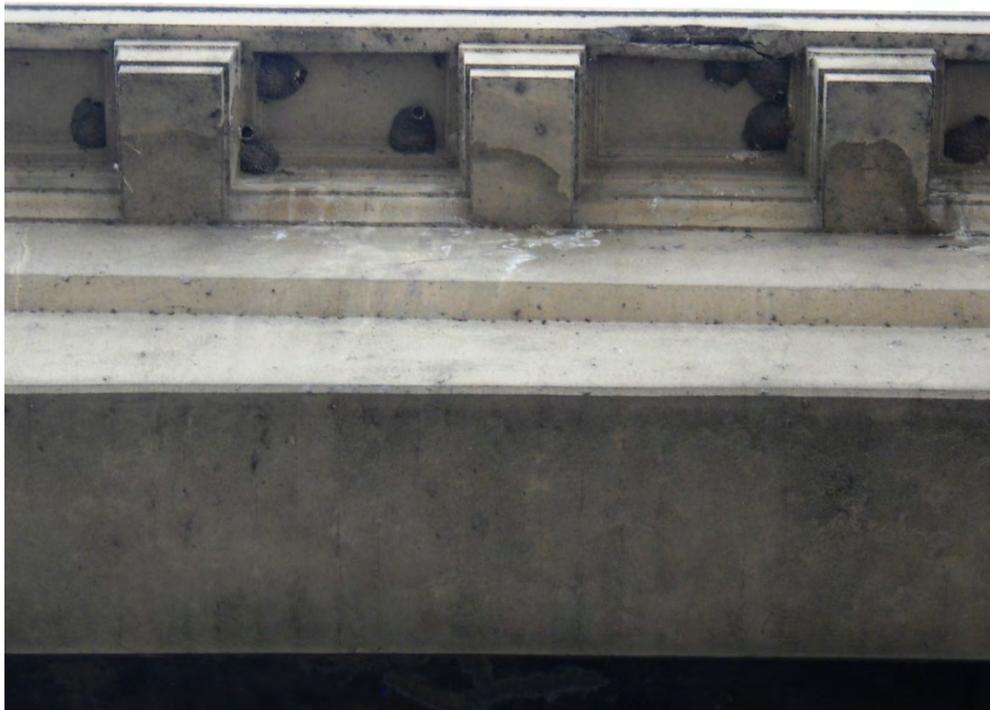
Photo 10: Active swallow nests on the viaduct near Santa Fe Avenue; view facing south

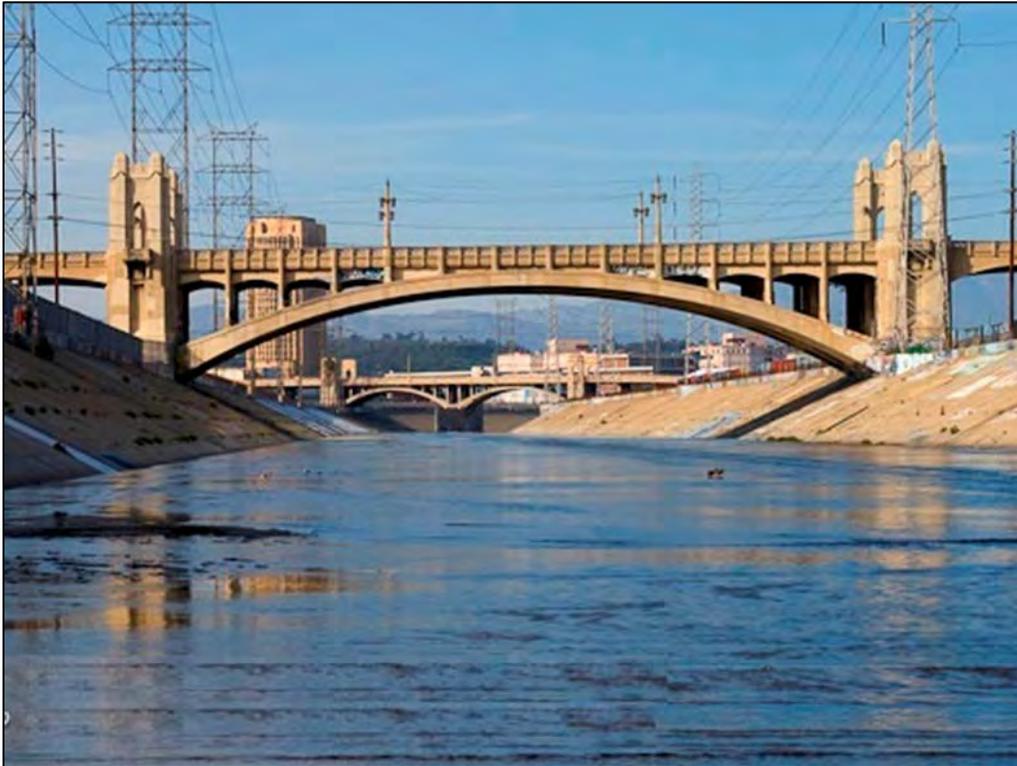
Photo 1: Fourth Street Viaduct over the Los Angeles River; view facing north

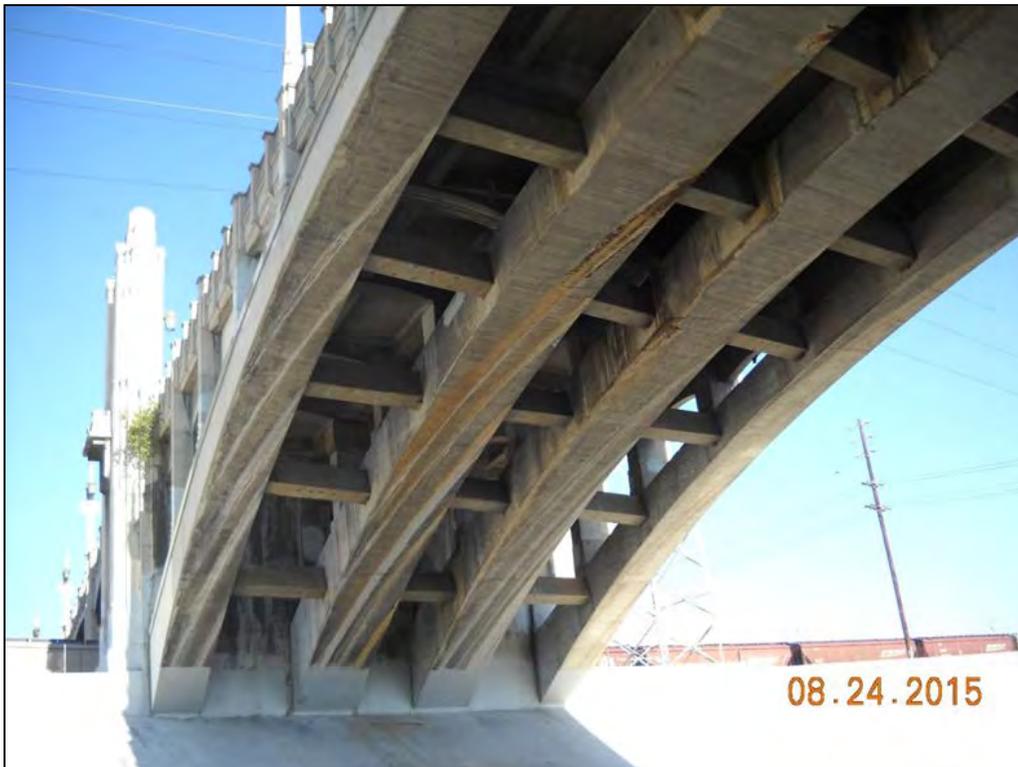
The Fourth Street Viaduct is a solid structure with concrete abutments, concrete piers, concrete girders, and concrete arches. The viaduct is approximately 50 feet above the river channel and approximately 20 to 30 feet above ground level outside of the river channel (see **Appendix A, Photos 1 and 2**). There are two visible expansion joints, extending across the bottom of the bridge deck in the river channel, which provide suitable day and night bat roosting habitat (see **Appendix A, Photos 3 and 4**). There are also several expansion joints and cracks on the structure, outside of the river channel, that provide suitable day and night bat roosting habitat. The remaining portion of the structure is made of sealed concrete girders that do not provide suitable bat roosting habitat. Four swallow nests were observed on the structure, west of the river channel, which could be used by bats for roosting. Compared to the Sixth Street Viaduct, there is considerably less bat roosting habitat on the Fourth Street Viaduct.

Photo 2: Underside of Fourth Street Viaduct showing concrete arches and girders; view facing east

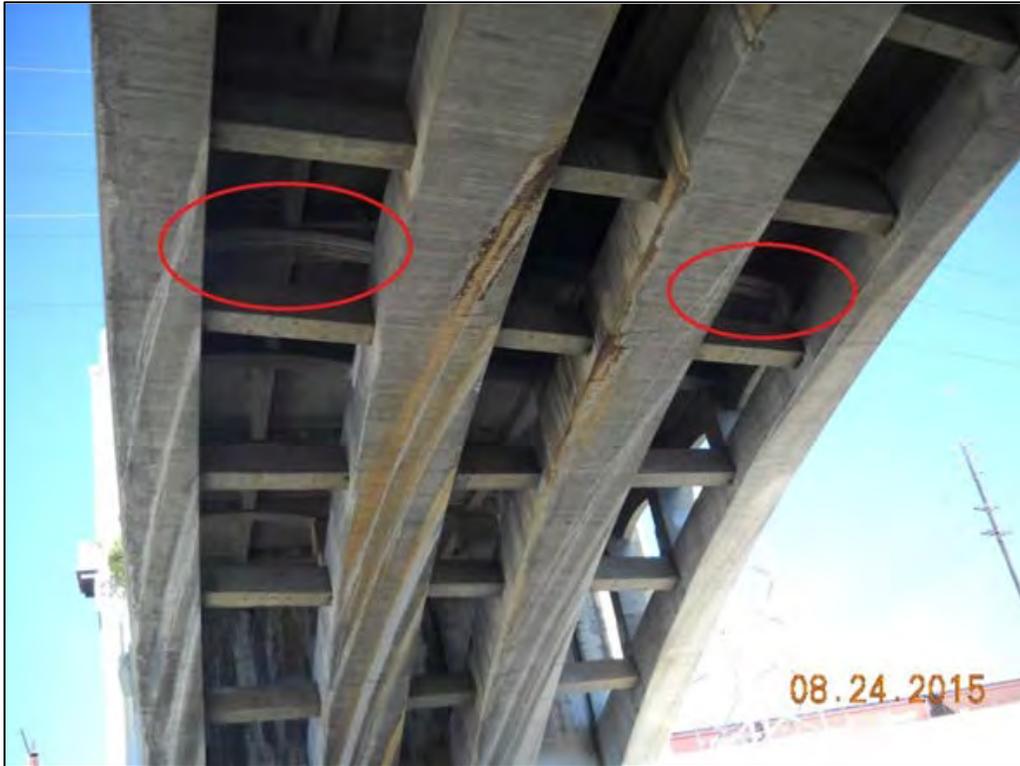
Photo 3: Underside of Fourth Street Viaduct showing eastern expansion joint; view facing east

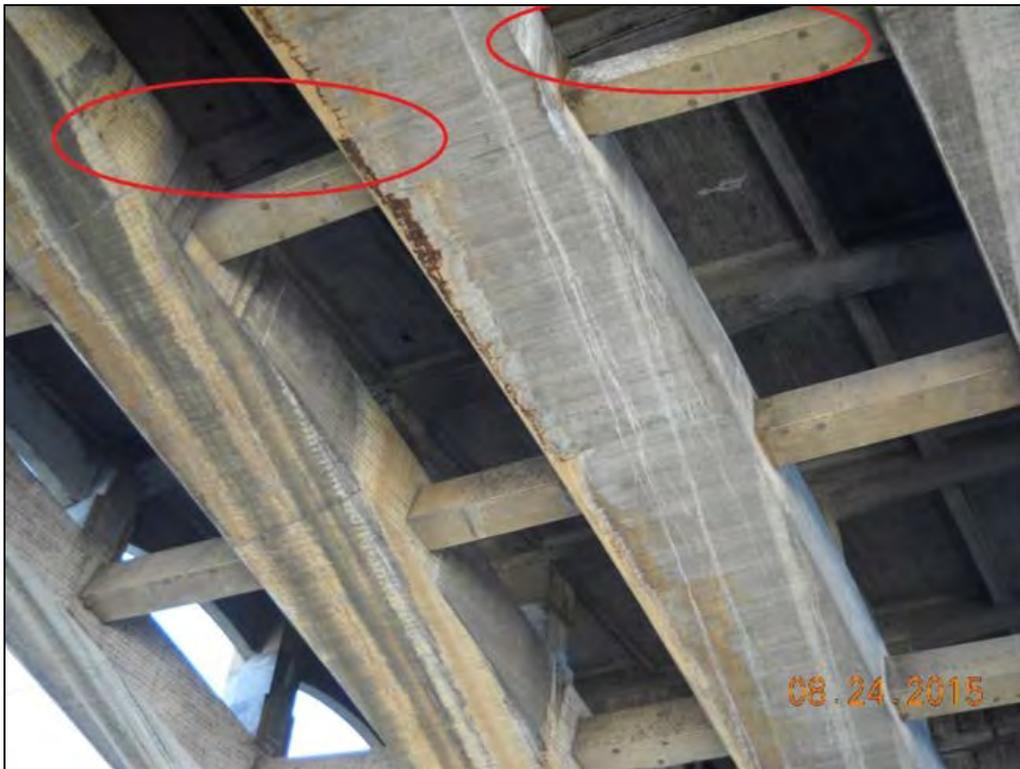
Photo 4: Underside of Fourth Street Viaduct showing western expansion joint; view facing west

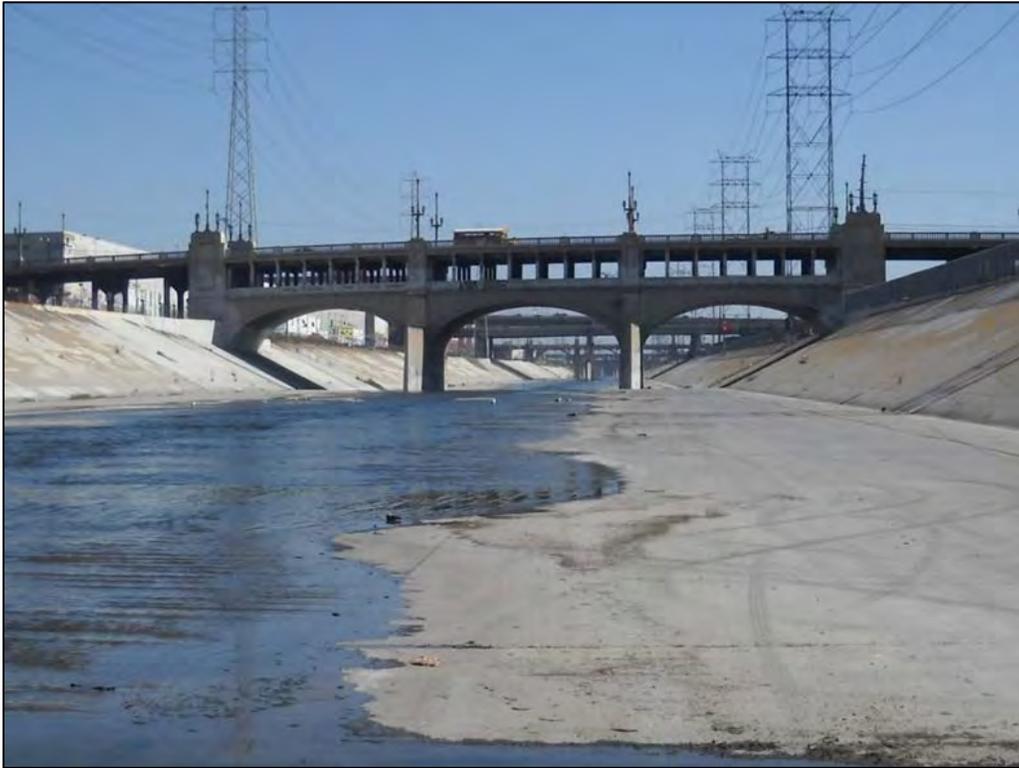
Photo 5: Seventh Street Viaduct over the Los Angeles River; view facing south

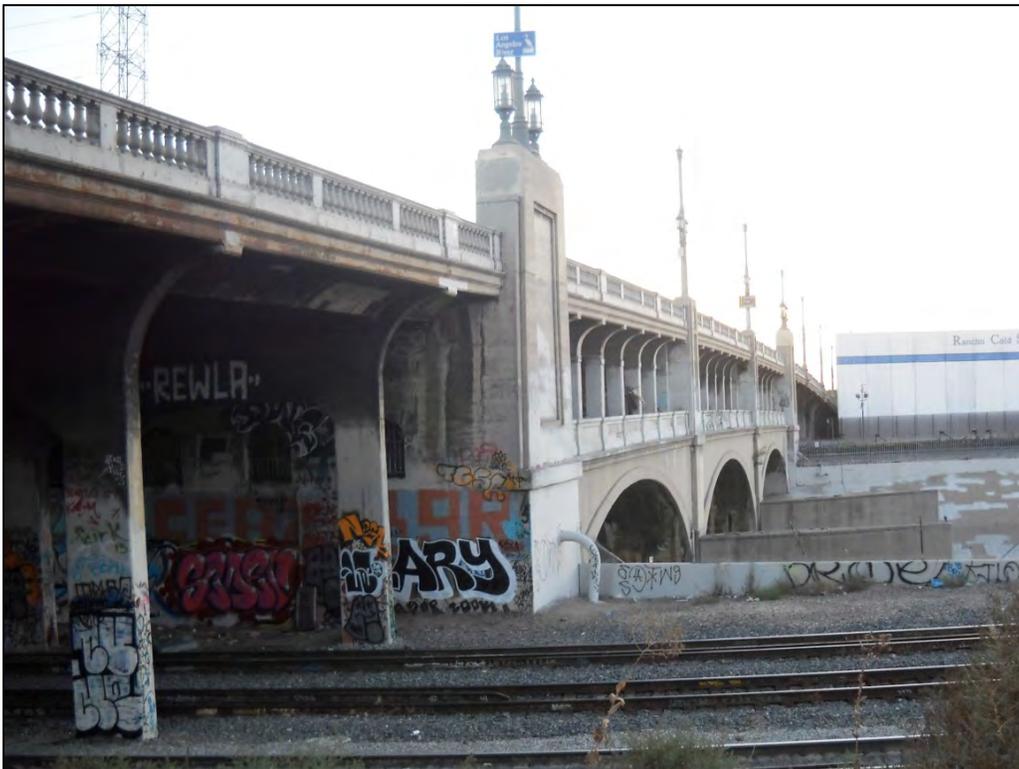
Photo 6: East side of Seventh Street Viaduct over the Los Angeles River showing double-decked structure; view facing west

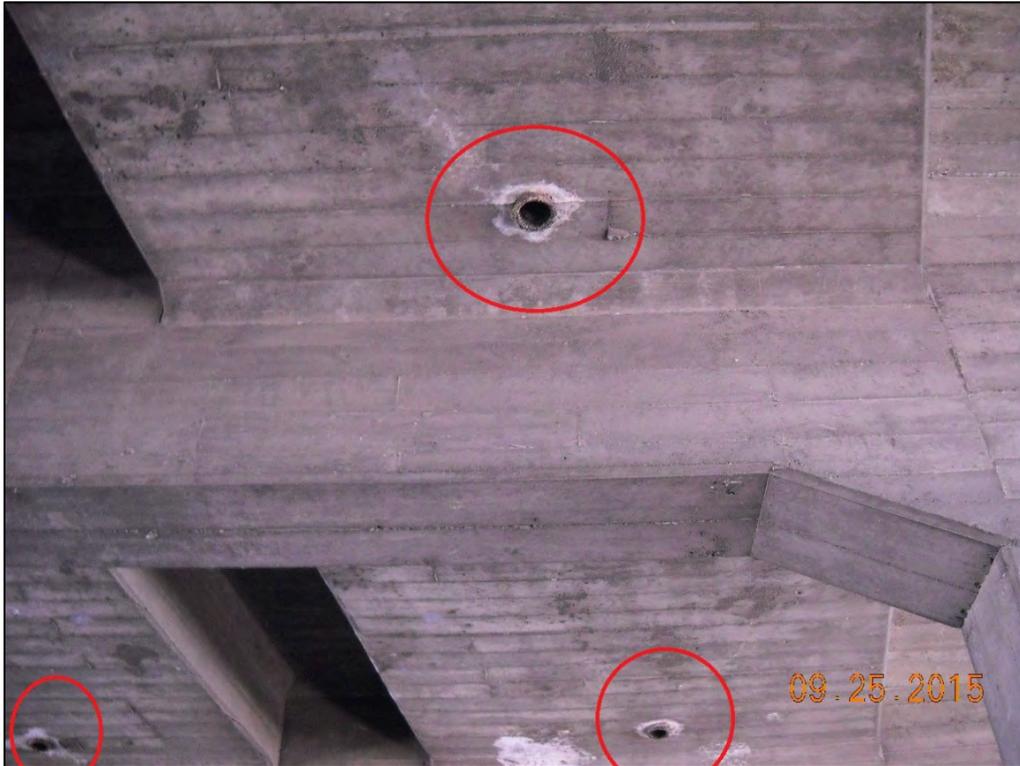
Photo 7: Drainage holes on the underside of the Seventh Street Viaduct upper bridge deck; view facing east

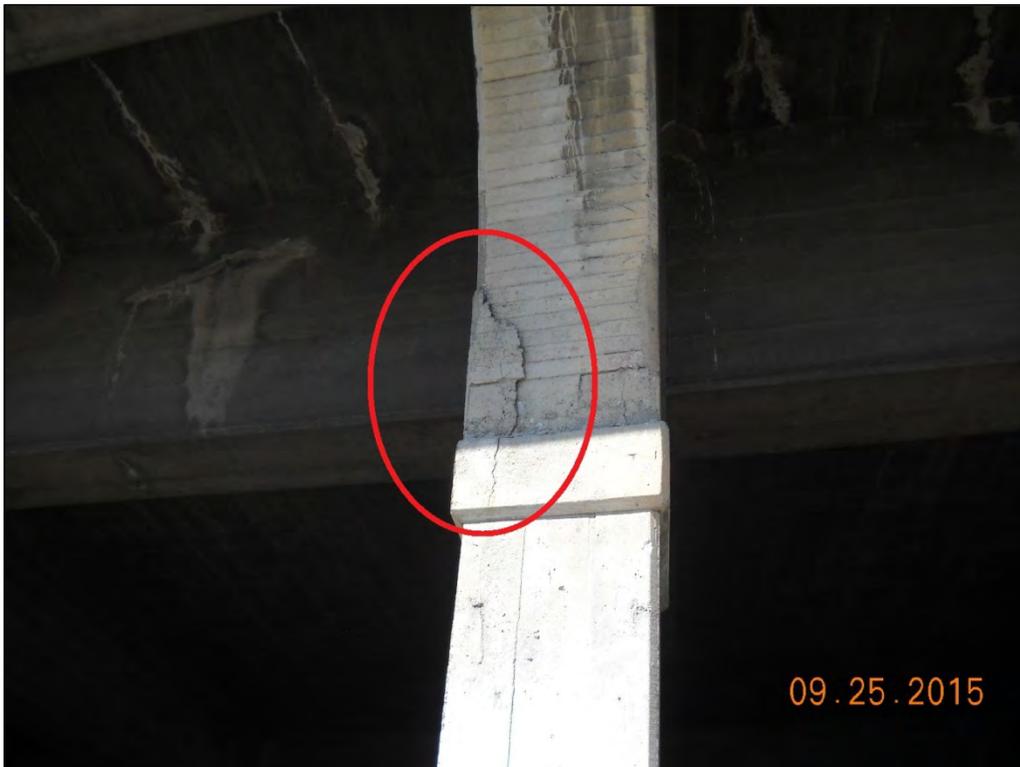
Photo 8: Cracks on the outer girders of the Seventh Street Viaduct upper bridge deck provide suitable bat roosting habitat; view facing north

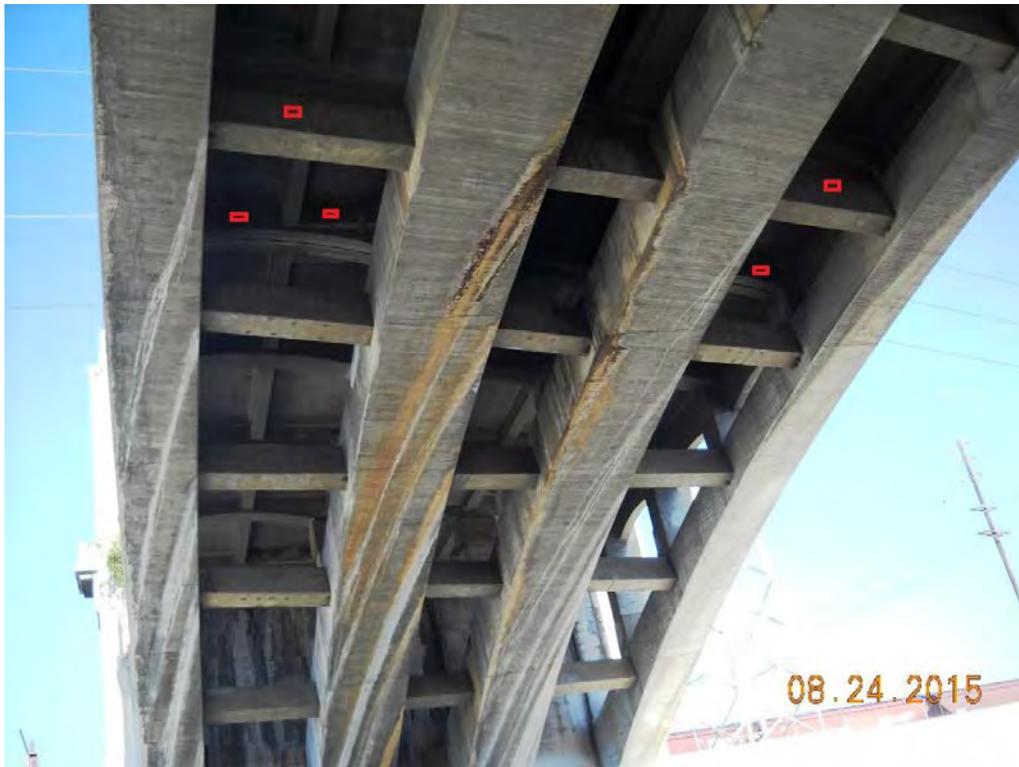
Photo 9: Approximate locations selected for placement of alternative bat habitat enclosures on the concrete girders of the Fourth Street Viaduct; view facing east

Suitable locations for alternative bat habitat enclosures were identified during surveys of the Fourth Street Viaduct and Seventh Street Viaduct. Areas on the underside of the Fourth Street Viaduct on the concrete girders near the existing expansion joints were selected as the most suitable locations to place alternative bat habitat enclosures because these areas had sufficient ground clearance, were near the expansion joints where bats were observed night roosting, were concrete, and were inaccessible to human disturbance (see **Appendix A, Photo 9**). Areas beneath the upper bridge deck of the Seventh Street Viaduct on the concrete girders facing out towards the river channel were selected as the most suitable locations to place alternative bat habitat enclosures **because** these areas had sufficient ground clearance, were near the areas where bats were observed exiting the structure during evening emergence surveys, were concrete, and were inaccessible to human disturbance (see **Appendix A, Photo 10**).

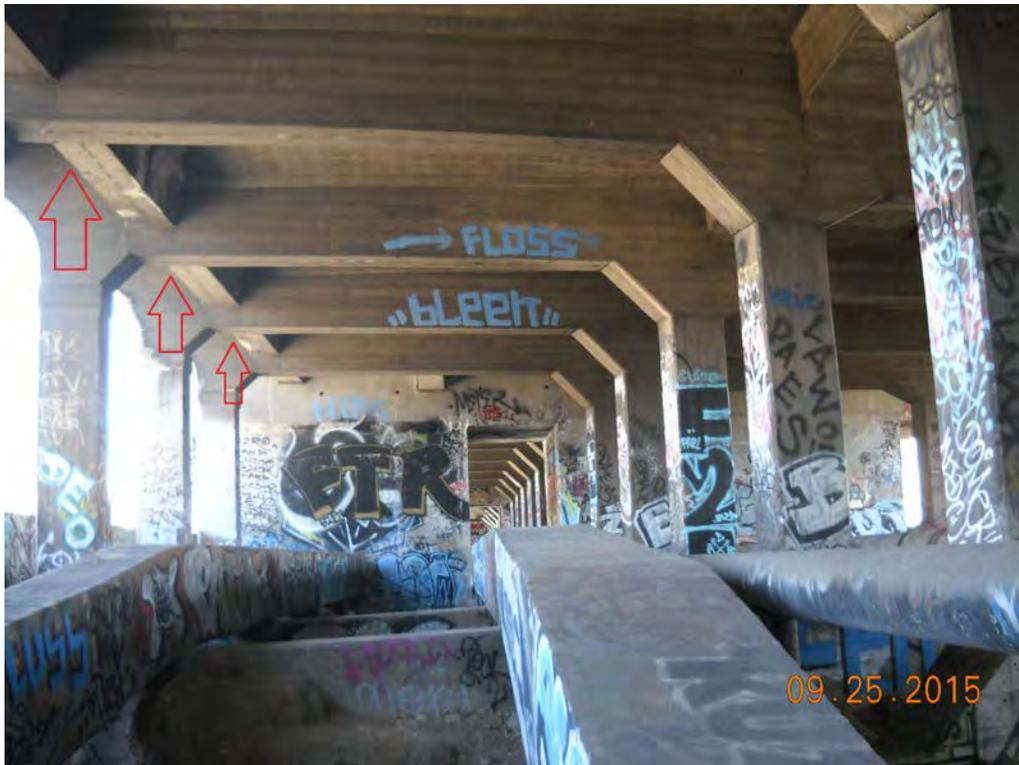
Photo 10: Approximate locations selected for placement of alternative bat habitat enclosures on the concrete girders (facing out towards the river channel) of the Seventh Street Viaduct; view facing east
