**Viterbi Family Vision Research Center and
East Campus Loop Road Projects
UC San Diego Project Number/Job Number: 5301 and 5548**

**Addendum No. 10 to the Program Environmental Impact Report for the
University of California San Diego, 2018 Long Range Development Plan,
La Jolla Campus**

**CAMPUS PLANNING OFFICE
University of California, San Diego
9500 Gilman Drive, MC 0074
La Jolla, California 92093-0074**

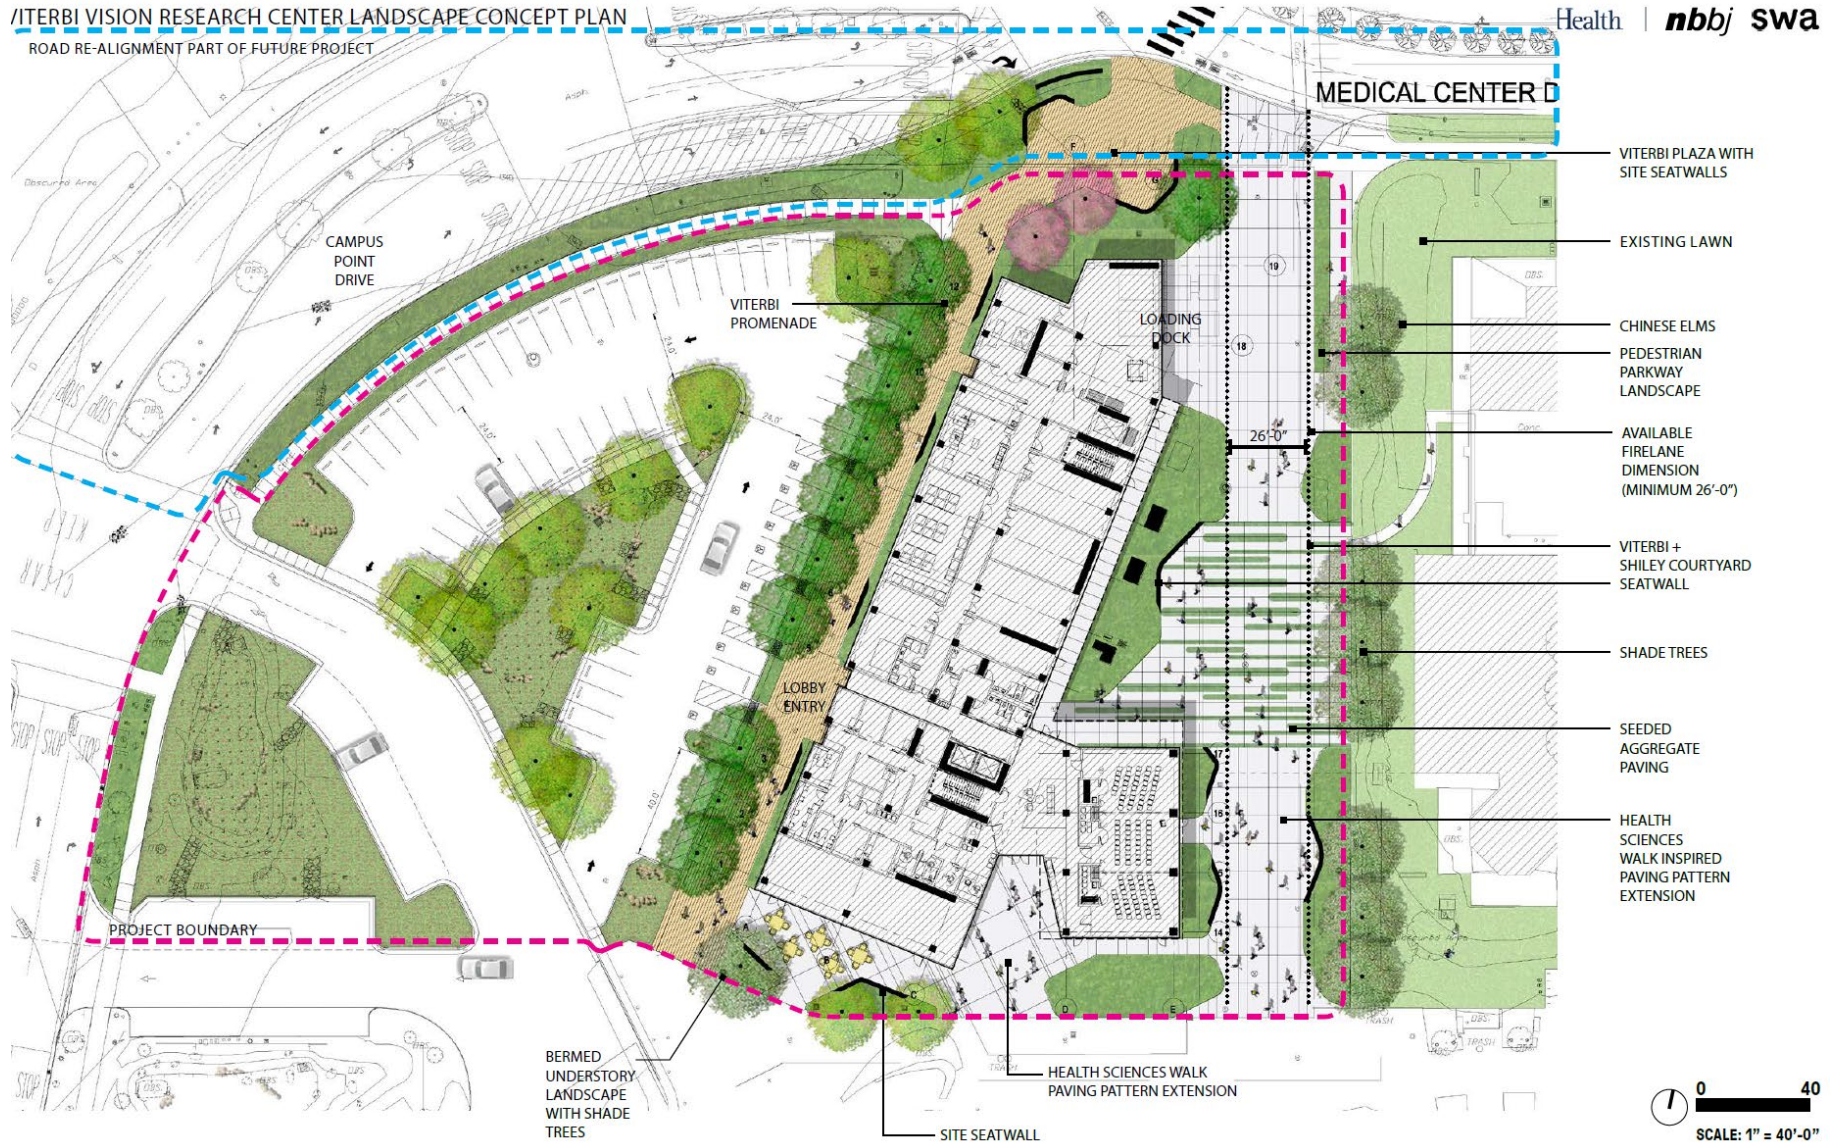
Figure 2-8: VFVRC Conceptual Landscape Plan

Key landscape and hardscape features for the VFVRC Project would include a tree-lined pedestrian promenade along the building's western façade. Pedestrian amenities would be located along this promenade. The new centralized median and adjacent areas would be landscaped and pedestrian access would include architectural paving. Tree selection would complement existing surrounding streetscape of the East Campus. Shrubs and trees would be selectively planted within the utility corridor located to the east of the VFVRC Project where possible to maintain clearance for utility maintenance and fire access. Potted trees and shrubs would be an alternative if in-ground locations are not feasible. Exterior tables, chairs and built-in seating options would further enhance the pedestrian experience surrounding the proposed VFVRC. All landscape would be irrigated using recycled water. See Figure 2-8, VFVRC Conceptual Landscape Plan, for a visual representation of planting locations.

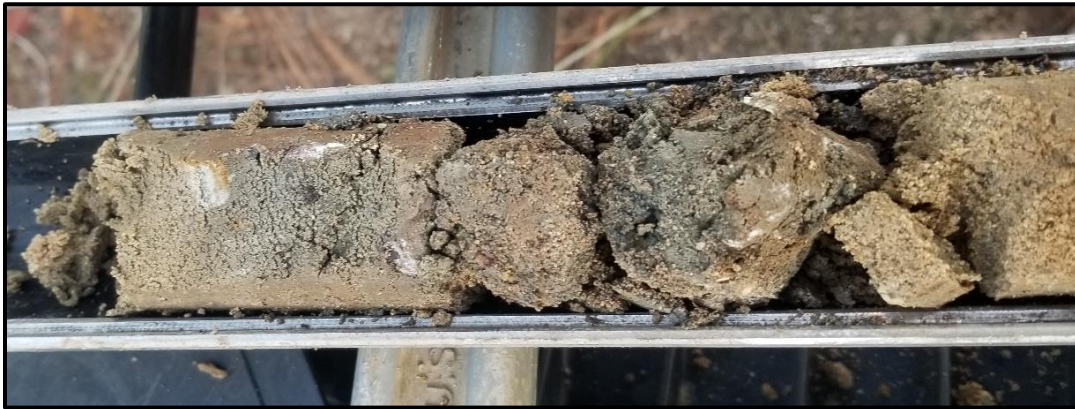
Figure 4-2. Fill at Boring B-1

Fill (afu): Fill was encountered in each of the borings. The fill consisted of very loose to medium dense silty sand and clayey sand with varying amounts of gravel, cobbles, and asphalt debris. The fill extended to depths varying from about 2 feet bgs in Boring B-2 to the maximum-explored depth of about 7 feet bgs in Boring B-3. Previous borings by SCS&T (2013, 2014) indicate that the southern portion of the site is underlain by up to about 15 feet of fill. Because we have no records regarding the placement and compaction of the fill, the fill is considered undocumented and at risk for wide variations in quality.

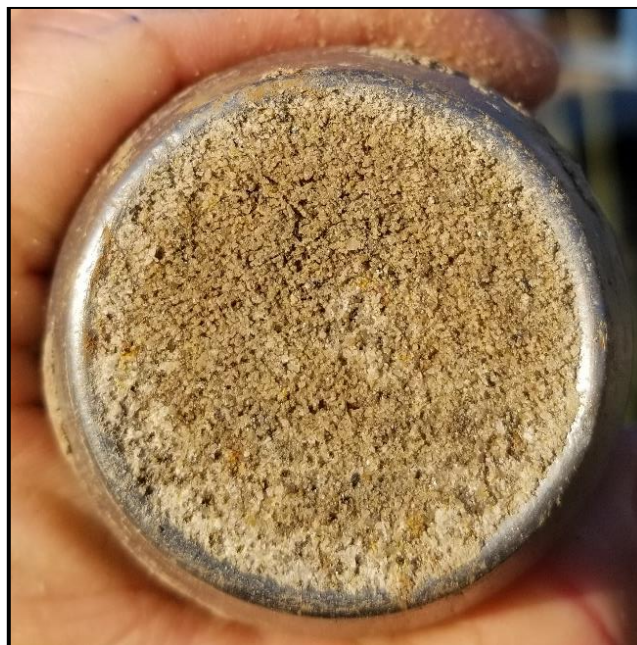
Figure 4-3. Very Old Paralic Deposits in Boring B-1

Very Old Paralic Deposits (Q_{vop10}): Beneath the fill, Very Old Paralic Deposits were encountered to depths varying from about 20 to 22 feet bgs. As encountered in the borings, these deposits consisted of medium dense to very dense, weakly cemented silty sandstone. Figure 4-3 presents a photograph of the Very Old Paralic Deposits.

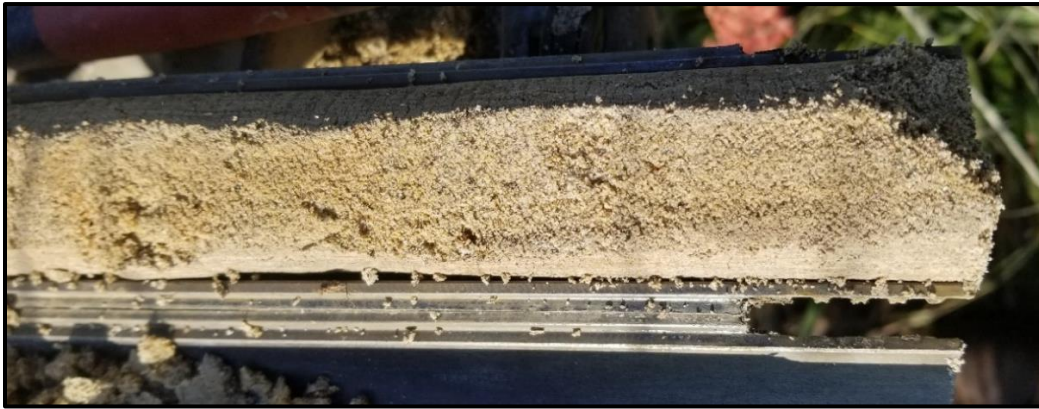
Figure 4-4. Scripps Formation in Boring B-2

Scripps Formation (Tsc): Beneath the Very Old Paralic Deposits, Scripps Formation was encountered to the maximum-explored depth of about 31 feet bgs. As encountered in the borings, the Scripps Formation consisted of very dense, weakly to moderately cemented silty sandstone. Concretions up to several feet in dimension are known to exist in the Scripps Formation. Figure 4-4 presents a photograph of the Scripps Formation.
