Advanced Tree Care

Veterans Memorial Building/Senior Center

October 9, 2018

Tree Survey

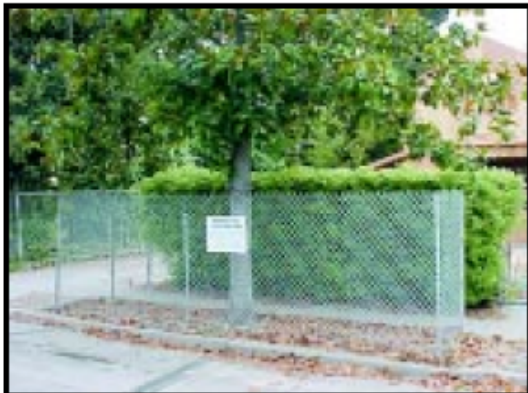
IMAGE 2.15-3
Tree Protection within a Planter Strip

Tree #s 1, 2, 3, 4 and 11 are located in the median next to the parking strip along St Francis Street and in an existing parking lot. The parking strip will be realigned to accommodate more vehicles. All 5 trees are quite small and already have a restricted root system from the existing curb. Tree protection fencing should be placed as close to the existing curb as possible to allow for safe removal and replacement of the curb in accordance with Type II Tree Protection as outlined below and illustrated in image 2.15-3 ⁽⁶⁾.

1. The Tree Protection Zone (TPZ) should be defined with protective fencing. This should be cyclone or chain link fencing on 1 1/2" or 2" posts driven at least 2 feet in to the ground standing at least 6 feet tall. Normally a TPZ is defined by the dripline of the tree. I recommend the TPZ's as follows:-

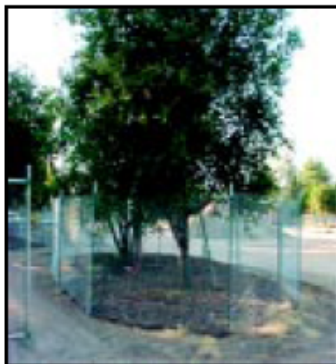
IMAGE 2.15-1
Tree Protection Fence at the Dripline

Tree #s 42, 43 and 44: TPZ should be at 10 feet from the trunk in accordance with Type I Tree Protection as outlined and illustrated in image 2.15-1 and 2 ⁽⁶⁾

Tree #s 40 and 41: TPZ should be at 20 feet from the trunk closing on the edge of sidewalk in accordance with Type I Tree Protection as outlined and illustrated in image 2.15-1 and 2 ⁽⁶⁾

1. The Tree Protection Zone (TPZ) should be defined with protective fencing. This should be cyclone or chain link fencing on 1 1/2" or 2" posts driven at least 2 feet in to the ground standing at least 6 feet tall. Normally a TPZ is defined by the dripline of the tree. I recommend the TPZ's as follows:-
