PRELIMINARY ARBORIST REPORT

Tree Inventory, Tree Descriptions and Preliminary Recommendations Relative to Proposed Construction

Red Morton Park YMCA & Senior Center

1455 Madison Avenue, Redwood City, California

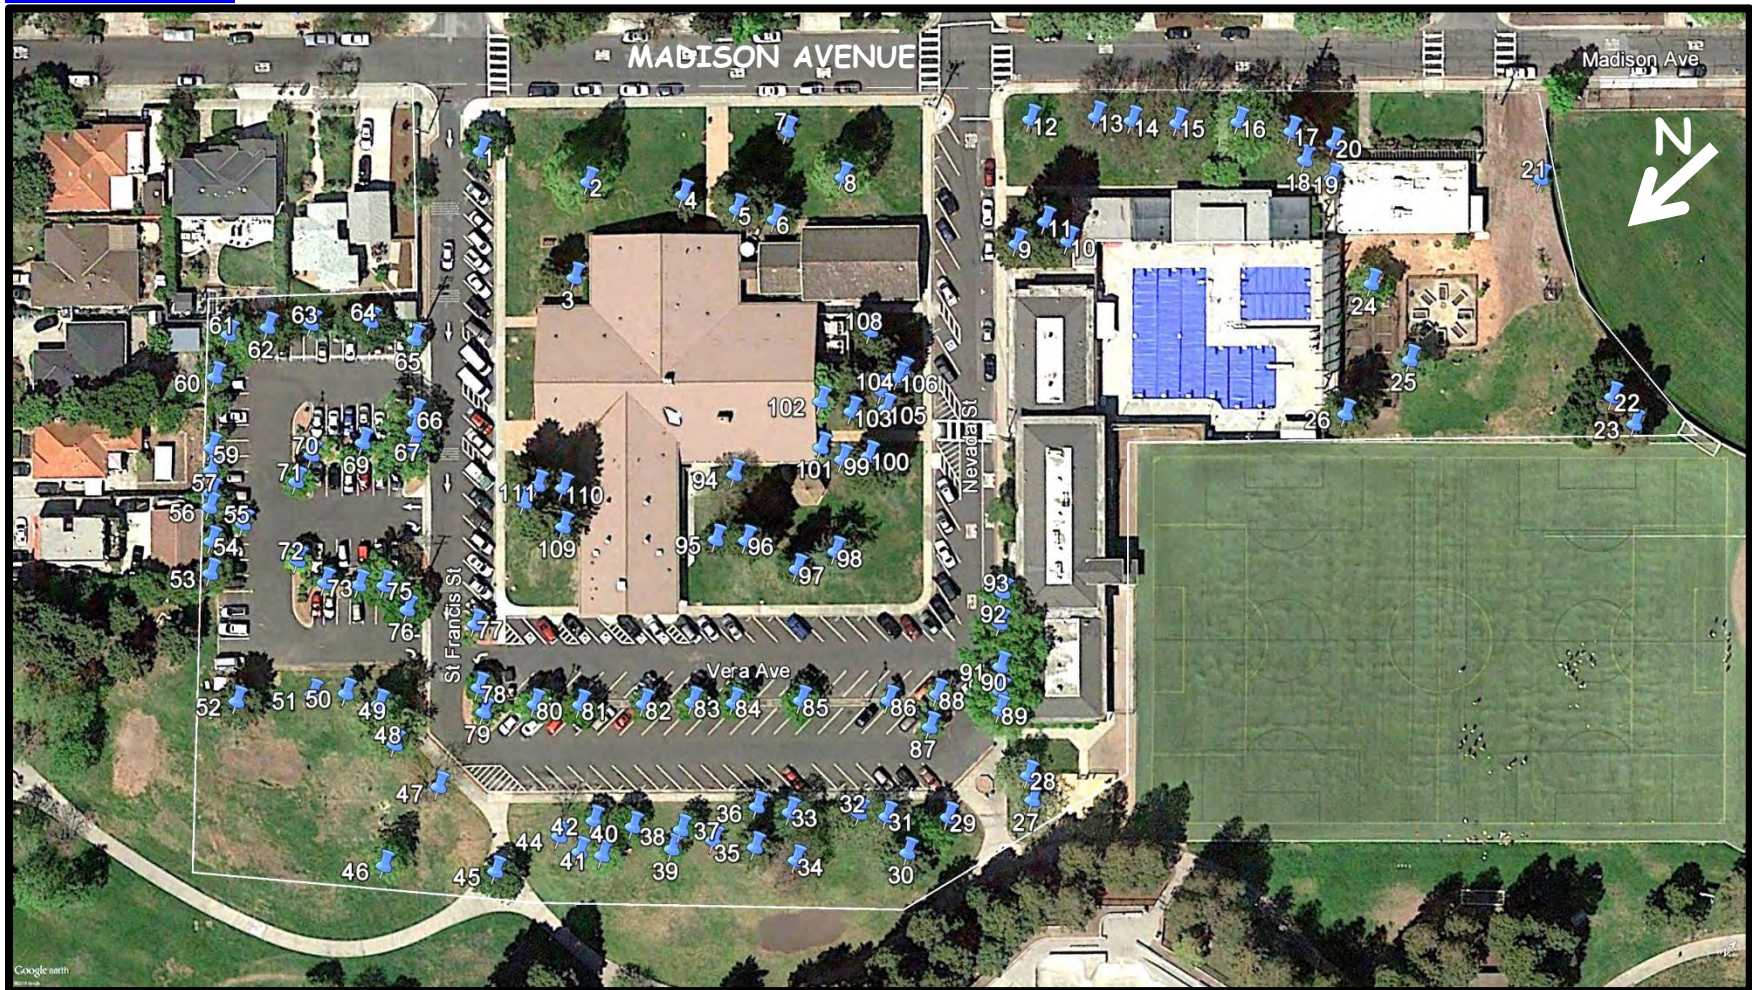
TREE MAP

Note that all tree numbers may not be visible due to the size of the map relative to the size of the tree and number symbols.
