Appendix D2
Creek Enhancement Report

Google Downtown San Jose Los Gatos Creek Enhancement Project Site Assessment Summary Report

H. T. Harvey Proposal #10170
March 5, 2020

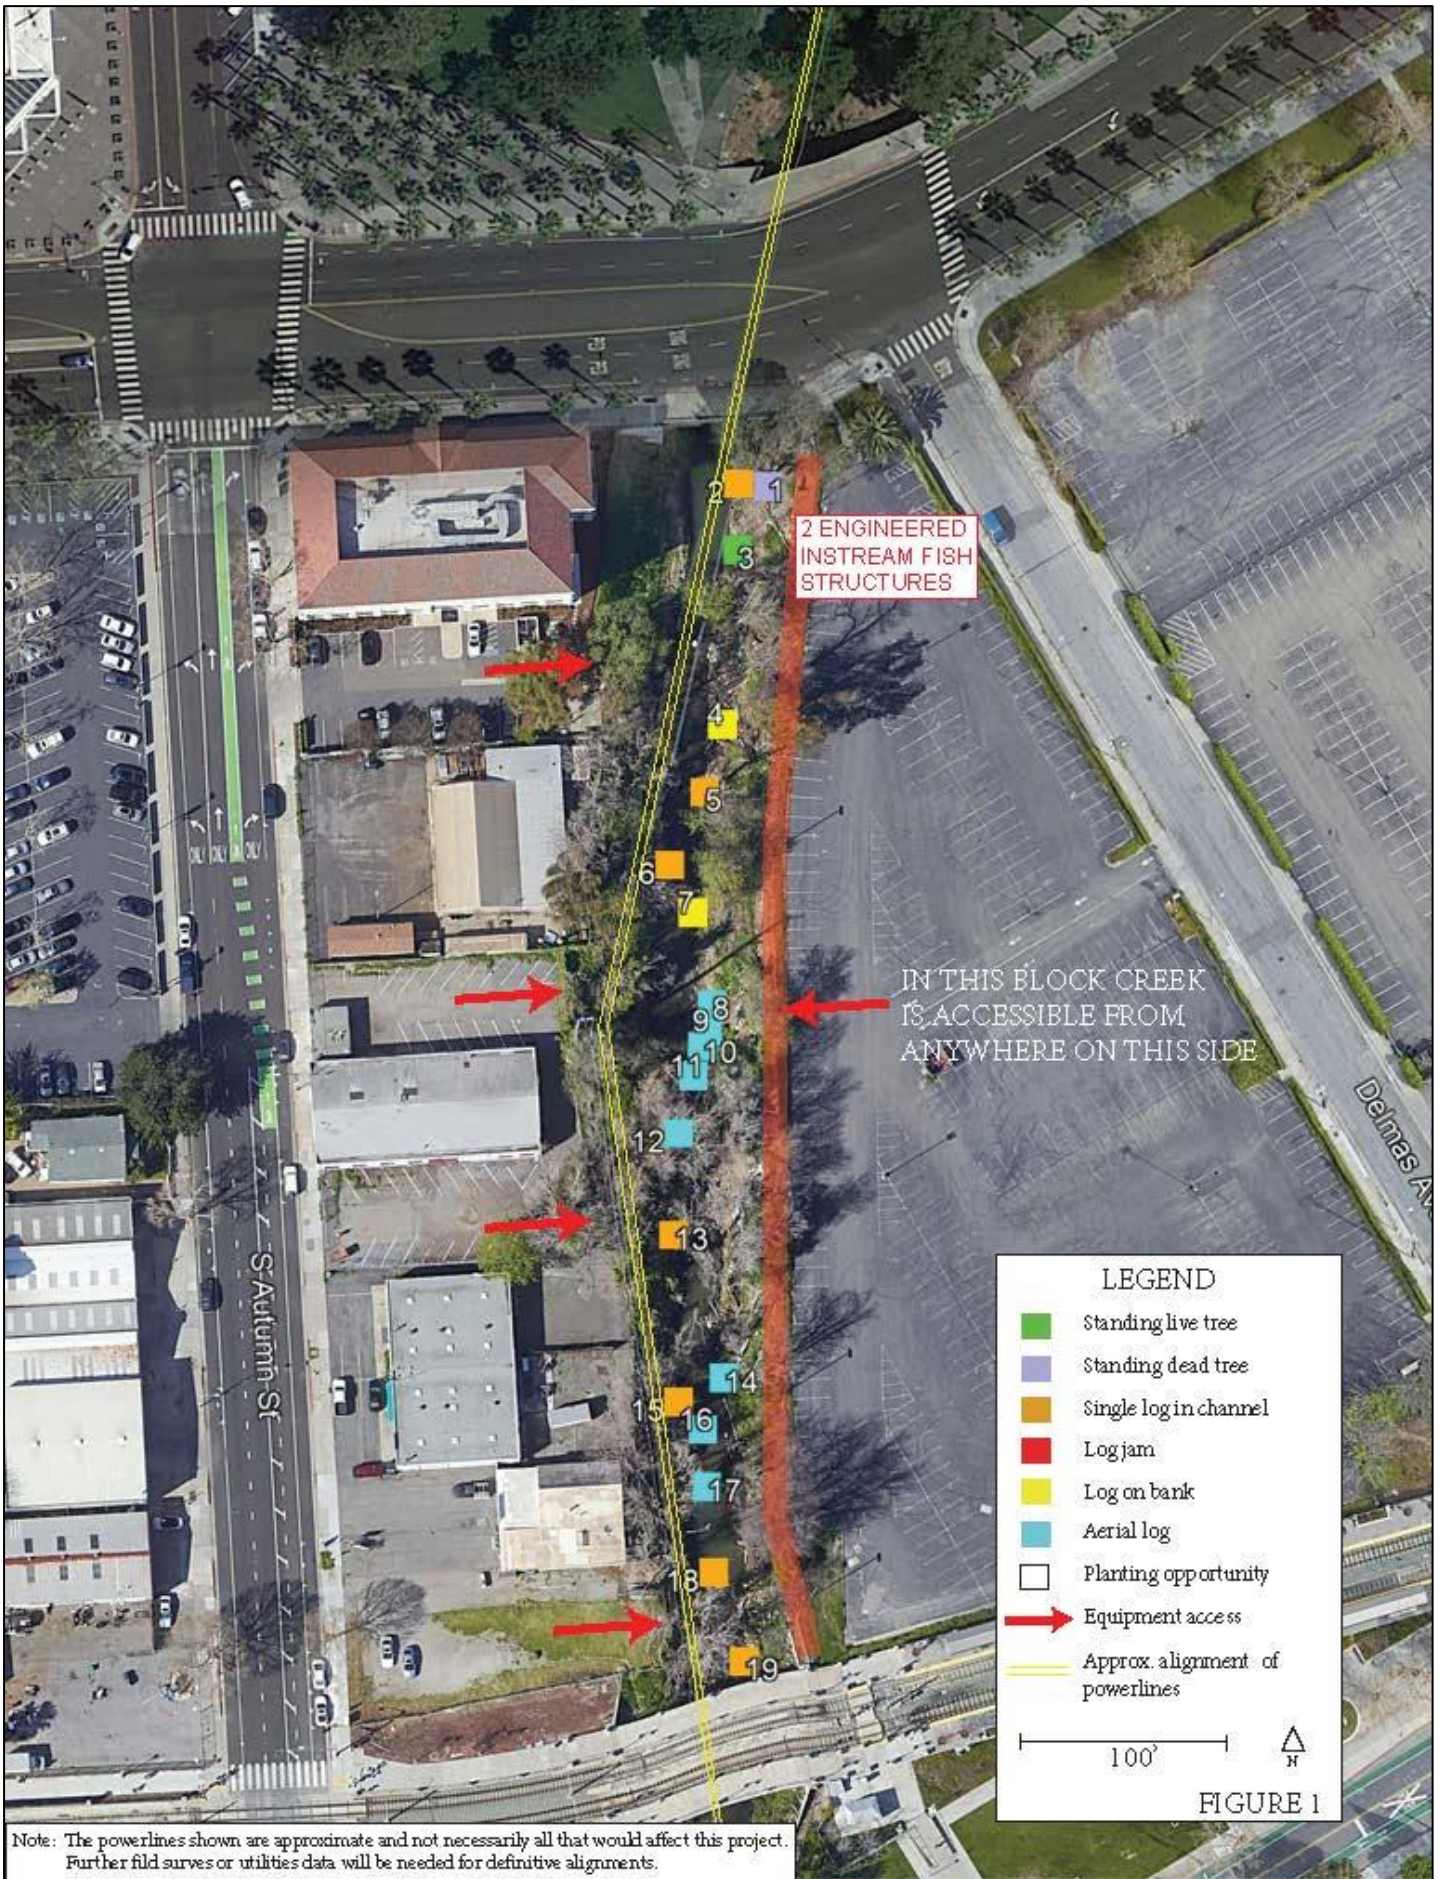
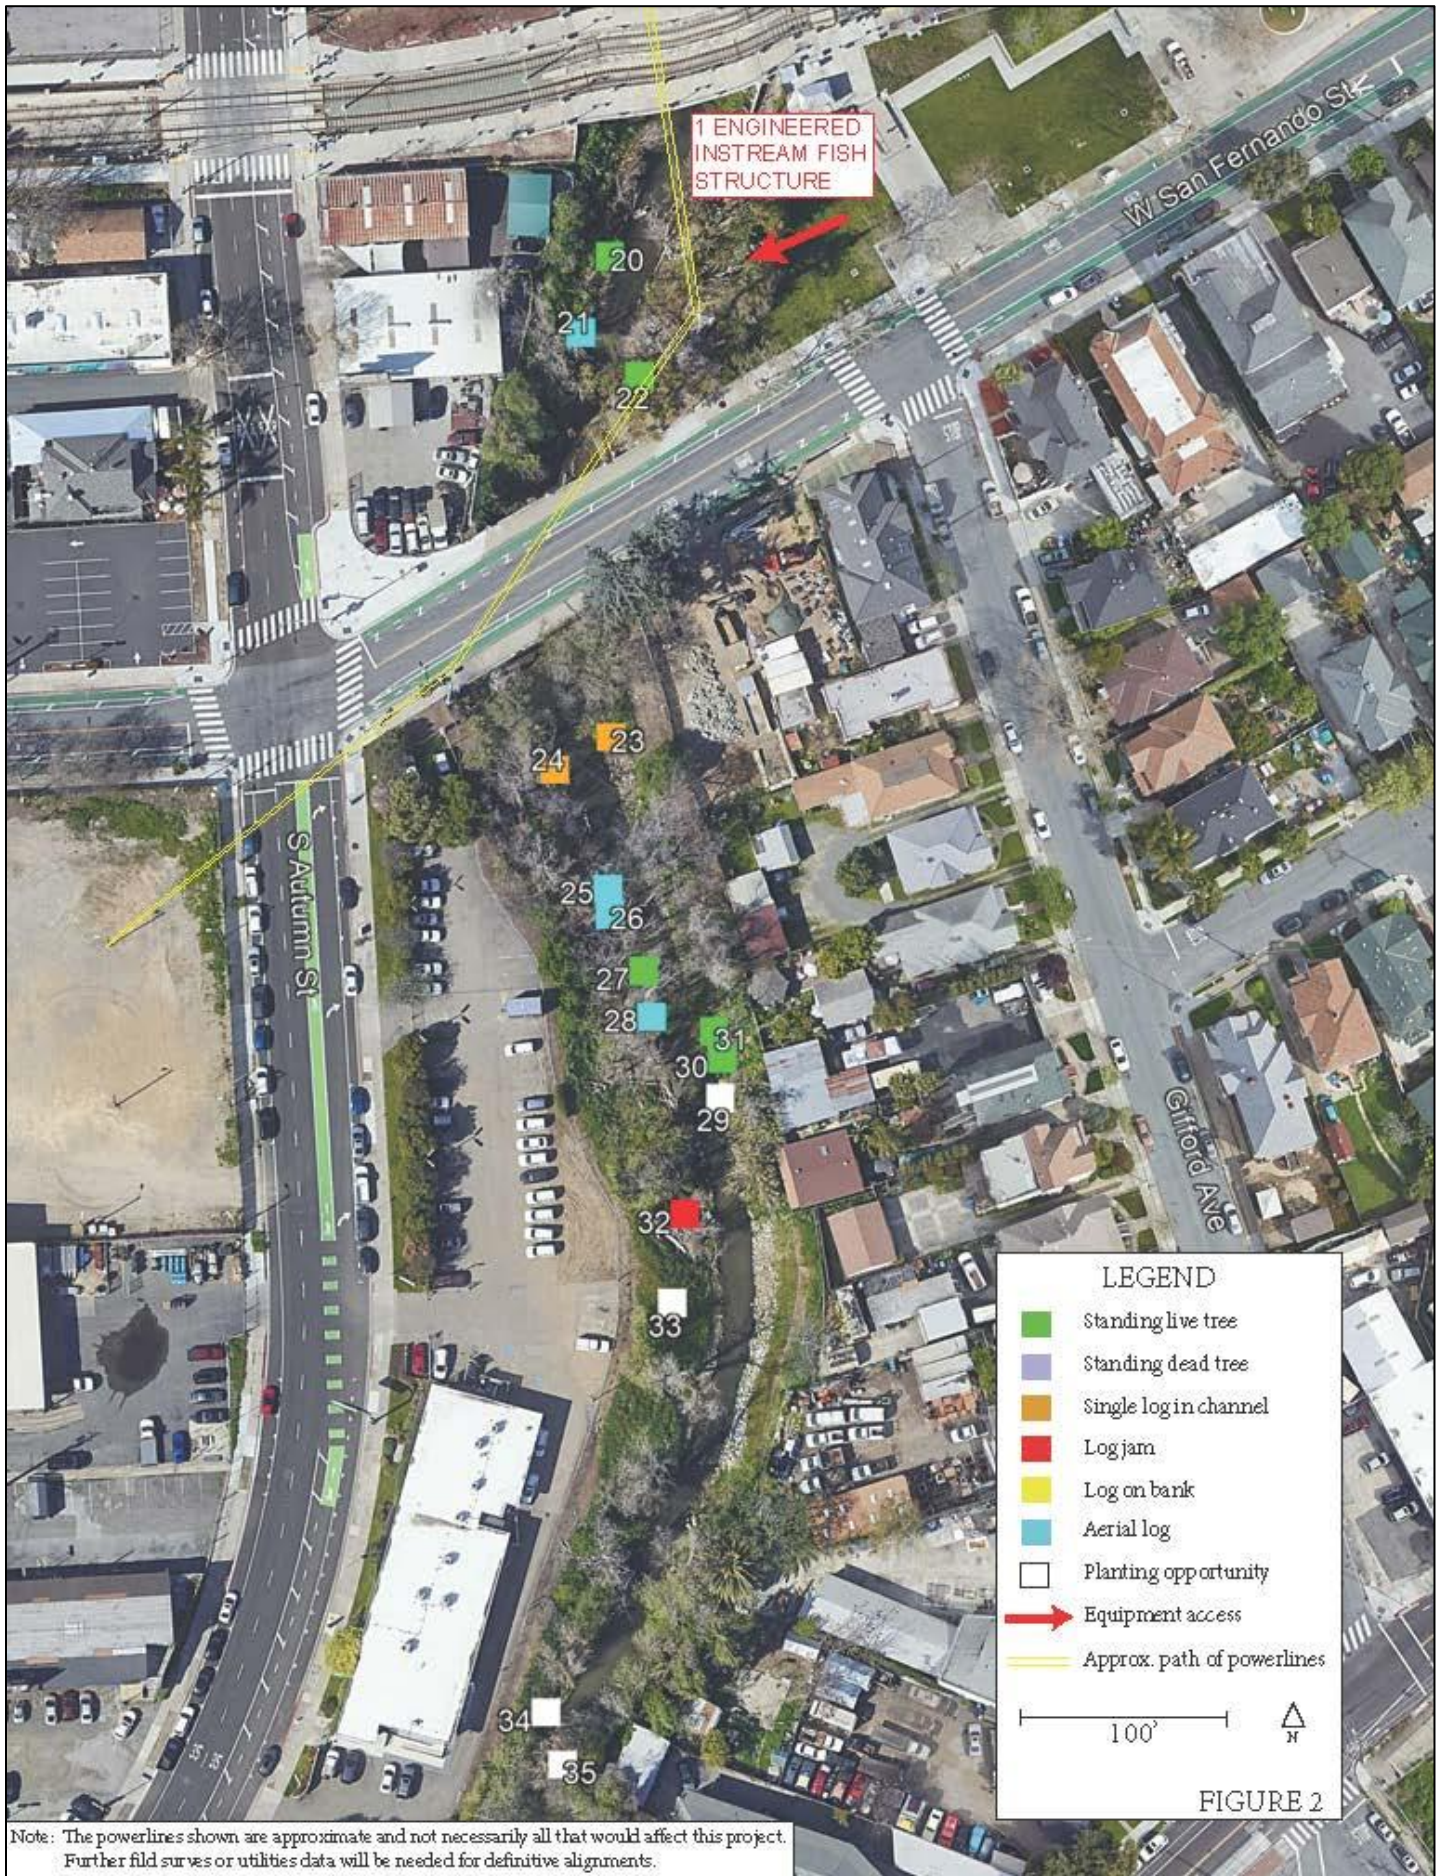
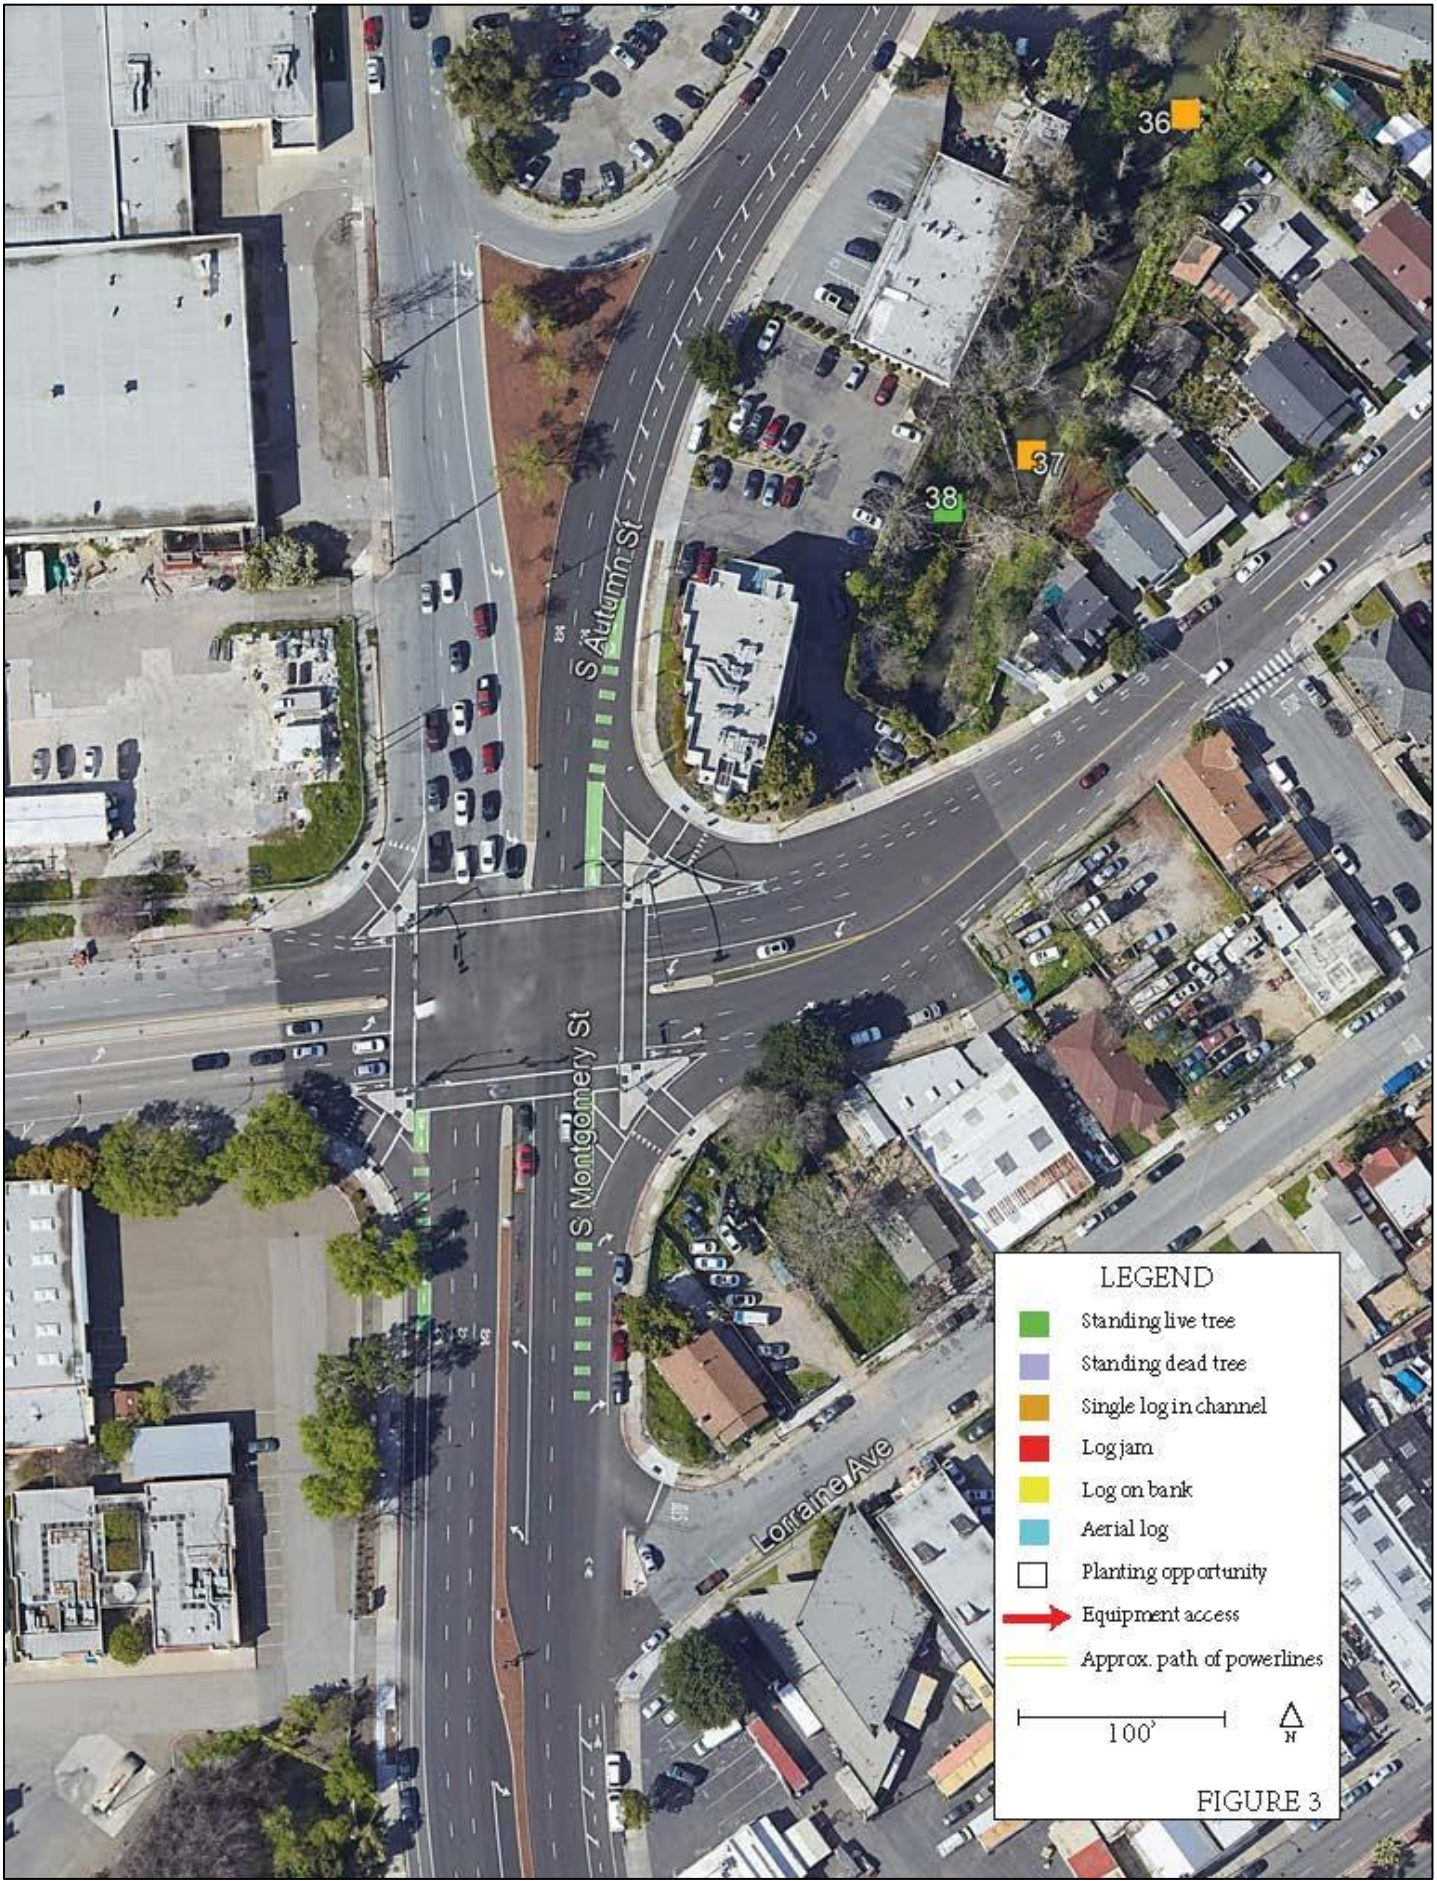
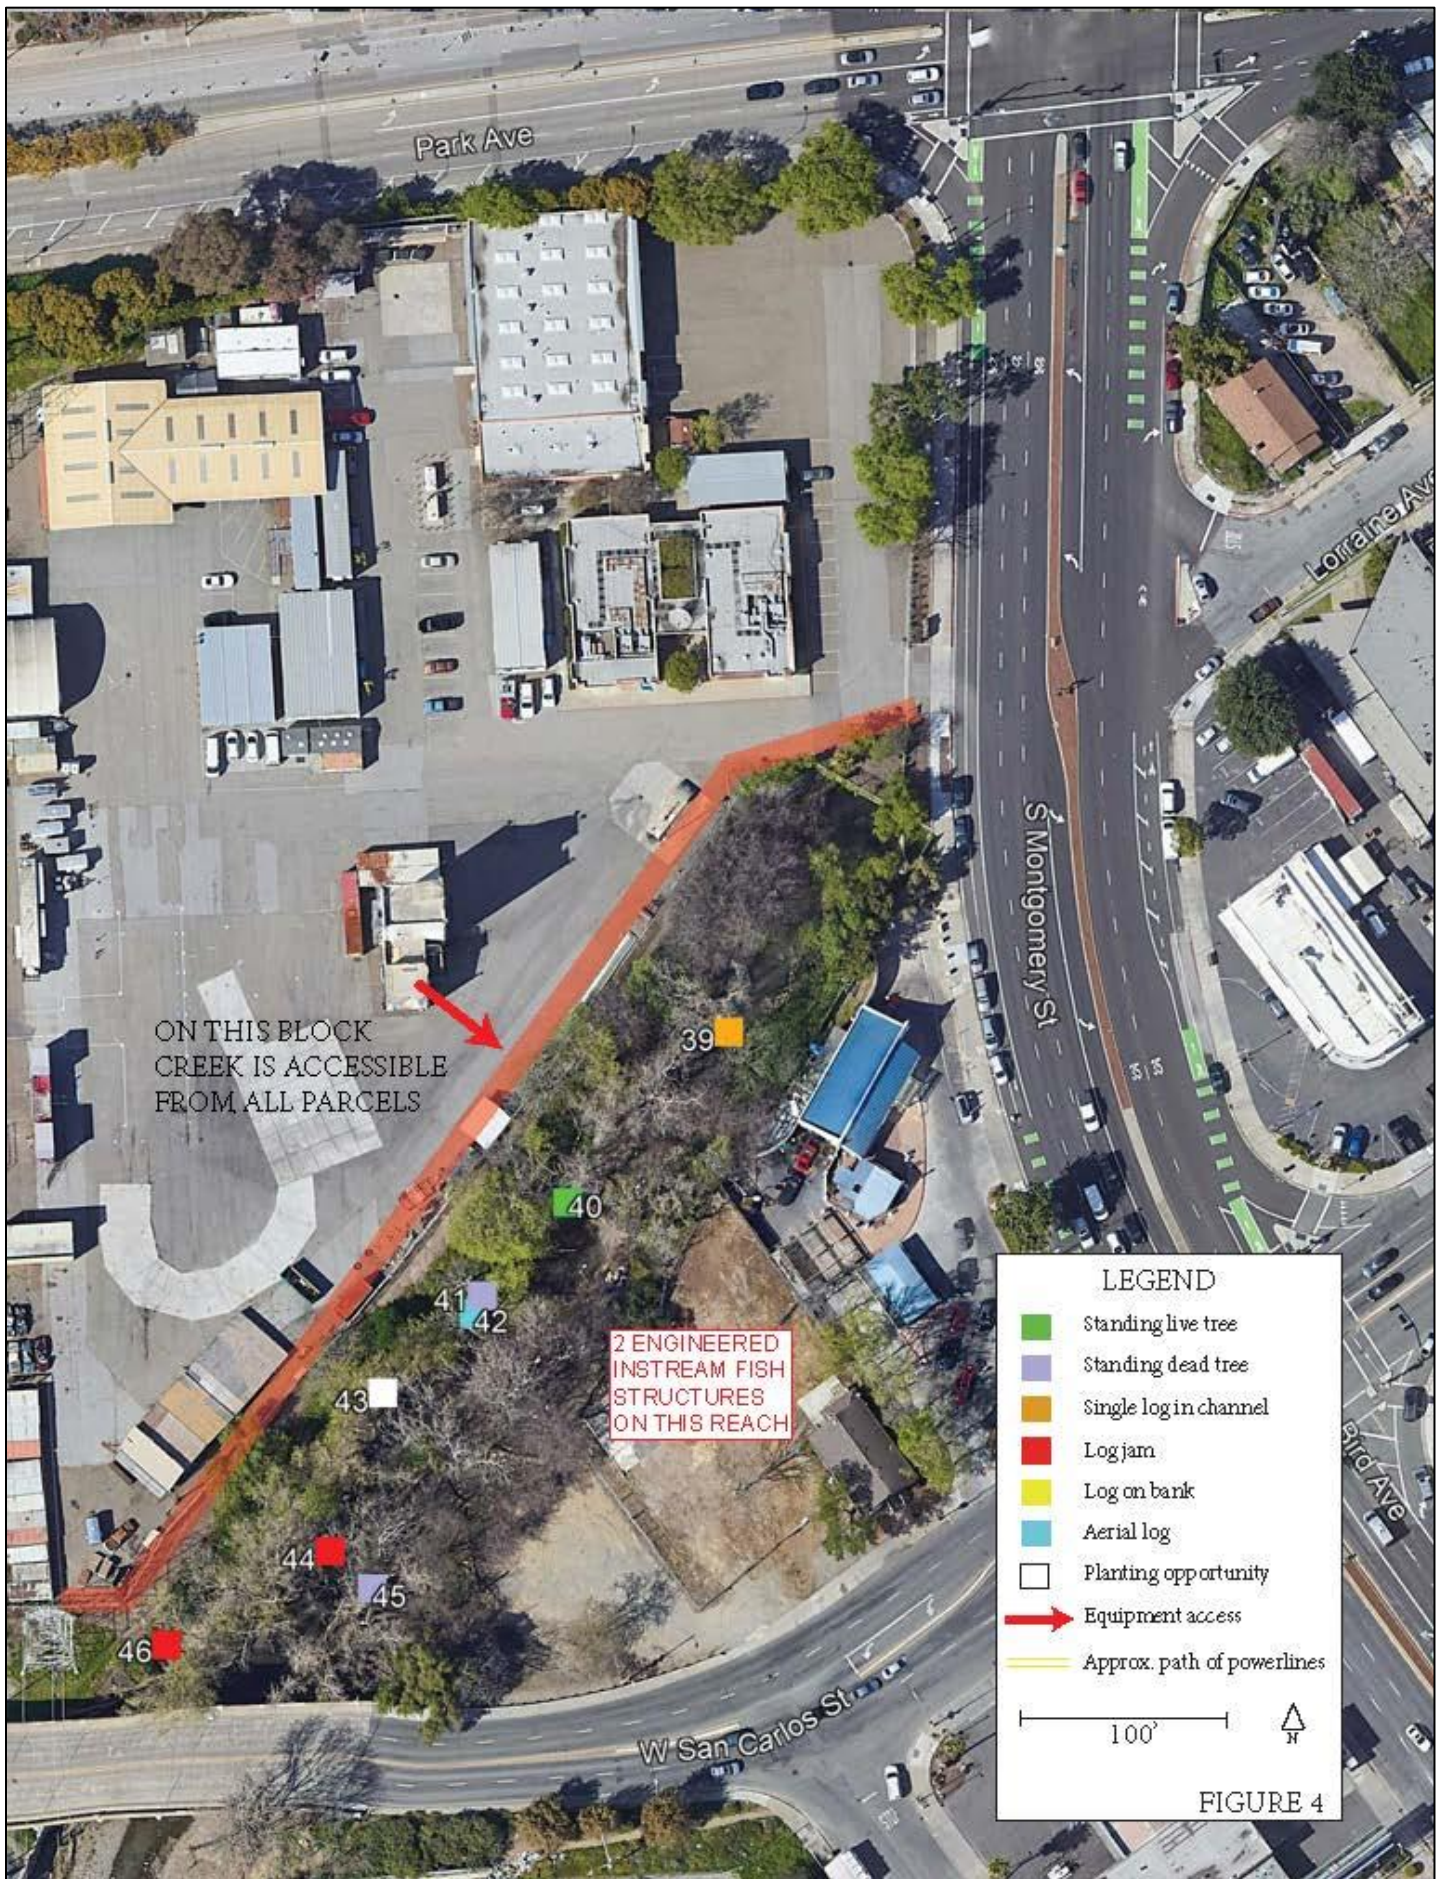
A small number of nonnative and native trees may be removed (Table 1 and Figures 1-4). Live trees over 6 inches dbh should be mitigated at a minimum of 3:1 for native trees and 2:1 for nonnative trees, but no mitigation is proposed for invasive tree species. Live trees 2-6 inches dbh should be mitigated at a minimum of 1:1 for native trees and no mitigation for nonnative trees. In future design efforts it may be necessary to find locations for planting mitigation trees near the channel to mitigate loss of channel shading. Dead trees should be replaced by planting 1 native riparian tree for each dead tree removed. While dead trees can provide valuable habitat for birds, this reach of the creek has ample dead large branches on existing native trees to remain, so this resource is not considered particularly limited at this site, and a 1:1 replacement with a live tree is adequate mitigation. To the extent feasible all mitigation planting should occur within the project reach, on the channel banks at least 10 feet above the channel bed to avoid creating new flow impediments. Replanting areas within the reach include gaps in existing tree canopy, and areas with pervasive invasive plant species (giant reed, tree of heaven, etc.) that can be removed to provide a planting area.

Figures 1-4 show the location of potential access for creek work (note that power lines need further study but are preliminarily shown), and preliminary locations for placement of engineered instream fish structures as mitigation.
