CERTIFIED ARBORIST REPORT

March 19, 2019
Revised October 31, 2019

PROJECT LOCATION:
9th Street and Vineyard
Rancho Cucamonga, CA

PREPARED FOR:
Environmental Project Manager
Jericho Systems
47 N. 1st Street
Redlands CA 92373

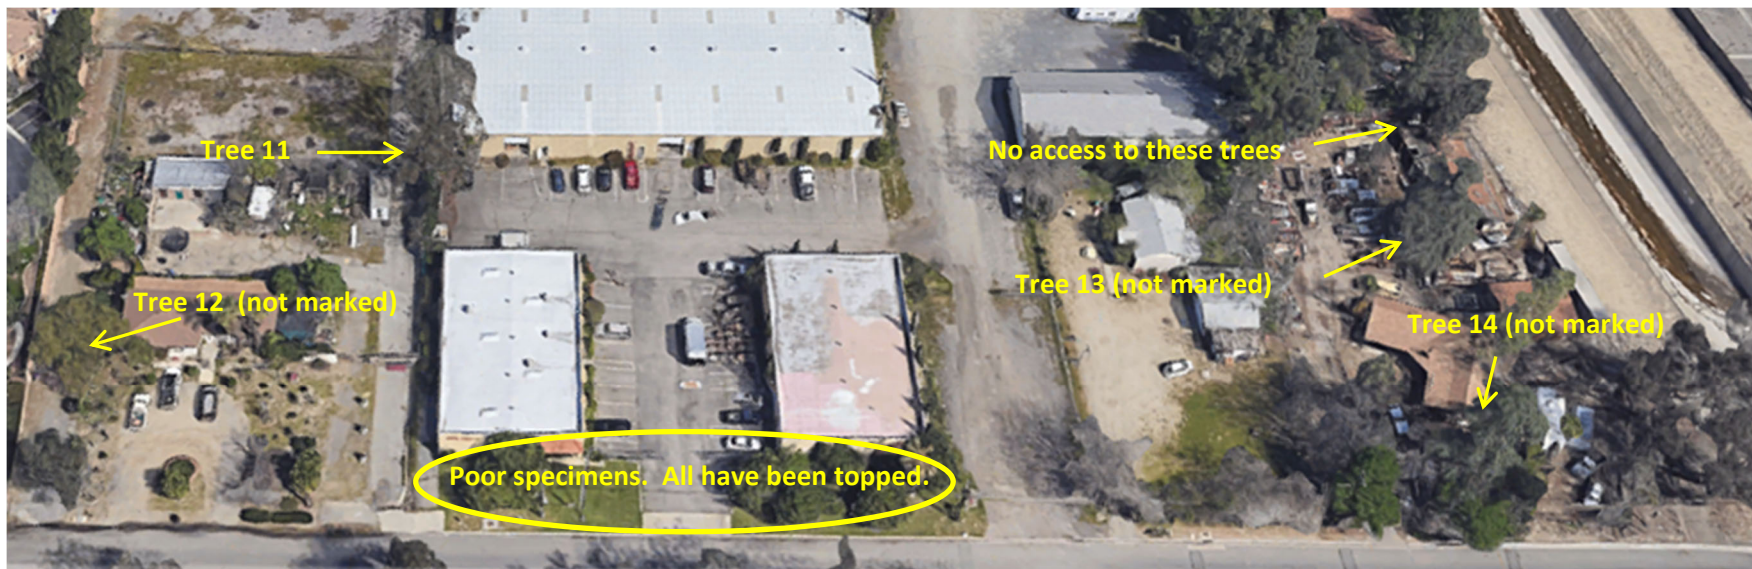
Map 3

Trees 4, 5, 6 and 7 indicated on Map 1 are in a dense area marked with yellow flagging. Trees 5 and 6 are particularly fine specimens, while Trees 4 and 7 are large enough, but are poor specimens. Located in the residential lots in the southwest and southeast corners, Trees 12, 13, and 14 all qualify as heritage trees, but are not marked on March 11th when they were observed but access to them was limited. However, all three are easy to locate according to their relative location in the landscape and with their provided longitude and latitude.

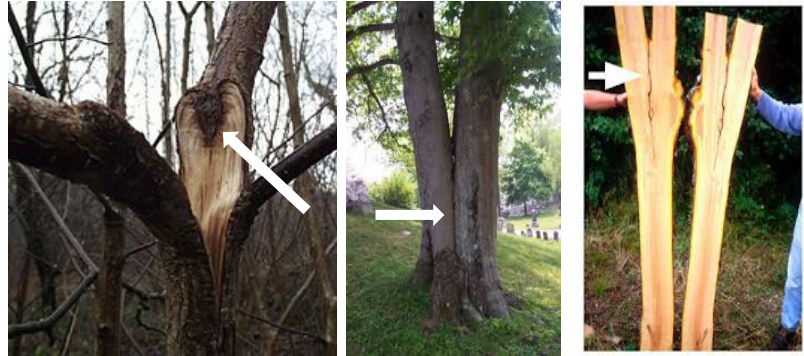
Included bark: This frequently develops with co-dominant stems with acute angle unions. The stems grow against each other until the bark ultimately disappears from view and forms “bark inclusion” (see arrows in photos) as the stems gain

diameter. The stems push extremely hard against each other and become more prone to failure. This can be a very serious structural issue and lead to catastrophic failure as shown above.
