**Blossom Hill Station  
Arborist Report**

**Project #4361-01**

February 19, 2020

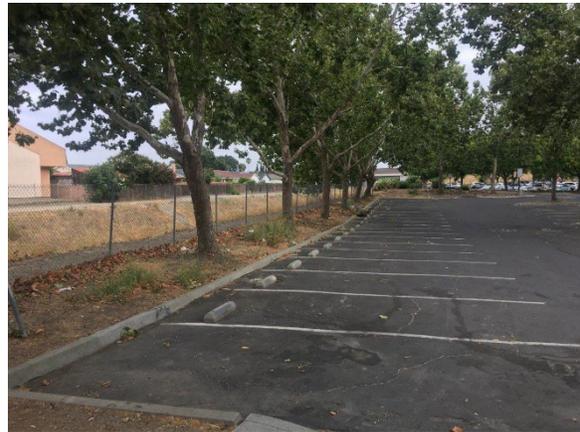
**Photo 1. Ornamental London plane trees lining the parking lot on the project site, with channel slopes of Canoas Creek (outside the project site) in the background.**

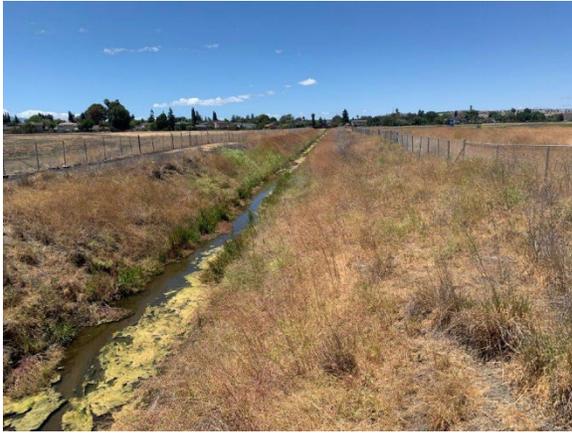
The northernmost approximately 640 feet of the proposed trail alignment passes along the edge of a fallowed agricultural field and consists of the grain, row-crop, hay and pasture, disked/short-term fallowed VHP land cover type (Photo 2). The proposed trail would be constructed in between the edge of the existing field and the top of bank of Canoas Creek. The vegetation in this portion of the alignment is dominated by a dense cover of non-native annual grasses, such as bromes (*Bromus* spp.) and invasive forbs such as black mustard (*Brassica nigra*) and Italian thistle (Photo 2).

**Photo 2. The proposed trail alignment at the north end of the site follows the edge of a fallowed field (view to the north).**

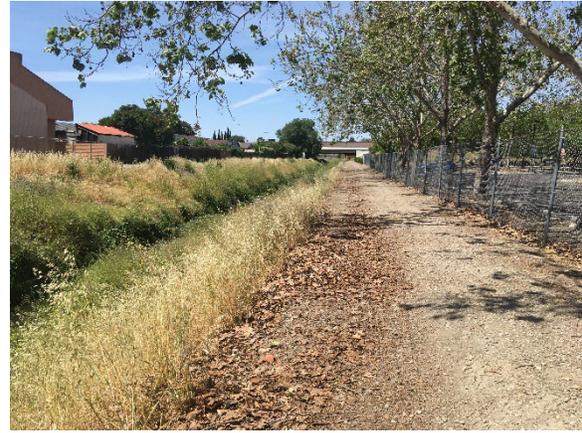
**Photo 3. The Valley Water access road and Canoas Creek channel adjacent to the project site (looking downstream).**

The Canoas Creek corridor adjacent to the project site (i.e., outside the project's impact footprint) is an engineered, trapezoidal stormwater and flood-control channel owned and operated by Valley Water (Photos 3–5). Water was present in the channel during the August 2019 and June 2021 field surveys, indicating that flow in the channel is perennial. The channel alignment is straight along the length of the project site. The bed of the channel is approximately 4 feet wide and lacked any continuous wetland vegetation within the channel bed at the time of the August 2019 and June 2021 surveys. Due to the straightened nature of channel adjacent to the project site, flows in this stretch following winter storm events are expected to be high-velocity and scouring, prohibiting the establishment of wetland vegetation. In addition, Valley Water maintains the channel by periodically removing accumulated sediment and vegetation to encourage the stormwater conveyance function of the channel when necessary. Vegetation cover on the banks of the channel is herbaceous, with the dominant species being non-native grasses and forbs such as wild oats (*Avena* spp.), Harding grass (*Phalaris aquatica*), and Italian thistle (*Carduus pycnocephala*). This vegetation is periodically mown by Valley Water along most of the alignment. An existing gravel road that currently serves as a Valley Water maintenance access road extends northward from Blossom Hill Road along approximately 1,390 feet of the project site on the eastern side of Canoas Creek (Photos 3–5).

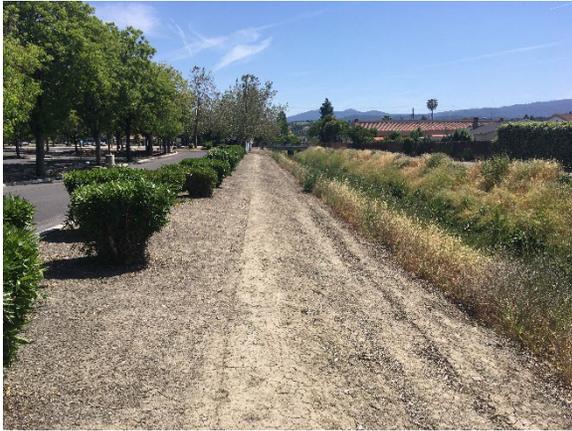
**Photo 4. The Valley Water access road and Canoas Creek channel adjacent to the project site (looking upstream).**

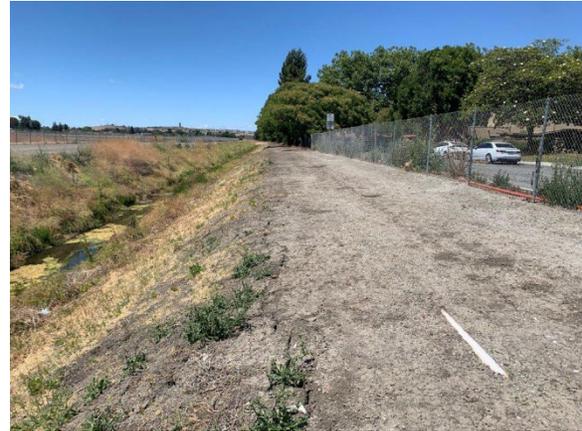
**Photo 5. The Valley Water access road and Canoas Creek channel to the north of State Route 85 (view to the north).**

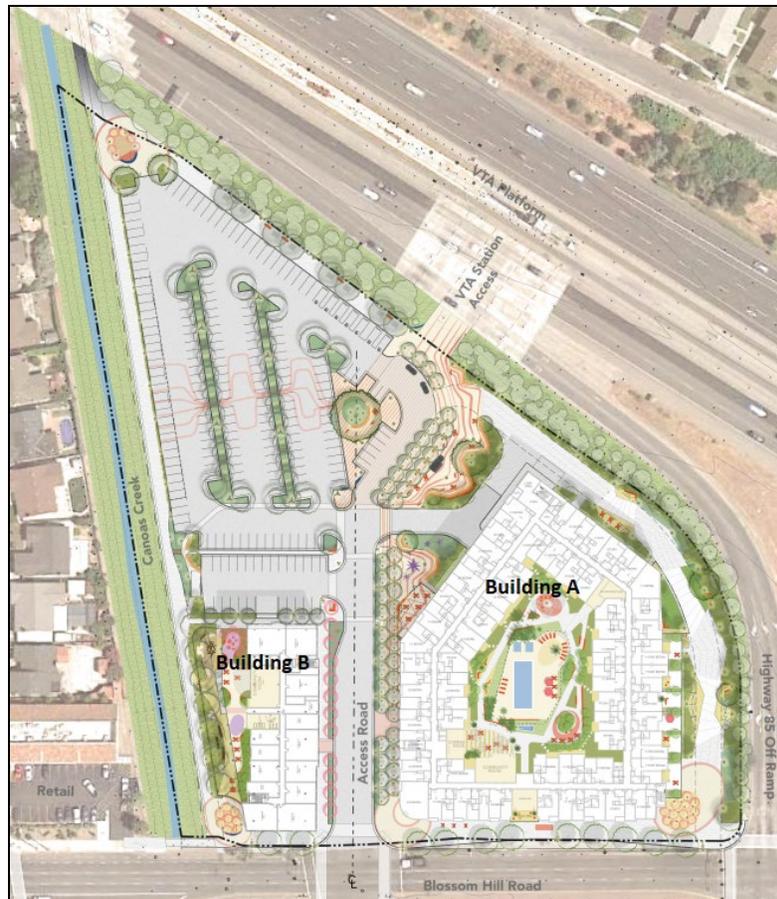
- Under the project, trees and other landscaping will be present immediately adjacent to the glass façades (e.g., along Canoas Creek and on the building's green roofs) (Figure 4). Such vegetation is expected to attract birds. Once birds are using that vegetation, they may not perceive the adjacent glass as a solid structure. The vegetation would reflect in the glass of the building's façades, potentially causing birds to attempt to fly in to the reflected "vegetation" and strike the glass. As a result, some birds that are attracted to the trees and other landscaping that is adjacent to the glass façades are expected to collide with the glass.

the west façade of Building B faces Canoas Creek, which is expected to support higher numbers of birds compared to other areas of the site. Because vegetation is planted immediately adjacent to the building's west facade, birds moving along the creek may be attracted to this vegetation, where they would be more likely to collide with glazing on the west façade. In addition, Building A includes a vegetated courtyard on the Level 3 podium, which is surrounded on all sides by facades (Figure 4). Birds may be attracted to the vegetation within the courtyard, and potentially collide with glazing on the surrounding facades when attempting to exit the courtyard.

**Figure 4. Project site plan showing the extent of proposed landscape vegetation relative to building facades.**
