Preliminary Geological Hazards Study

City of San Diego Task 15GT15 - Water and Storm Drain
Group 968
San Diego, California

Project No.: 200055.2

Subject: Preliminary Geologic Hazards Study (9 sites)

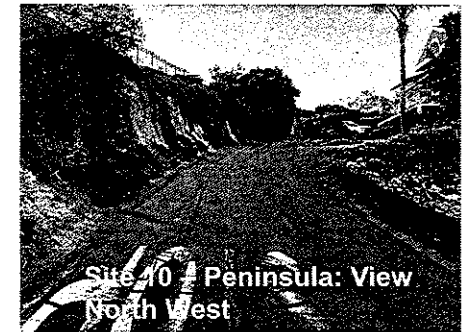
Site 10 - Peninsula: View North West

Based on our field reconnaissance at Site 10, we note that the proposed water main replacement would be located within the improved portions of Kellogg Drive. A small section of the improvements includes a new water service at the southern end of Site 10. The design plans note this small section is not part of the water main; rather, it is a 2-inch-diameter copper water service to the adjacent private residence. This small section is not included in this analysis. Existing topography along the alignment for Site 10 ranged between 300 and 355 feet. Excavations for the water main replacement are anticipated to be within existing pipeline backfill and/or Very Old Paralic Deposits. The excavations for Site 10 may or may not be deep enough in the southeastern area to encounter the Cabrillo Formation. Seepage or shallow groundwater was not observed during our site visit.
