11973 San Vicente Boulevard

ASCE 41-13 Seismic Assessment

Los Angeles, California

June 6, 2022

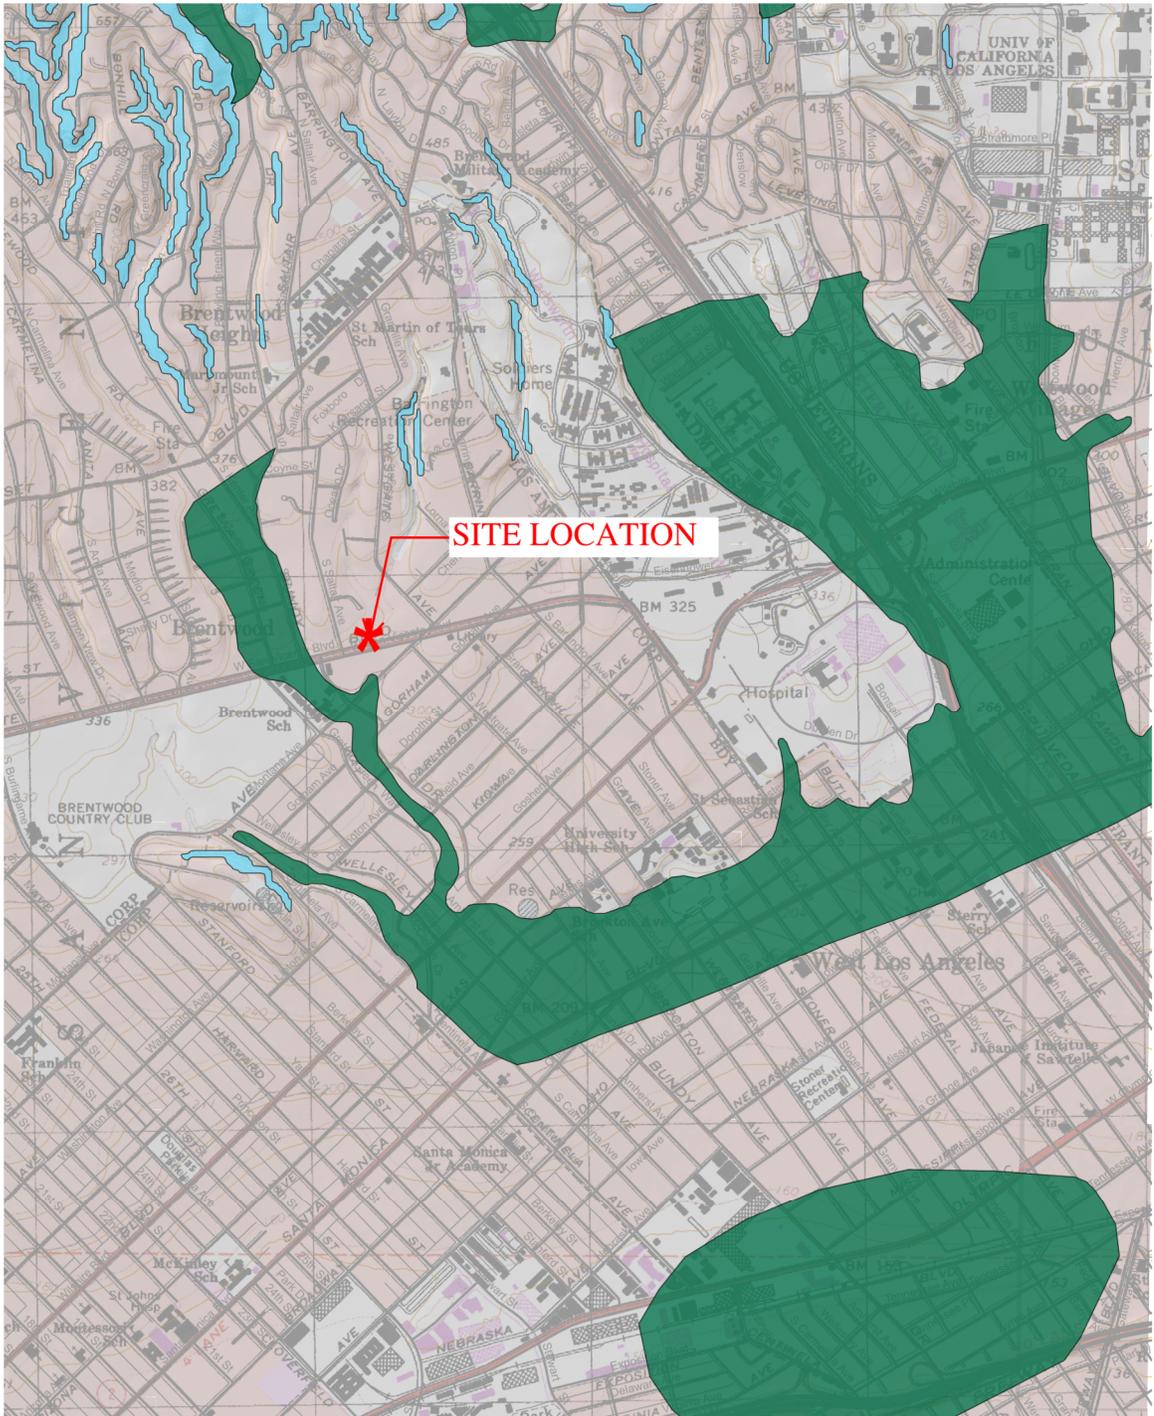
Figure 4.2: State of California Regulatory Map for Seismic Hazards (Beverly Hills Quadrangle)

The state of California has issued a set of regulatory maps detailing regions of potential liquefaction, landside and ground fault rupture. This site is in the Beverly Hills Quadrangle, as shown in Figure 4.2. Areas shown in white have not been identified as locations of potential liquefaction, landside or ground

fault rupture. The map indicates that the site, shown in Figure 4.2, has not been identified as a potential location for any of these seismic or geotechnical hazards.
