December 2, 2021

Project No. 2101-0252

Subject: Report of Findings – Asbestos and Lead-Based Paint Survey,
PRC 421 Decommissioning Project, Pier Access Road,
Goleta, Santa Barbara County, California

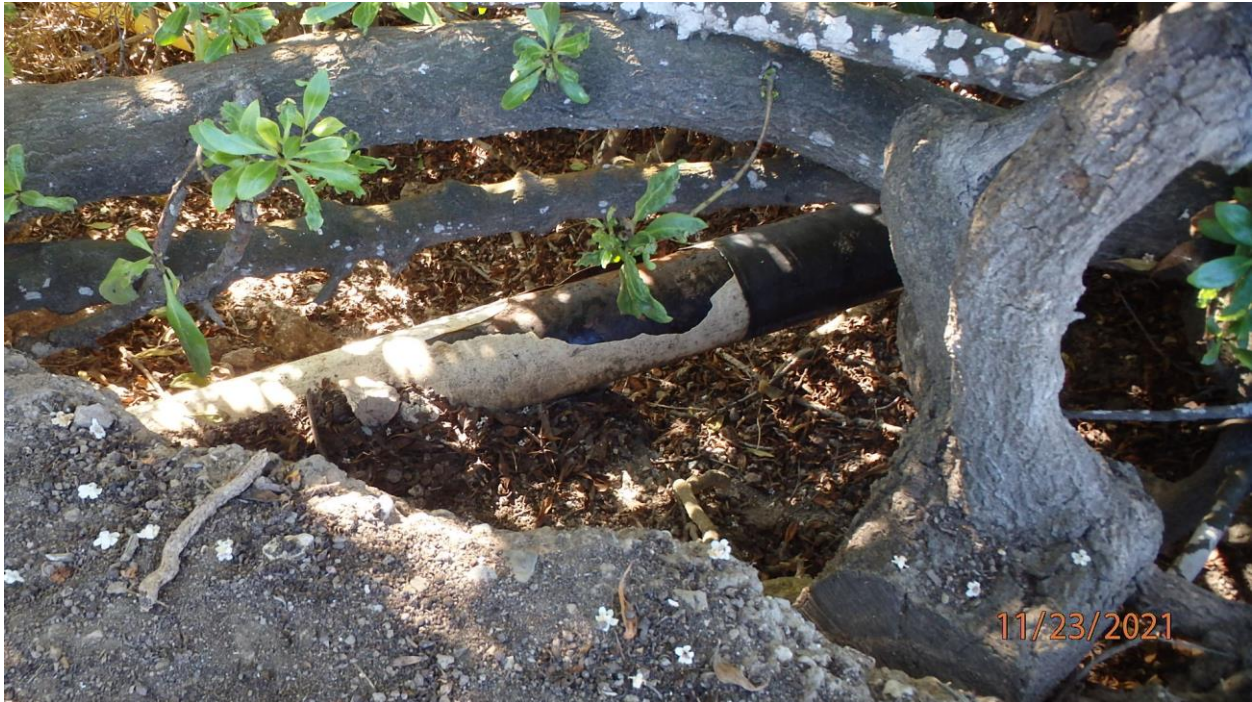
Asbestos Survey
Partially Exposed 6-Inch Diameter Steel Pipeline along Pier Access Road
PRC 421 Decommissioning Project, Goleta,
Santa Barbara County, California

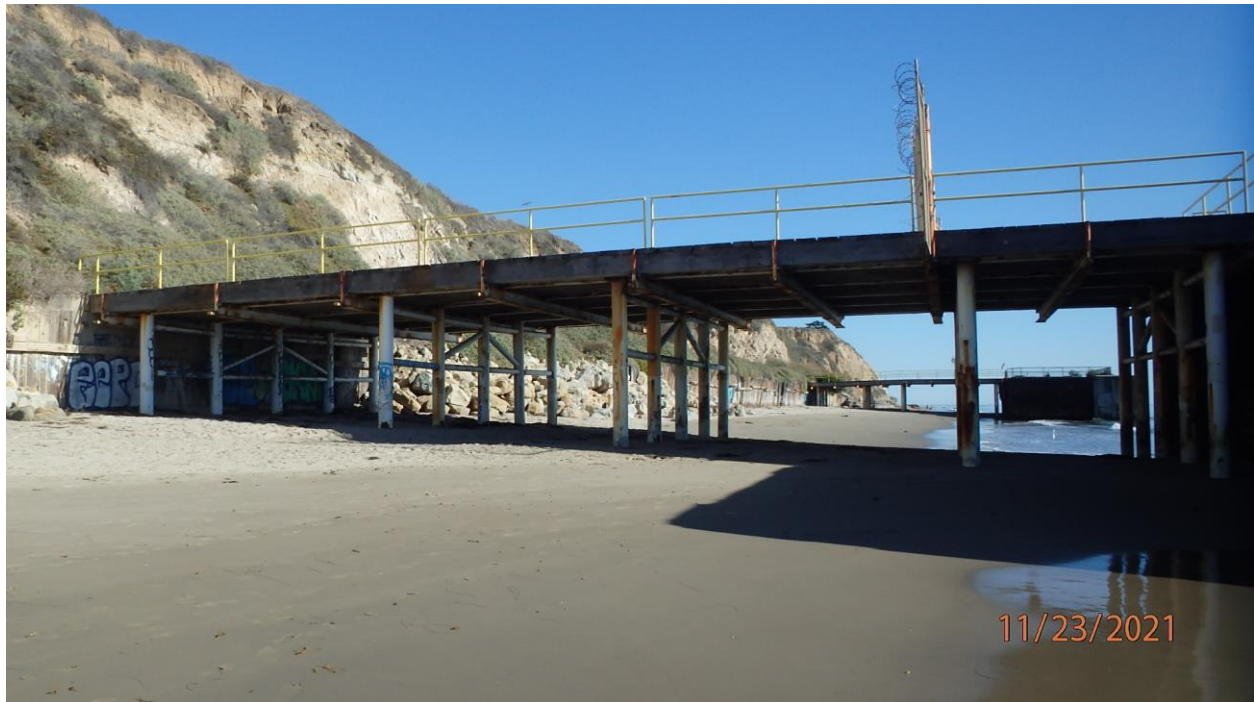
Lead-Based Paint Survey
Piers 421-1 and 421-2
PRC 421 Decommissioning Project, Goleta,
Santa Barbara County, California
