## Updated Arborist Report

**550 E. Brokaw Rd.,  
San Jose, CA**

December 15, 2021

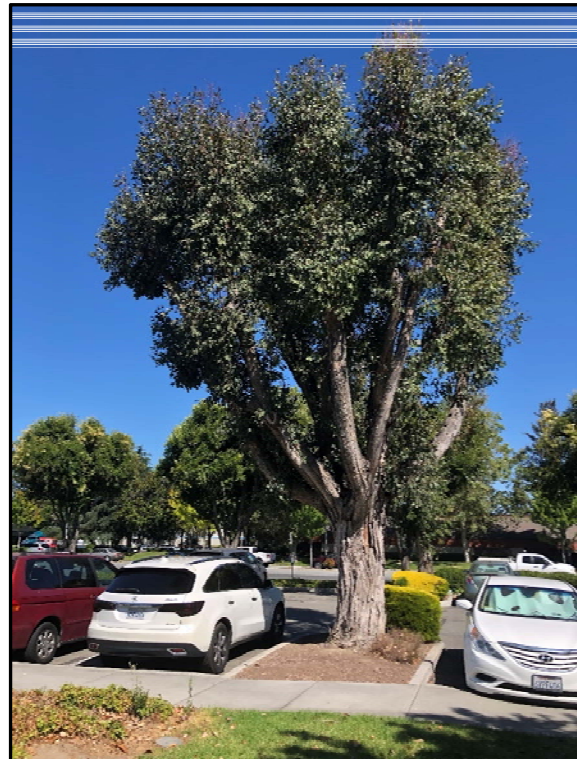
Thirteen (13) evergreen pears were growing on either side of the north entrance on the building. The pears were semi-mature to mature with trunk diameters ranging from 8 to 19 inches. Eleven (11) trees were in fair condition and two were in poor condition. Pear trees had either multiple or dominant branching between five and eight feet.
