Phase II Environmental Site Assessment

PHASE II ENVIRONMENTAL SITE ASSESSMENT MERIDIAN – WEST CAMPUS UPPER PLATEAU

Project No. 13226.003

January 17, 2022

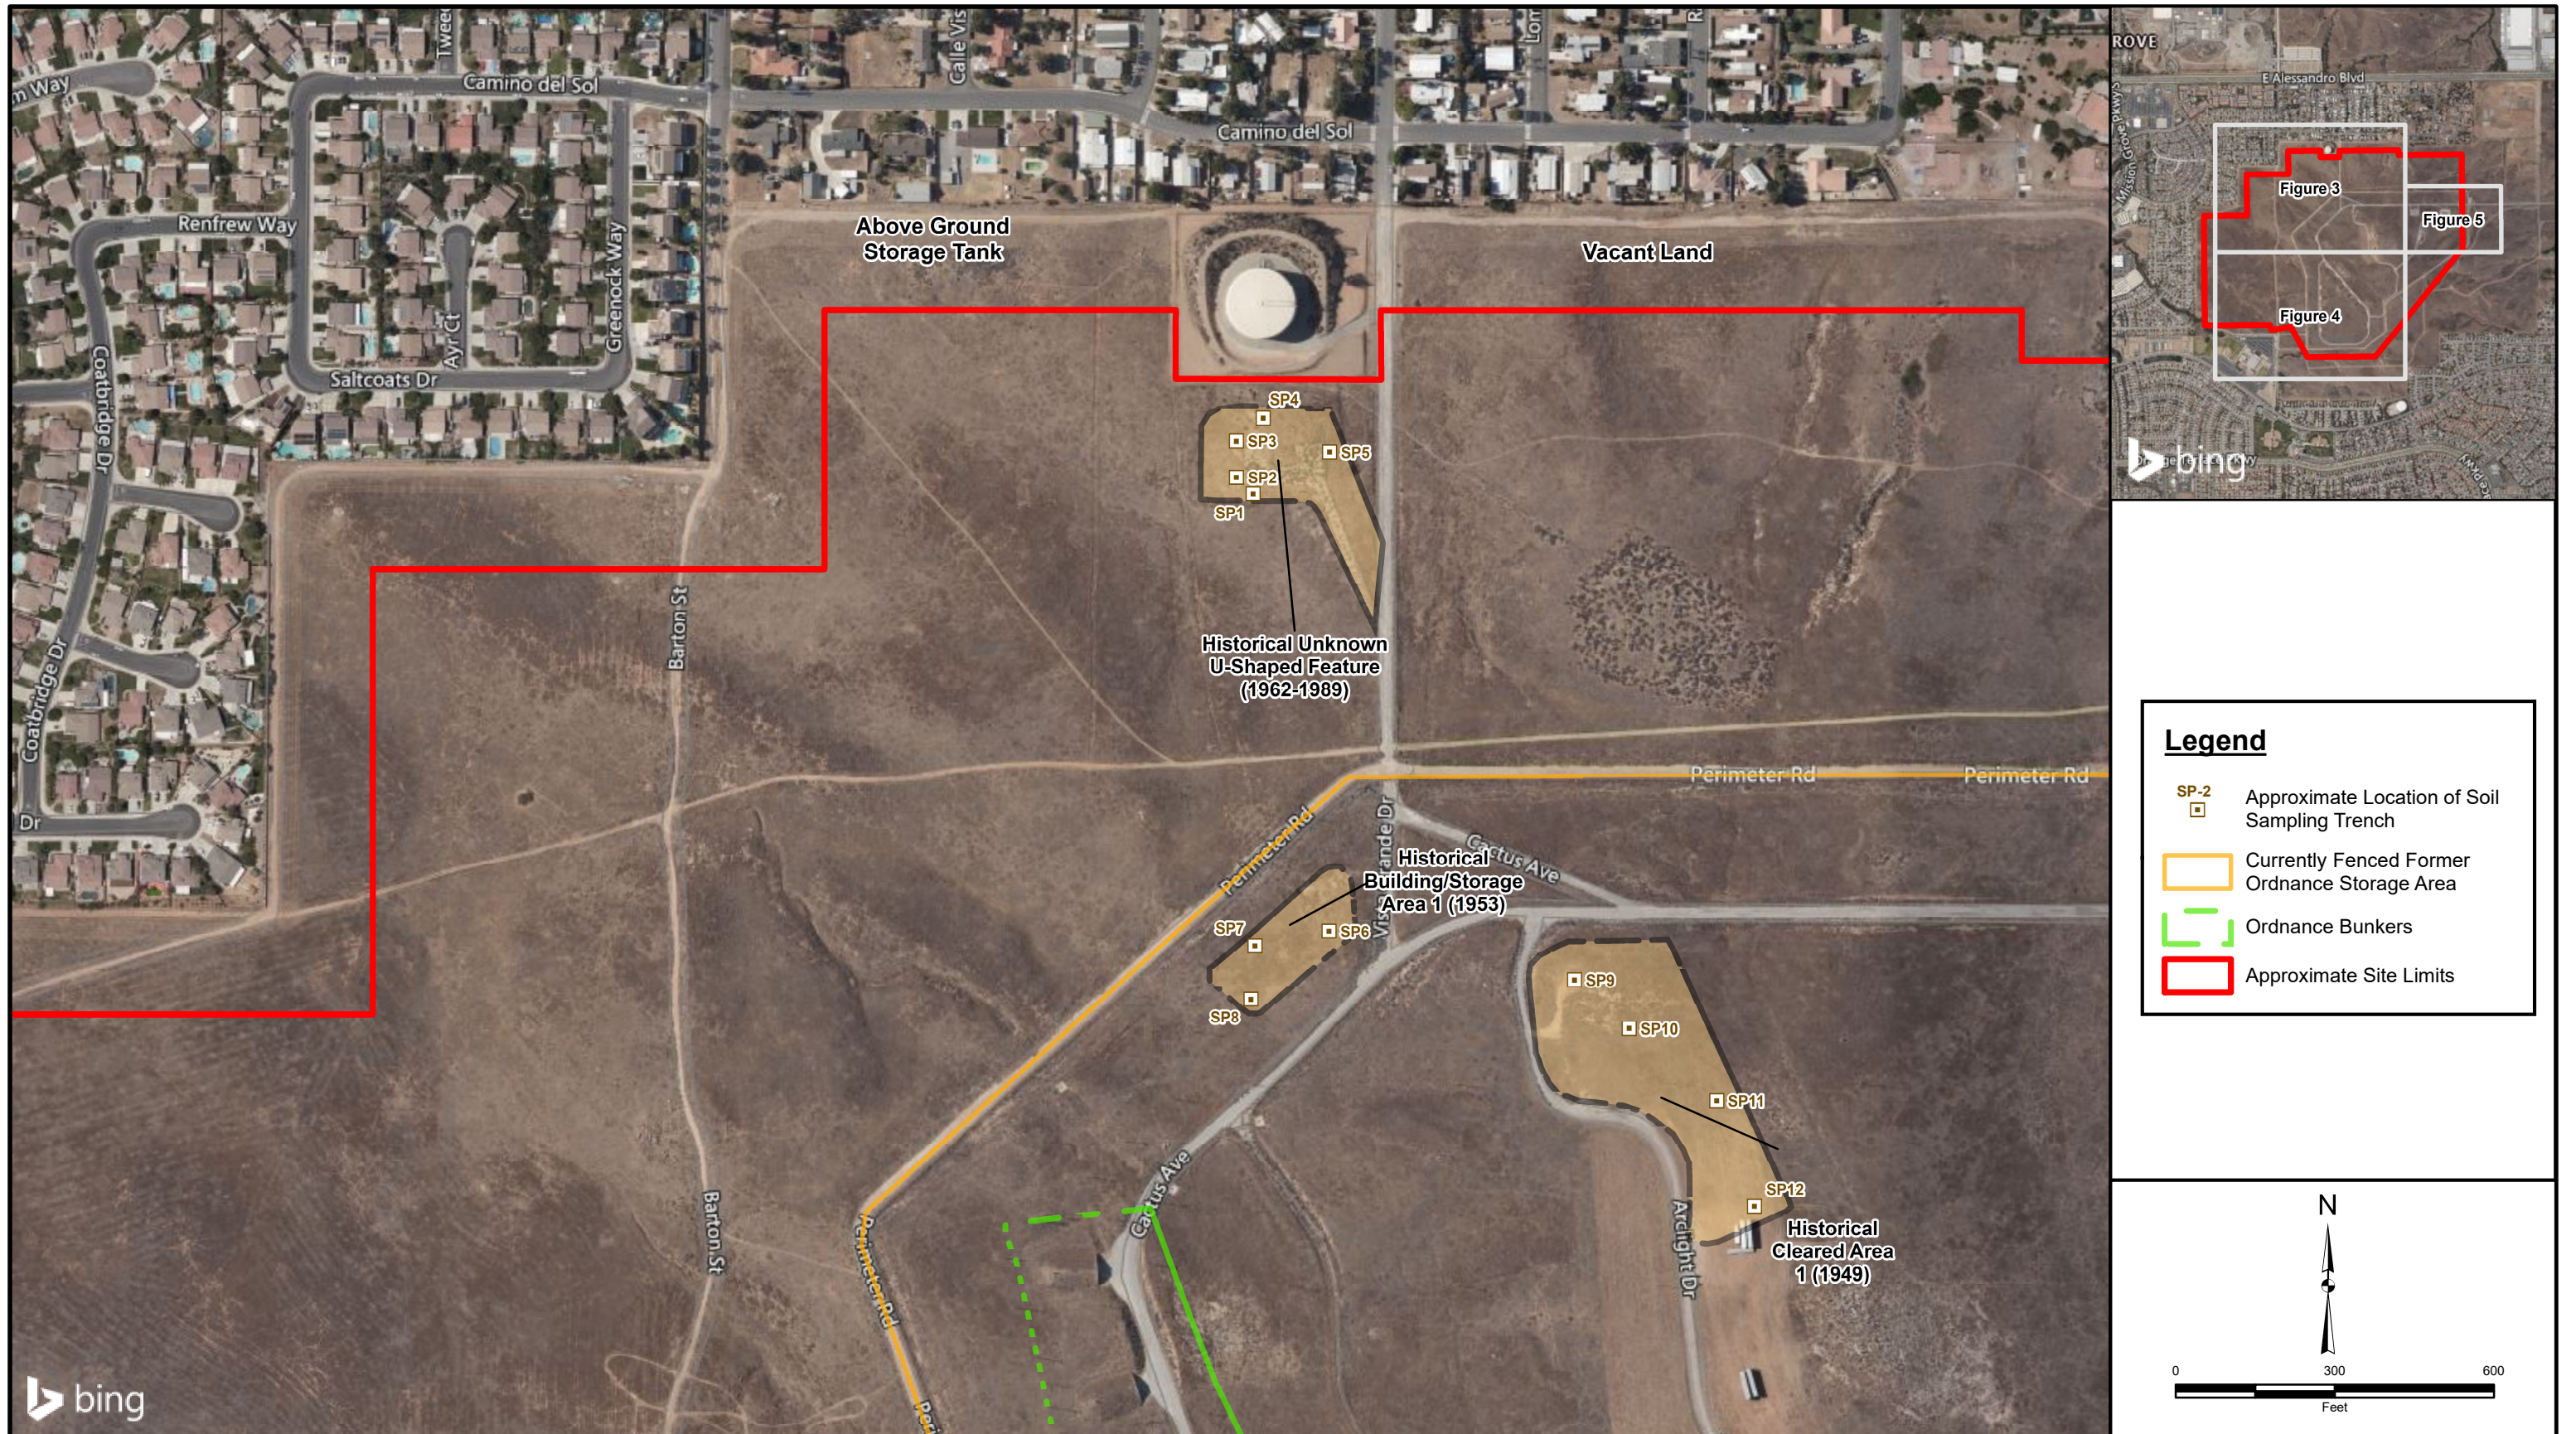
Figure 3

The locations of the sampling trenches, designated **SP1-SP5**, are shown on attached **Figure 3**. The trenches were generally completed around the U-shaped feature, with some emphasis on the southern and western sides, which appeared in historical aerial photographs to be have been actively used. Attached **Photos nos. 3-7 (Appendix B)** show this general area and associated sampling activities.

The locations of the sampling trenches, designated **SP6-SP8**, are shown on attached **Figure 3**. The trenches were randomly located over this historical clearing/building area.

The locations of the sampling trenches, designated **SP9-SP12**, are shown on attached **Figure 3**. The trenches were randomly located over this historical cleared area.

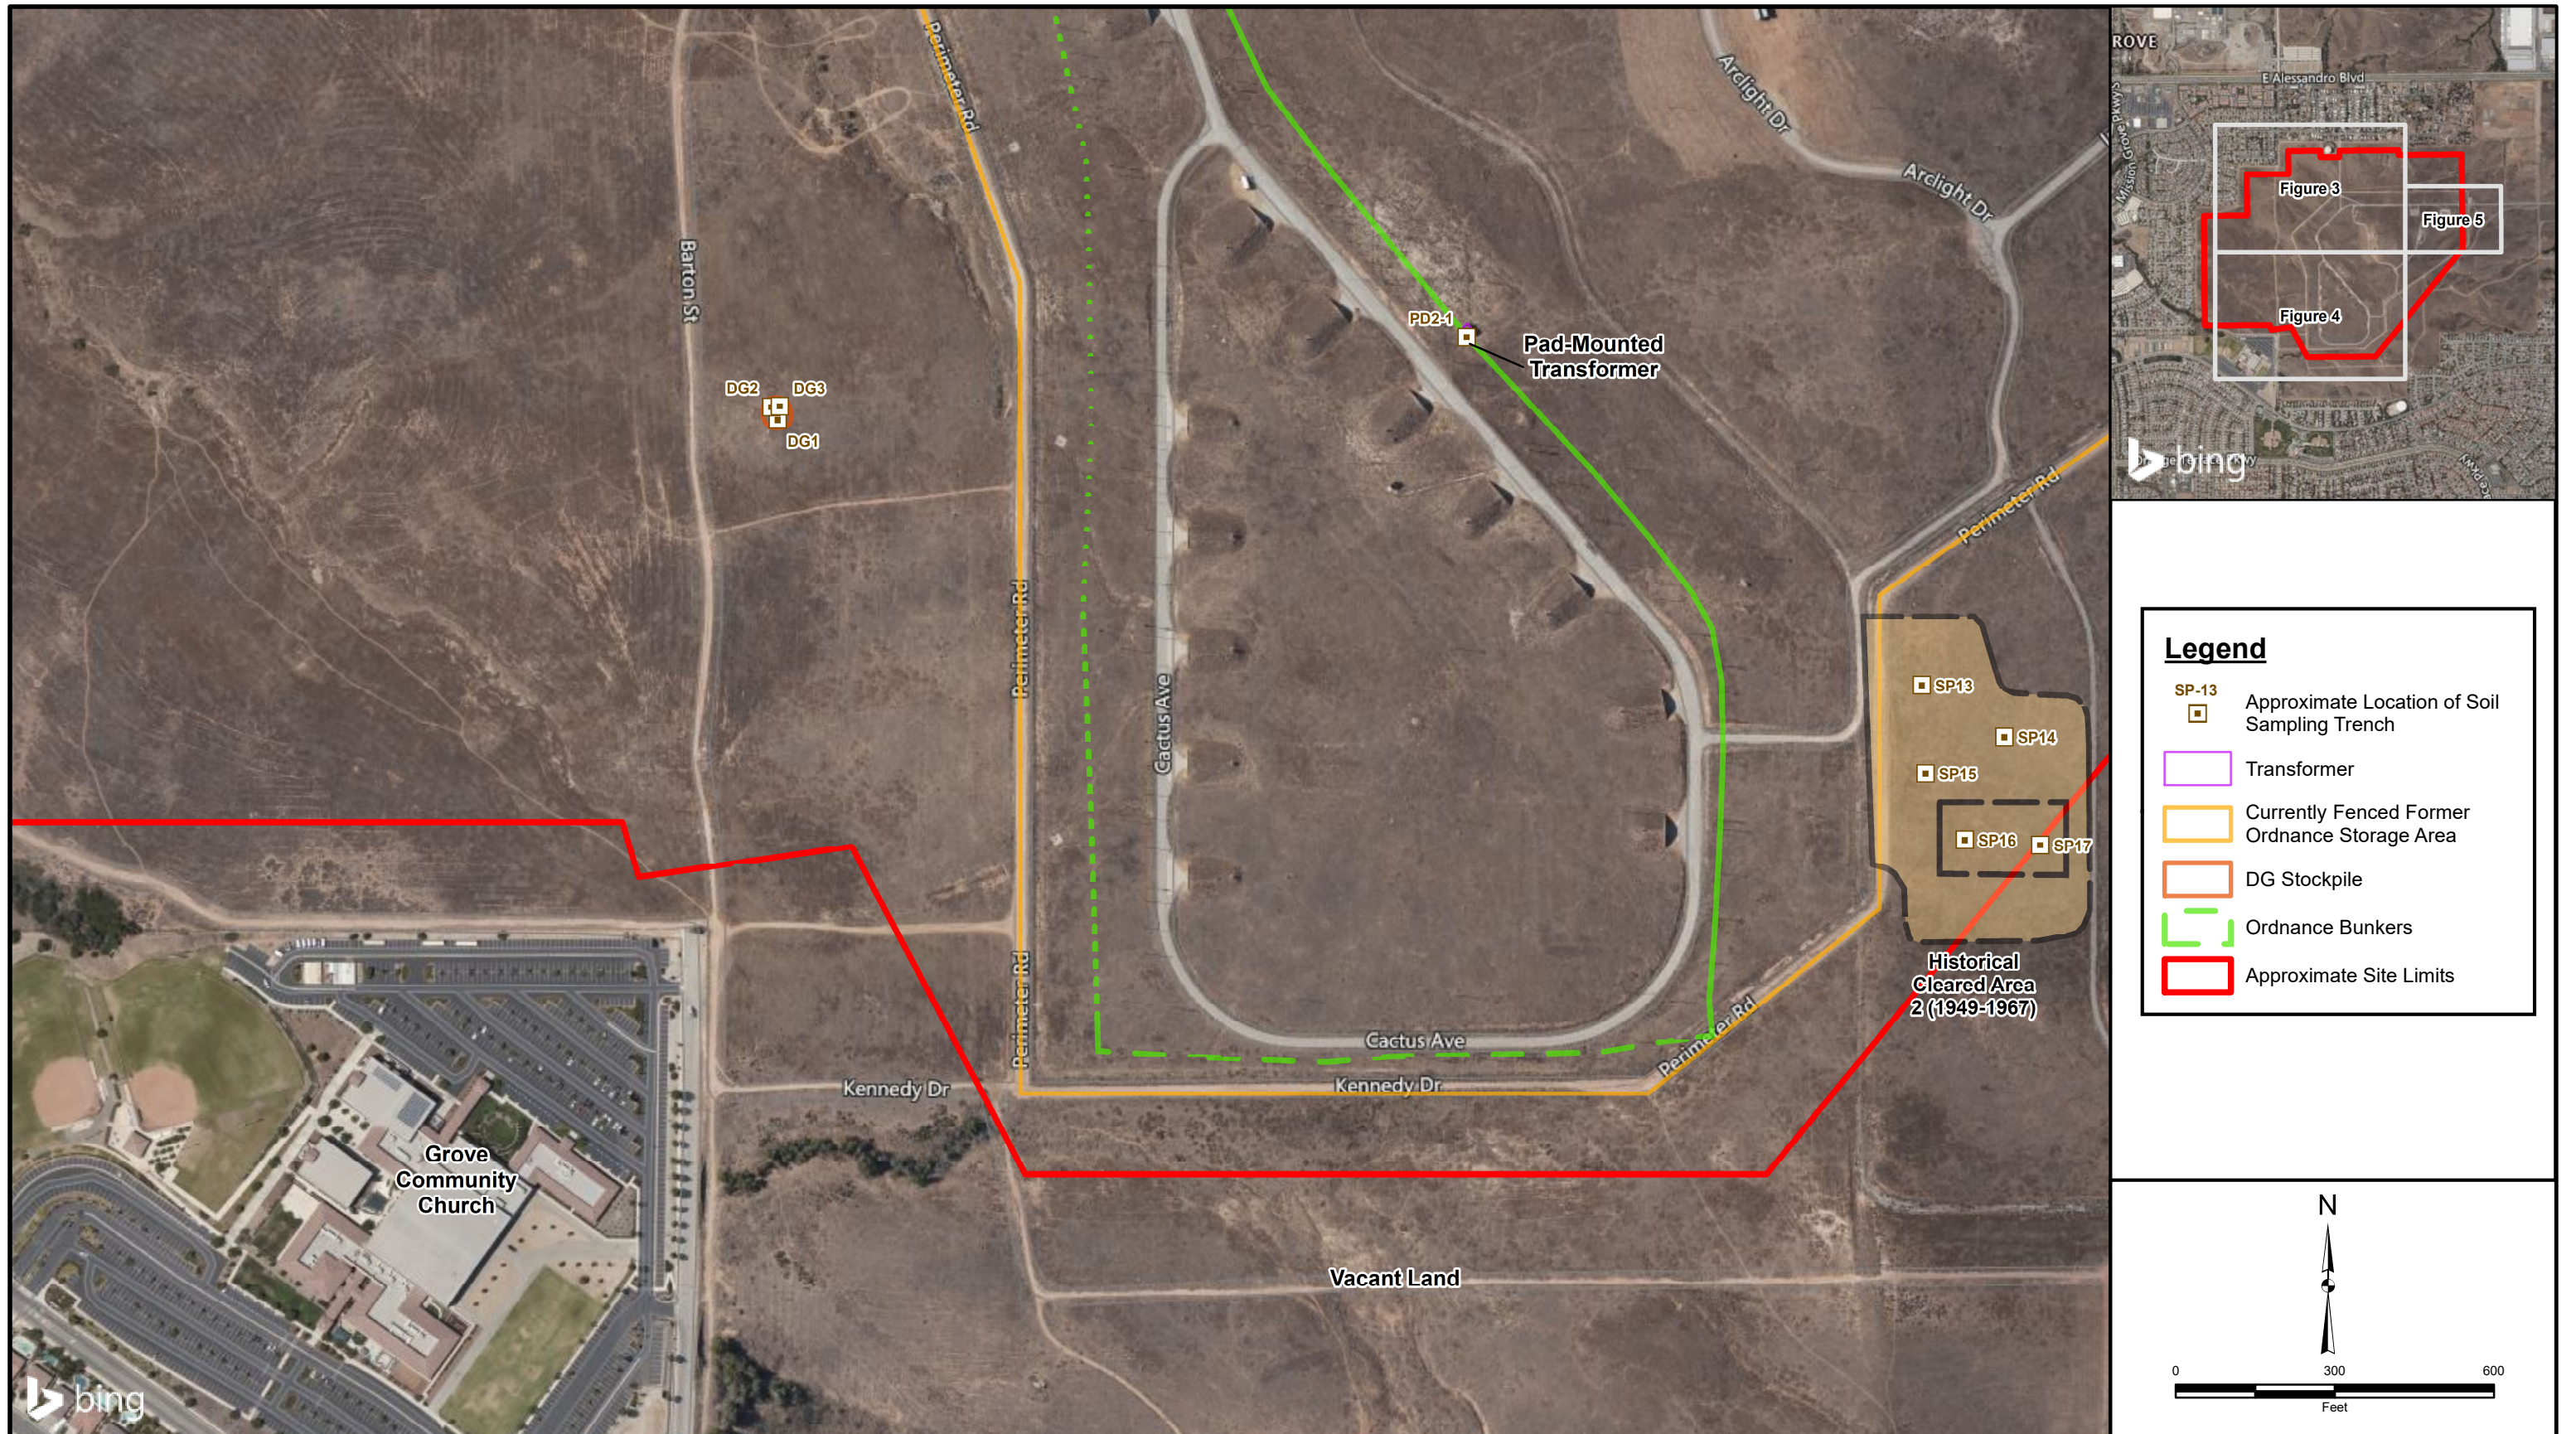
Figure 4

The locations of the sampling trenches, designated **SP13-SP17**, are shown on attached **Figure 4**. The trenches were randomly located over this historical clearing/building area.

Three grab soil samples were collected from a stockpile of decomposed granite, of unknown origin, which had previously been noted during the Phase I ESA. The locations of the samples, designated **DG1-DG3**, are shown on attached **Figure 4**.

A sampling trench was also completed near an electrical equipment enclosure at the northeast edge of the ordnance bunkers area. The location of trench **PD2-1** is shown on attached **Figure 4**. **Photo 17 (Appendix B)** shows the completion of this sampling trench.
