# T.O. Ranch Mixed-Use and Multi-Family Residential Redevelopment Project

## Oak and Landmark Tree Report

**March 2022**

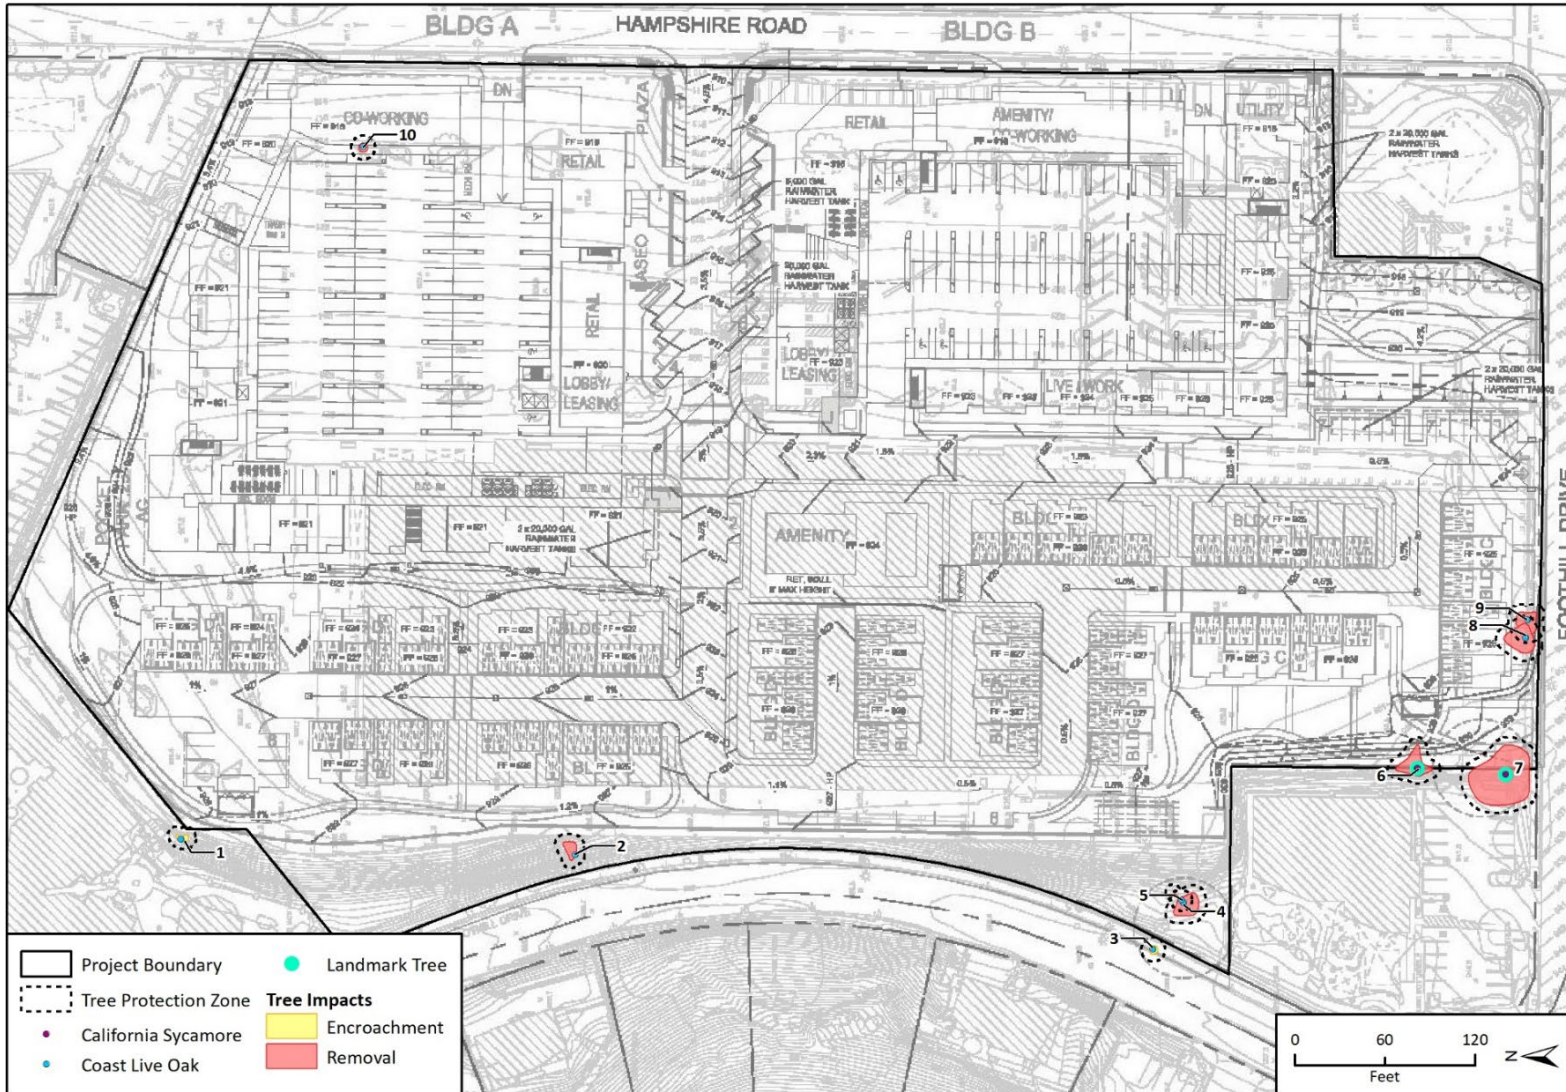
Figure 1 Tree Location Map

Ten protected trees were surveyed as shown in Figure 1. Of the 10 protected trees, eight are coast live oaks and two are California sycamores. One tree has a health rating of B (Above Average), Four trees have a health rating of C (Average/Fair) and five trees have a rating of D (Below Average/Poor) as summarized in Table 2 below. No protected trees surveyed had a health rating of E (Dead). No designated historic trees were present on the project site, according to the City’s General Plan Conservation Element (City of Thousand Oaks 2013); however, two landmark sycamores were present on and immediately adjacent to the project site.
