**Appendix C-1**  
**Recommendations Memo, Chattel Historic Preservation Consultants**

## MEMORANDUM

**RE** San Marino Center (San Marino Women's Club)  
1800 Huntington Drive, San Marino, California  
Recommendations Memorandum

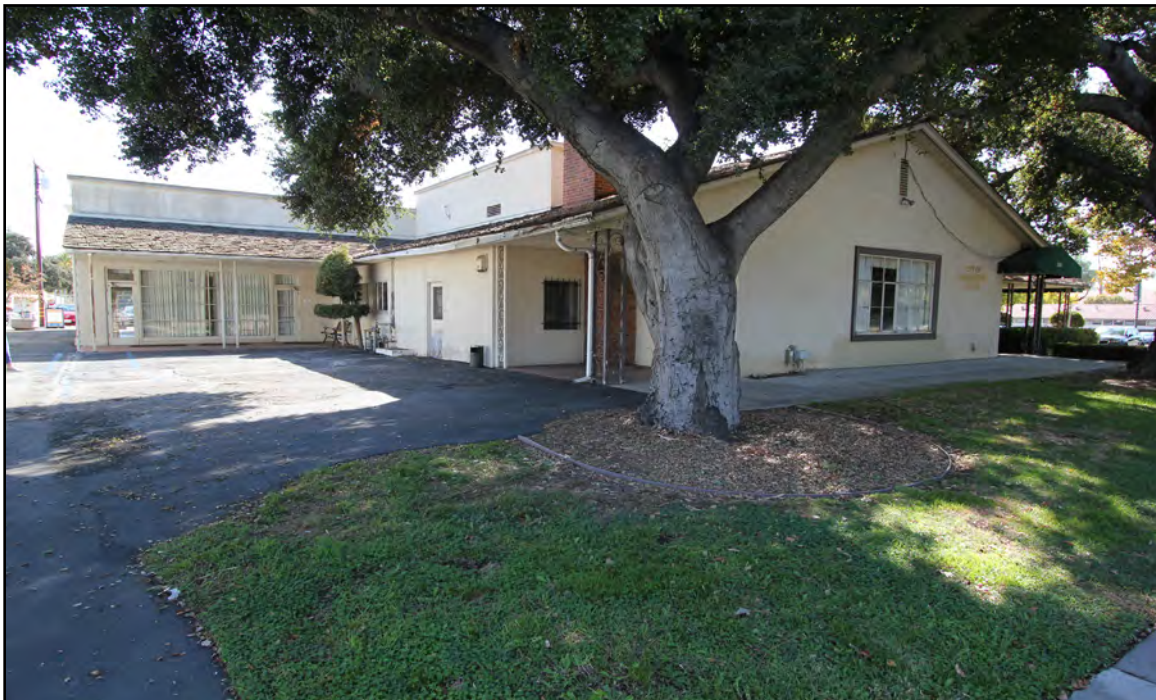
**Image 6:** San Marino Center, east elevation (left) and north elevation (right), view southwest (Chattel, 2021)

- Remove two porch additions (east storage addition and west office addition). Ensure that brick chimney is not damaged in removal of east storage addition. Chemically remove overpaint on brick.

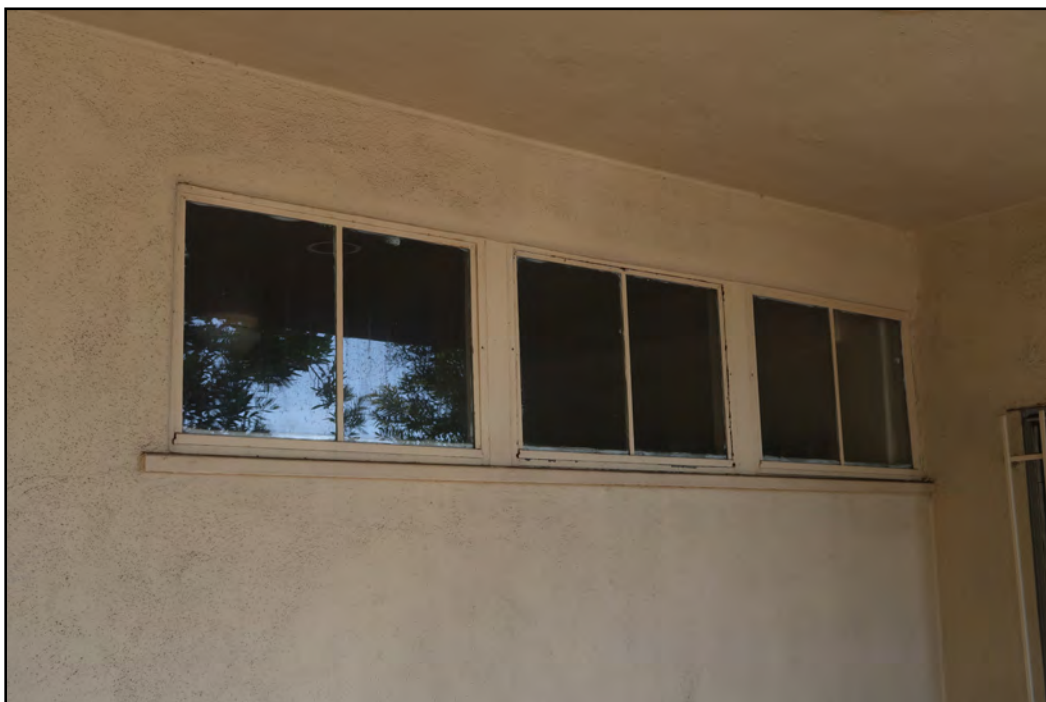
**Image 23:** Detail of steel sash windows on west elevation, view southeast (Chattel, 2021)

- Retain and rehabilitate character-defining features to greatest extent feasible.
- Patch, repair and repaint stucco, as necessary. Stucco can be painted to be compatible with the adjacent library.
- Rehabilitate and repair sheet metal window awnings, repaint as necessary.
- Rehabilitate and repair steel sash windows, as necessary.
