FOURTH & CENTRAL PROJECT

Street Tree Report

June 2021

Prepared by:
Environmental Science Associates
80 South Lake Avenue, Suite 570
Pasadena, California 91101
Ryan Gilmore
ISA Certified Arborist WE-9009BM

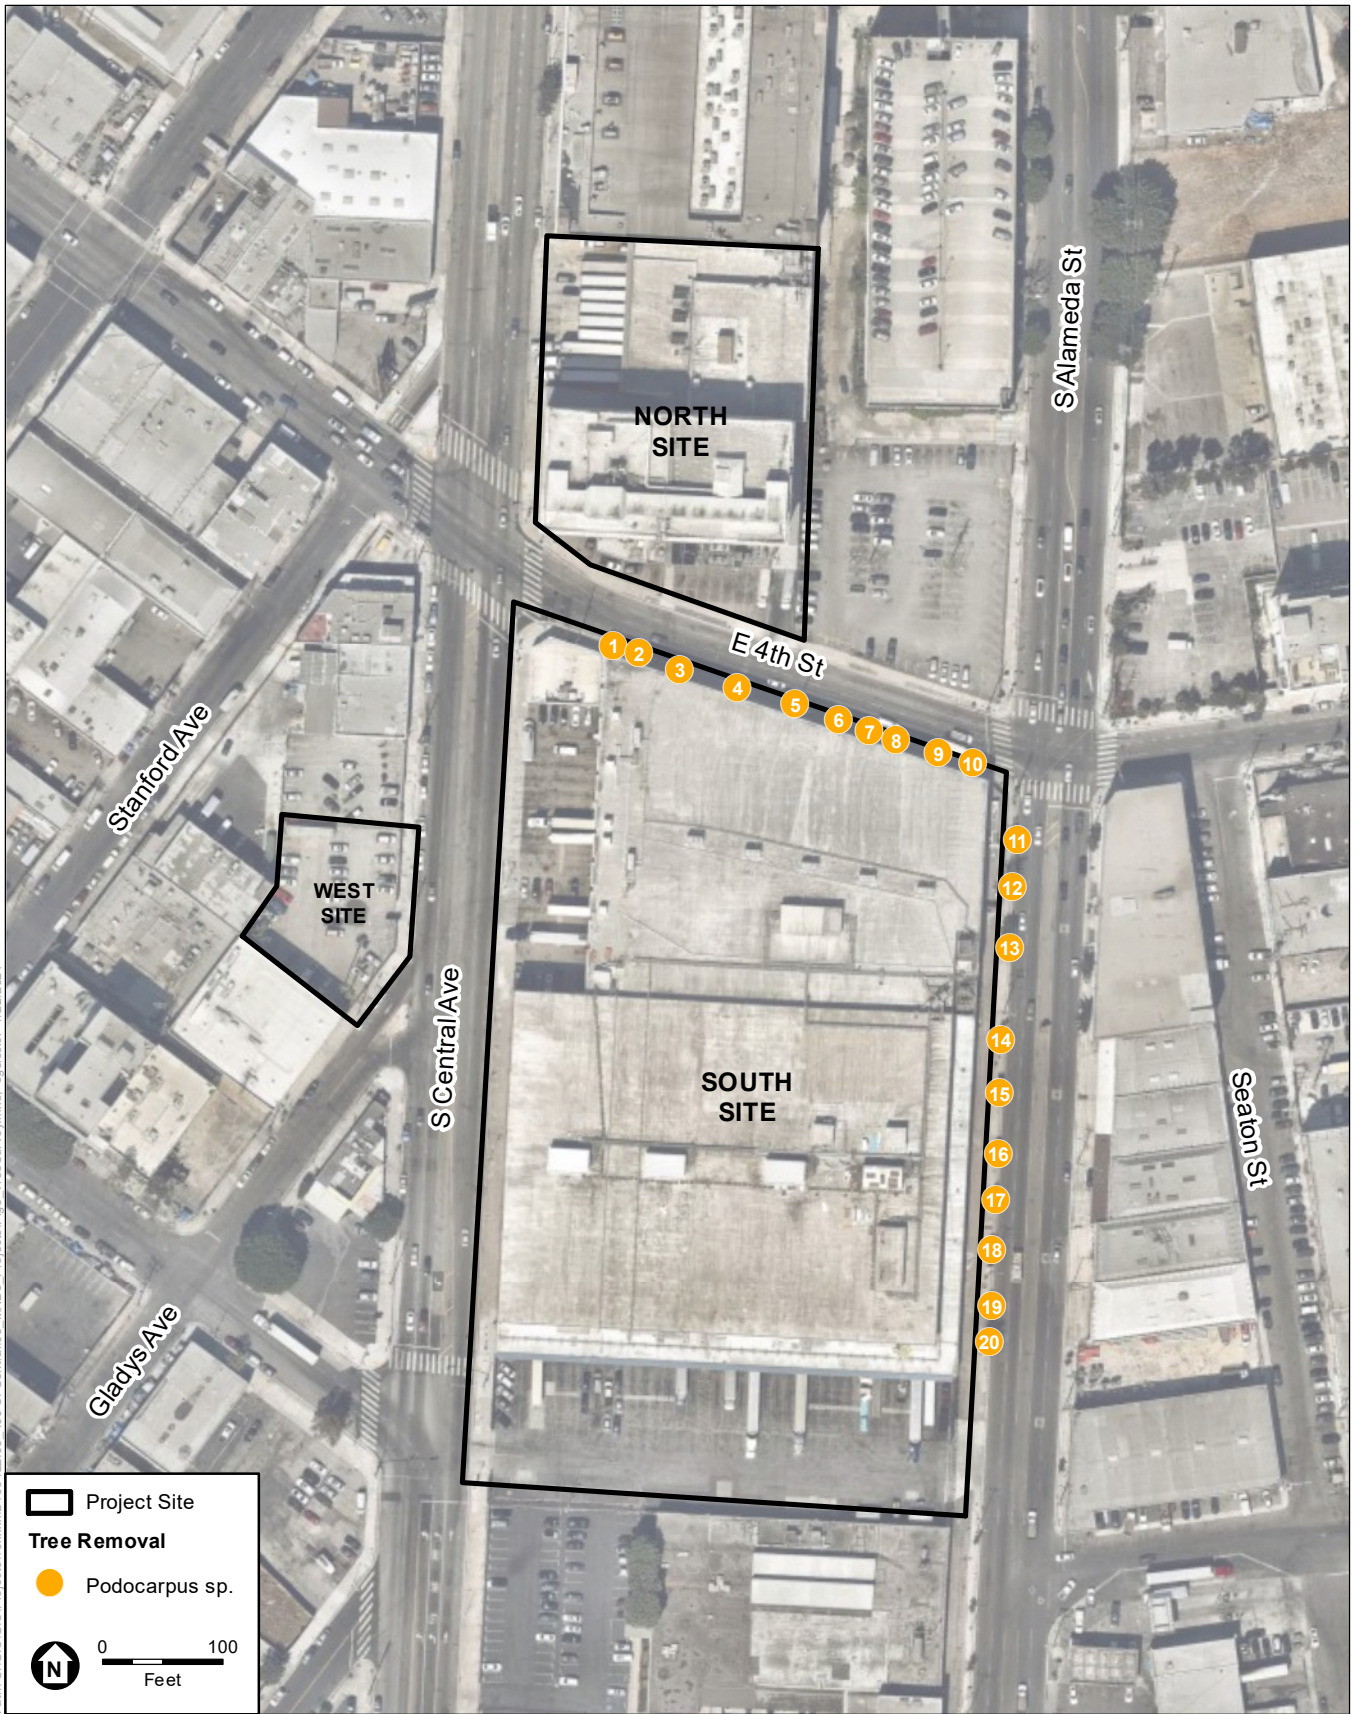
Figure 3
Tree Survey

A total of 20 street trees were observed within the Project Site. The locations of the street trees are provided in **Figure 3 – Tree Survey**. A summary of the street trees on the Project Site is provided in **Appendix A – Street Tree Inventory**. Representative photographs of each tree are provided in **Appendix B – Tree Photographs**. All of the street trees observed are fern pines (*Podocarpus* sp.). Tree number #1 through #10 are recent tree plantings and are quite young. Tree numbers #11 through #20 are of moderate to mature age. Tree numbers #15 through #17 have homeless encampments immediately adjacent to the tree locations.

All 20 observed street trees will require removal to accommodate Project implementation. It is anticipated that the entirety of the project site will need to be graded to accommodate the construction of buildings and associated infrastructure.

A total of 20 street trees will require removal to accommodate project implementation. Currently, the UFD requires a 2 to 1 street tree replacement ratio. In total, 40 replacement trees will be required to compensate for the 20 street trees proposed for removal.
