**RINCON PHASE 2 DECOMMISSIONING PROJECT –
EVALUATION OF EFFECTS AND EFFECTIVENESS OF THREE DIFFERENT TREATMENTS OF STATE
COASTAL CONSERVANCY PARCEL AT PUNTA GORDA,
VENTURA COUNTY COAST**

**GARY GRIGGS
CONSULTING COASTAL GEOLOGIST
321 ALTA AVENUE, SANTA CRUZ, CA. 95060
(831) 332-9318 – GRIGGS@UCSC.EDU**

INTRODUCTION AND SCOPE OF REPORT

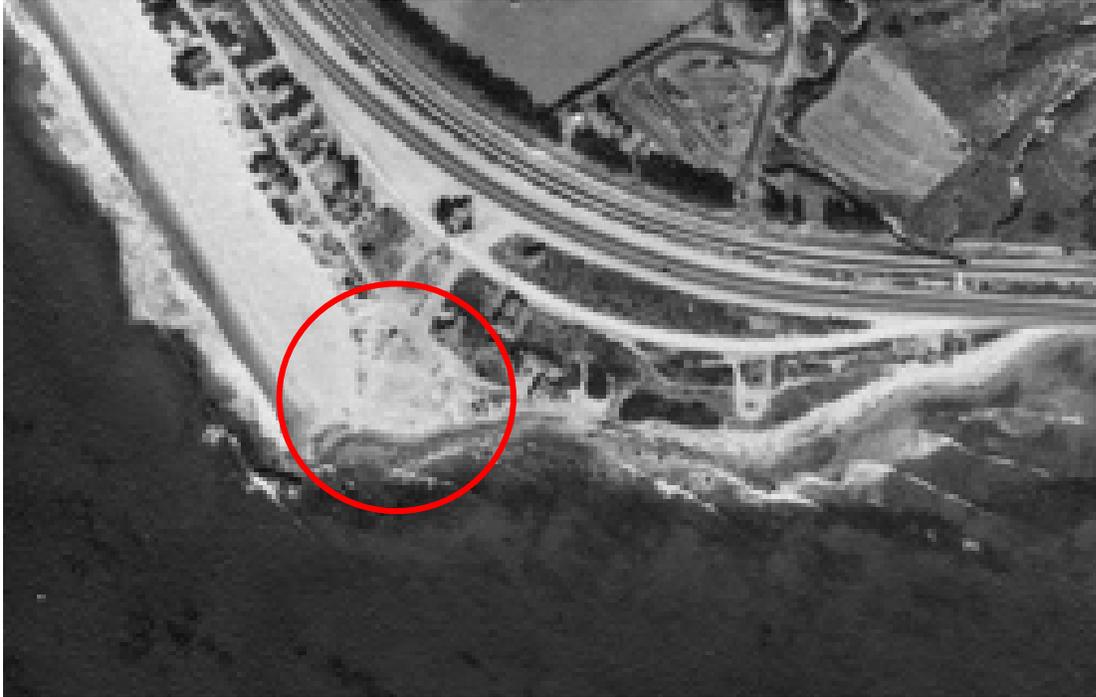
Figure 6. State Coastal Conservancy parcel (contained within red circle) in 1945 showing continued shoreline retreat east of the point.

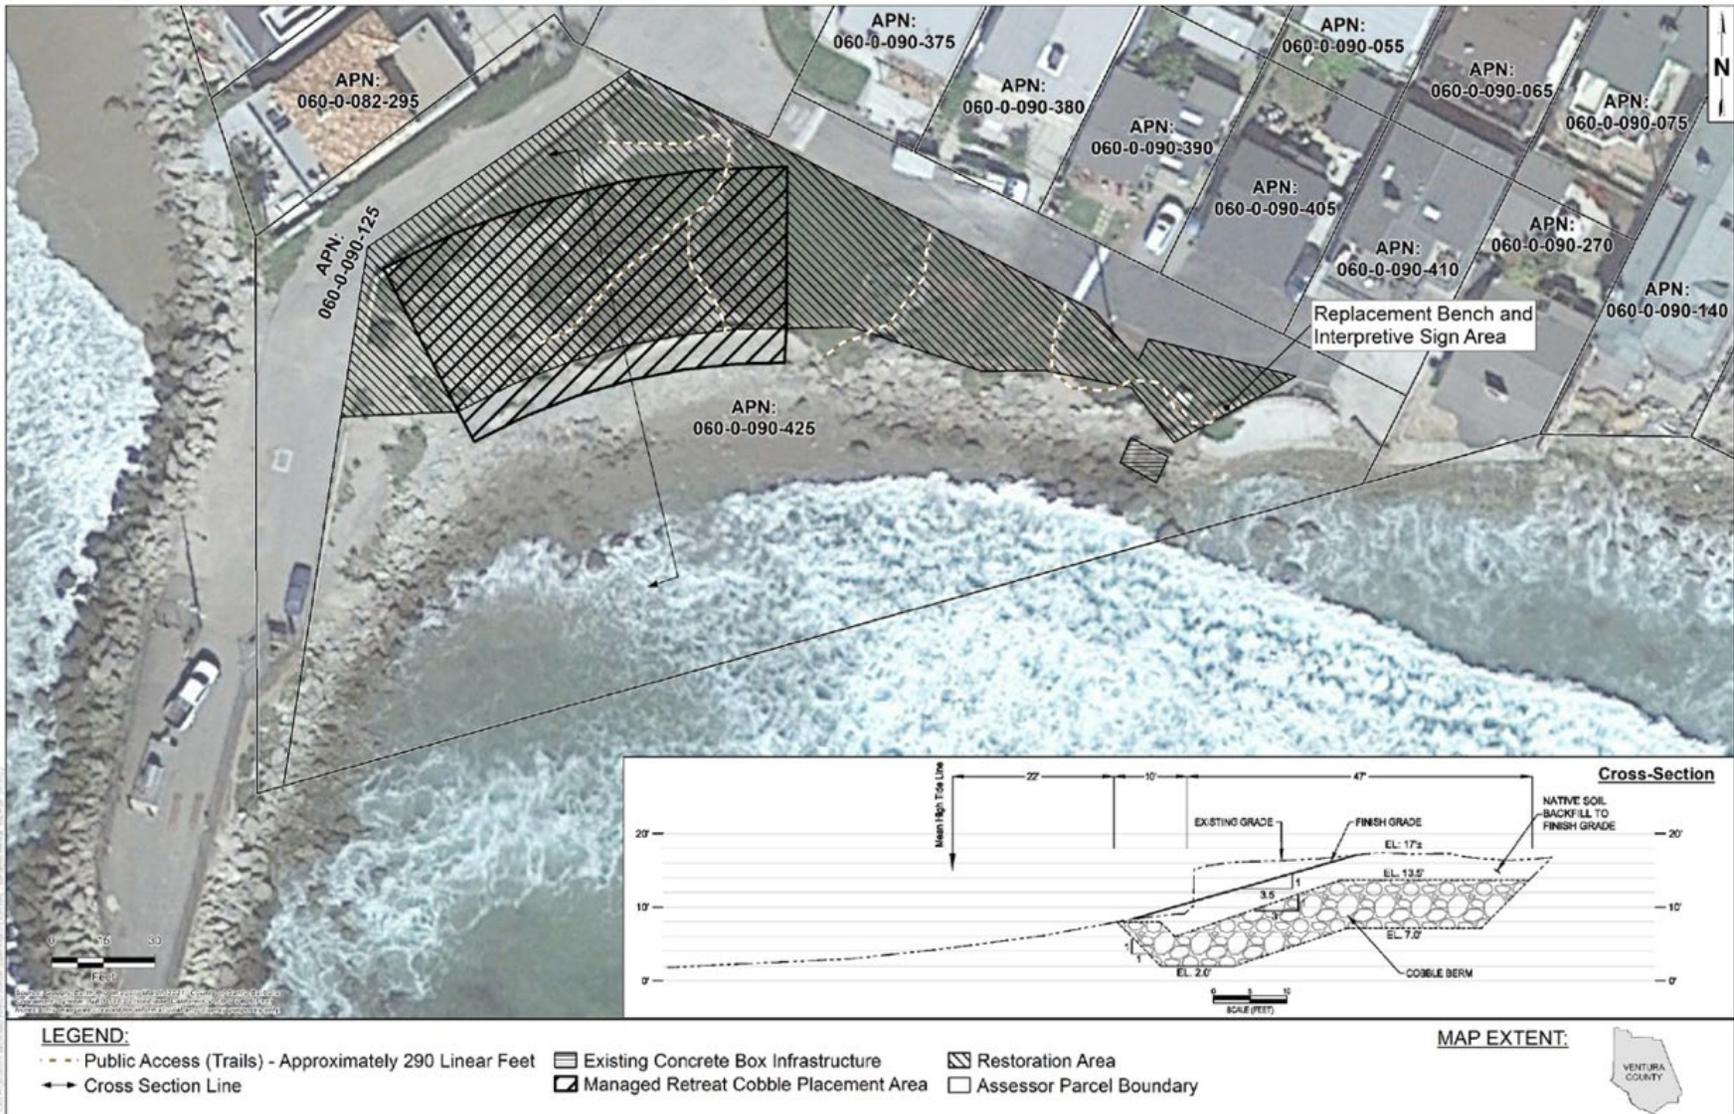
Figure 17. Plan and cross-section view of Alternative 9B (State Lands Commission).

The cobble back berm would transition into a new cobble fill placed further down on the beach that would provide additional stability to the inland cobble fill. The profile of the cobbles was planned to mimic a “natural grade” from the inland vegetated portion of the parcel down to the beach and intertidal area (Figures 17 & 18). It is estimated that about 2,500 cubic yards of cobbles would be required to complete the cobble back berm and the back beach coverage of cobbles over an alongshore distance of “about 50 feet”. This is planned to fill in the existing gap between the revetments on either side (while 50 feet is the distance stated in the State Lands Commission report, the actual gap is closer to 100 feet). The cobbles would be imported to the site using dump trucks and placed with two excavators on the beach. Using dump trucks with a 10 yd³ capacity, would require about 250 truckloads of cobbles.

The cobble back berm proposed as Alternative Plan 9B beneath the upper portion of the site would transition into the new cobble fill placed further down on the beach within the unarmored section of shoreline and would provide additional stability to that cobble fill (see Figure 17). The cobble berm should be relatively stable at this location as evidenced by the cobbles and boulders that have existed on the shoreline for many years. Even if the sand and soil covering was partially removed by an extreme wave event, as evidenced at Surfer's Point, the cobbles should rotate and move around, but overall should remain intact and provide a more stable shoreline.

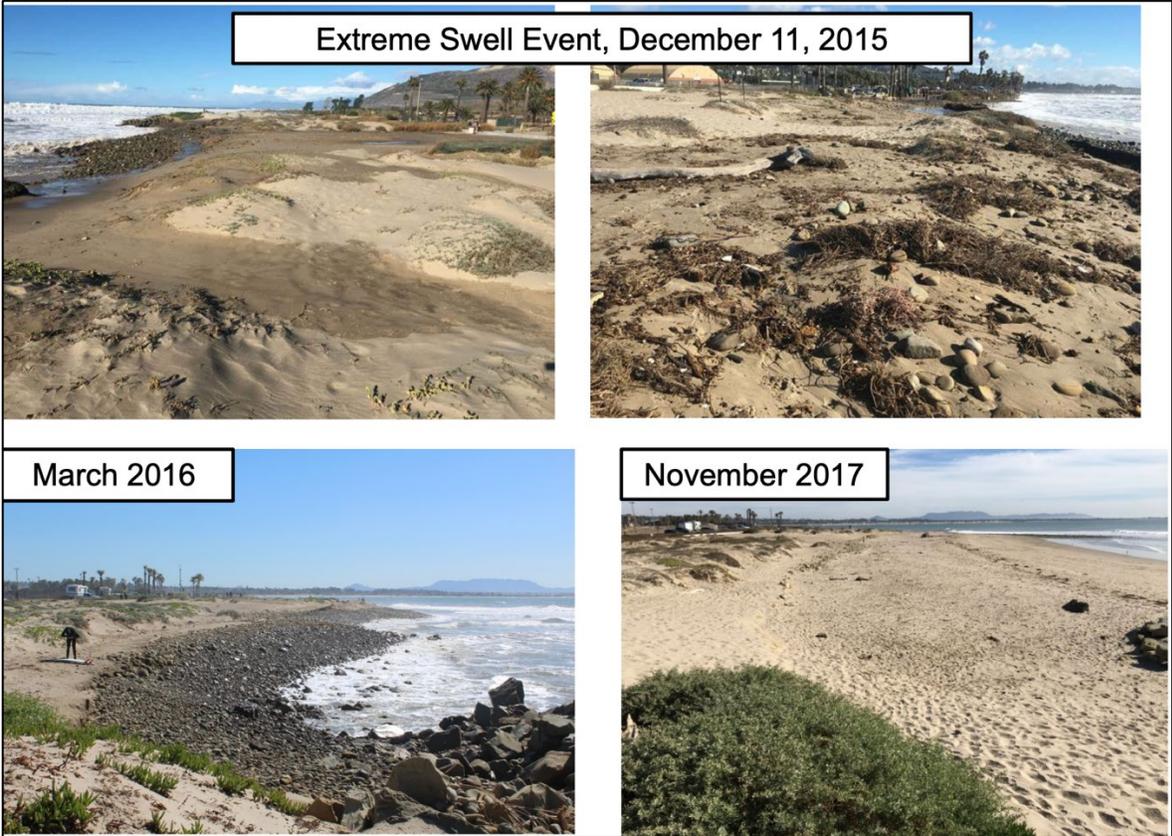
Figure 25. Cobble berm at Surfer’s Point following 2015-16 storm wave attack and then recovery.

While significant wave attack occurred in the winter of 2015-2016, removing the sand cover and exposing the cobbles, a year later the beach had rebuilt and the cobble berm was nearly completely covered again (Figure 25).

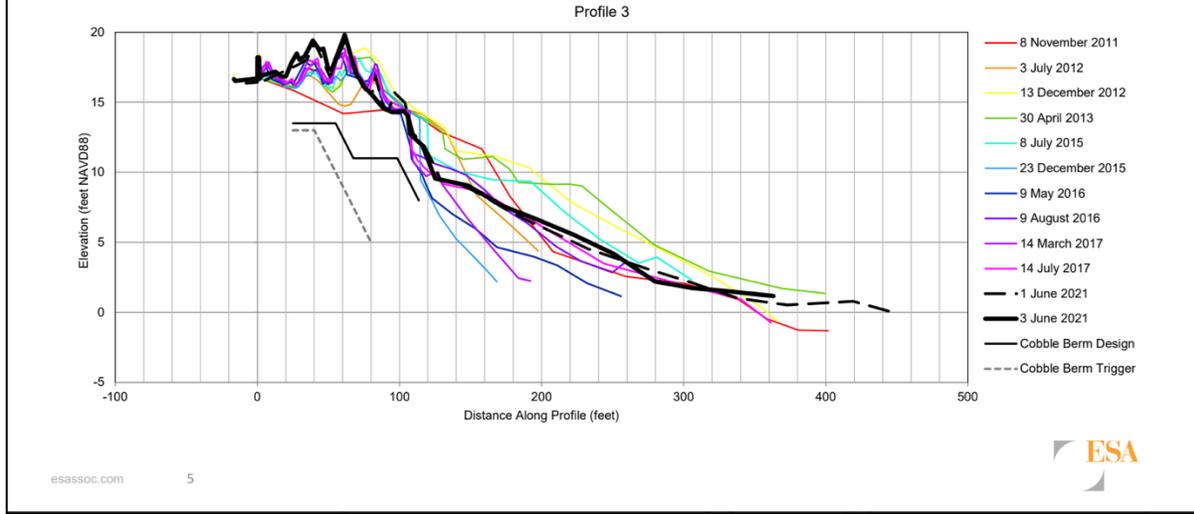
Profile 3 – City of Ventura and ESA Surveys

Figure 27. Profile 3 across dunes and shoreline at Surfer’s Point built over the 10-year period from 2011 to 2021 showing stability and little change on the upper portion of the profile where cobbles were placed and dunes were constructed.

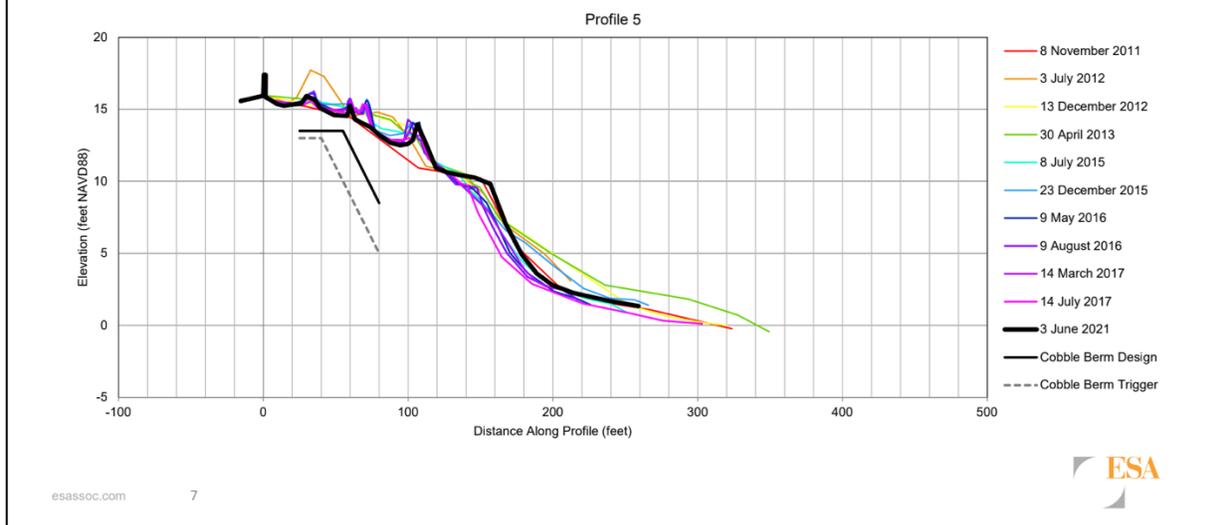
Profile 5 – City of Ventura and ESA Surveys

Figure 28. Profile 5 across the eastern end of the project, showing virtually no change on the upper portion of the profile over ten years of surveys. The sand on the beach does come and go seasonally.

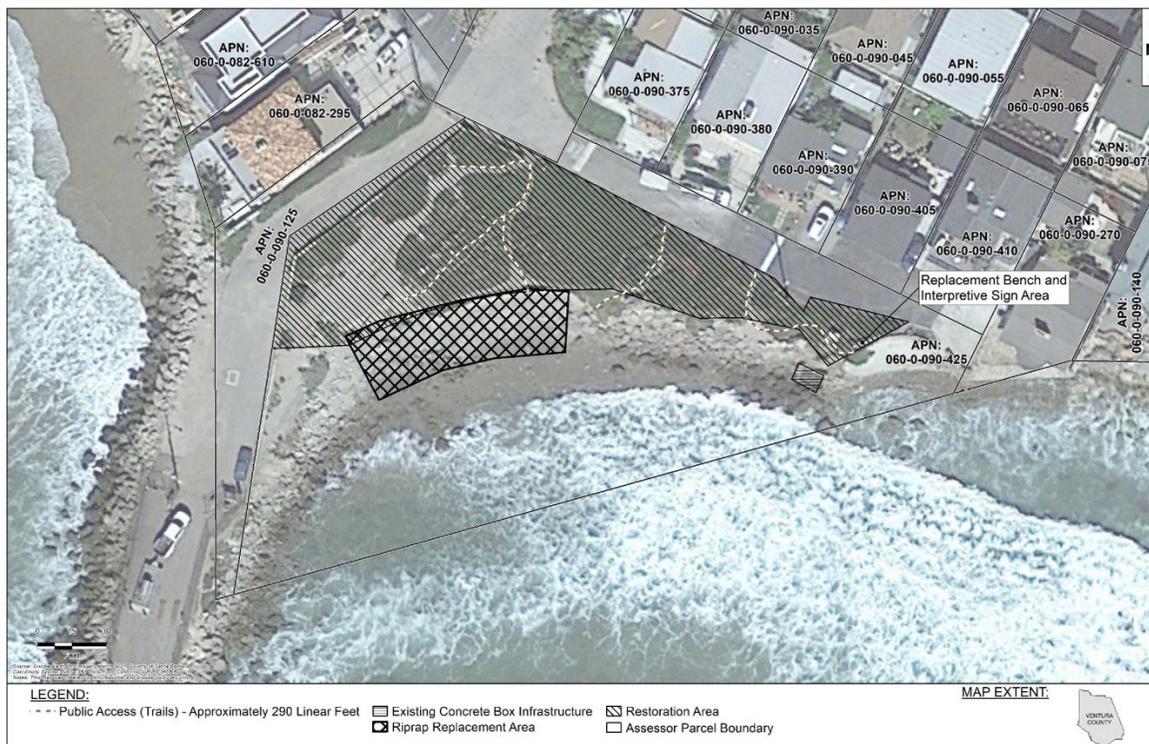
Figure 29. Details of placement of riprap for Alternative Plan 9c.

An estimated 360 yds³ of riprap (chosen to match the size of the riprap that currently exists onsite) would be needed to complete the shoreline armoring in this area. The riprap would be initially hauled from a quarry in Ventura County to the SCC area in covered dump trucks and staged within the upper portion of the site between the beach and Breakers Way. Approximately 90 truckloads would be required. A small crane with a rock grapple and spider excavator would then be utilized to place the riprap onto this section of beach. The riprap configuration would be placed to match the configuration of the existing riprap on either side.
