TREE PROTECTION REPORT

660 UNIVERSITY AVENUE

PALO ALTO, CALIFORNIA

Prior: December 20, 2023
Current: February 7, 2024

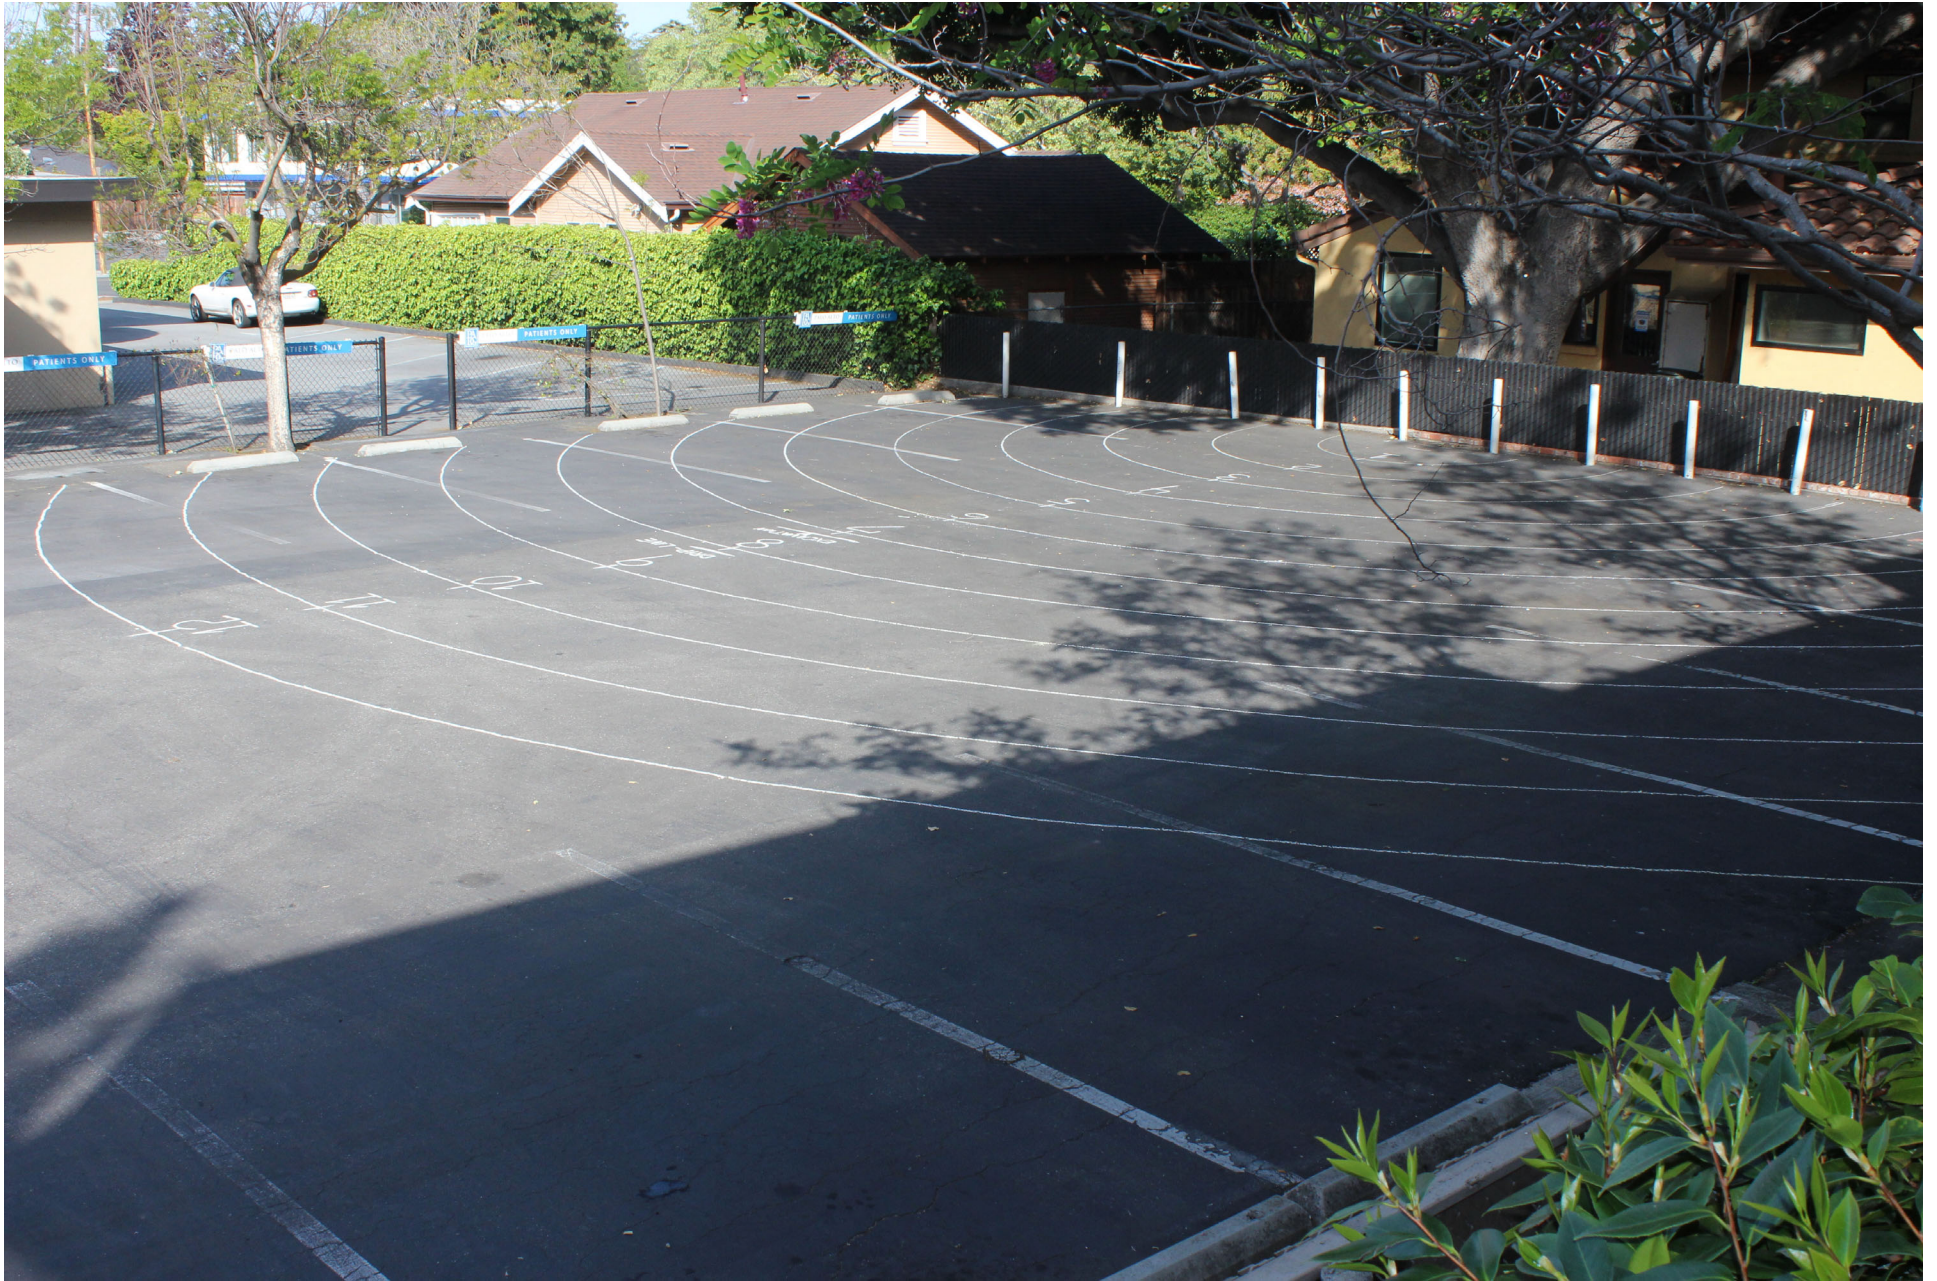
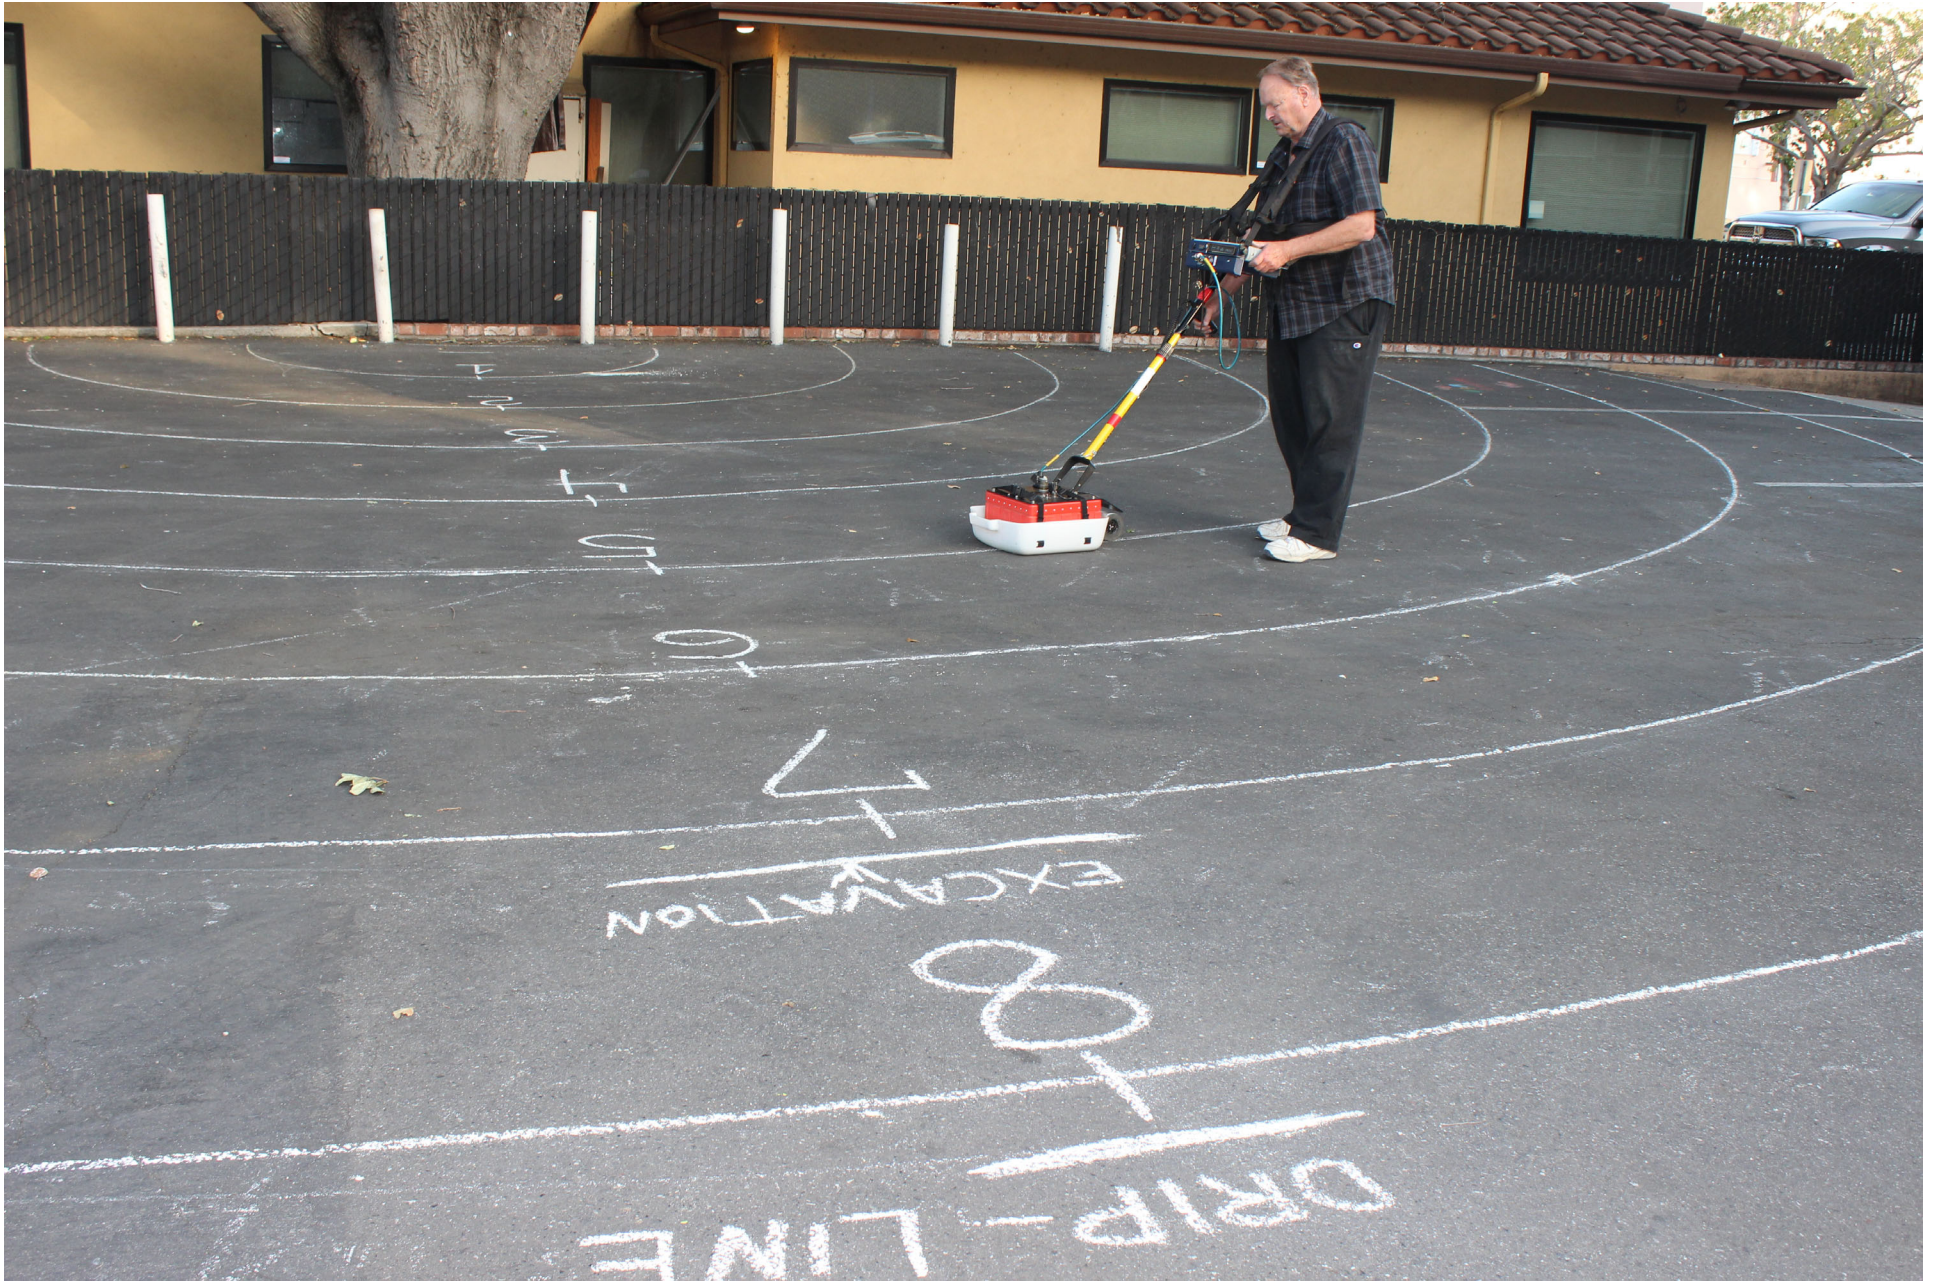
These chalk lines represent the locations of half circle scans. Scan #8 represents the edge of the canopy drip-line. Scan #7 represents the edge of the proposed excavation for the below ground garage about 30 feet away from the Oak tree.

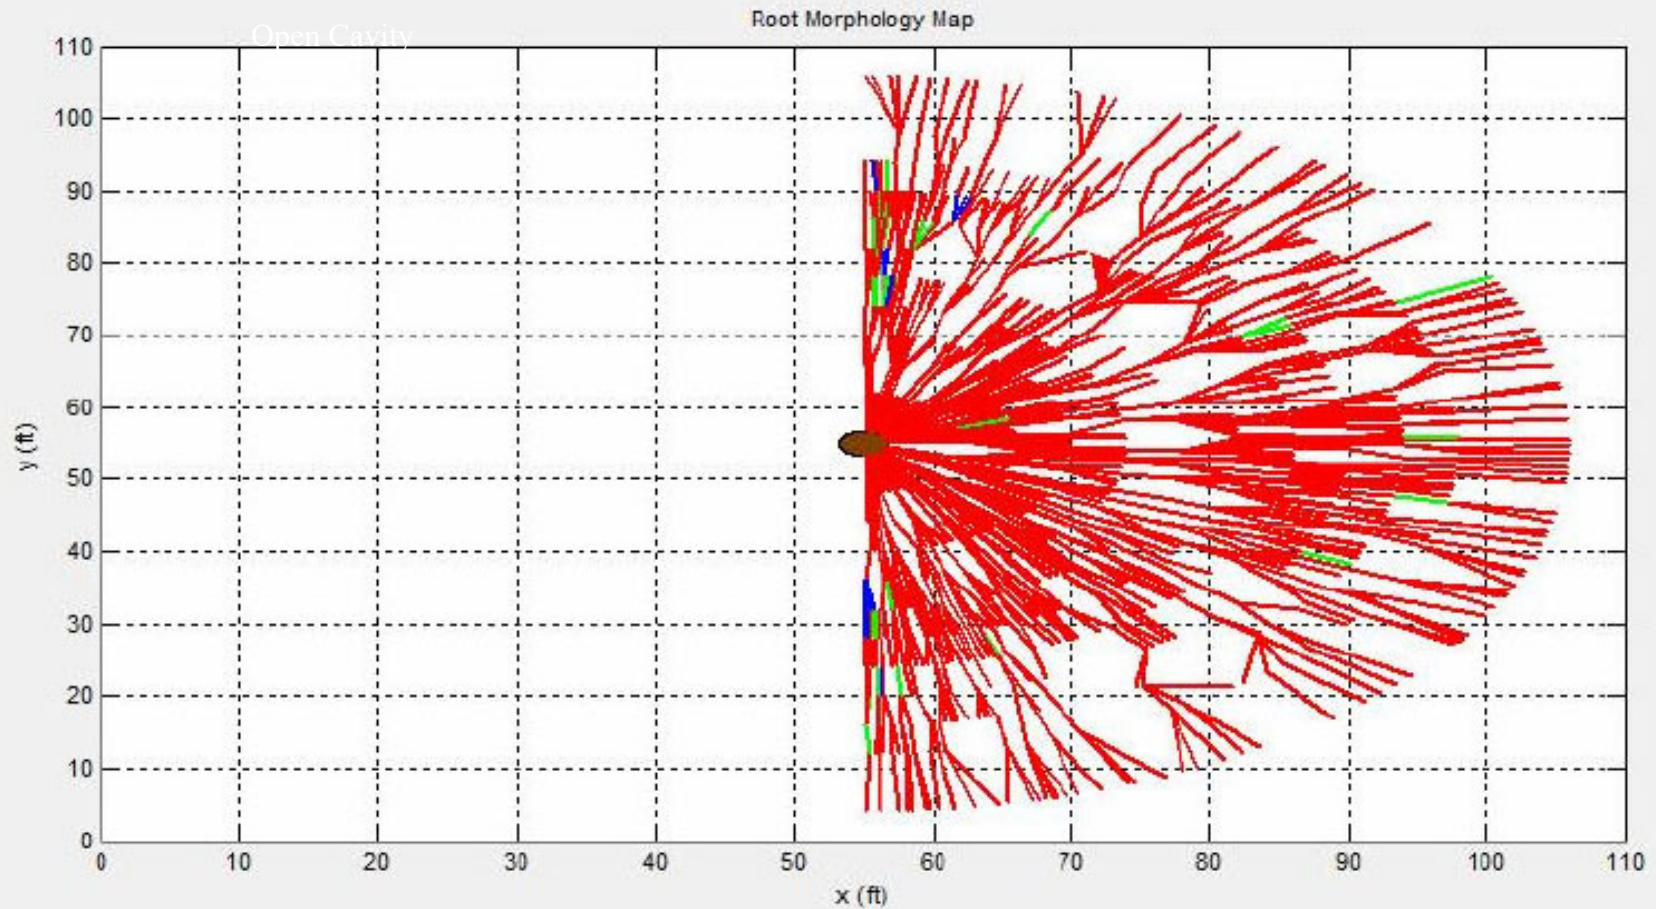
Top-down view of the root system

This is a conceptual 3D Top-Down diagram of what the root structure may look like below the ground of Oak Tree #1572 on University Avenue. It is obtained from the root data collected from the 12 half circle scans performed over the asphalt parking lot.

Estimated root sizes are indicated by the colors red, green and blue
Small Red 2.5 inches or less **Medium Green** 2.5 – 5 inches. **Large Blue** 5 inches and larger.

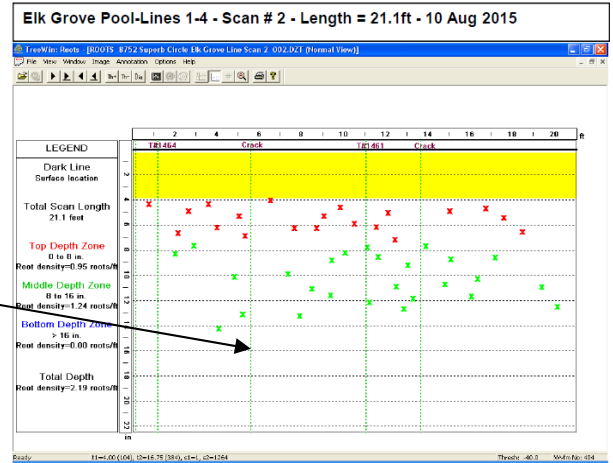
Green dotted lines are markers physically placed on the field computer by the technician during the scanning.

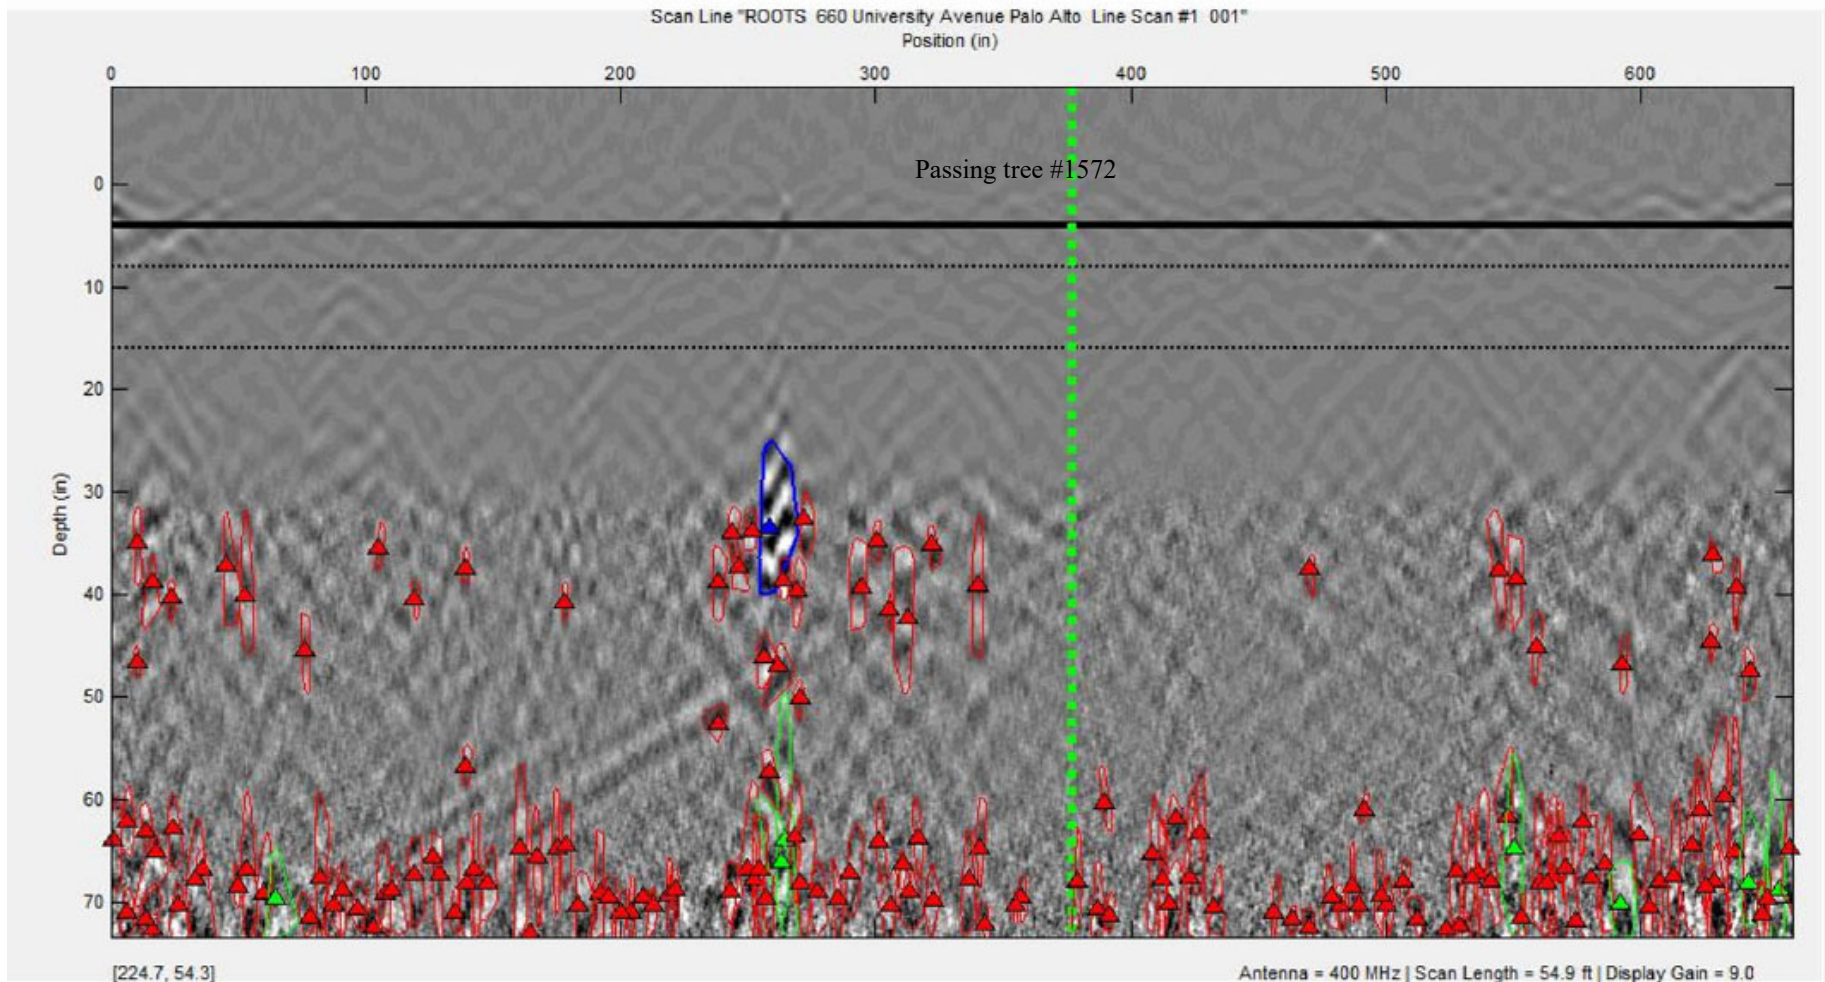
Scan #1 Root size estimate using Polygon region, reflection field size around root.

Small Red 2.5 inches or less Medium Green 2.5 – 5 inches. Large Blue 5 inches and larger.

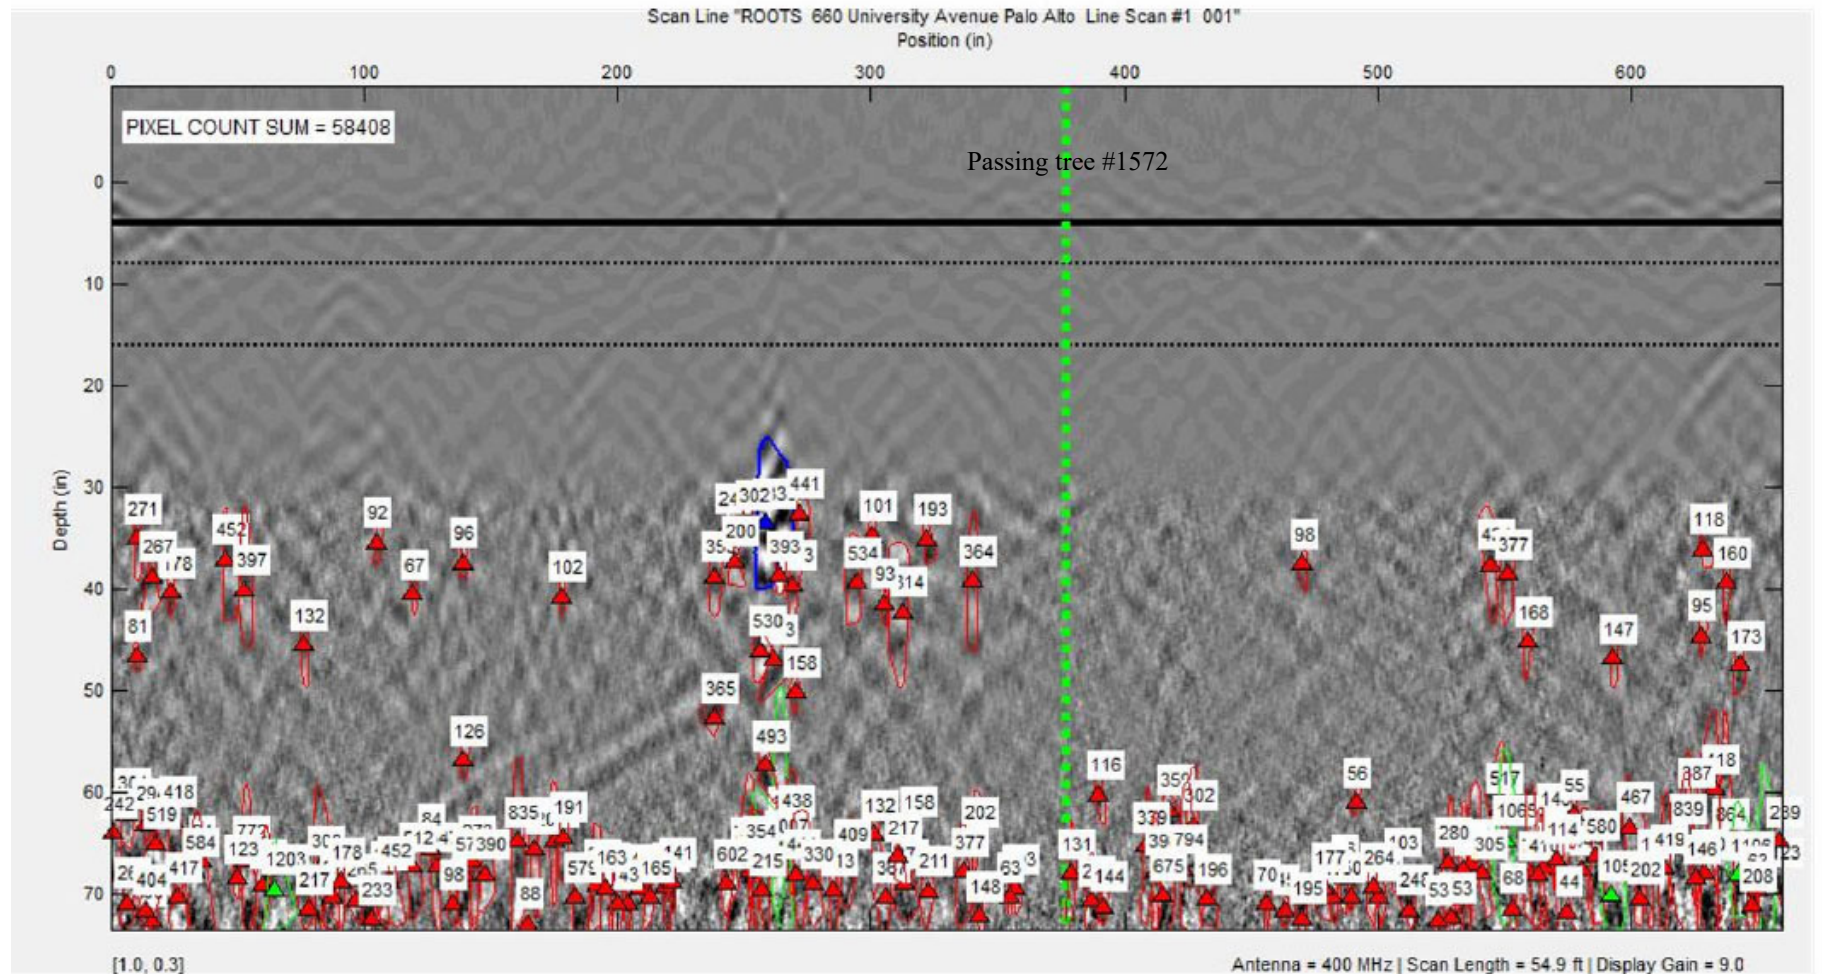
Scan #1 Root size estimate, Pixel count. The area inside each Area Shape Polygon reflection field, is determined by the number of pixels (related to root size) printed inside each white box. This will provide more insight as to individual root size estimates within each of the 3 size categories below.

Small Red 2.5 inches or less **Medium Green** 2.5 – 5 inches. **Large Blue** 5 inches and larger.
