SUPPLEMENTAL GEOLOGIC FAULT HAZARD STUDY OF THE RIVERSIDE COUNTY EARTHQUAKE ZONE, FOR THE PROPOSED RESIDENTIAL DEVELOPMENT, LOCATED AT 800 N. GIRARD STREET, CITY OF HEMET, RIVERSIDE COUNTY, CALIFORNIA.

***Dated: September 10, 2018
Project No. G18-1647-10***

Subject: Supplemental Geologic Fault Hazard Study of the Riverside County Earthquake Fault Zone, For the Proposed Residential Development, Located at 800 N. Girard Street, City of Hemet, Riverside County, California

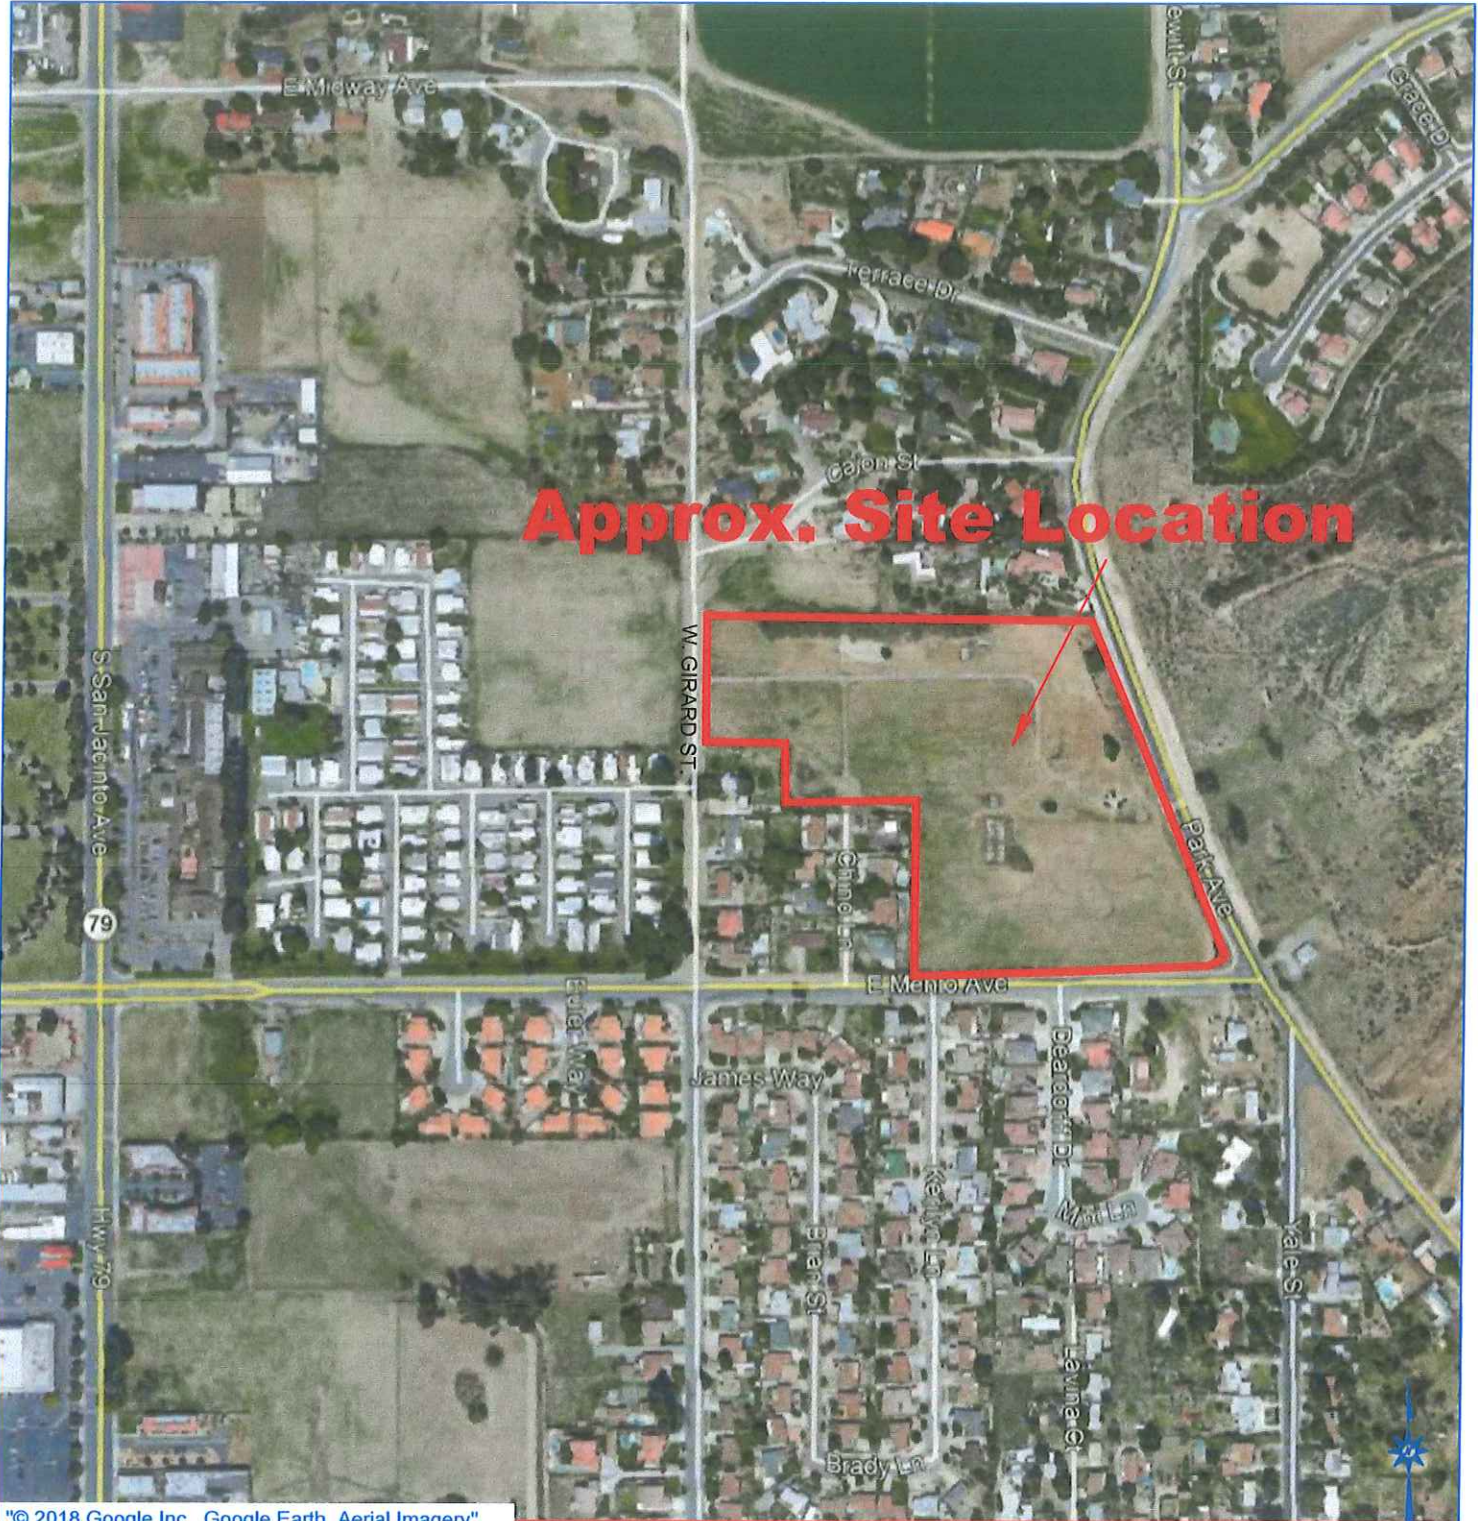
**FIGURE 1
SITE LOCATION MAP**

The subject site is irregular in shape and is located north of East Menlo Avenue and west of Park Avenue in the City of Hemet, Riverside County, California. The existing site elevations vary from approximately 1,640 feet above mean sea level (msl) on the northeast descending slope, to approximately 1,616 msl in the southwesterly section of the site. Local drainage is generally directed to the west and southwest portions of the site. The general location and configuration of the site is shown on the Site Location Map (Figure 1).
