Tree Inventory Report

**CITY OF LOS ANGELES TREE INVENTORY REPORT
THE BLOC, 700 S. FLOWER STREET, 700 W. 7TH
STREET, AND 711 S. HOPE STREET
LOS ANGELES, CALIFORNIA 90017**

MAY 26, 2022

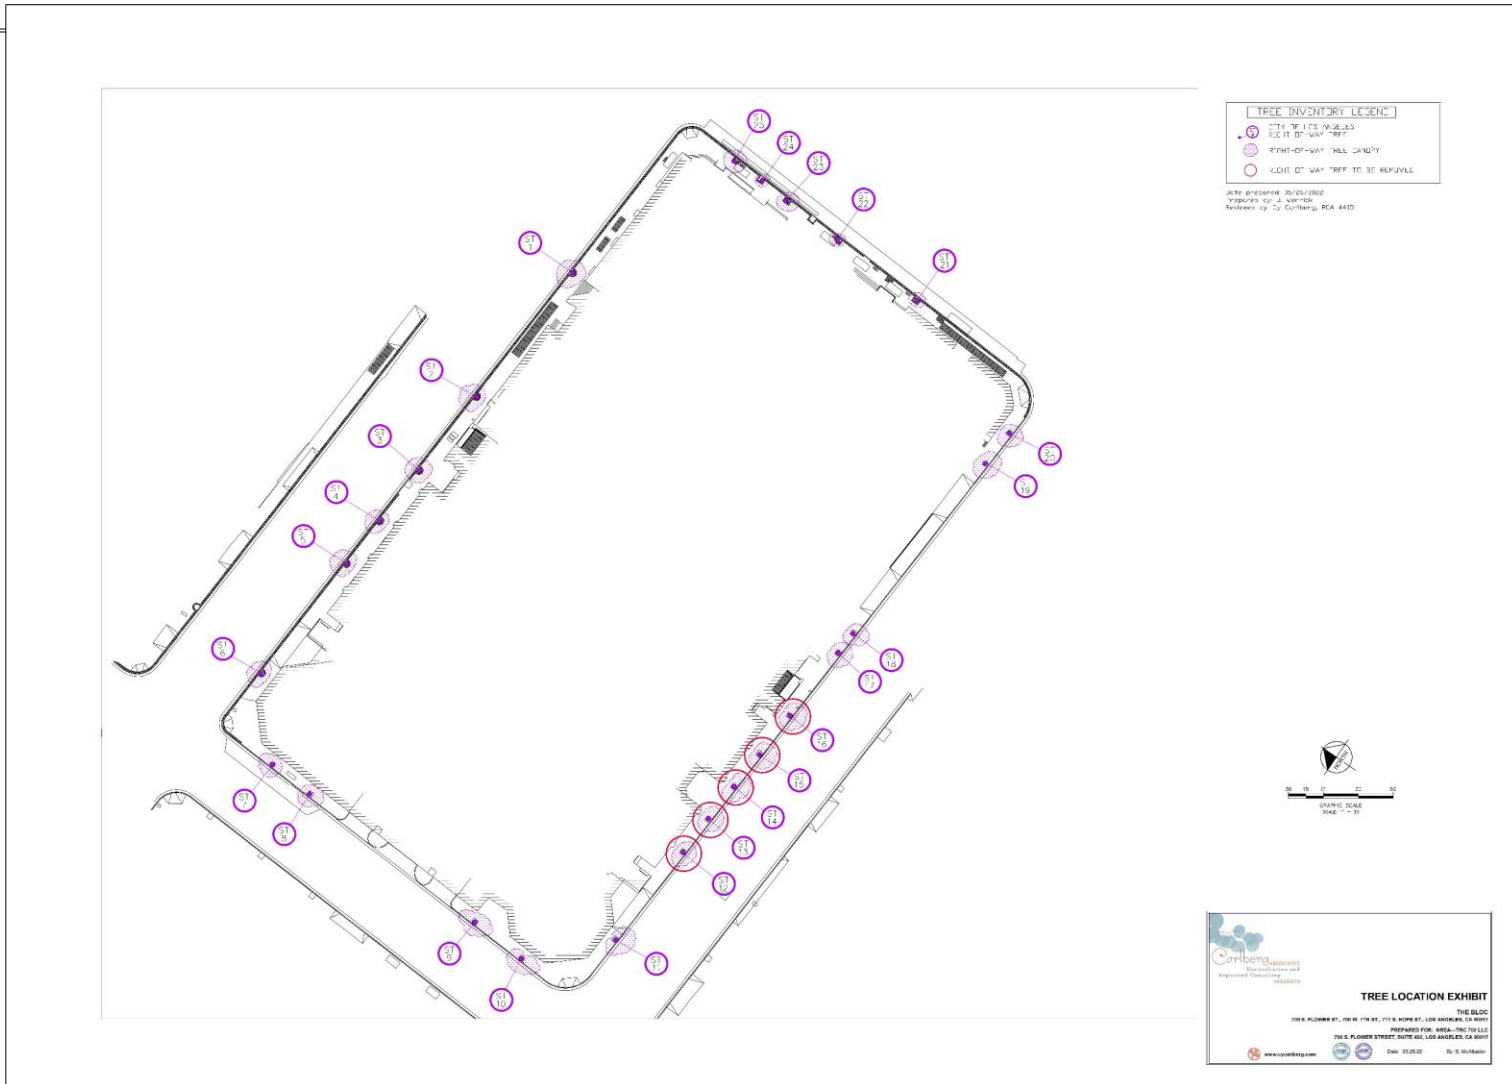
EXHIBIT B – REDUCED COPY OF THE TREE LOCATION EXHIBIT

As described above and seen in Exhibit B, the parking lane along the curb line will need to be free for trucks, dumpsters, equipment and deliveries. Currently the tree canopy extends beyond the parking lane and, in some cases, is touching the façade of the structure. There is no logistical approach that could protect the five trees (ST12 – ST16) from damage due to the removal of the existing skin of the building and/or the lifting of materials via the crane. These five trees are requested for removal; they will be replaced within the same building frontage, with their exact placement being modified to improve access to the residential lobby, new retail, and pedestrian passageway that accesses Macy's and the interior retail courtyard.

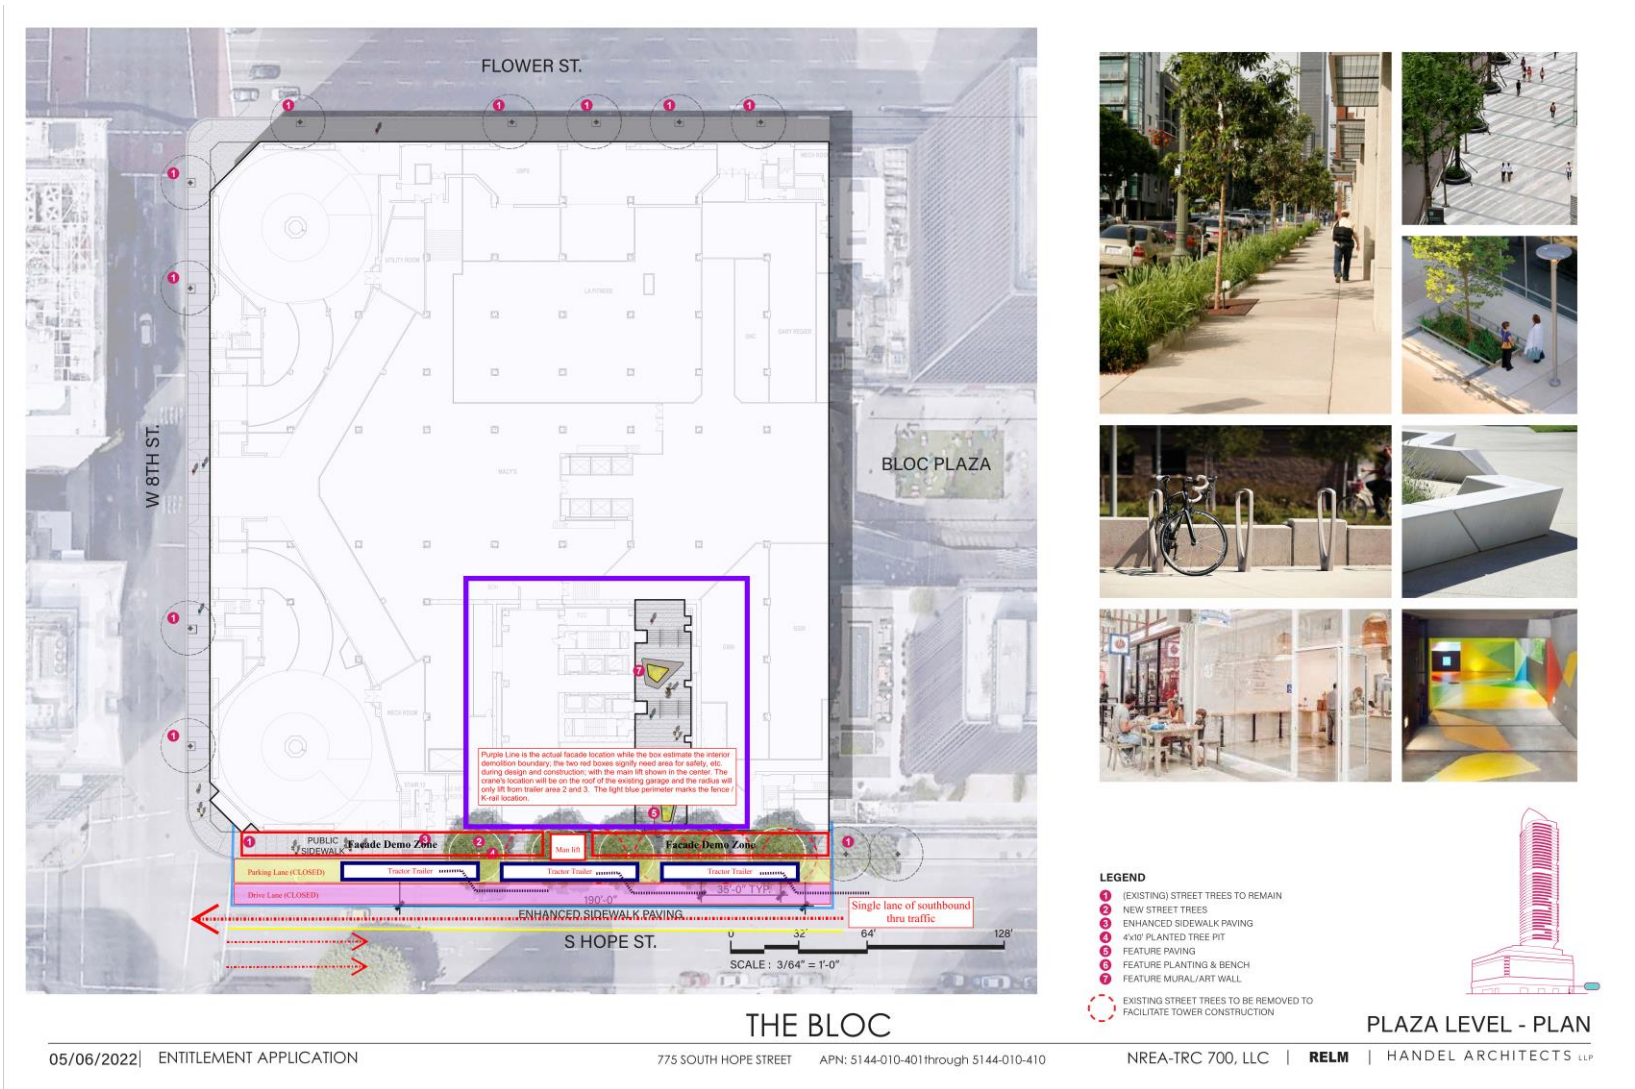
EXHIBIT C – TREE DISPOSITION EXHIBIT

It will be necessary to remove five of the ROW trees on Hope Street (ST 12 – ST16) in order to construct the new tower at The Bloc. For the initial phase of construction, the façade and interior of The Bloc (shown by purple line in Exhibit C on page 8) will be demolished and removed from the site. This demolition will occur both from the exterior and interior of the façade line. After the removal of demolished materials, the same location will be used to erect and replace not only the base structure/new façade, but also, the ultimate residential tower above; as such, this area will be required throughout the construction process.
