# BROOKSIDE GOLF COURSE IMPROVEMENTS PROJECT

## Tree Report

November 2020

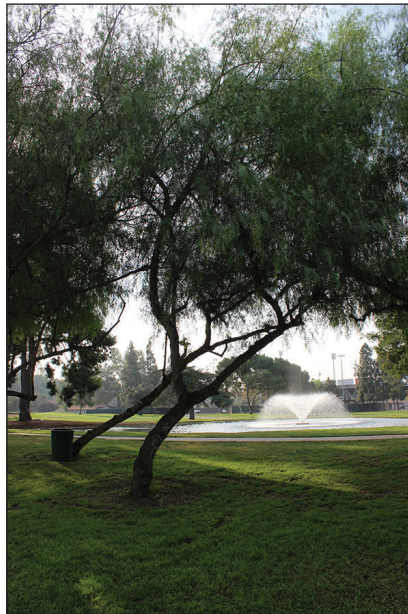
Tree 59 - Peruvian pepper

59	Peruvian pepper	<i>Schinus molle</i>	34.16462272	-118.1683236	P	10.5	20	8	13	15	15	13	10	4	4	B	C	C	C	self corrected lean, root damage, exposed roots, basal sprouting	normal
60	Peruvian pepper	<i>Schinus molle</i>	34.1646015	-118.1682719	P	8.0	13	1	1	18	16	5	1	1	1	C	C	D	C	strong lean to w-sw, basal sprouting, lion tailed, exposed damaged roots, decay at base	normal
61	Peruvian pepper	<i>Schinus molle</i>	34.164594	-118.1683748	P	15.6	30	11	12	10	14	18	15	12	8	B	B	C	C	root damage, self corrected lean, basal sprouting,	normal
62	Peruvian pepper	<i>Schinus molle</i>	34.16460405	-118.1684377	P	13.1	26	10	12	13	16	15	14	12	13	C	B	B	C	damaged roots with decay, crown raised, recommend decay assessment	normal
63	Peruvian pepper	<i>Schinus molle</i>	34.1647125	-118.1684683	P	14.5	25	5	11	15	17	17	11	14	6	C	C	C	B	basal sprouting, lopsided due to presence of driving range fence, built up soil over roots, burls on trunk	normal

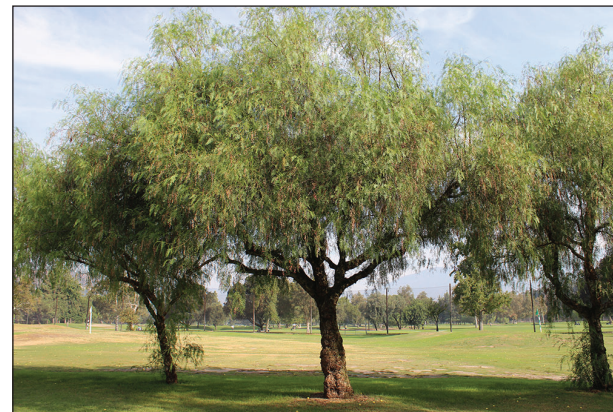
Tree 75 - Peruvian pepper

74	Peruvian pepper	<i>Schinus molle</i>	34.16479735	-118.1689614	P	13.3	25	12	13	9	13	10	7	8	9	B	C	C	B	golfball damage, basal sprouting	normal
75	Peruvian pepper	<i>Schinus molle</i>	34.1647948	-118.1690292	P	18.3	18	10	11	19	11	12	12	13	11	C	C	C	C	golfball damage, exposed damaged roots	normal
76	Peruvian pepper	<i>Schinus molle</i>	34.1648121	-118.1690845	P	8.3	14	10	12	11	10	12	7	5	5	C	C	B	C	golfball damage, basal sprouting, crown raised	normal
77	Peruvian pepper	<i>Schinus molle</i>	34.16481319	-118.1691521	P	13.3	28	9	13	14	15	13	12	12	8	C	B	C	C	golfball damage, crown raised	normal
78	Peruvian pepper	<i>Schinus molle</i>	34.1648411	-118.1692159	P	8.3	18	6	8	10	9	10	6	7	7	C	C	C	C	golfball damage, basal sprouting, crown raised	normal
79	Peruvian pepper	<i>Schinus molle</i>	34.16483821	-118.1692768	P	12.3	25	13	14	13	19	12	11	13	12	B	B	B	C	golfball damage, crown raised, basal sprouting	normal
