Consulting Arborist's Report

Tree Evaluation Report

For: Terraces in Murrieta

Dated: 1/11/2022

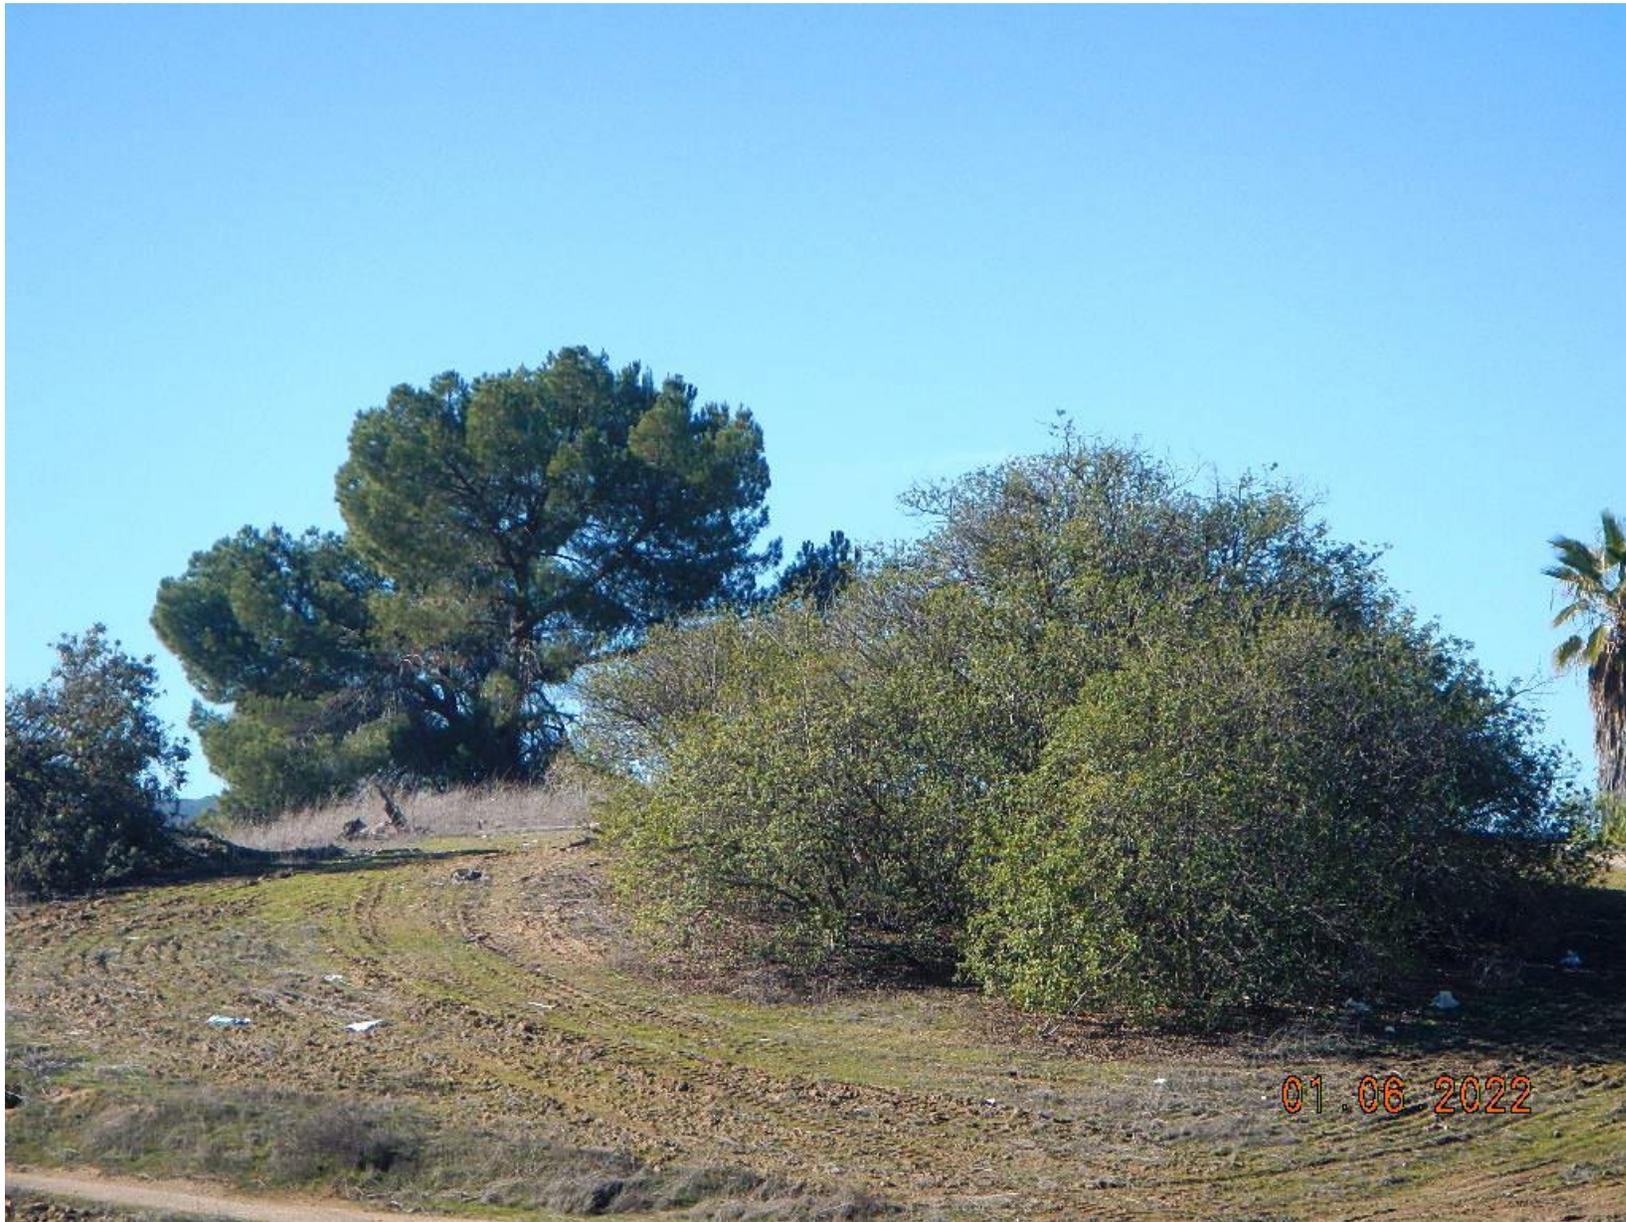
#197 Aleppo pine in a ravine in the central part of the site.
