Hazardous Materials Assessment

**Morningside High School
10500 S. Yukon Avenue
Inglewood, CA 90303**

**Sampling Date: December 2018 – January 2019
Project No: 18-547**

Prepared for:
*Inglewood Unified School District
401 S. Inglewood Ave., Inglewood, CA 60301*

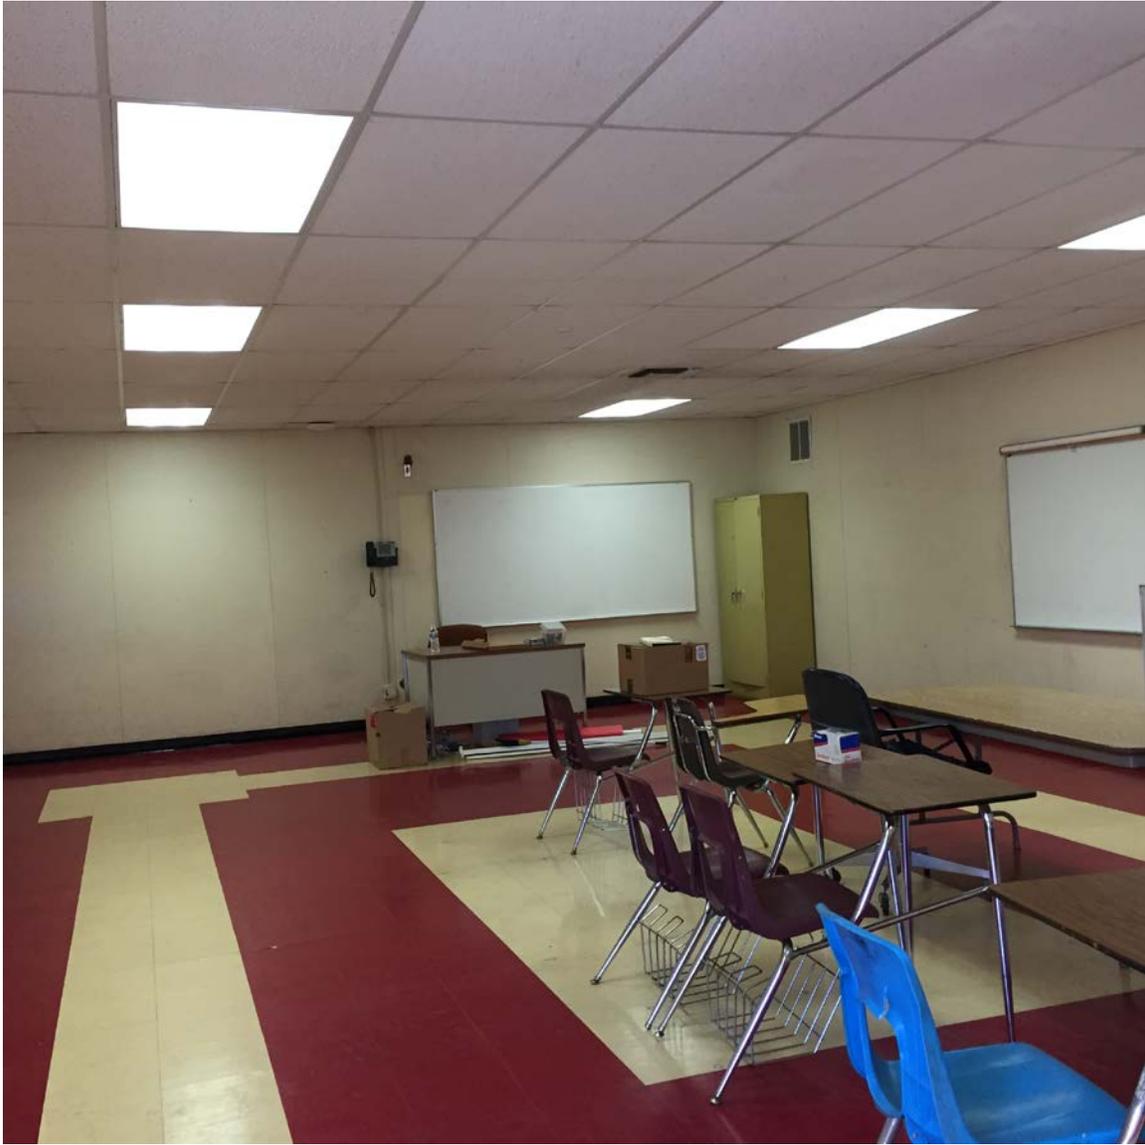
Thermostats were noted to be mechanical contact thermostats with no mercury. Light switches did not appear to contain mercury. Avoid contact with any silver liquid. Do not break liquid vials. Separate, drum, profile, transport and dispose of thermostats separately from other demolition materials. Provide a copy of profile results to the accepting landfill.

Classroom in Building C1.

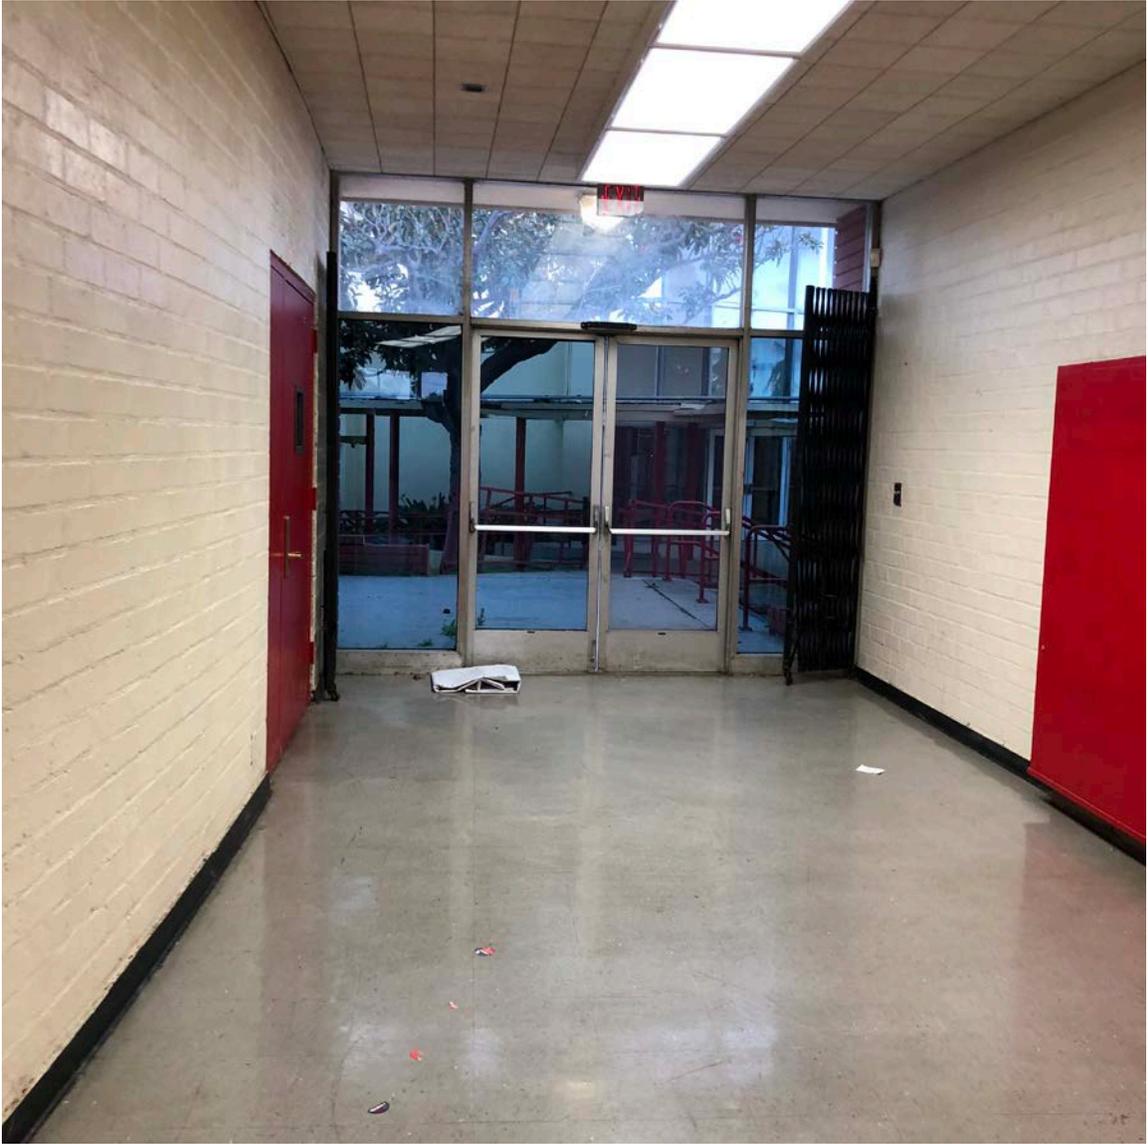
Building F lobby light fixtures.
