## Biological Resources

**PROTECTED TREE REPORT  
FOR  
PROPERTY  
AT**

**8426 N. KESTER AVENUE  
LOS ANGELES, CA 91402**

May 12, 2022

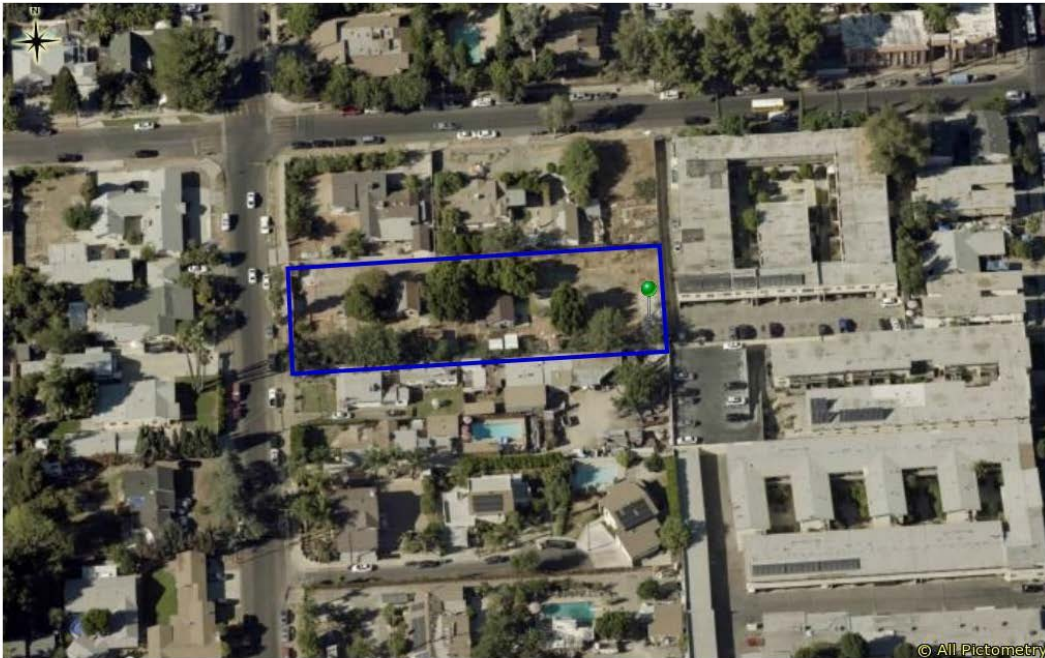
09/13/2021

**View of the property as seen on the Los Angeles County Assessor's website.**

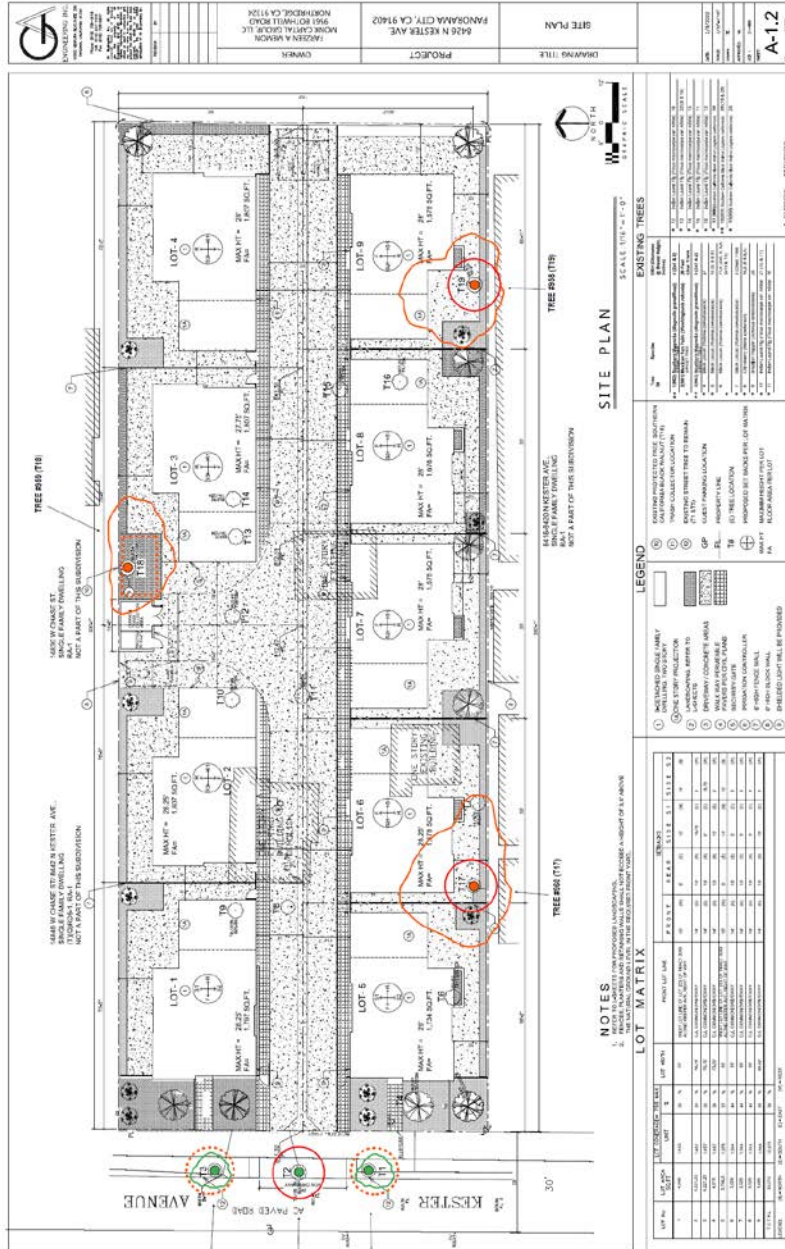
PROTECTED TREE REPORT  
 APPENDIX IV  
 SITE PLAN  
 BY  
 ARSEN MARGOSSIAN CONSULTING ARBORIST (WE-22154)  
 915 965 6469, ARSEN@PACELL.NET  
 MAY 12, 2022

I took measurements and used the surveyor's and architect's plans for the location of the trees. I located some missing trees from the provided survey. All the trees are located (per color code) on the Site Plan (**Appendix IV**).
