Project No. G2755-42-01
November 15, 2021

Subject: SUPPLEMENTAL GEOTECHNICAL FAULT INVESTIGATION
NIRVANA PROPERTY
821 MAIN STREET
CHULA VISTA, CALIFORNIA

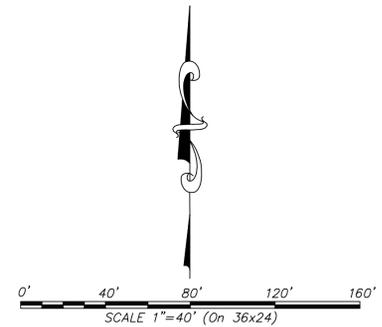
GEOLOGIC MAP AND FAULT TRENCH LOG
NIRVANA INDUSTRIAL BUILDINGS AND SELF STORAGE COMPLEX
821 MAIN STREET
CHULA VISTA, CALIFORNIA

Based on our field logging, there is no evidence of faulting or offset in the Pleistocene age Terrace Deposits exposed in our fault trench excavation. Our field observations support the conclusions presented in the referenced geotechnical reports. Therefore, we opine that the La Nacion fault segment depicted on regional maps and fault databases is not active as no evidence of faulting in Pleistocene age sediments has been observed on the site. The La Nacion fault segment, if present at the site, is confined to the Oligocene age Otay Formation (approximately 23 to 34 million years old) that underlies the Quaternary Terrace Deposits at the site and will not impact site development. A fault setback for the proposed development is not required.

- Otay Formation (To)** (3) Stiff to hard, dry, dark reddish-brown Claystone (CH); blocky, fractured with caliche stringers throughout.
- APPROX. LOCATION OF GEOLOGIC CONTACT
