Preliminary Arborist Report

749 West El Camino Real

April 22, 2021
Revised April 2022

**Preliminary Arborist Report
749 W El Camino Real
Mountain View, CA**

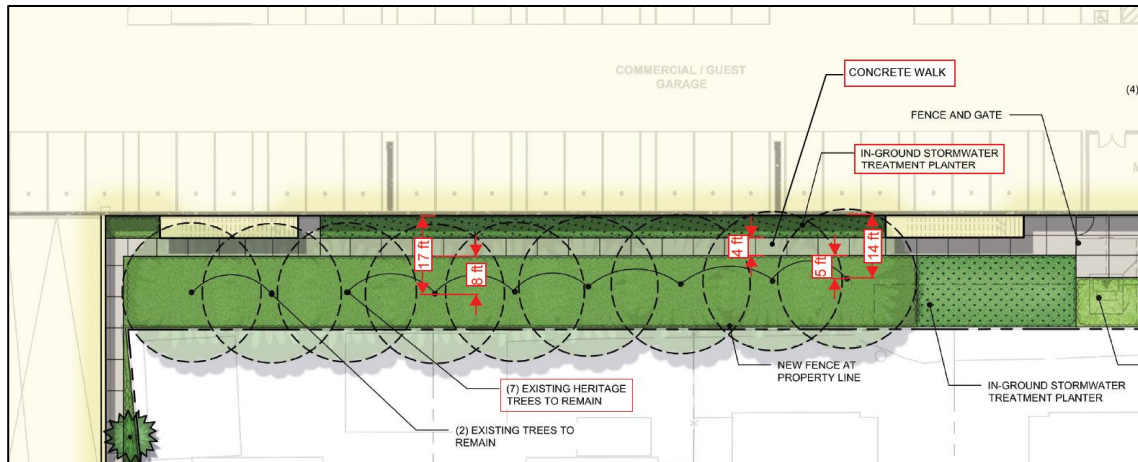
Coast redwoods #36-41 can be preserved with meticulous adherence to the tree preservation guidelines. The walkway is planned between 5 to 8 feet away from the trunks of the trees (Sheet L-1 screenshot 1 below). To enable preservation, I recommend reducing the extent of the excavation required for the adjacent concrete walkway. Considering alternatives to a concrete walkway like permeable pavers on top of geotextile grid mats to reduce the severity of root impacts.

The in-ground stormwater treatment planter is located where the existing parking lot is located. Root loss in this area is expected to be minimal. Excavation within the tree protection zone should be done by hand and should seek to preserve roots 2-inches in diameter and larger. Once roots are severed, they should be covered. The trees should be irrigated regularly with potable water before, during, and after construction to help the trees tolerate and recover from construction impacts better. Tree protection fencing should also be installed between the trees and the edge of the proposed work area. Fencing should remain in place for the duration of the project.
