*Re: Serramonte Del Rey Campus Redevelopment, City of Daly City
Federal and State Wetlands Jurisdiction Assessment*

**Subject: Hydrologic reconnaissance, Jefferson Union High School District,
699 Serramonte Blvd., Daly City, CA**

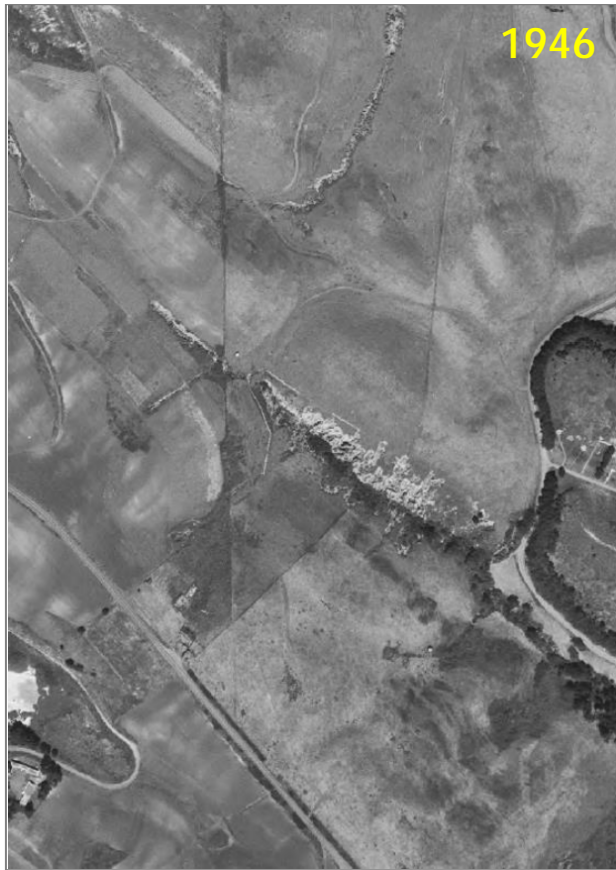
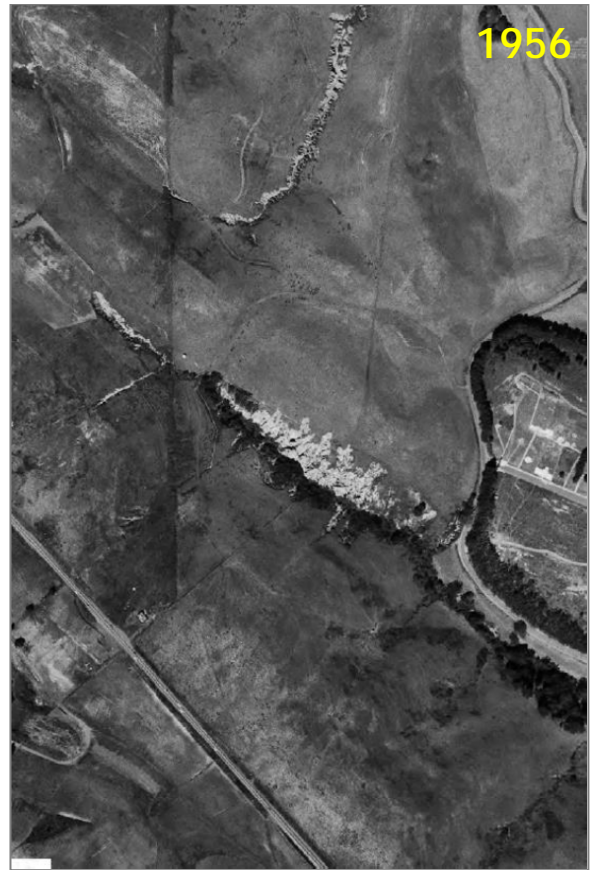
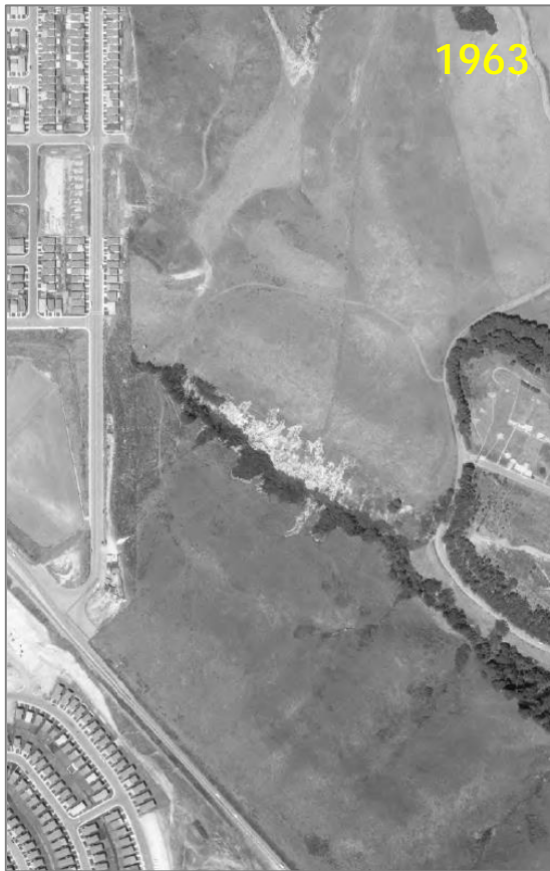
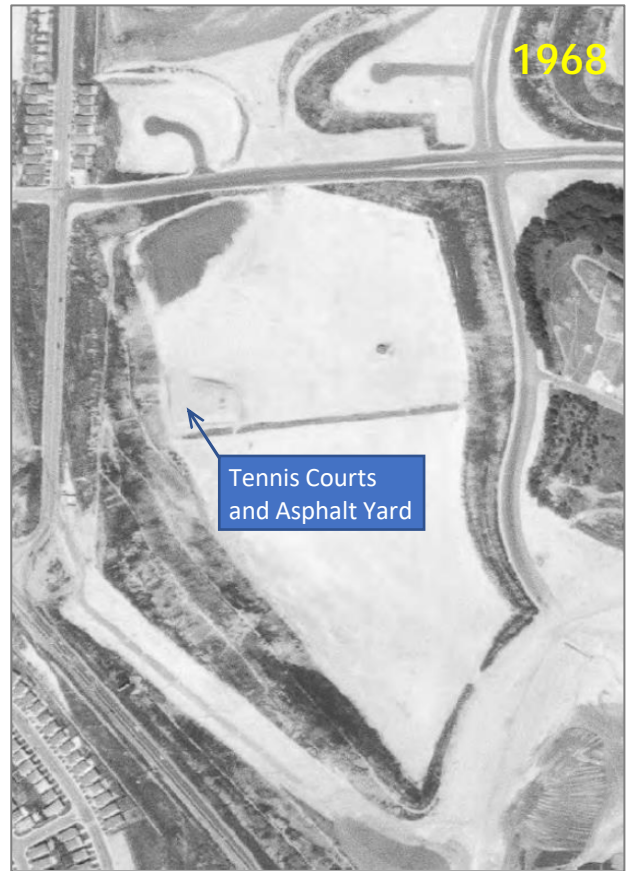
Figure 1. Historical aerial photos show a grazed landscape and extensive erosion prior to development, Jefferson Union High School District, 699 Serramonte Boulevard, Daly City, CA.

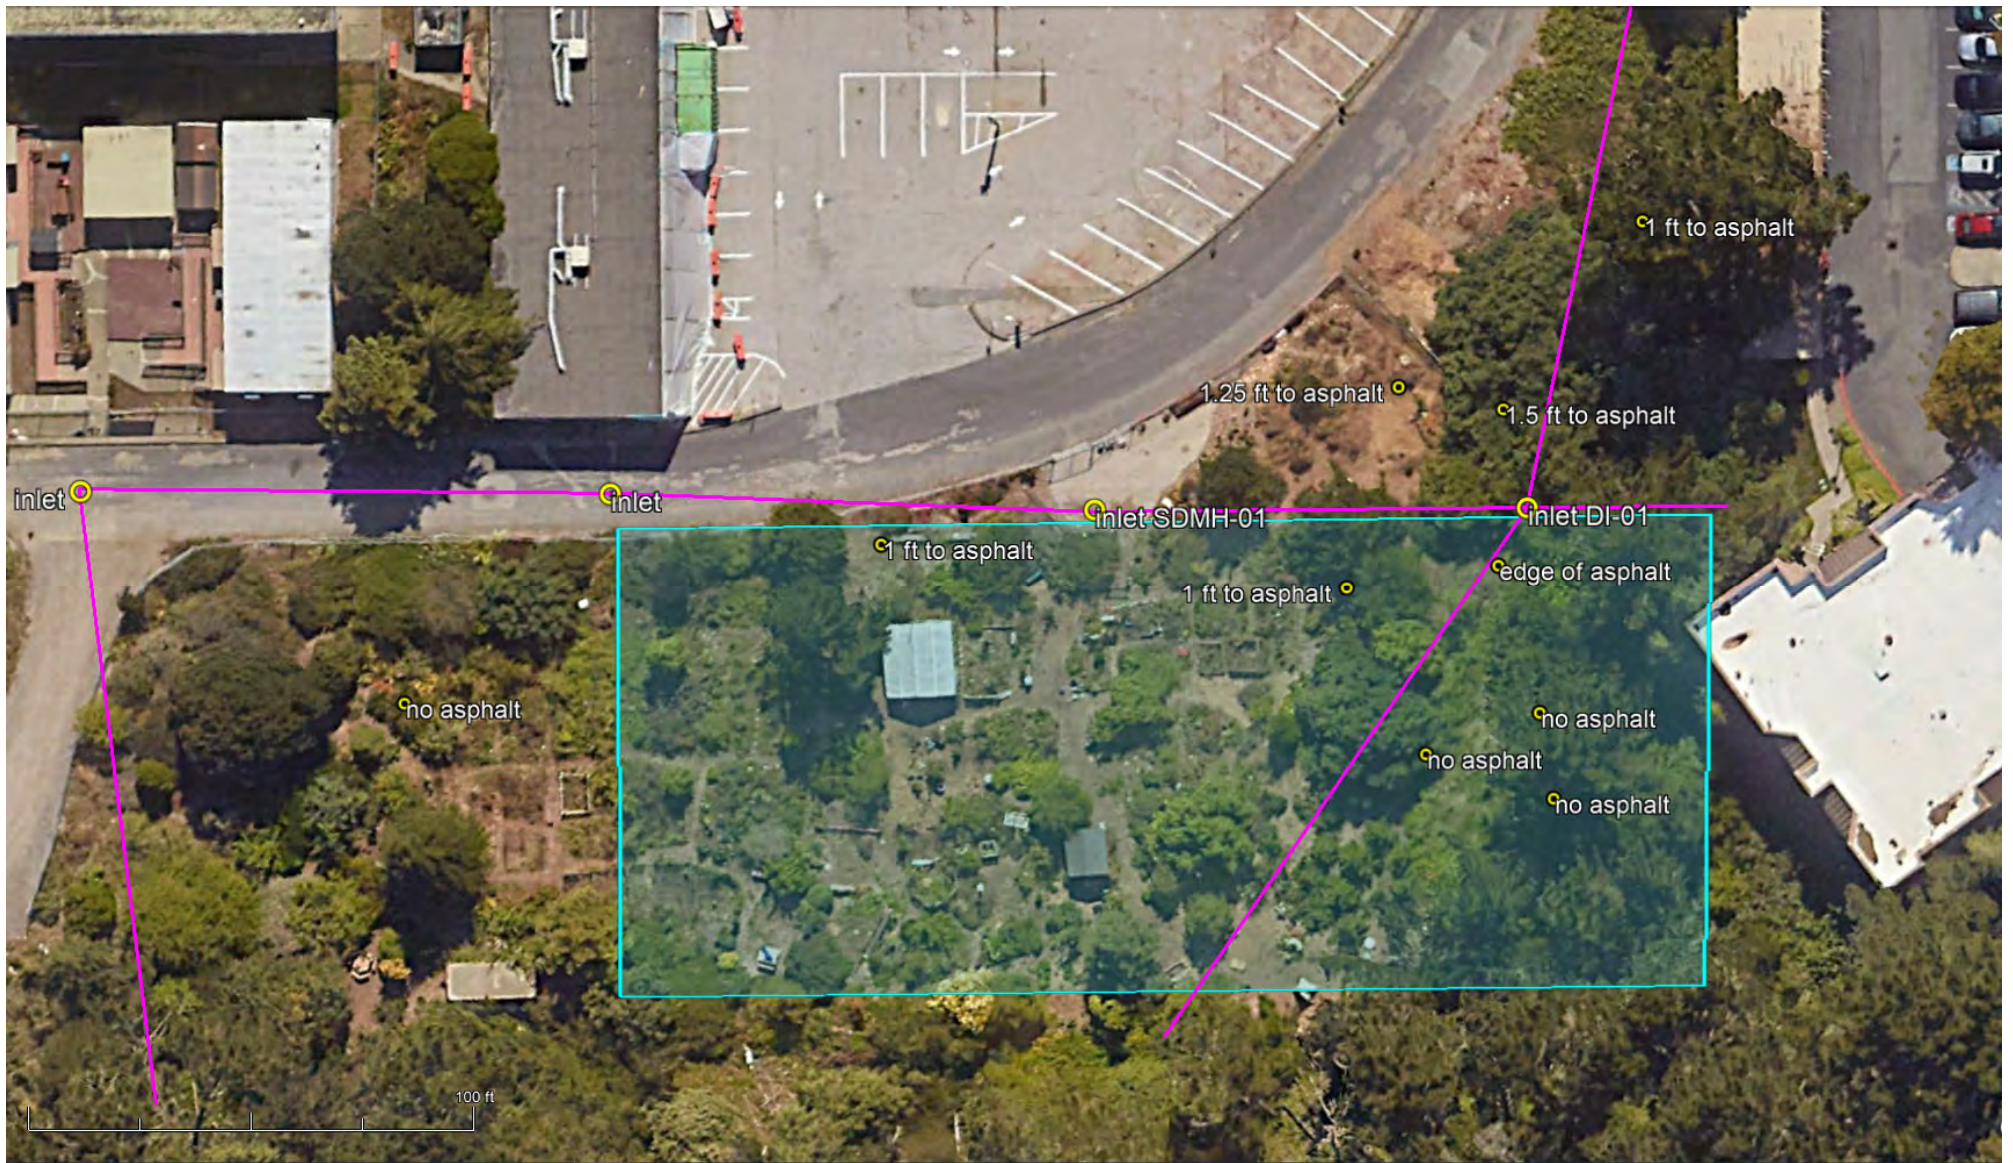
- The general mineral (major ion) composition is plotted in a Piper diagram to illustrate the charge balance of the dissolved ions (**Figure 8**). This plot can be interpreted as showing an ionic fingerprint of water sources. Though groundwater chemistry may change along a flow path, the Inlet #2 seepage is grouped with local groundwater suggesting its source may not be leaks from water or sewer lines (imported water from the Sierra Nevada). Crystal Spring Reservoir, Hetch Hetchy Reservoir, seawater, and regional groundwater data are also plotted for reference.

Figure 8. Piper diagram illustrating ionic signatures of water samples collected at the Serramonte Del Rey Campus relative to Sierran source water and local groundwater, San Mateo County, California. On-site subdrain seepage at inlet DI-01 is grouped similar to local groundwater suggesting its source may not be leaks from water or sewer lines (imported water from the Sierra Nevada) though groundwater chemistry may change along a flow path.

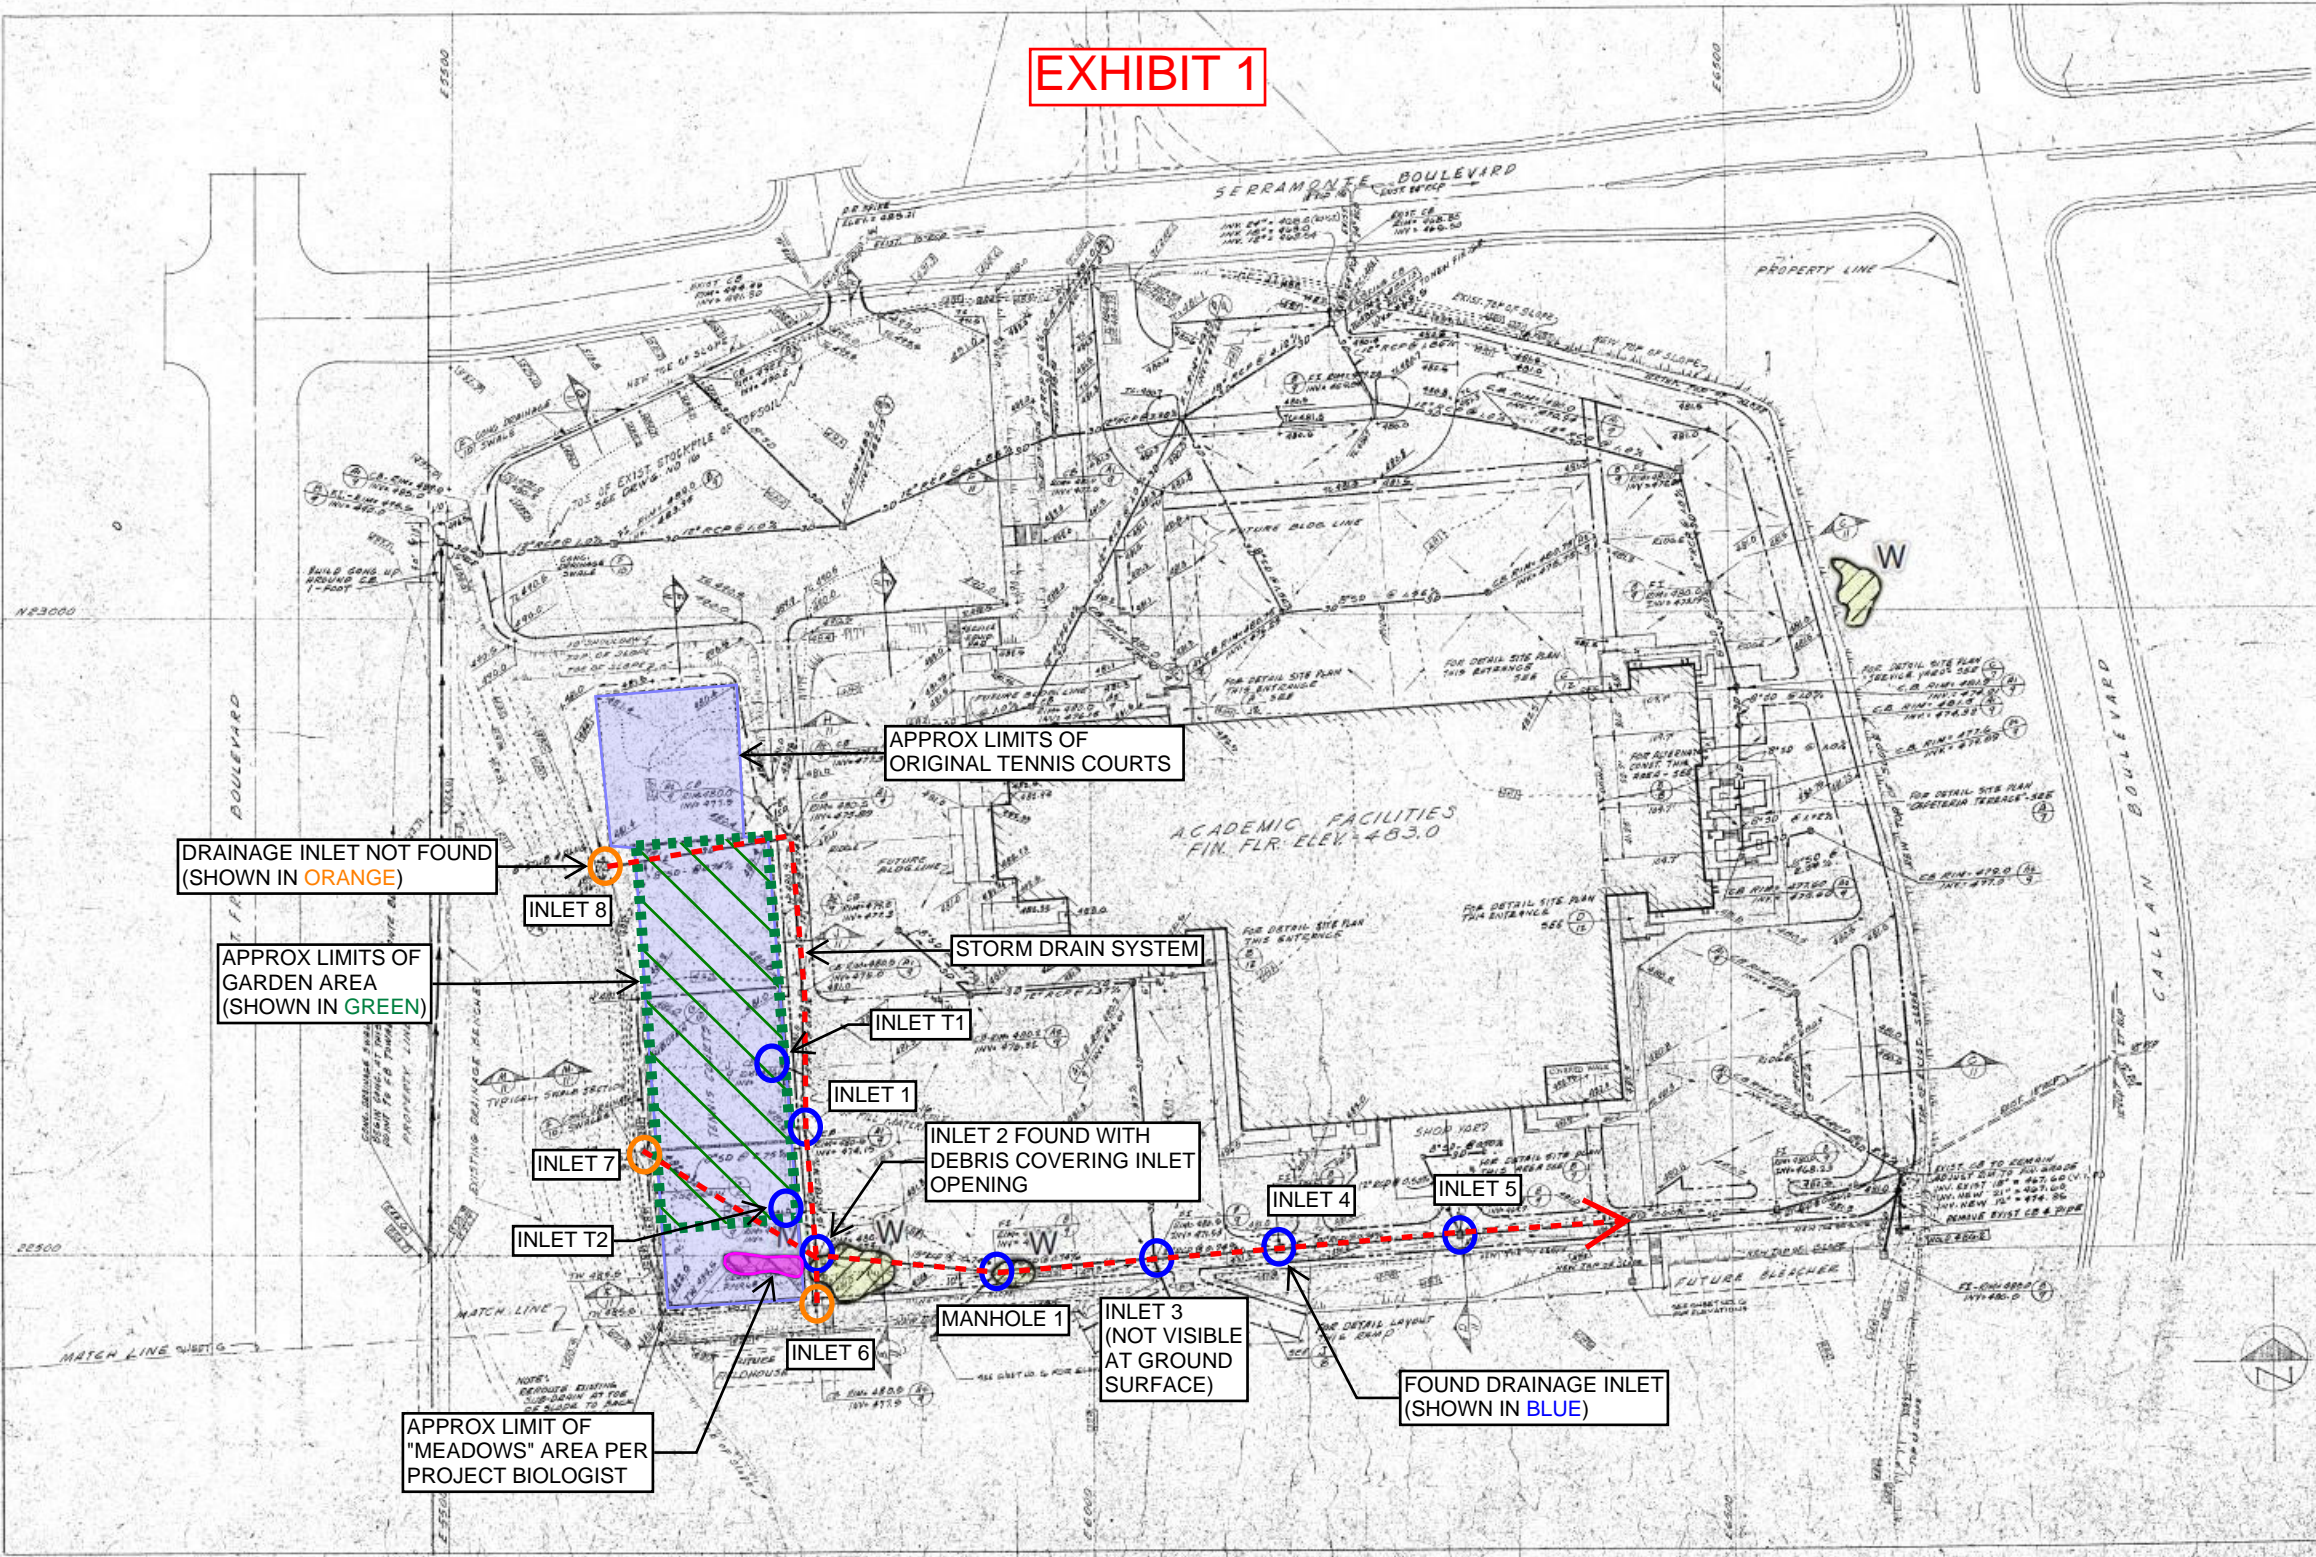
DRAINAGE INLET NOT FOUND (SHOWN IN ORANGE)

INLET 2 FOUND WITH DEBRIS COVERING INLET OPENING

INLET 3 (NOT VISIBLE AT GROUND SURFACE)
