### Tree Inventory Report

**CITY OF LOS ANGELES TREE REPORT  
1811 SACRAMENTO STREET  
LOS ANGELES, CALIFORNIA 90021**

**MARCH 21, 2023**

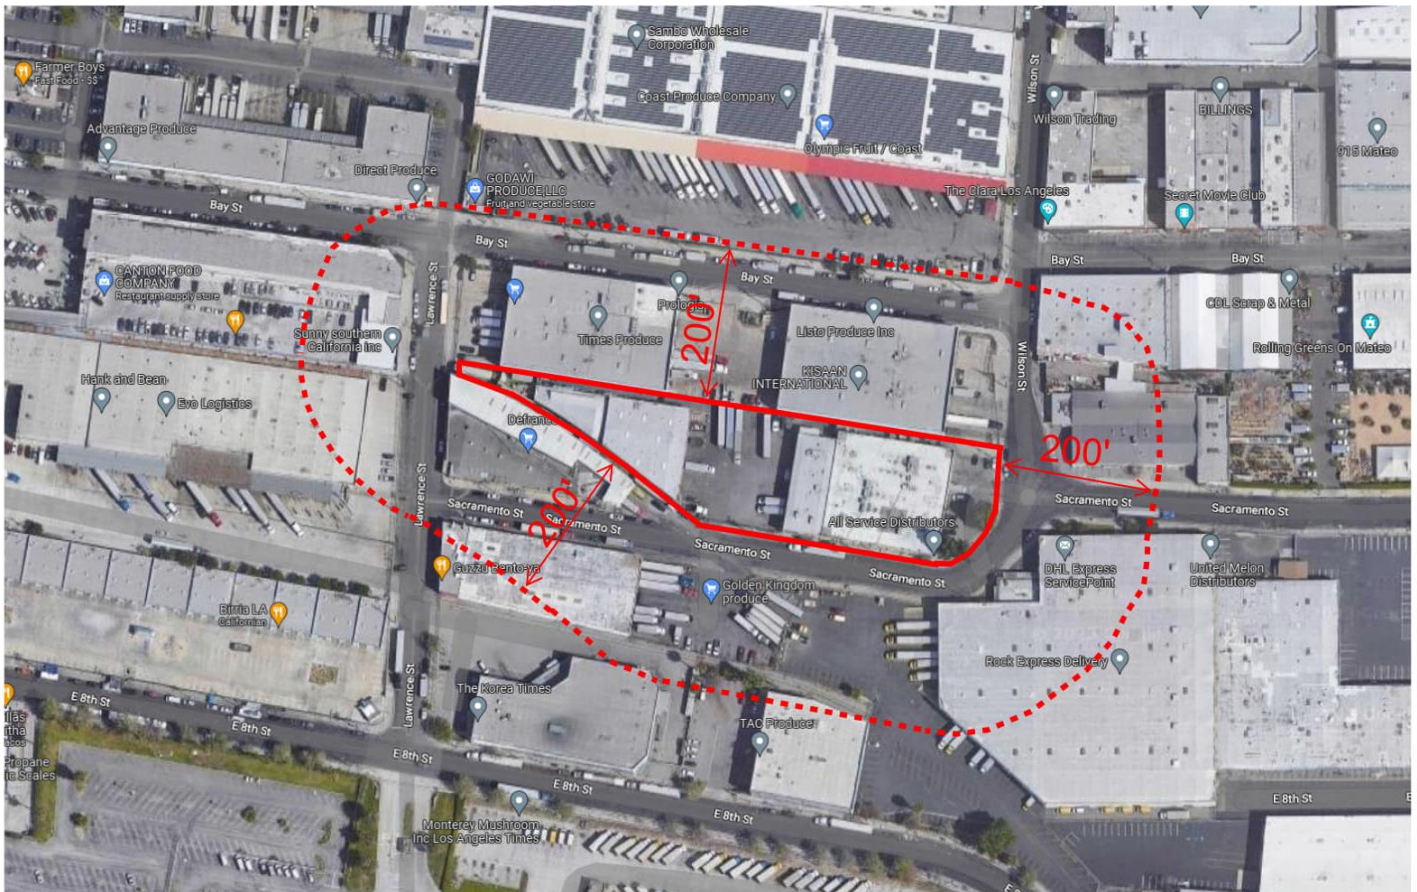
**EXHIBIT D – 200-FEET RADIUS MAP TREE EXHIBIT**

There are approximately 15 street trees and five private property trees within the 200-foot radius envelope outside the Project boundaries. None of these offsite trees will be, in our opinion, affected by the Project's grading or construction activities. (see Exhibit D).
