ARBORIST REPORT for 10635 TWIN CITIES ROAD

September 9, 2021

This arborist report is required for the proposed subdivision of 10635 Twin Cities Road, APN 148-0730-015, owners Wade and Beverly Hammonds, into two parcels. It is for the requirements of the Sacramento County Tree Preservation Ordinance which shall be submitted to Planning and Environmental Review in order to evaluate project impacts and create appropriate mitigation pursuant to Sacramento County General Plan policies and CEQA.

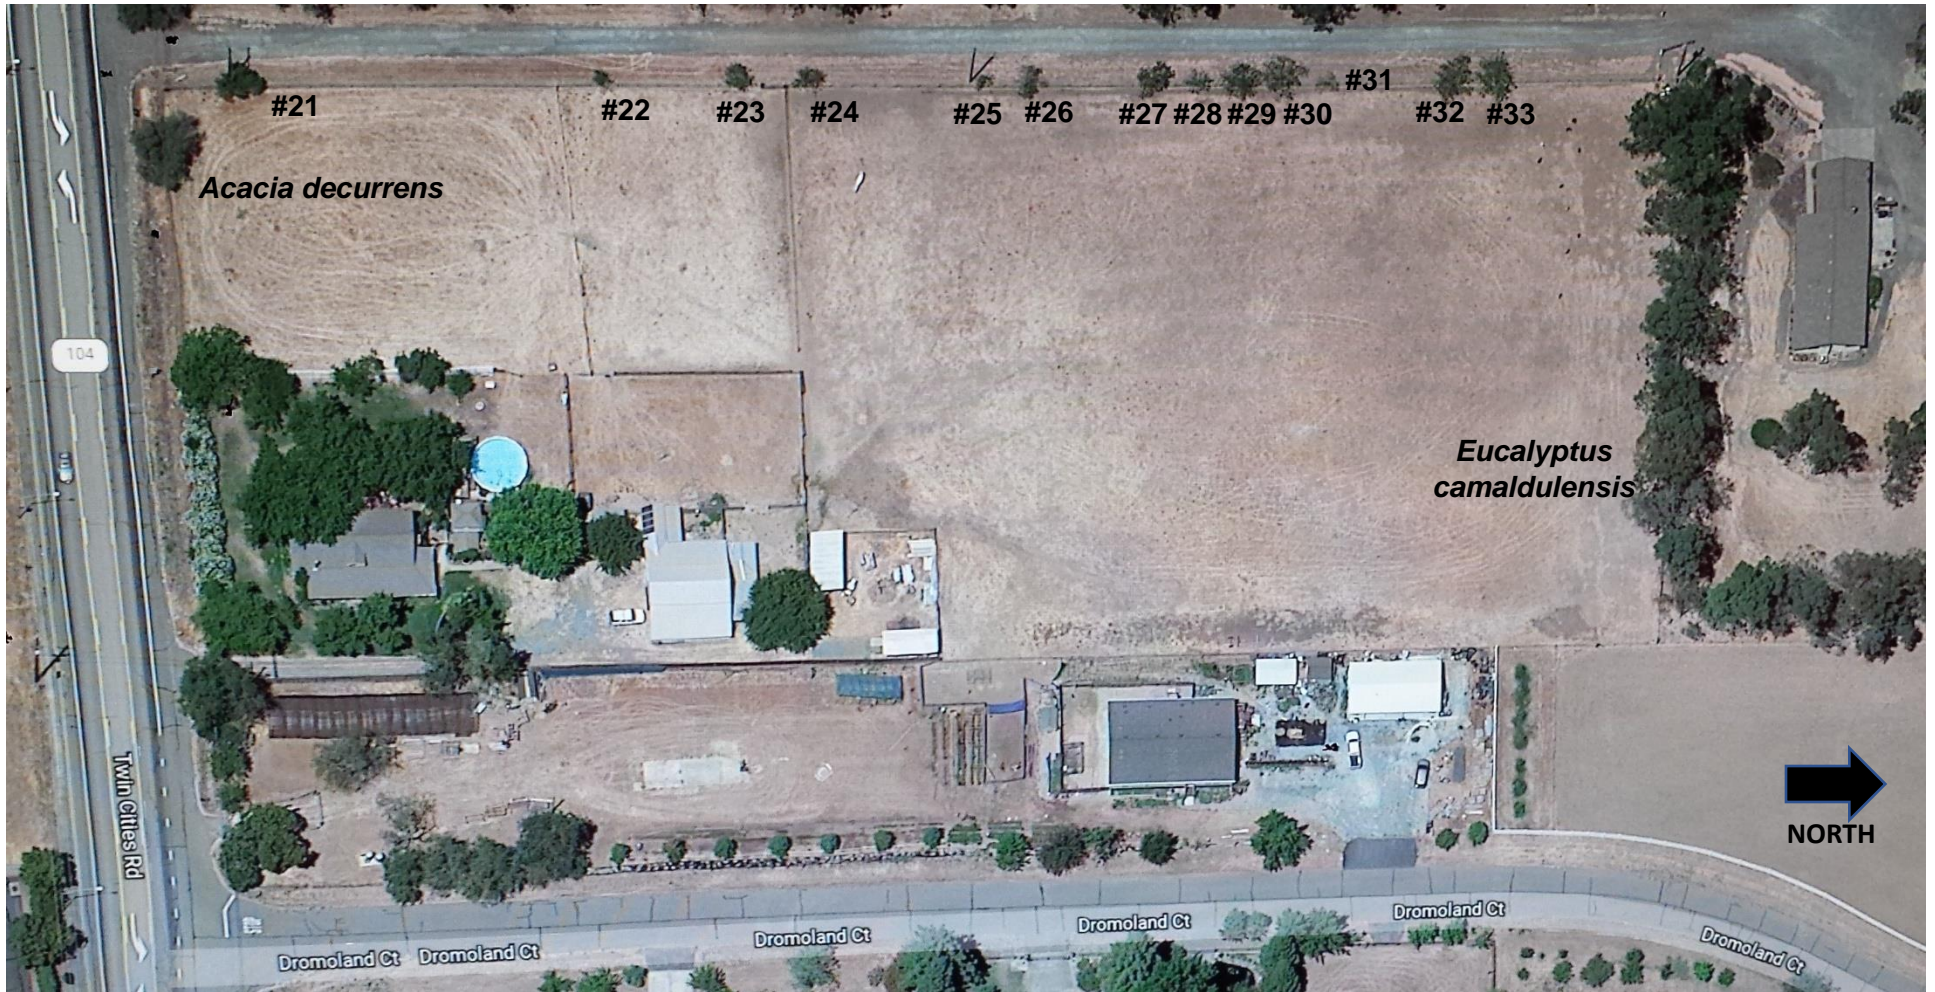
AERIAL PHOTO of 10635 TWIN CITIES ROAD, GALT, CA95632, APN 148-0730-015.

This is an aerial photo of the Hammonds property at 10635 Twin Cities Road, Galt, CA 95632, APN 148-0730-015. This is a copy from Google Earth dated 6/04/2021. It also shows the adjacent property, 10619 Twin Cities Road, Galt, CA 95632, APN 148-0730-013, with the driveway to the west or top of picture and the house and River Red Gum (*Eucalyptus camaldulensis*) screen between the house and north property line to the right of the picture. The group of Green Wattle Acacias (*Acacia decurrens*) is visible along Twin Cities Road in the upper left-hand corner of the picture. Along the driveway are located the thirteen (13) native Northern California Black Walnuts (*Juglans californica v. hindsii*).
