**UPDATED GEOTECHNICAL INVESTIGATION  
VALLE VERDE AND HERITAGE HOUSE PROJECTS  
NAPA, CALIFORNIA**

Project 1687.01

Prepared for:  
Burbank Housing Development Corporation  
790 Sonoma Avenue  
Santa Rosa, California 95404

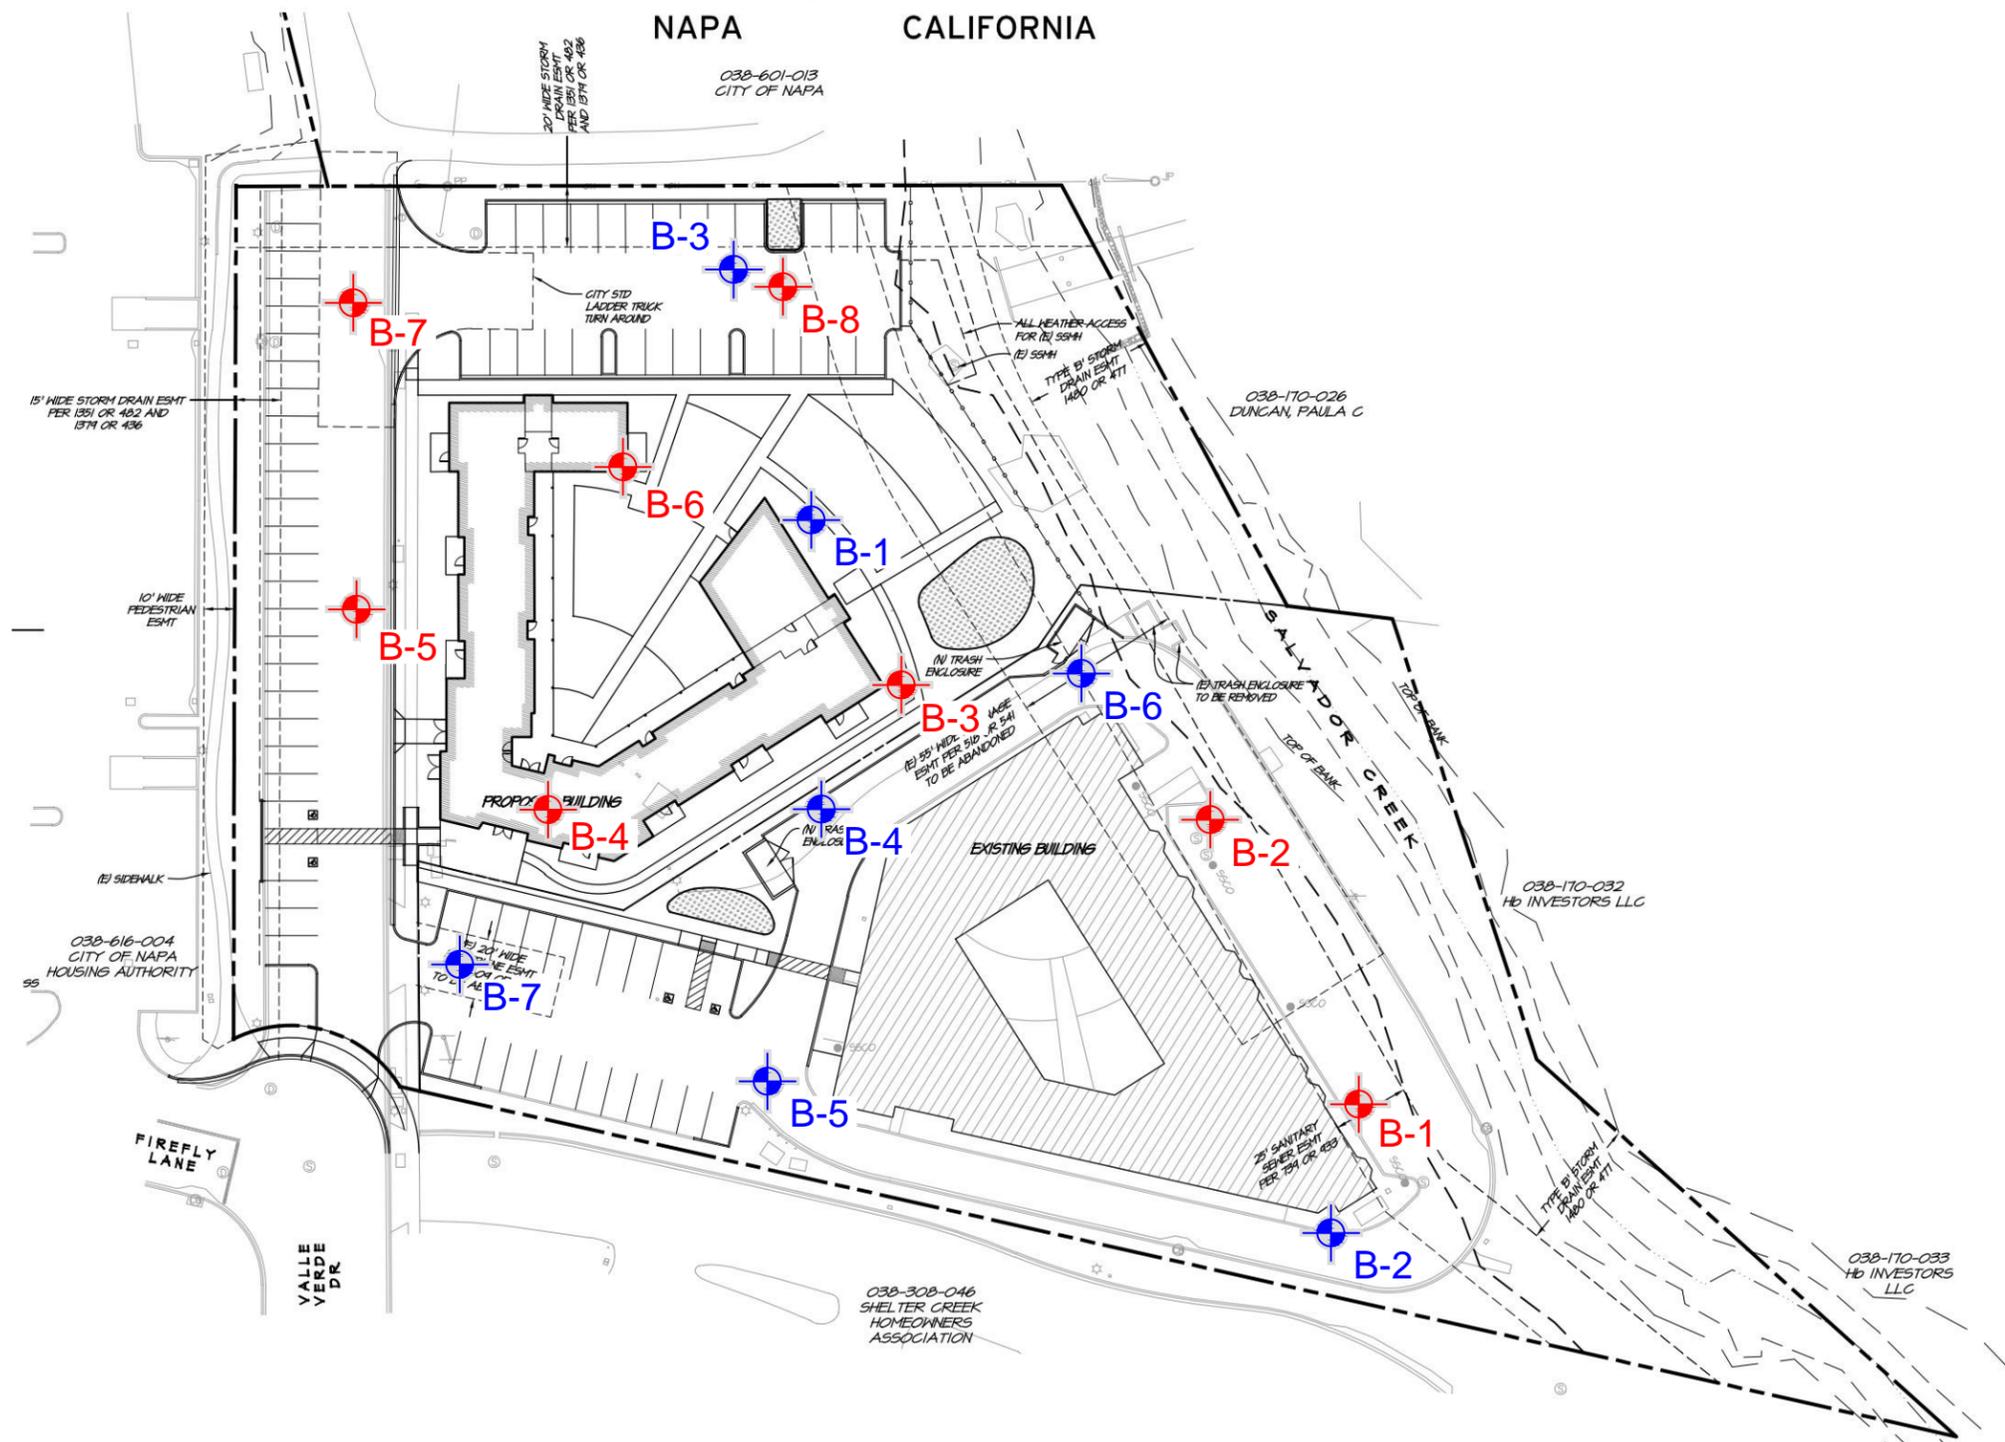
FIGURE

- Approximate location of boring completed by MPEG, 2018
- Approximate location of boring completed by MPEG, 2010

In addition, we previously explored the subsurface conditions on the project site on December 9, 2010, with seven exploratory soil borings drilled with truck-mounted drilling equipment to a maximum explored depth of 31.5-feet below the ground surface. The approximate locations of our previous borings are shown on Figure 2 and the boring logs are presented in Appendix B.

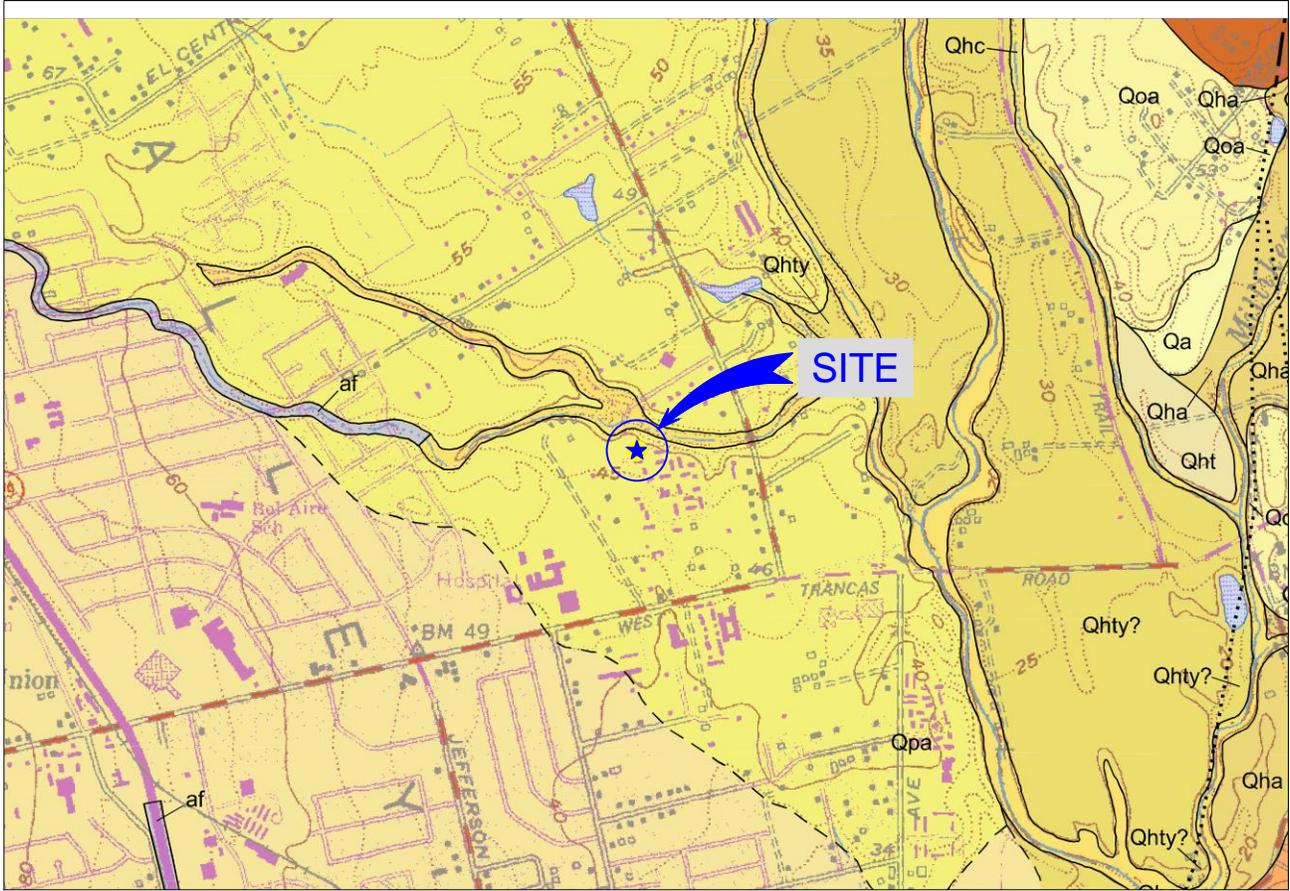
**REGIONAL GEOLOGIC MAP**  
(NOT TO SCALE)

<b>MILLER PACIFIC</b> <b>ENGINEERING GROUP</b>	504 Redwood Blvd. Suite 220 Novato, CA 94947 T 415 / 382-3444 F 415 / 382-3450 www.millerpac.com	<b>REGIONAL GEOLOGIC MAP</b>  Valle Verde Development Napa, California	Drawn _____ MMT Checked _____
	A CALIFORNIA CORPORATION, 2018, ALL RIGHTS RESERVED FILENAME: 1687.010 Figures.dwg	Project No. 1687.01      Date: 10/16/2018	<b>3</b> FIGURE

Our subsurface exploration generally confirms the regionally-mapped geologic conditions at the site. The project site is underlain by alluvial deposits variously composed of medium stiff to very stiff clay with silt, sand, and gravel interbedded with occasional lenses of clayey and sandy gravel.

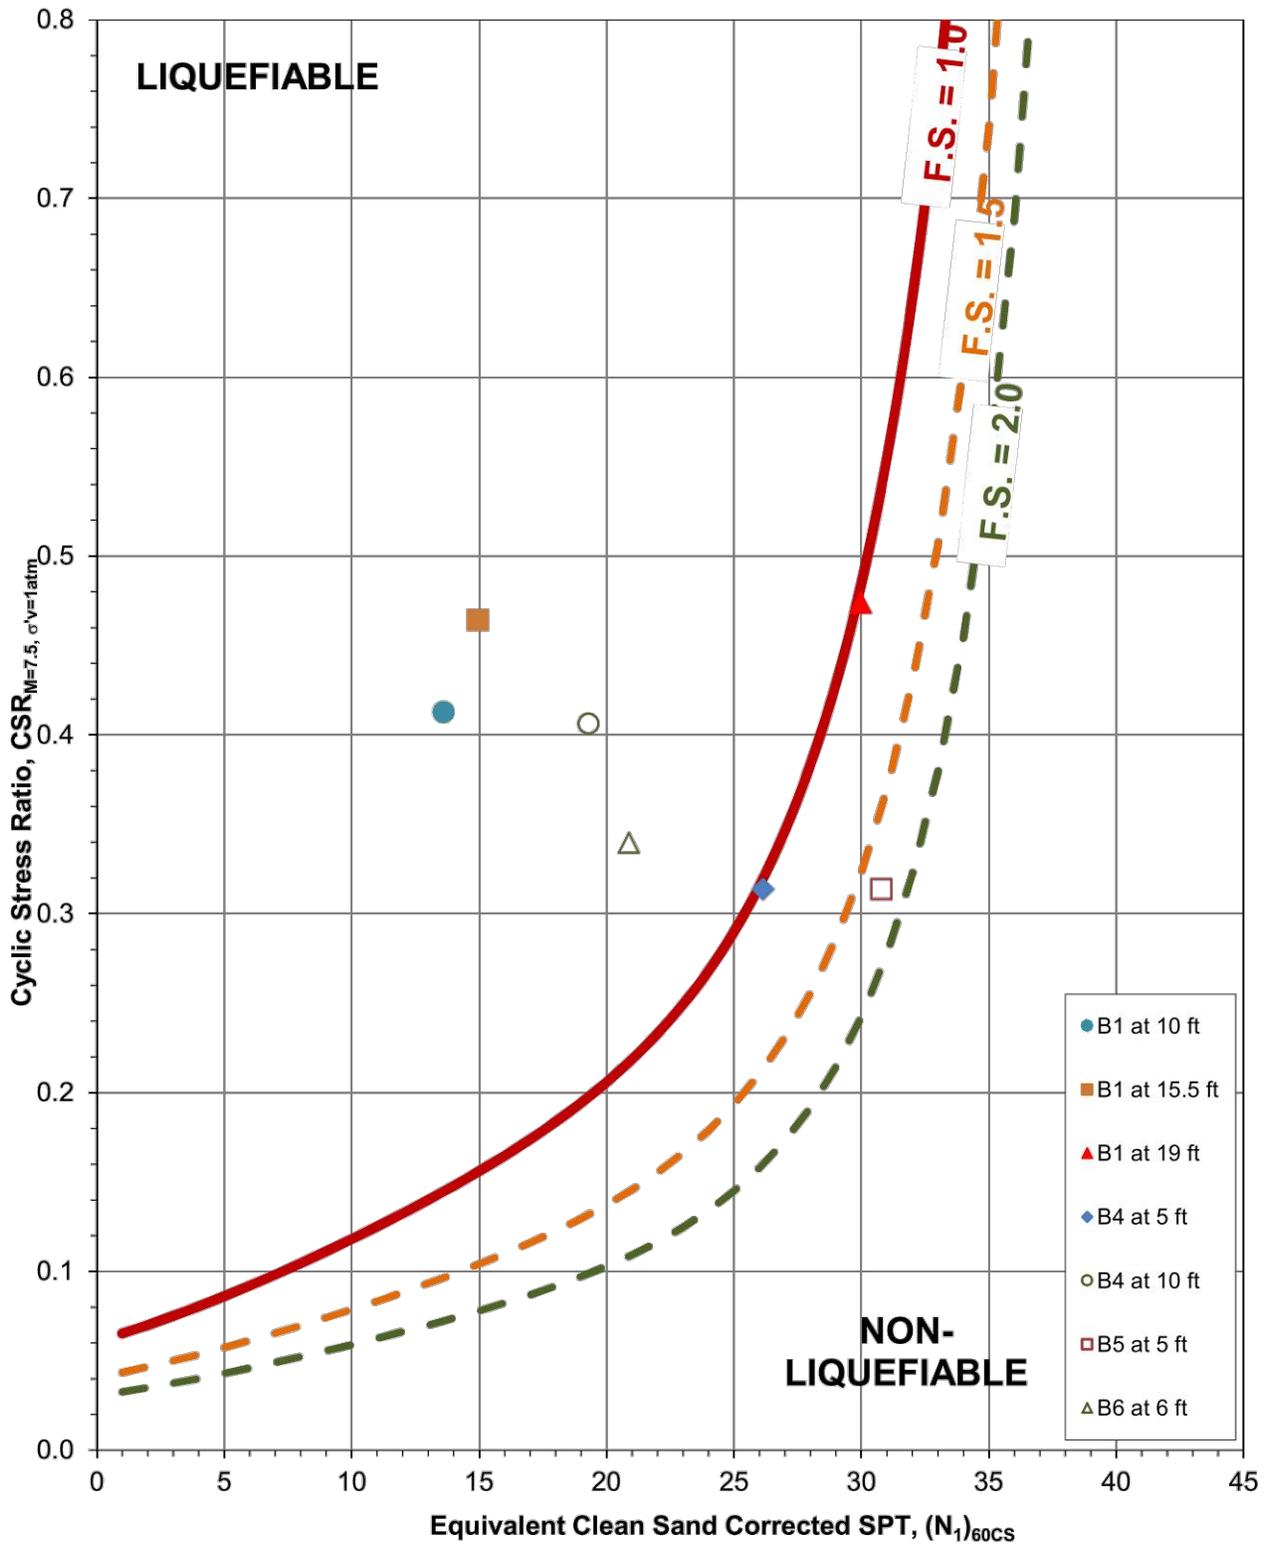
**Liquefaction Analysis**  
(Idriss, I.M. & Boulanger, R.W., 2008 & 2010)

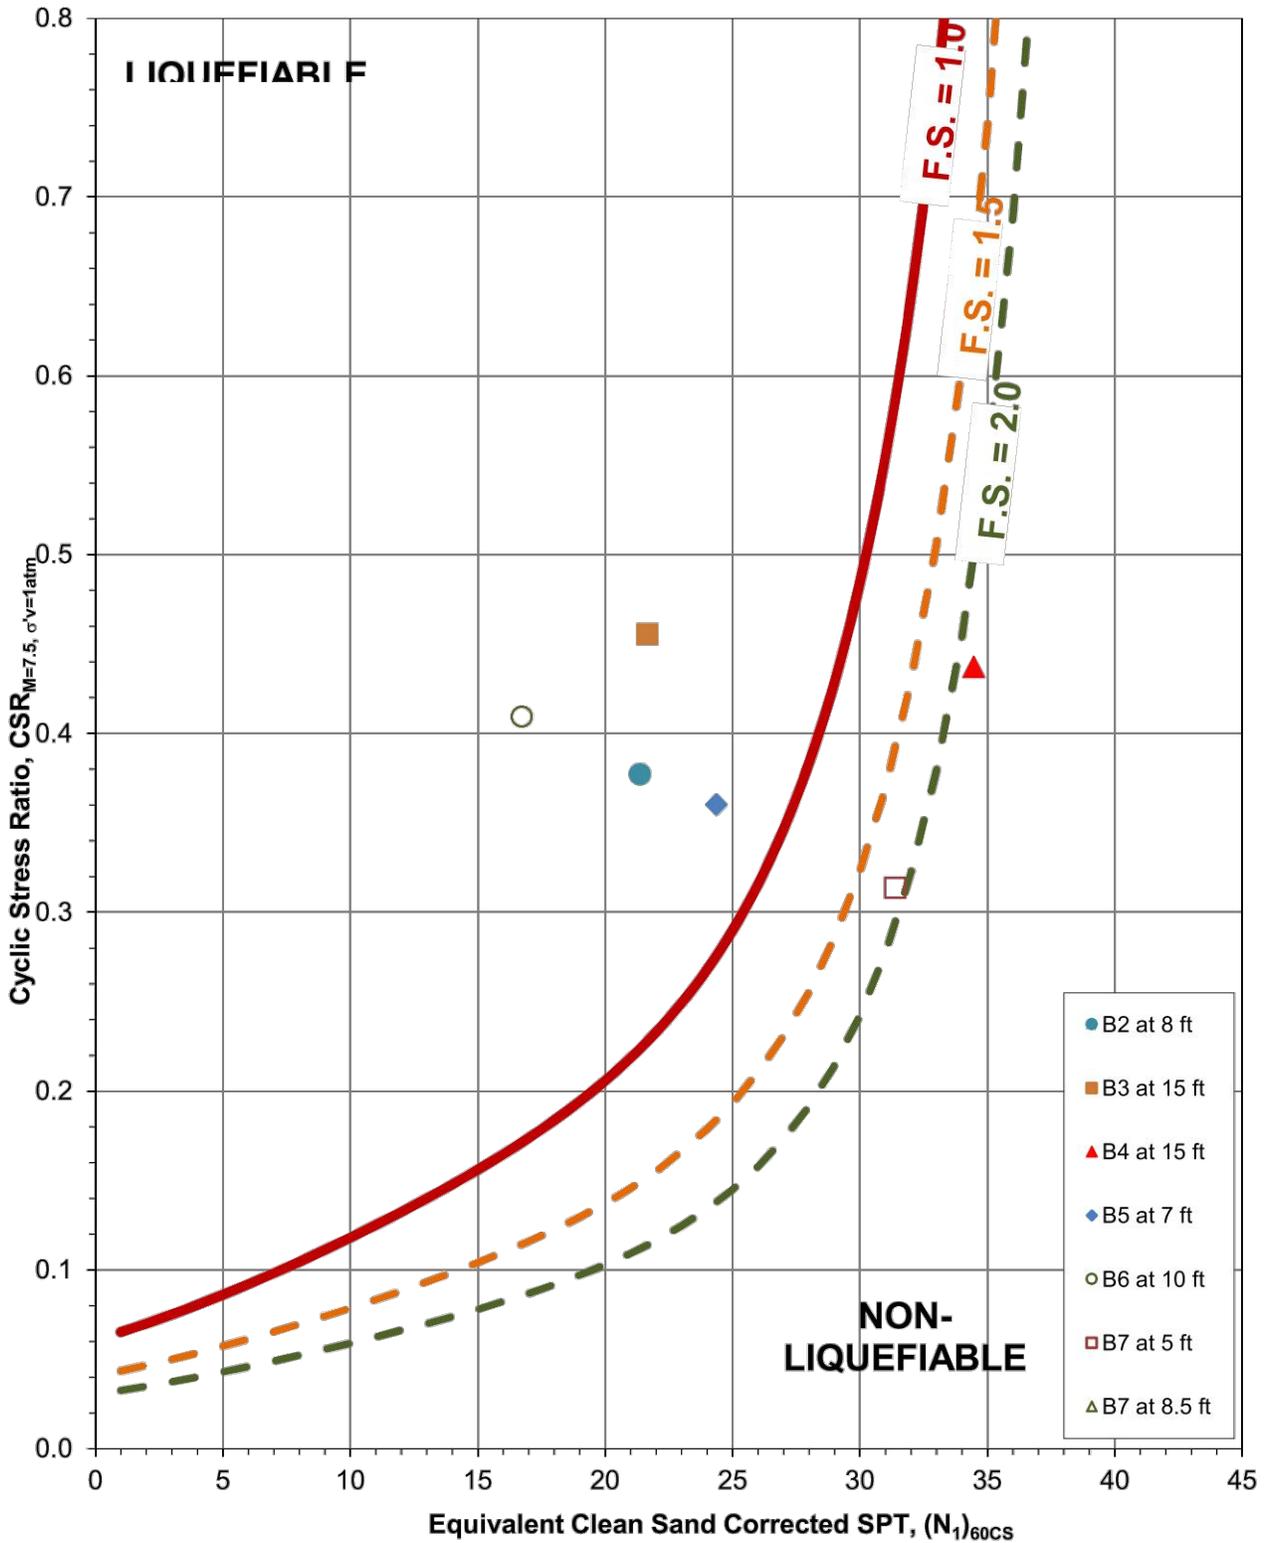
**Liquefaction Analysis**  
 (Idriss, I.M. & Boulanger, R.W., 2008 & 2010)

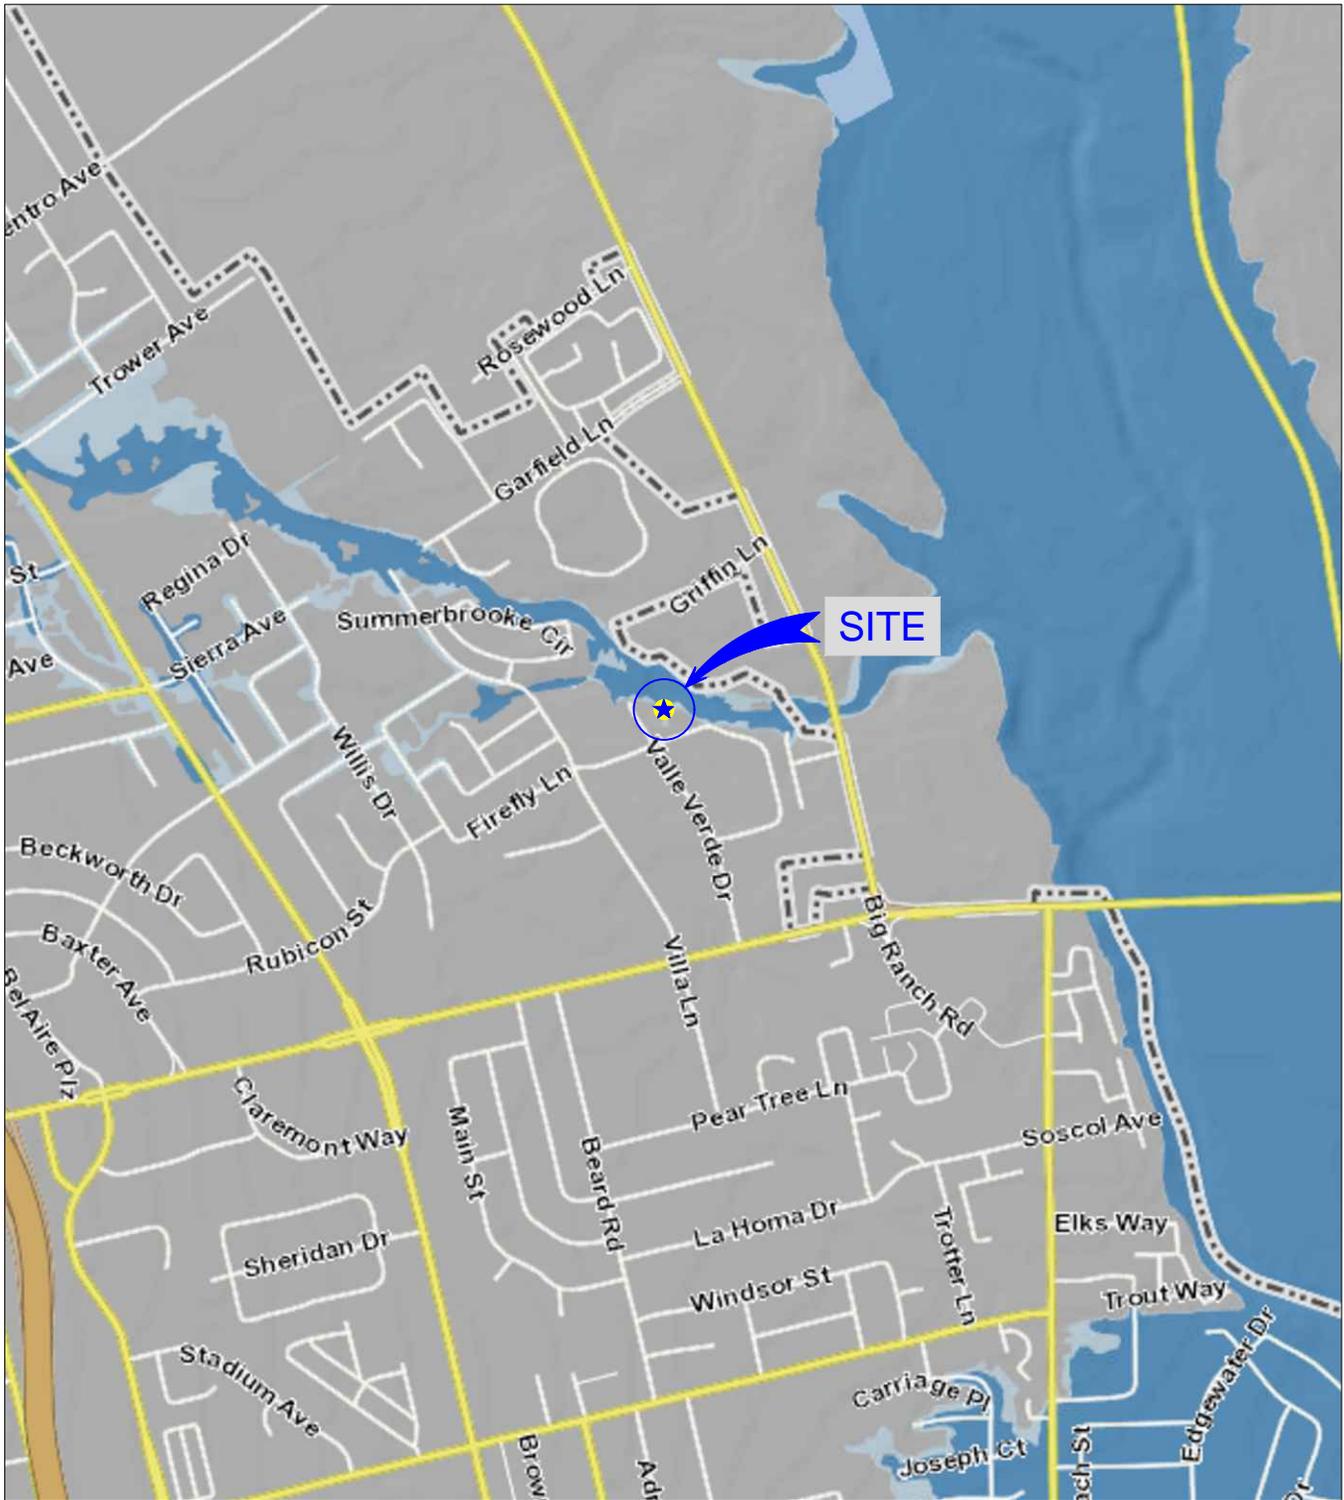
Flood Hazard Area:

- Zone V - 100yr.
- Zone X - 500yr.
- Zone A - 100yr.
- Urbanized Area

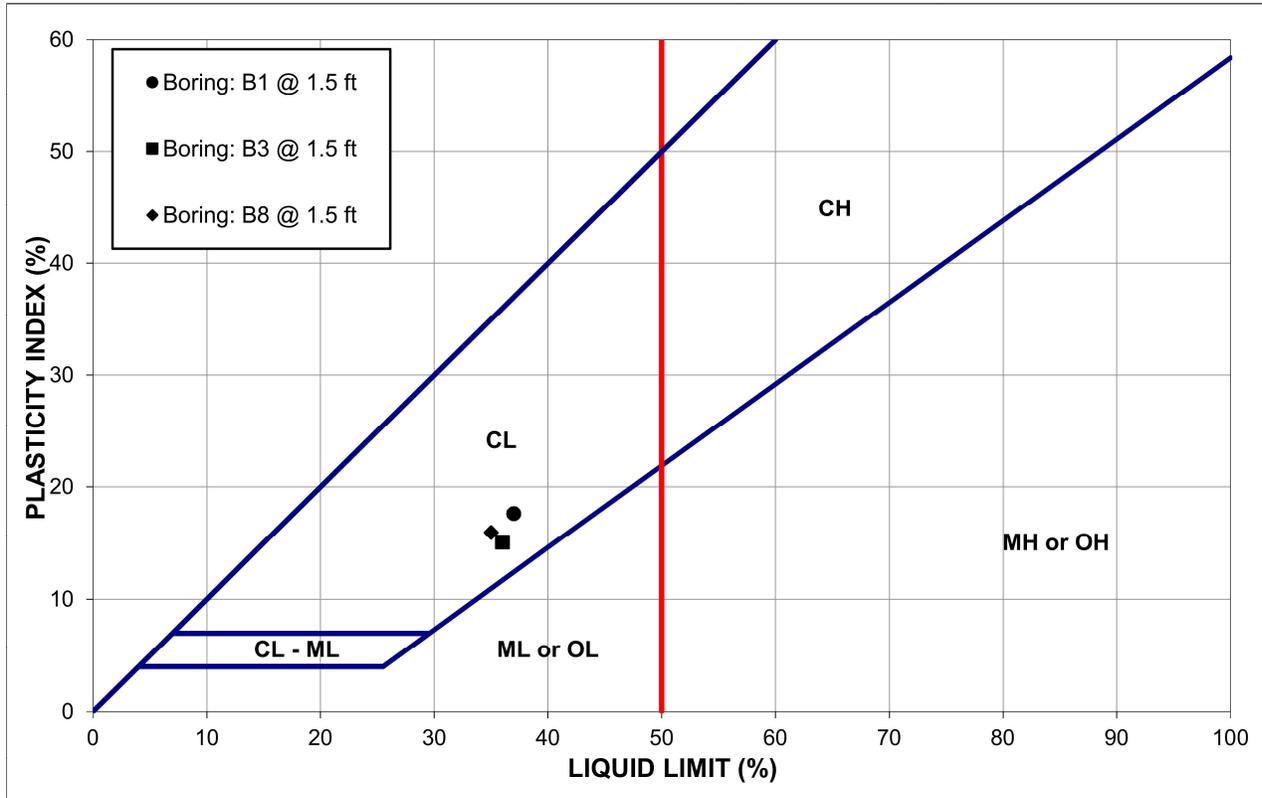
## ATTERBERG LIMITS TEST (ASTM D 4318)

Sample	Classification	Liquid Limit (%)	Plastic Limit (%)	Plasticity Index (%)
Boring: B1 @ 1.5 ft	Sandy CLAY (CL) gray mottled orange	37	19	18
Boring: B3 @ 1.5 ft	Sandy CLAY with Gravel (CL) medium brown	36	21	15
Boring: B8 @ 1.5 ft	Sandy CLAY with Gravel (CL) medium brown	35	19	16

PI = 0-3: Non-Plastic  
 PI = 3-15: Slightly Plastic  
 PI = 15-30: Medium Plasticity  
 PI = >30: High Plasticity

Laboratory testing of select soil samples included determination of moisture content, dry density, unconfined compressive strength, percent passing the #200 sieve, and plasticity index. The results of the moisture content, dry density, unconfined compressive strength, and percent passing #200 sieve tests are presented on the boring logs. The results of the plasticity tests are presented on Figure A-15. The laboratory testing program is discussed in further detail in Appendix A.

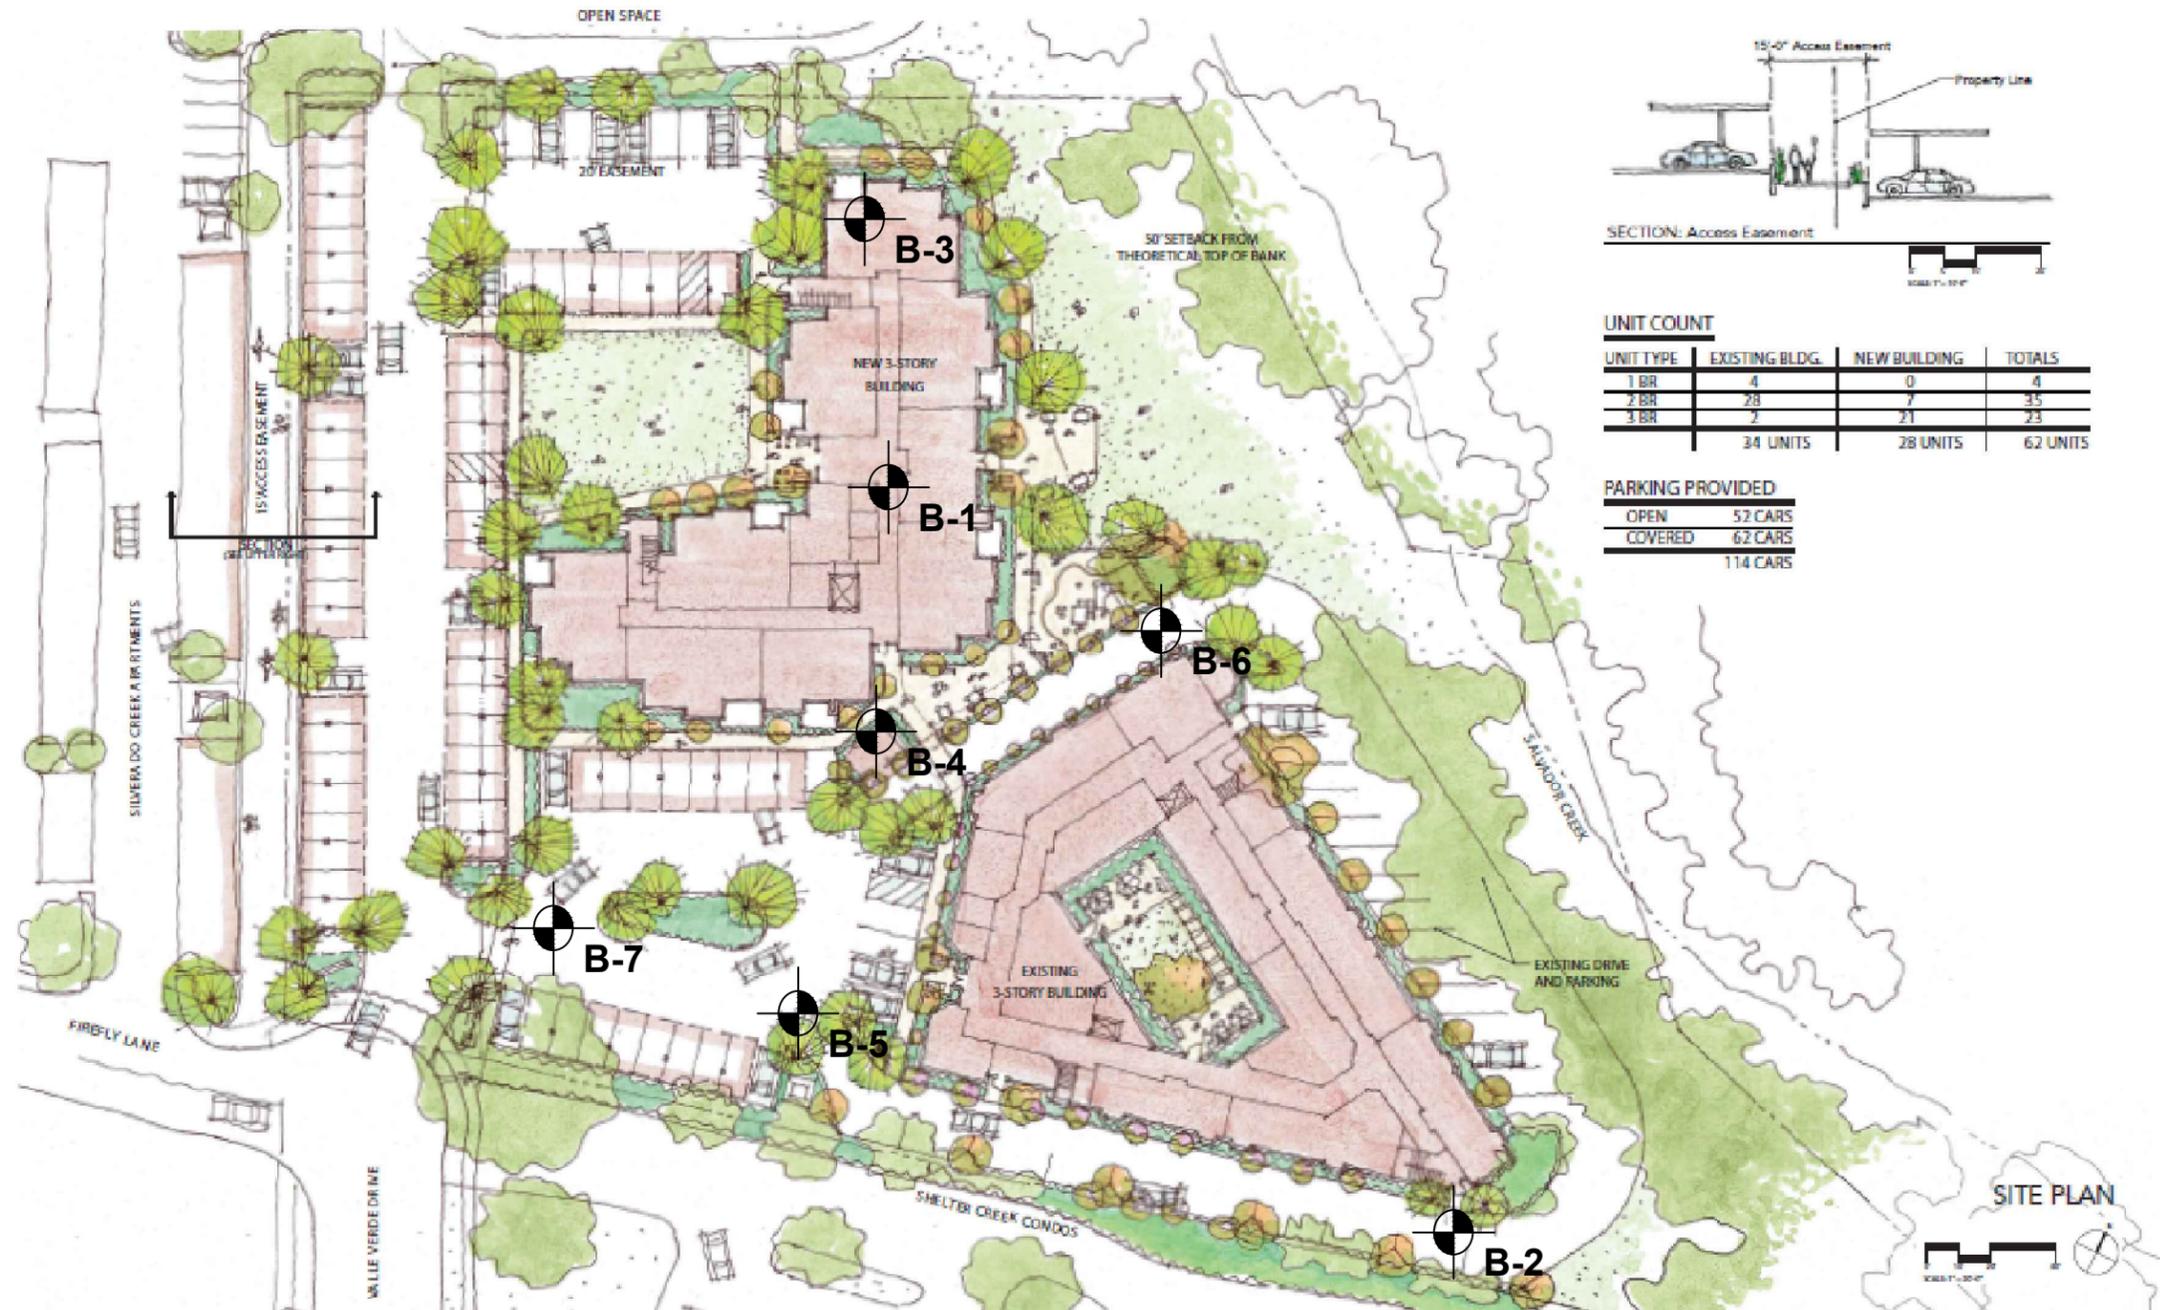
**2**  
FIGURE

**UNIT COUNT**

UNIT TYPE	EXISTING BLDG.	NEW BUILDING	TOTALS
1 BR	4	0	4
2 BR	28	7	35
3 BR	2	21	23
	34 UNITS	28 UNITS	62 UNITS

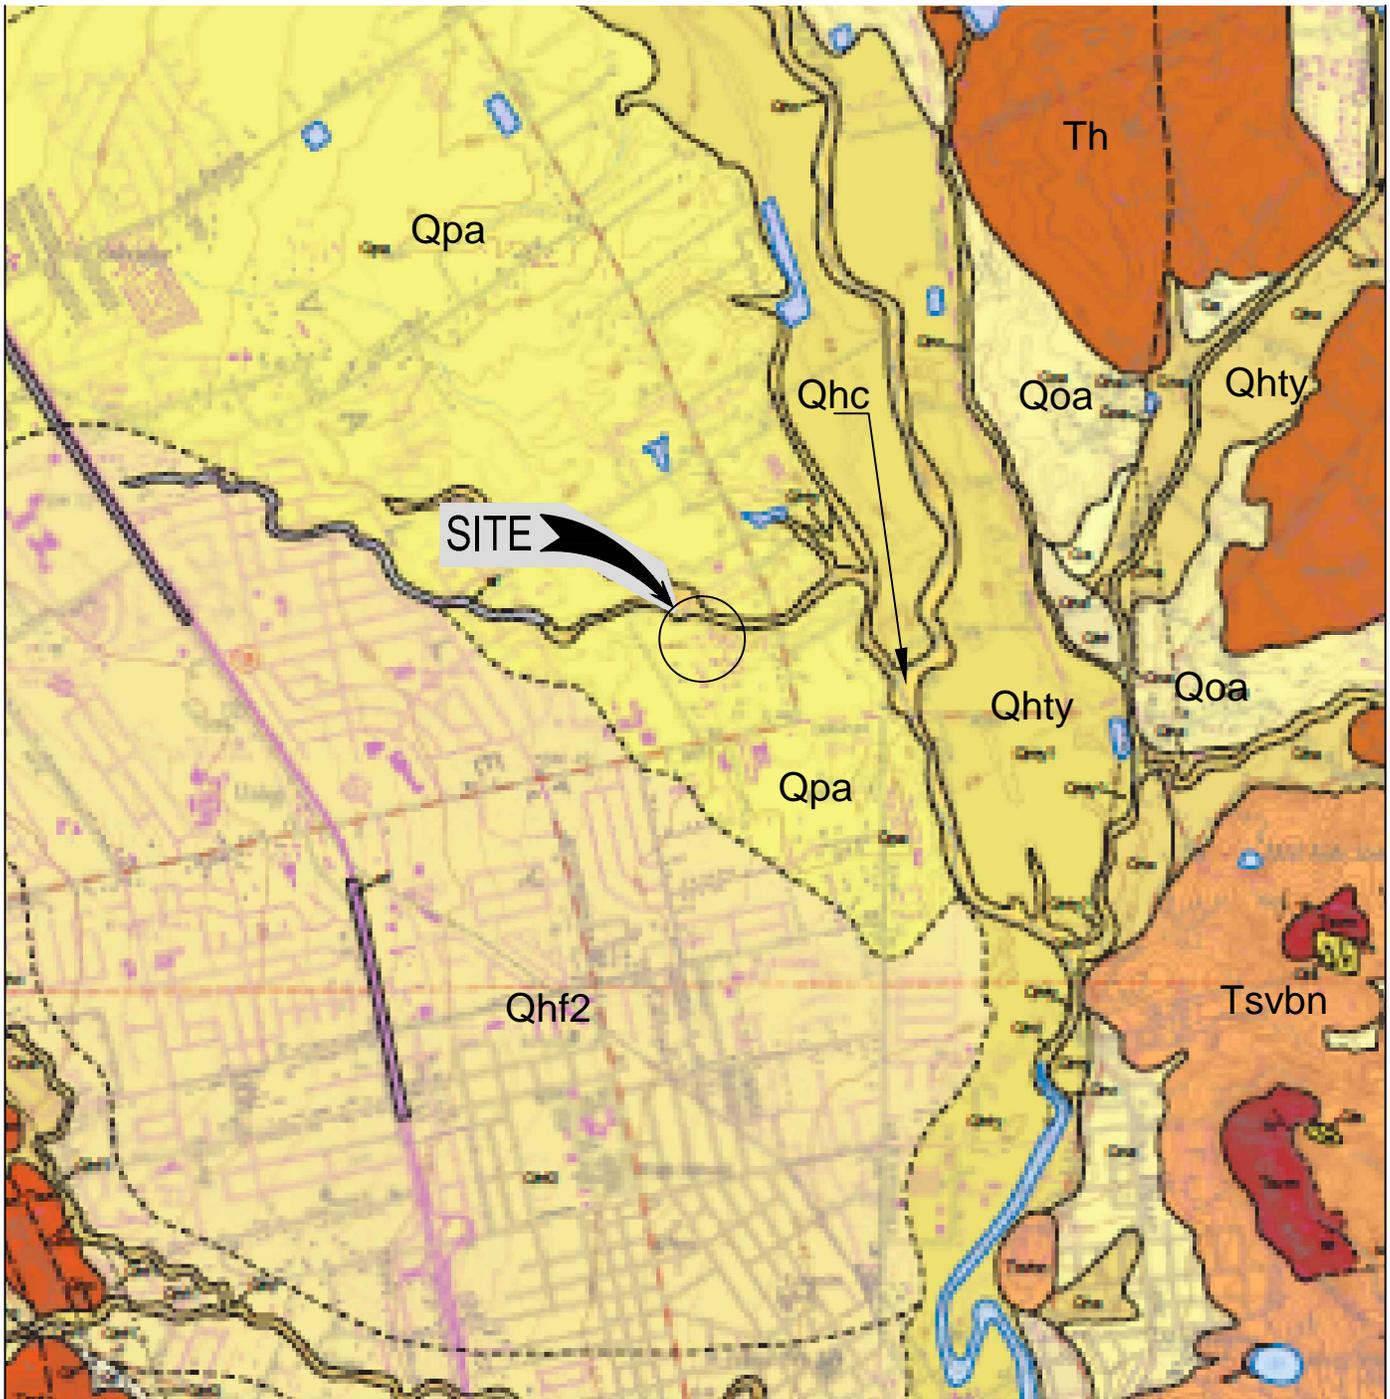
**Key:**

- Qpa** Alluvium, undivided (latest pleistocene)- Alluvium fan, stream terrace, basin, and Channel deposits, composed of poorly to moderately sorted sand, silt, clay and gravel.
- Qhty** Stream terrace deposits (Latest Holocene) Stream terrace deposited as point bar and over bank deposits along napa river, composed of moderately sorted clayey sand and sandy clay with gravel.
- Qhc** Stream Channel deposits (Latest Holocene < 1,000 years) Deposits in active, natural stream, channels, consist of loose alluvial sands and silts.

<b>Miller Pacific</b> ENGINEERING GROUP	1333 N. McDowell Blvd.	<b>GEOLOGICAL MAP</b>	
	Suite C	Bridge Housing Valle Verde Dr. Napa, California	
A CALIFORNIA CORPORATION, © 2010, ALL RIGHTS RESERVED FILE: 1687.01GM.dwg	Petaluma, CA 94954	Drawn <u>JBG</u>	<div style="font-size: 2em; font-weight: bold;">3</div> FIGURE
	T 707 / 765-6140 F 707 / 765-6222	Checked <u>JJR</u>	
	www.millerpac.com	Project No. 1687.01	Date: 12/21/10

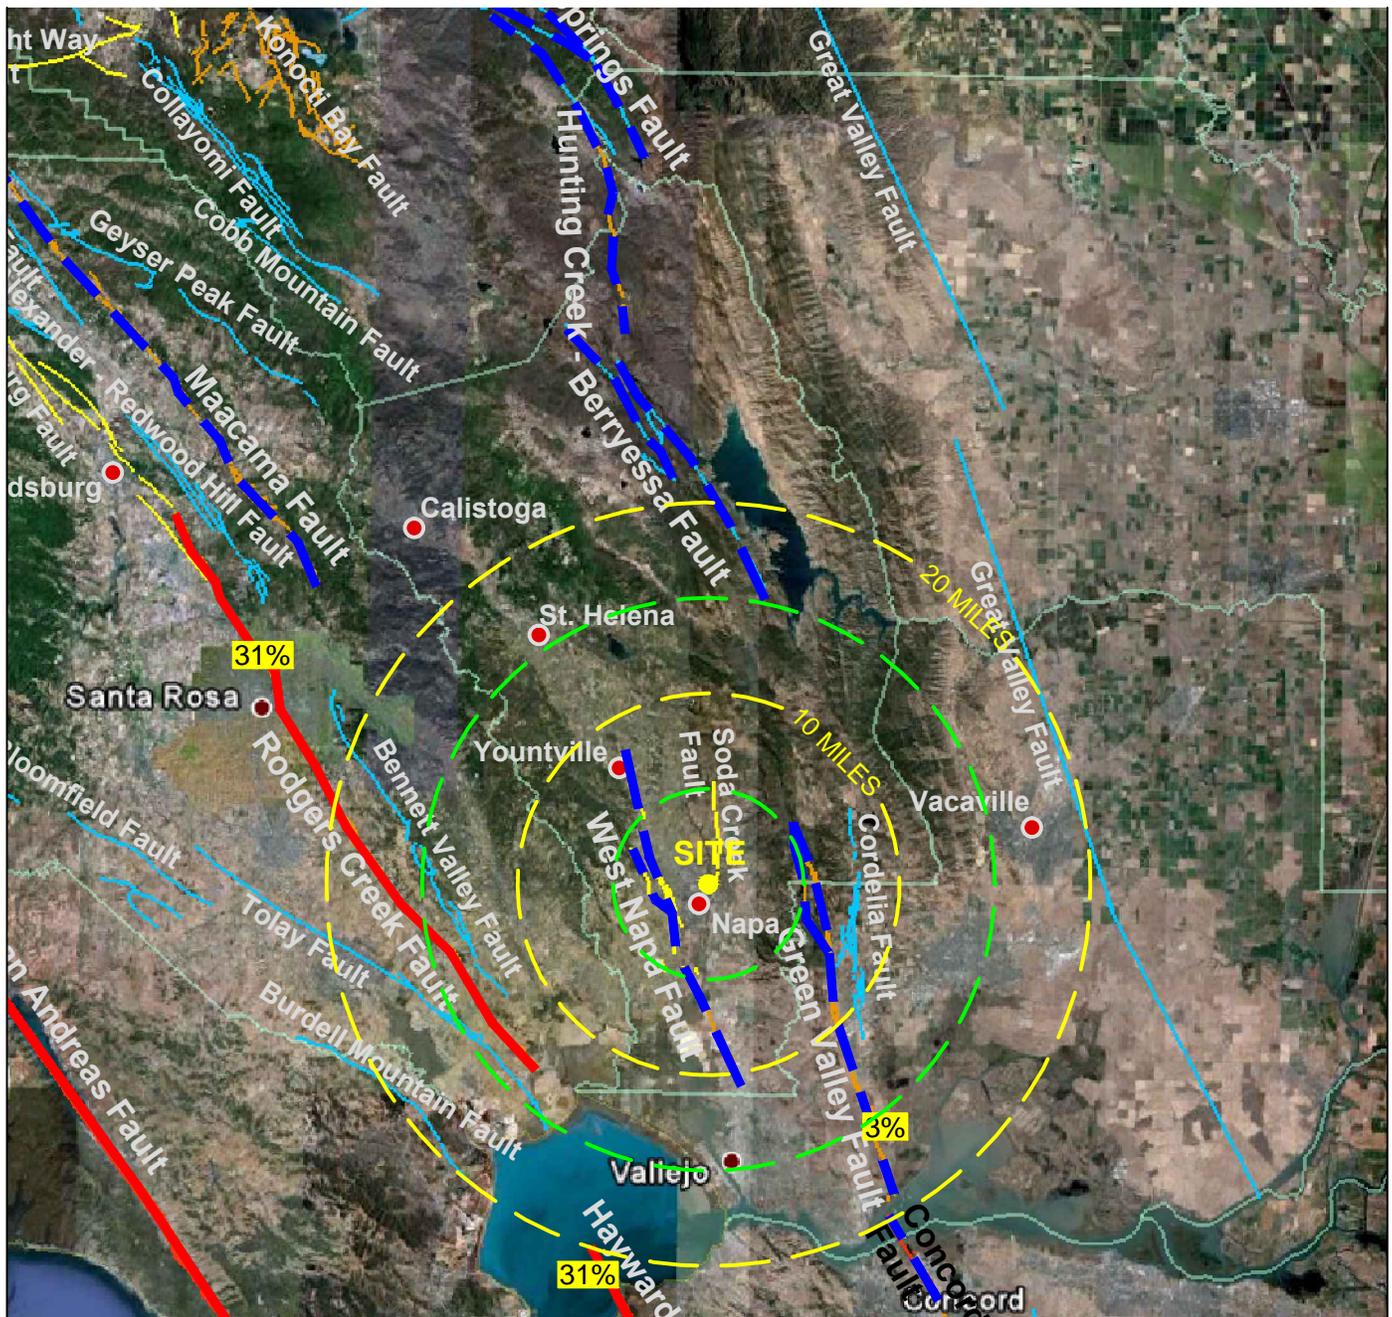
**LEGEND**

FAULT	TYPE	CBC DESCRIPTION
	"A"	CAPABLE OF LARGE MAGNITUDE EARTHQUAKES AND HIGH RATE OF SEISMIC ACTIVITY
	"B"	CAPABLE OF LARGE MAGNITUDE EARTHQUAKES OR HIGH RATE OF SEISMIC ACTIVITY

The site will likely experience seismic ground shaking from future earthquakes in the San Francisco Bay Area. Earthquakes along several active faults in the region, as shown on Figure 4, could cause strong ground shaking at the site.
