**GEOTECHNICAL REPORT  
THE INN AT SUNSET CLIFFS  
SAN DIEGO, CALIFORNIA**

Prepared for  
**PROJECT DESIGN CONSULTANTS**  
San Diego, California

Prepared by  
**TERRACOSTA CONSULTING GROUP, INC.**  
San Diego, California

Project No. 2317-01  
December 24, 2020

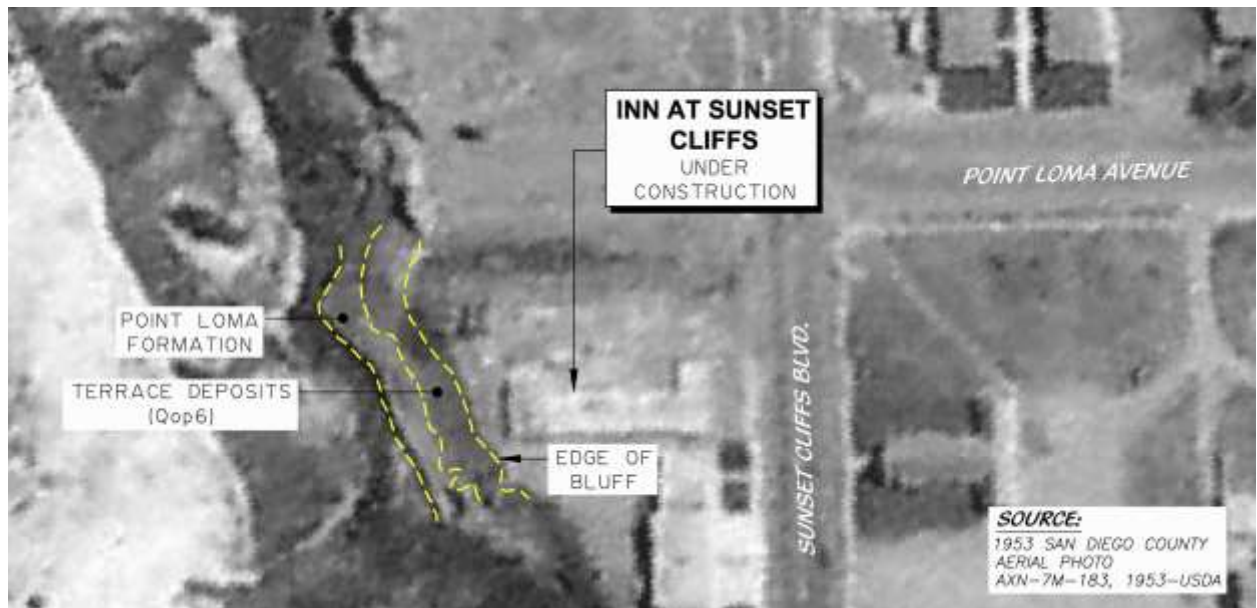
Photo 1

We have reviewed several historical photos dating back to 1939. The below 1953 aerial photo shows The Inn under construction and the seawall and lower viewing area constructed concurrently (Photo 1). Thus, all of the existing improvements pre-date the California Coastal Act.

1953 Aerial

In examining Figure 2, which shows the existing top-of-bluff from both GEI's and TerraCosta's measurements, the minimum distance from the top-of-bluff to the southwestern corner of the southern building is approximately 13 feet measured from GEI's reported top-of bluff, and only 8 feet measured from the 1953 aerial photograph (Photo 1).

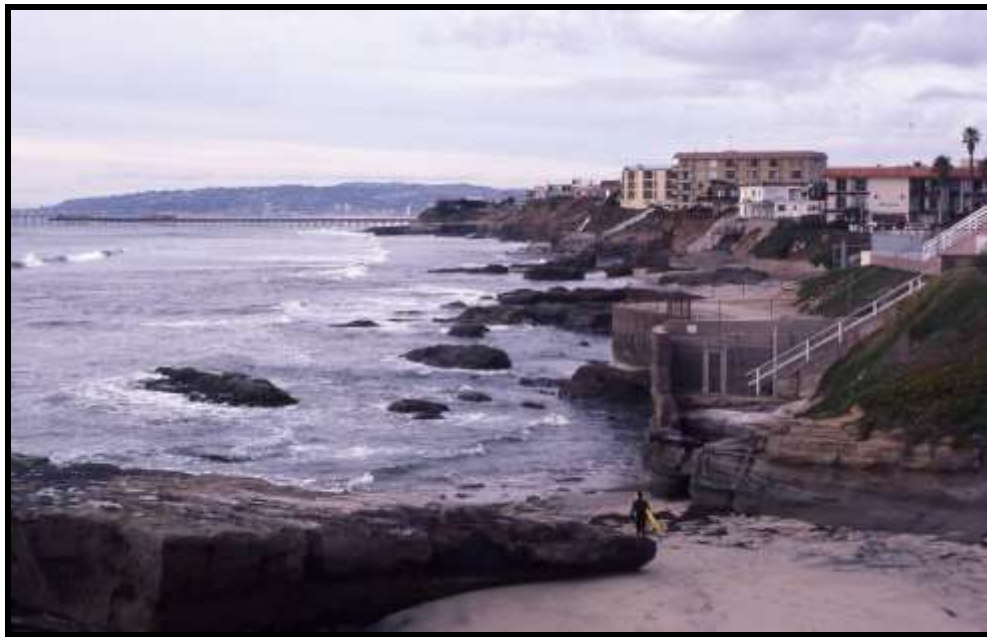
**Photo 2**

Photos taken from 1978 through 1982 during the construction of the Sunset Cliffs Shoreline Stabilization Project show the lower cliff-forming bedrock unit (Photos 2 and 3), the top of which is estimated to be near elevation +5 to +12 feet (MSL), on top of which the variable height masonry block wall was constructed in 1953. Although relatively erosion-resistant, marine erosion has continued to cause the lower cliff-forming geologic unit to retreat, undermining the existing wall foundation in 1990, in 2003, 2015, and again in 2018, causing the localized loss of wall backfill and necessitating the previously described foundation/wall maintenance.

**Photo Date: 1982**

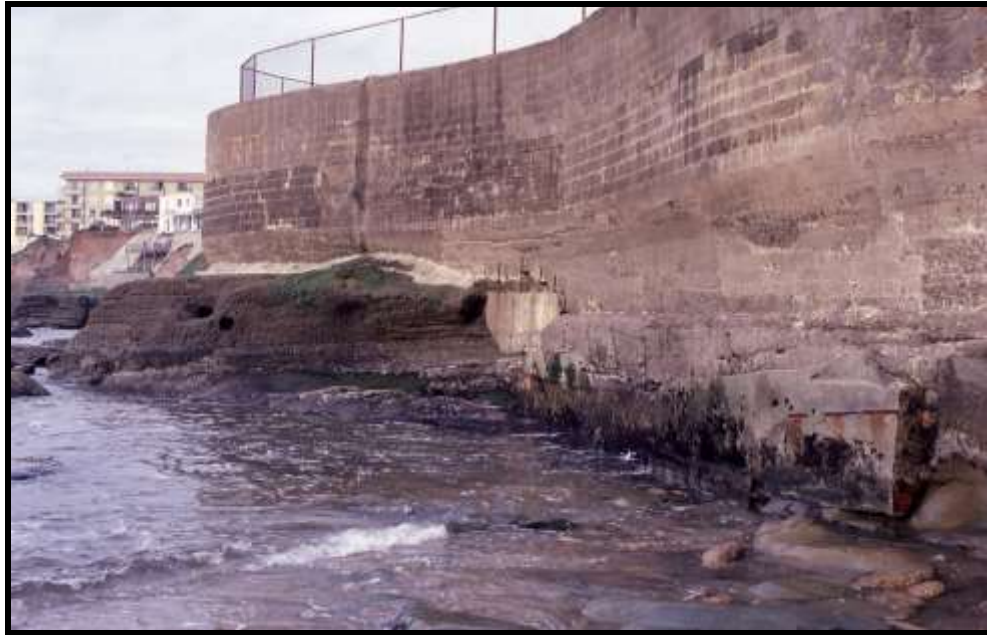
**Photo 3**

**Photo Date: 1982**

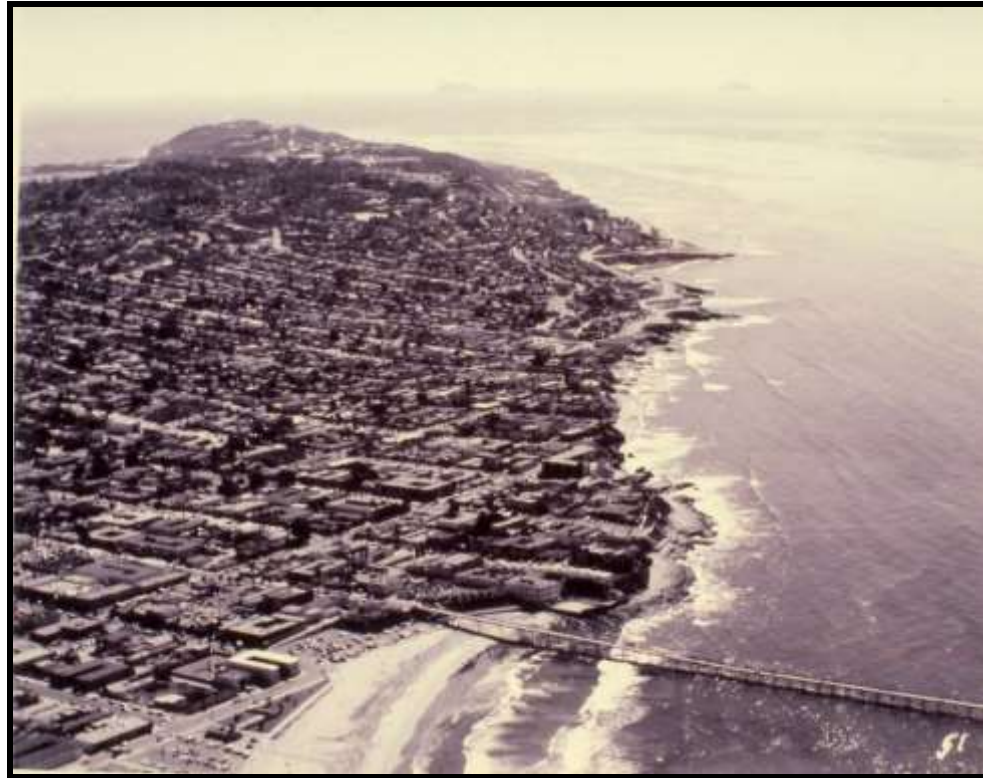
**Photo 4**

Point Loma is a 6-mile-long peninsular promontory (Photo 4), extending southerly from the low land adjacent to the mouth of the San Diego River. The Point Loma coastal bluffs are bordered by a narrow wave-abraded Quaternary-age terrace or bench, with elevations ranging from 25 to 95 feet MSL. Wave impact erosion has etched out the less resistant rock along faults and fractures in the coastal bluff, creating the shallow coves and sea caves that punctuate the Point Loma coastline. The more resistant rocks of the Point Loma Formation form the lower cliffed section of the coastal bluff and shore platform, which extends seaward. The relatively flat surface of the modern-day abrasion platform is interrupted by isolated remnants of more erosion-resistant rock, which have formed “sea stacks” and topographic highs. Further seaward, the abrasion platform becomes progressively deeper, and is locally incised by surge channels formed along the trends of major joint sets or faults.

**Photo Date: 1974**

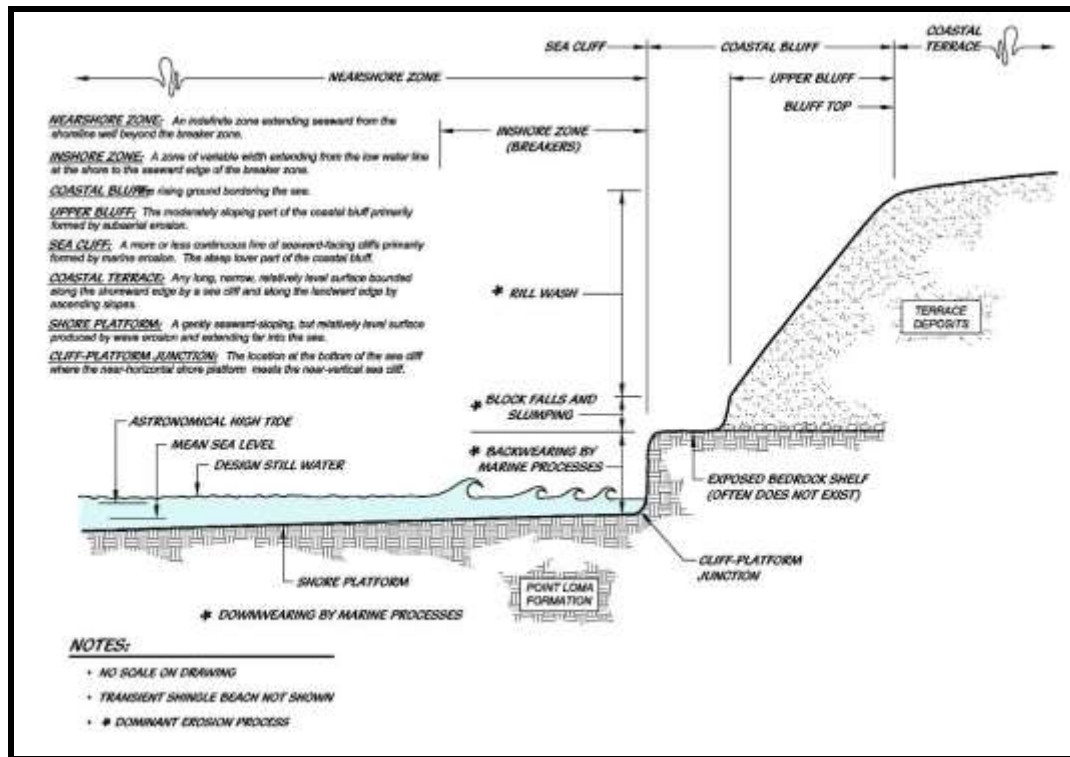
The geomorphology of a typical Point Loma sea cliff is shown in Figure 8. Depicted on Figure 8 are the shore platform, a lower, near-vertical cliffed surface called the sea cliff, and an upper-bluff slope generally ranging in inclination between 35 and 80 degrees (measured from the horizontal). Little or no flat area is exposed above sea level at the base of the cliff, even at very low tides. The sea cliff is bounded at its landward edge by the coastal terrace deposits.

Figure 8. Typical Coastal Bluff Profile (Looking North up the Coast).

Offshore from the sea cliff is an area of indefinite extent called the nearshore zone (see Figure 8). The bedrock surface in the nearshore zone, which extends out to sea from the base of the sea cliff, is the shore platform. Worldwide, the shore platform may vary in inclination from horizontal to a gradient of 3 horizontal to 1 vertical, or 33<sup>1/3</sup> percent (Trenhaile, 1987). Offshore, the gradient of the shore platform is approximated at 1 to 2 percent. The boundary between the sea cliff (the lower near-vertical section of the bluff) and the shore platform is designated as the cliff-platform junction.

Within the nearshore zone is a subdivision designated as the inshore zone, beginning where the waves begin to break (Figure 8). This boundary varies with time because the point at

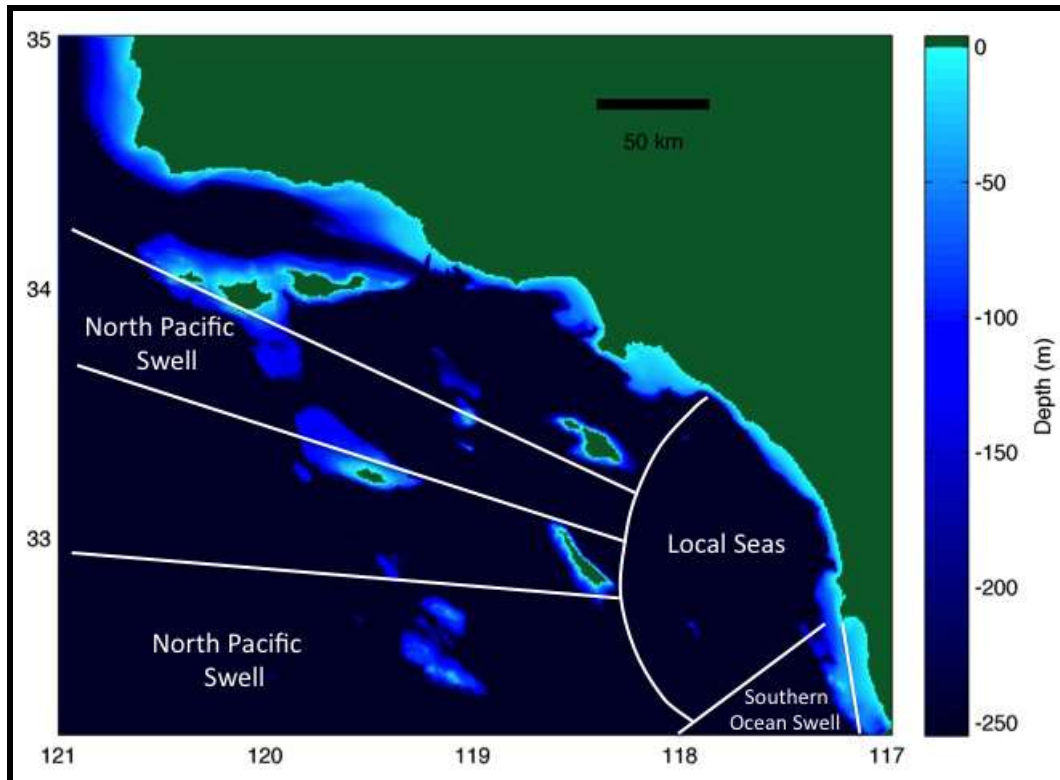
Coastal orientation, and the islands and banks greatly influence the swell propagating toward shore by partially sheltering southern California, including Point Loma, especially from directions north of west. Figure 11 shows the approximate directions from which incoming swell is blocked by the islands. The Point Loma coastline faces west and is therefore also relatively exposed to southern hemisphere swell. Because of the complicated effects of bathymetry and island shadowing, the wave height at the shoreline is sensitive to relatively small changes in the incoming direction of the deep ocean waves.

**Figure 11. Map Showing Generalized Bathymetry in the Southern California Bight and Wave Exposure Windows at Oceanside.**

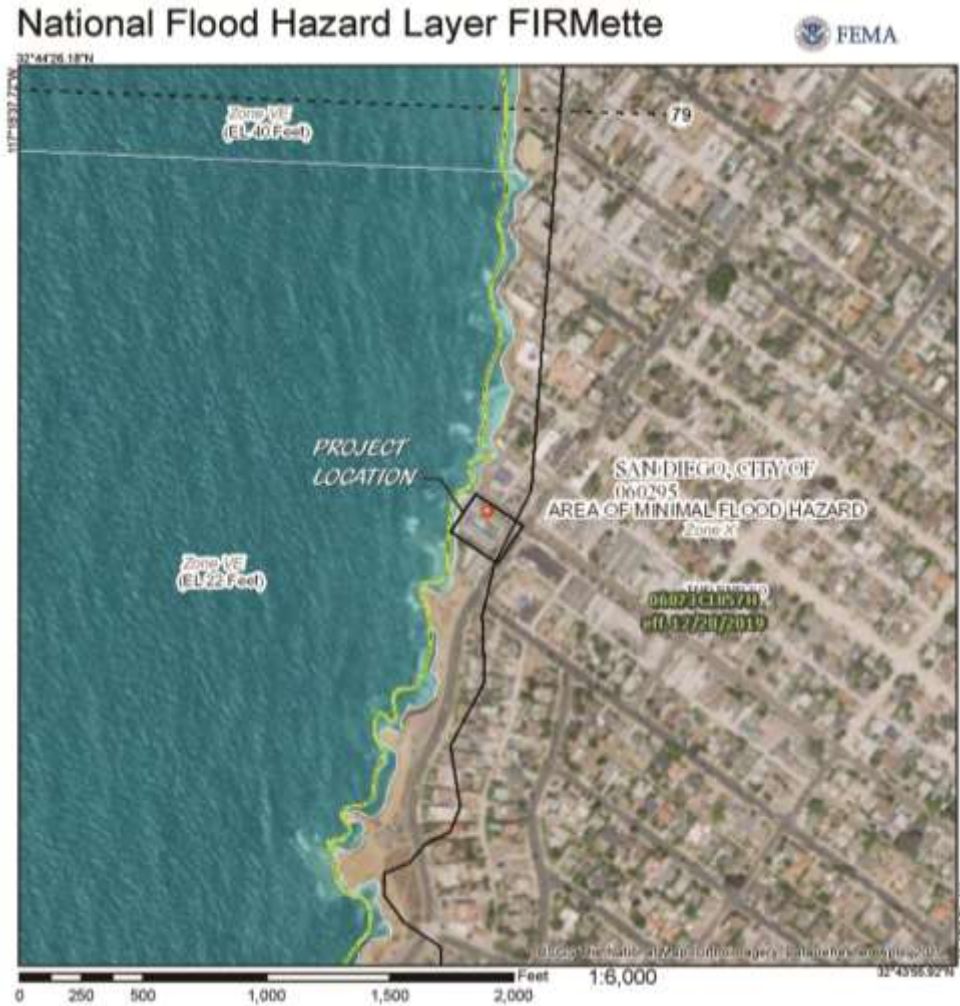
We conducted a review of the Federal Emergency Management Agency (FEMA) Flood Insurance Rate Map for the study area (Figures 12a and 12b). The Inn falls within a VE Zone (Coastal High Hazard Area), with a base flood elevation (BFE) of 22 feet (NAVD 88) or 19.69 feet (NGVD 29). The VE Zone designation also includes anticipated wave heights at or exceeding 3 feet, however allows construction when the structure is designed to accommodate anticipated wave forces and, notably, when minimum building foundations are 2 feet above the base flood elevation. The proposed top-of-wall elevation of 27.7 feet (NGVD 29) at The Inn is 8 feet higher than the FEMA BFE, with the existing structure foundations near elevation 28 feet (NGVD 29), well above the elevation 22 FEMA BFE + 2 feet.

Figure 12A. FEMA Map.

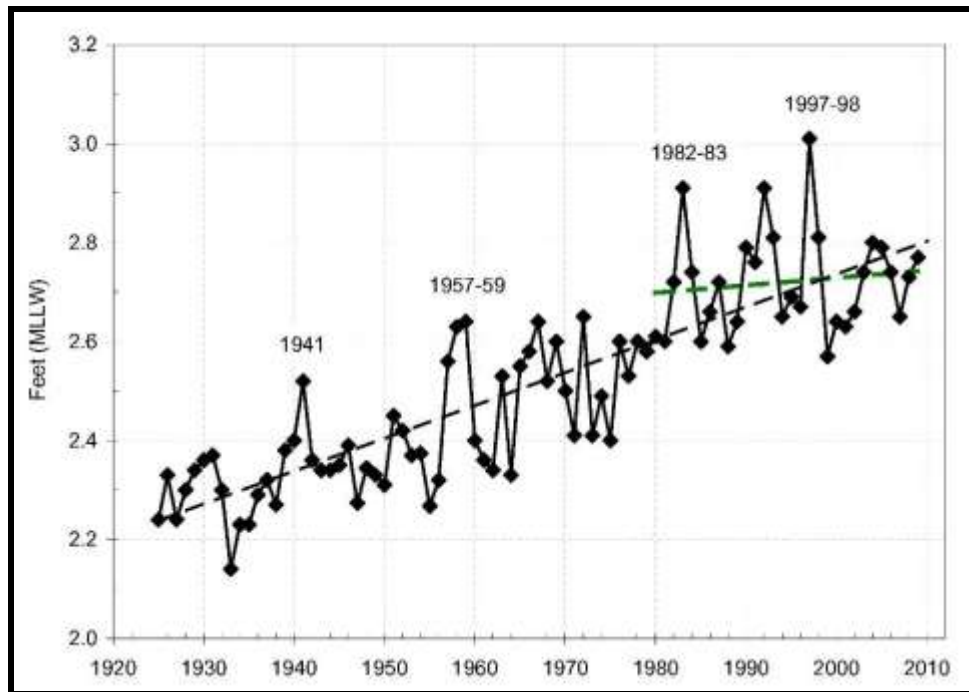
**Figure 13. Annual Average Sea Level History at La Jolla, 1925-2007. Broken Line Shows Linear Trend of 0.7 Feet/Century Rise.**

Figure 13 is a plot of the annual mean sea levels measured at the La Jolla tide gauge starting in 1925. The linear trend indicates the approximate 0.7 foot per century sea level rise. Also noticeable are the enhanced sea levels during the El Niño episodes of 1941, 1957-59, 1982-83, and 1997-98 (respectively labeled).

A notable feature of the sea level history at La Jolla is the leveling-off of sea level rise since about 1980 (Figure 13). The green broken line shows a much reduced trend of about 0.15 foot per century between 1980 and 2009, or about 4.5 times smaller than the overall trend of 0.67 foot per century. A similar reduction in the rate of sea level rise has been noted at San Francisco, which has a similar overall appearance as the La Jolla record, but is a much longer record extending back to 1856.

the eastern Pacific, extending from Central America north to Washington State, have fallen at a rate of 0-3 mm per year (0-30 cm per century, or 0-1 foot per century). This may explain the coastal tide gauge observations (La Jolla sea level history; Figure 13) described above.

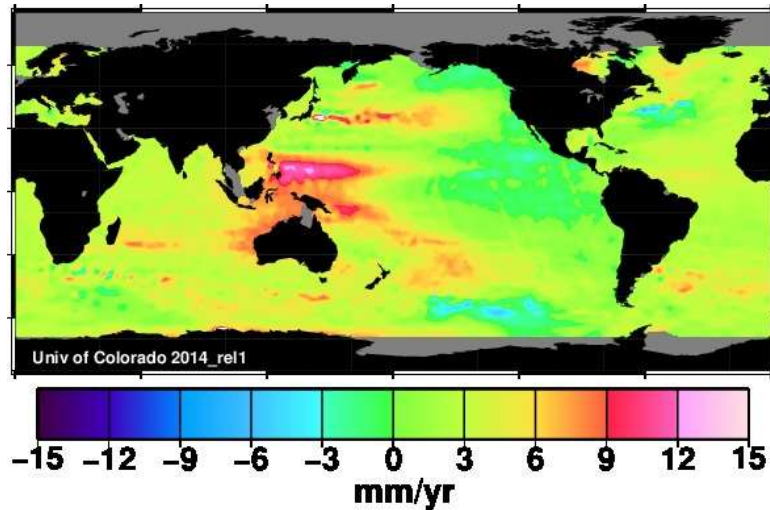
Figure 14 shows the global distribution of the rate of sea level change for the period of 1993-2012 (University of Colorado, 2012). Note that warm colors (yellow-orange-red) show areas of sea level rise (positive rates), while cool colors (green-blue) indicate falling sea level (negative rates) over the record. Inspection of the North Pacific reveals that sea levels in the western Pacific, especially in the lower latitudes, have risen at a rate of 3-9 mm/year (equivalent to 30-90 cm per century, or about 1-3 feet per century). Conversely, sea levels in

**Figure 14. Global Sea Level Change Rates 1993-2012 as derived from satellite altimetry measurements, following University of Colorado (2012).**

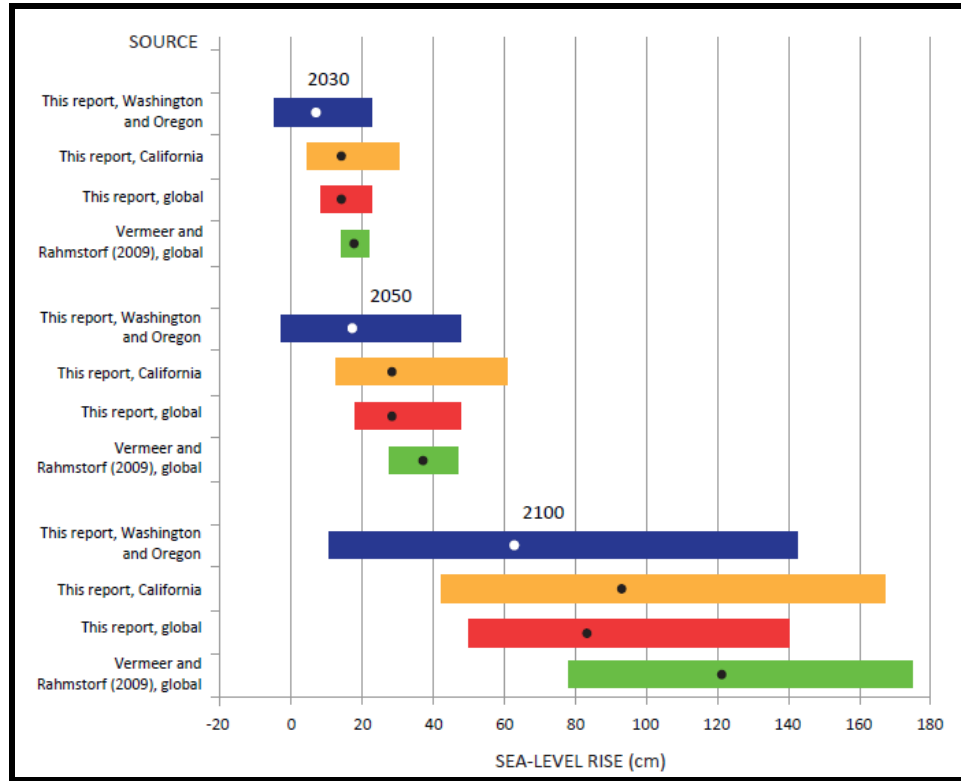
When considering the effects of future sea level rise, the National Academy of Sciences (NAS, 2012) presents a possible global, west-coast, and state-wide future Mean Sea Level Rise (MSLR) for California, Oregon, and Washington (Figure 15, dots) and its range (Figure 15, bars). These are based on the IPCC (2007) mid-range Green House Gas emissions scenarios for the ocean steric (warming) expansion component added to the results of new research projecting the likely contributions of future ice-melt. The resulting projected *global* MSLR relative to 2000 ranged from 0.08-0.23 m (0.26-0.75 ft) by 2030; 0.18-0.48 m (0.59-1.6 ft) by 2050; and 0.50-1.4 m (1.6-4.6 ft) by 2100 (Figure 15, red bars). The global estimates were adjusted for vertical crustal movement (uplift north of Cape Mendocino and

down-drop in the south) resulting in the orange bars, also shown in Figure 15. The State of California (2013) used these results of NAS (2012) shown as the updated MSLR guidance in Table 2.

Figure 15. NAS (2012) summary of global, Washington, Oregon, and California (south of Cape Mendocino) MSLR projections for 2030, 2050, and 2100 relative to 2000.

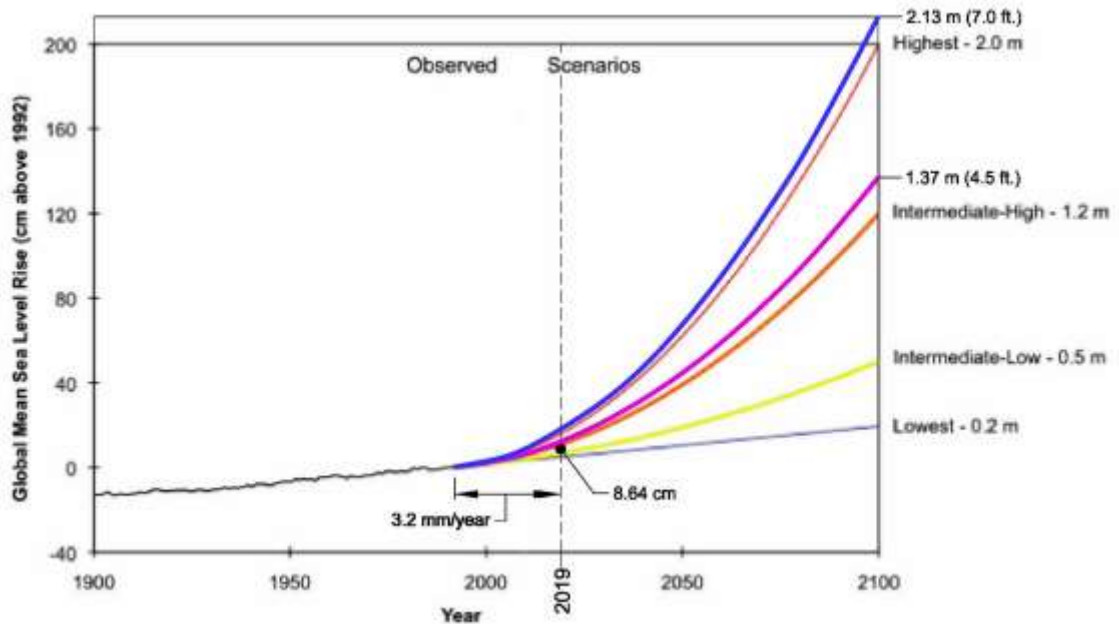
**FIGURE 16**

We have reproduced as Figure 16 the Coastal Commission’s four suggested sea level rise scenarios through the year 2100 from the Coastal Commission’s 2015 Sea Level Rise Policy Guidance Document, ranging from the Lowest at 0.2 meter, to the Highest at 2.0 meters, measured from the 1992 baseline. Based on recent discussions with Dr. Reinhard Flick, the State Oceanographer with the California Department of Boating and Waterways and a Research Scientist at Scripps Institution of Oceanography, global sea level has risen from 1992 through 2019 at a relatively uniform rate of 32 centimeters per century, or at the same trajectory as previously reported by Nerem (2005) and illustrated below in Figure 17. While Nerem’s data extended from 1993 to 2005, the more recent recorded global sea level elevation change from 1993 to 2019 provides essentially the same data. This information is also shown on Figure 16, which from 1992 through 2019 has resulted in 8.64 centimeters of relatively uniform sea level rise in the past 27 years. If this uniform rate of sea level rise (consistent with that shown on Figure 16) were to extend out to the year 2100, this would be equivalent to a future mean sea level of 0.35 meter (1.13 feet) above the 1992 datum, and slightly above the Coastal Commission’s 2015 suggested Lowest SLR scenario. Notably, and while we appreciate the Coastal Commission’s 2018 Sea Level Rise Policy Guidance Update requiring adaptive strategies to accommodate worst-case SLR scenarios, the OPC’s 2018 Sea-Level Rise Guidance also acknowledges that there is a 17 percent probability of sea level rise by the year 2100 being lower than 1.8 feet, as shown on Table 3.

Modified from Figure 5 of the California Coastal Commission Sea Level Rise Policy Guidance document adopted August 12, 2015.

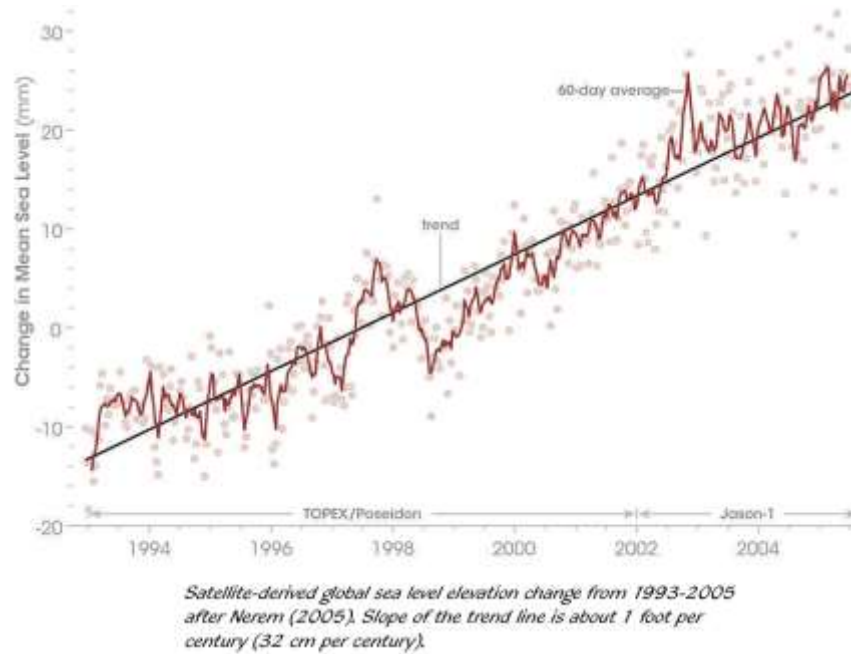
**FIGURE 17**

Global mean sea level rise rate over the past two decades has increased over the rate observed for the past century, and has reached about 1 foot per century (32 cm per century). This is indicated from satellite data reporting and trend analysis shown in Figure 17 (Nerem, 2005).

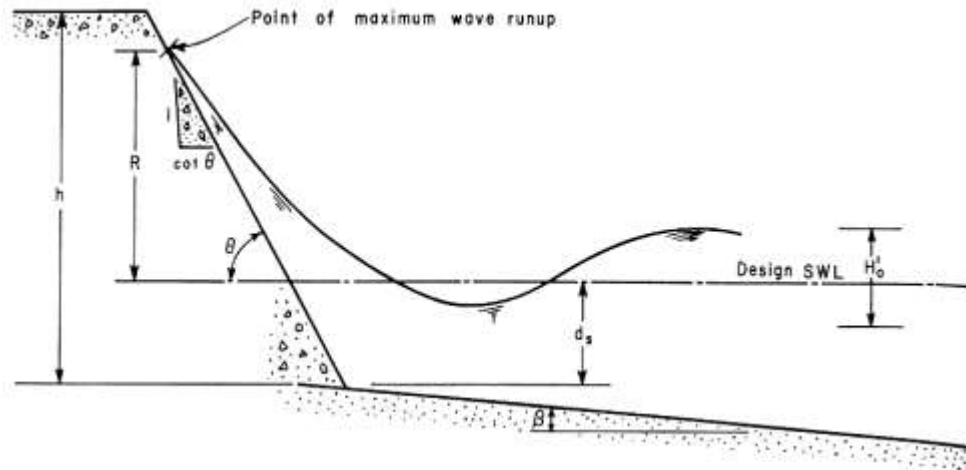
The following definition sketch for both wave runup and overtopping, reproduced from the 1984 SPM, graphically illustrates the point of maximum wave runup for a particular design condition.

**Definition sketch: wave runup and overtopping**

It should also be clear from the sketch that any wave runup exceeding the height of the structure then represents overtopping.

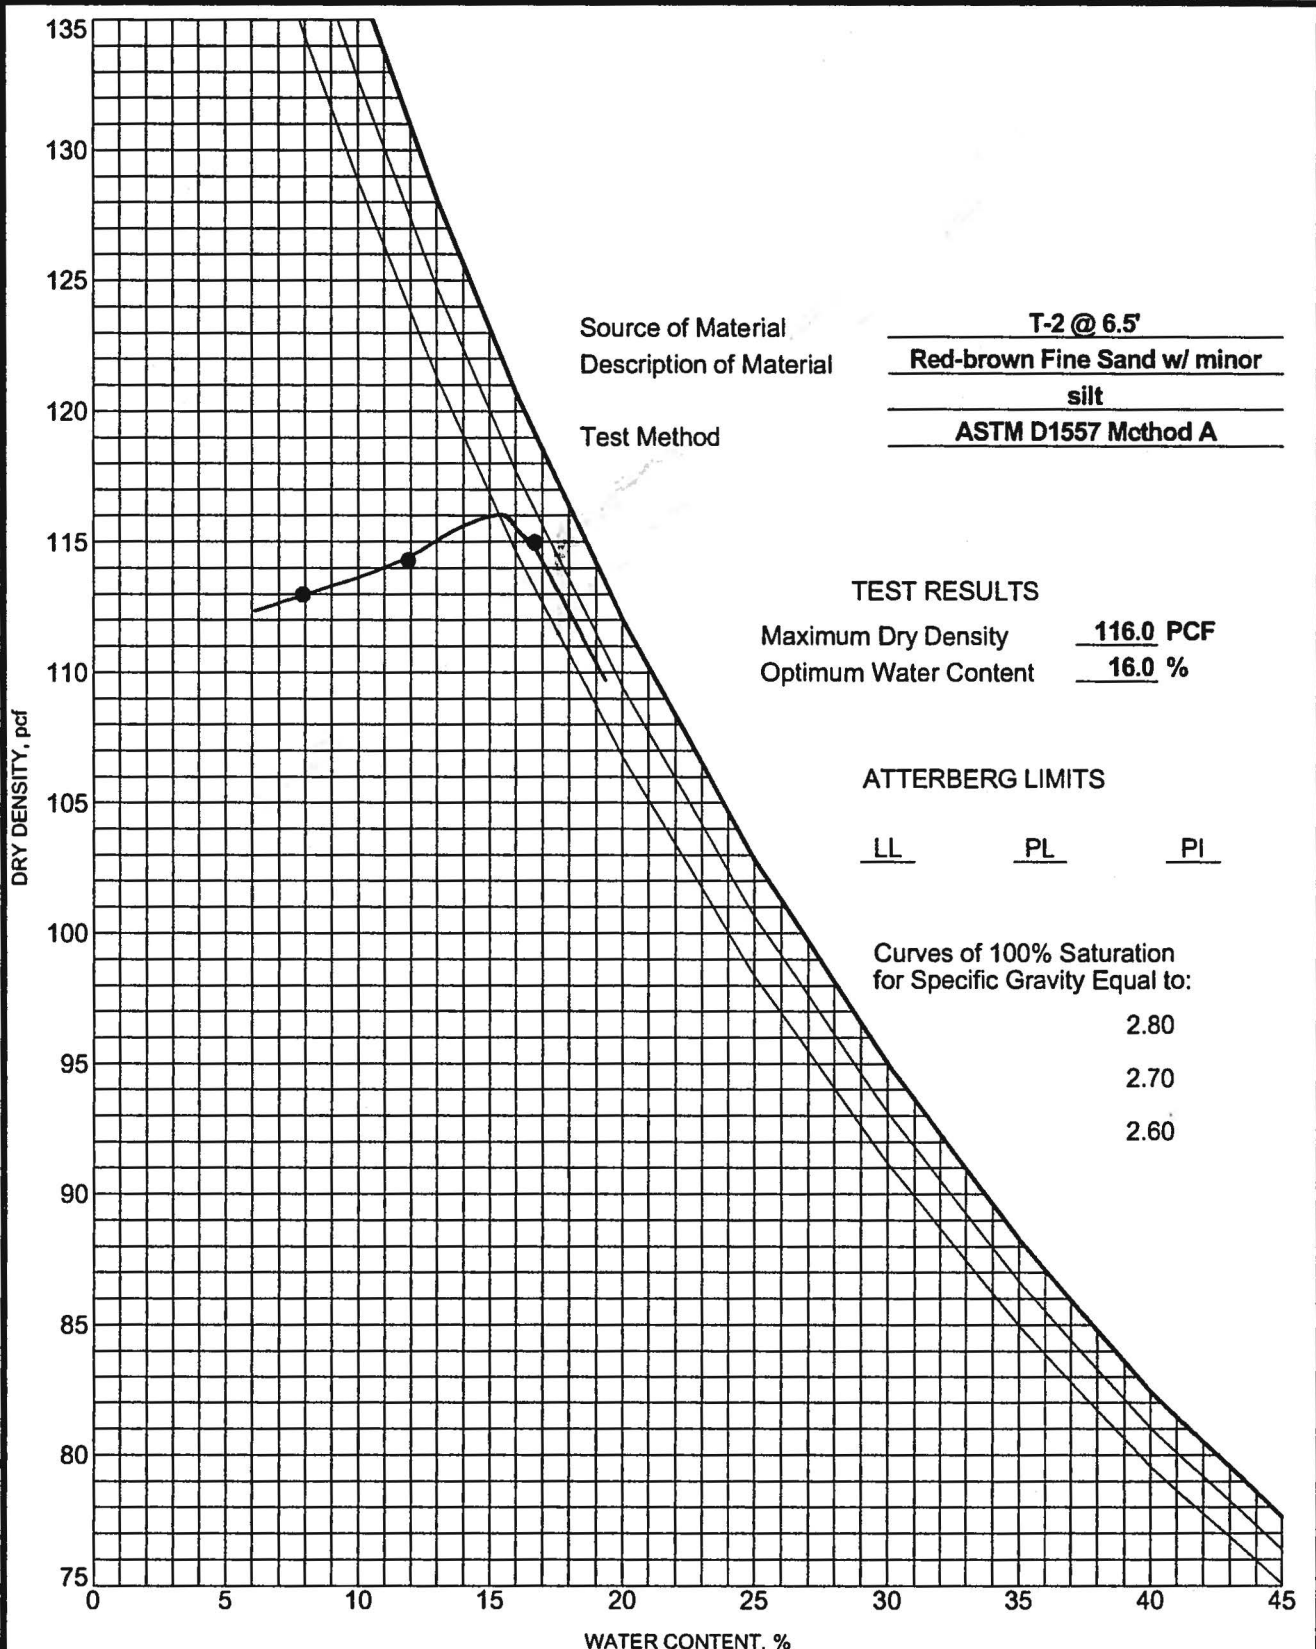
Figure Number: IIIa  
 Job Name: The Inn at Sunset Cliffs  
 Site Location: 1370 Sunset Cliffs Blvd., San Diego, California  
 Job Number: 03-8530

Source of Material T-2 @ 6.5'  
 Description of Material Red-brown Fine Sand w/ minor silt  
 Test Method ASTM D1557 Method A

TEST RESULTS  
 Maximum Dry Density 116.0 PCF  
 Optimum Water Content 16.0 %

**MOISTURE-DENSITY RELATIONSHIP**

Based upon our experience with the Bay Point and Point Loma formational materials in this area of San Diego, our observations of the primary soil types on the project, our laboratory test data, and our previous experience with laboratory testing of similar soils, our Geotechnical Engineer has utilized conservative values for friction angle and cohesion for those soils that will have significant lateral support or bearing functions on the project. These values have been utilized in recommending the allowable bearing value as well as the active and passive earth pressures for footing and caisson designs. Laboratory test results are presented on Figure No. IIIa-c.

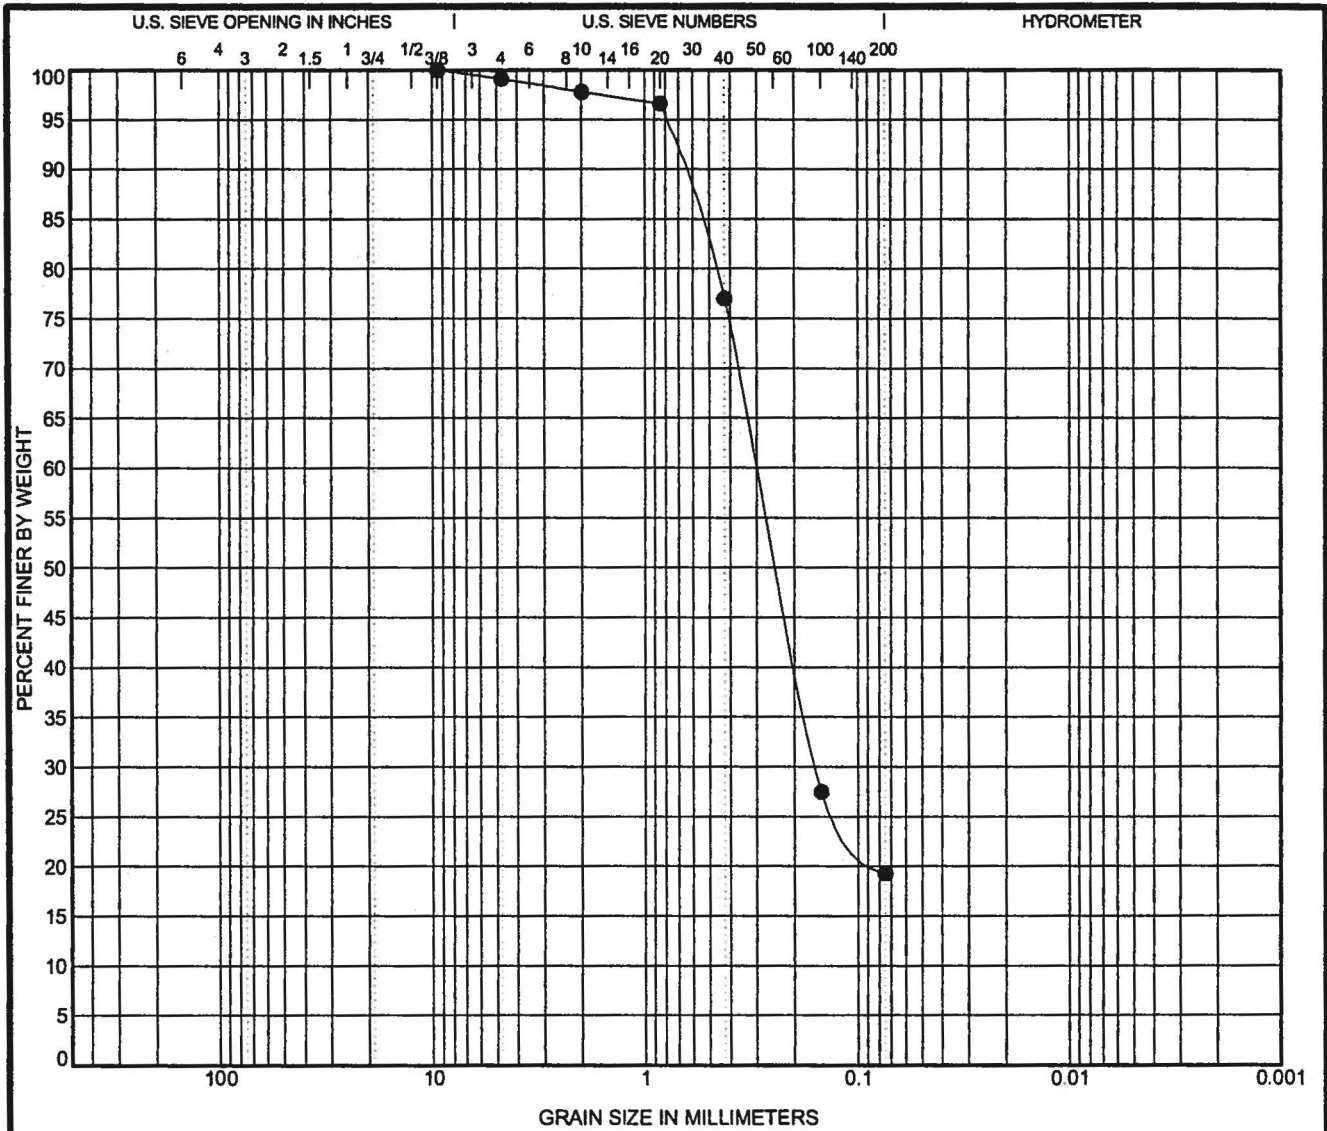
Specimen Identification	Classification	LL	PL	PI	Cc	Cu
● T-1 @ 3.5'	Red-brown Fine Sand w/ some silt

**GRAIN SIZE DISTRIBUTION**  
 Figure Number: IIIb  
 Job Name: The Inn at Sunset Cliffs  
 Site Location: 1370 Sunset Cliffs Blvd., San Diego, California  
 Job Number: 03-8530

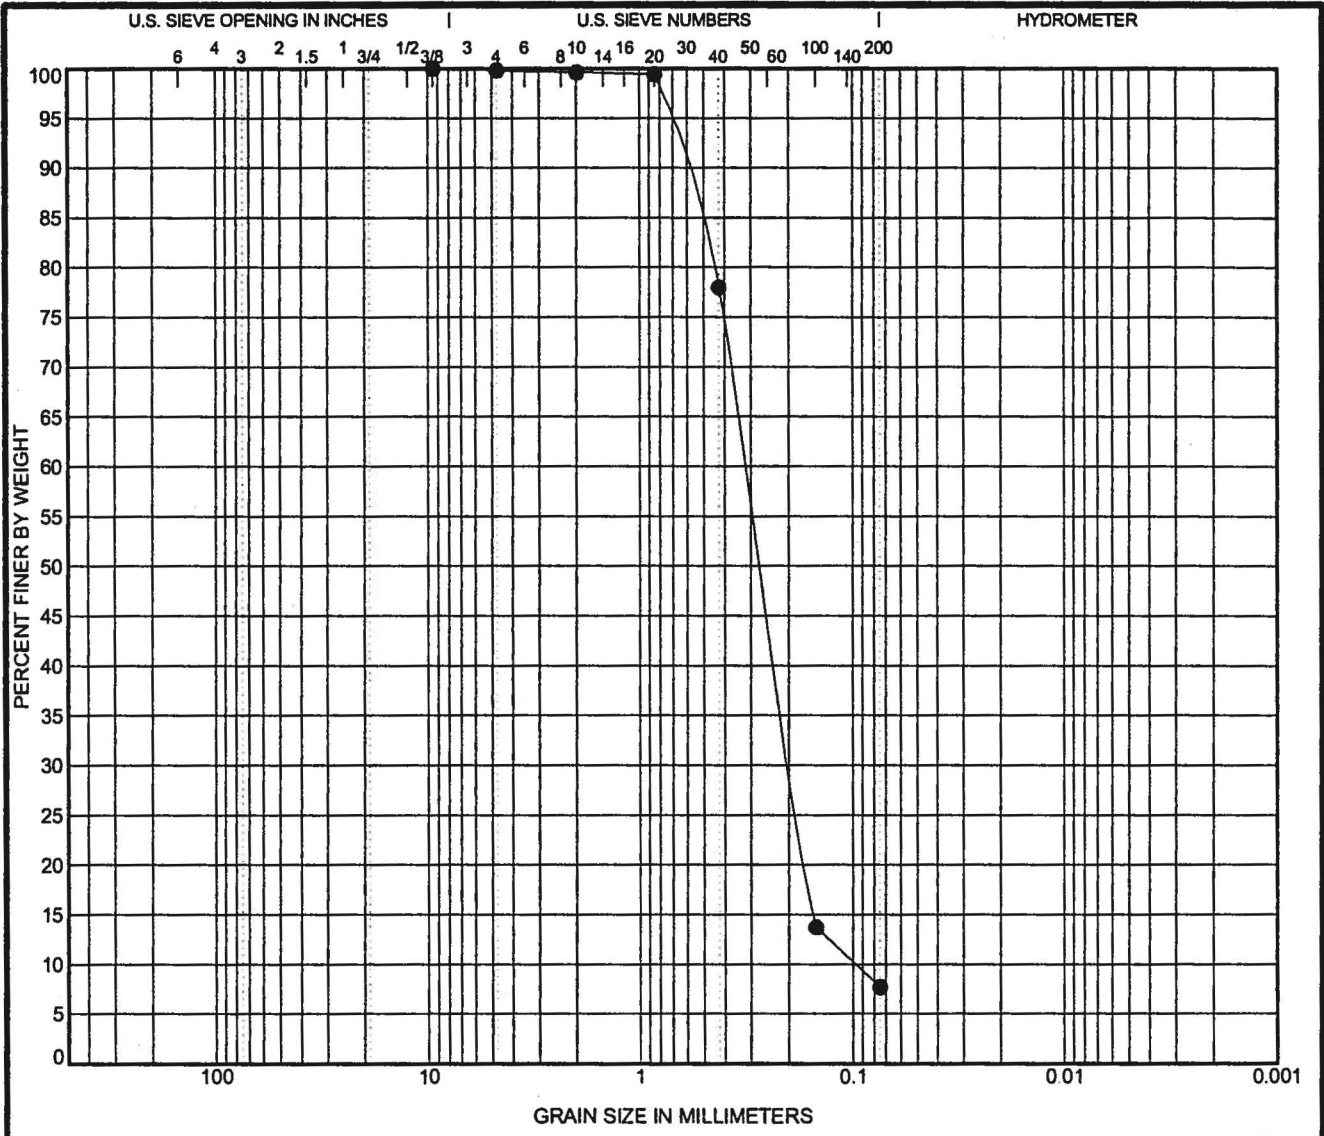
Figure Number: IIIc  
 Job Name: The Inn at Sunset Cliffs  
 Site Location: 1370 Sunset Cliffs Blvd., San Diego, California  
 Job Number: 03-8530

Specimen Identification	Classification					LL	PL	PI	Cc	Cu
● T-2 @ 6.5'	Red-brown Fine Sand w/ minor silt								1.23	3.25
Specimen Identification	D100	D60	D30	D10	%Gravel	%Sand	%Silt	%Clay		
● T-2 @ 6.5'	9.5	0.318	0.195	0.098	0.2	92.1	7.7

**GRAIN SIZE DISTRIBUTION**

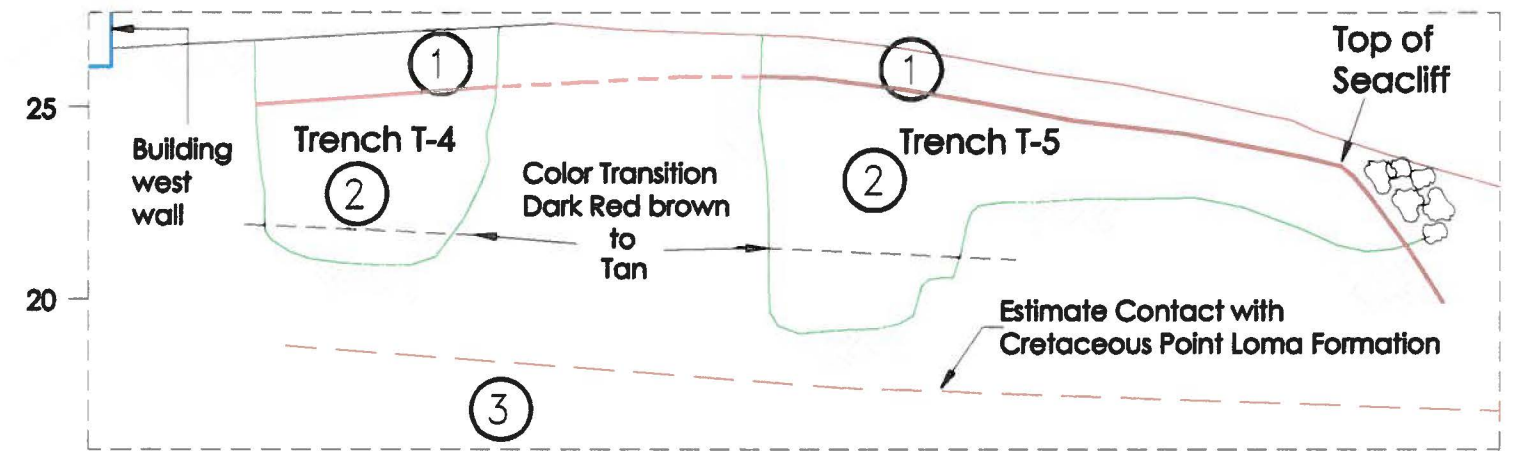
# CROSS SECTION A-A' Inn @ Sunset Cliffs

UNIT #	LOCATION	UNIT DESCRIPTION
①	<b>Fill</b>	<b>ARTIFICIAL FILL (Qaf)</b>
	0 to 4"/6"	Silty Sand and Gravel. Loose, dry, very light brown
②	<b>Bay Point Formation</b>	<b>Terrace Materials (Qbp)</b>
	4"/6" to 12"/15"	Silty Fine to Medium Sand and Mixed Angular Cobble-Boulder size Concrete Debris. Loose, damp, brown Buried Concrete Rubble Debris placed on sea cliff face. Angular, cobble to boulder size.
③	<b>Point Loma Formation</b>	<b>Cretaceous Point Loma Formation Kp</b>
	12"/15" to 5'-6"	Slightly Silty Fine to Medium Sand. Highly bioturbated. Medium dense, damp-moist, dark reddish brown. Subvertical black linear manganese/iron mineral accumulations. 7" to 9" long. Color transition to tan at approximate elev: 21' to 22' MSL. Estimated contact between Qbp/Kp 18' to 19' feet above Mean Sea Level.

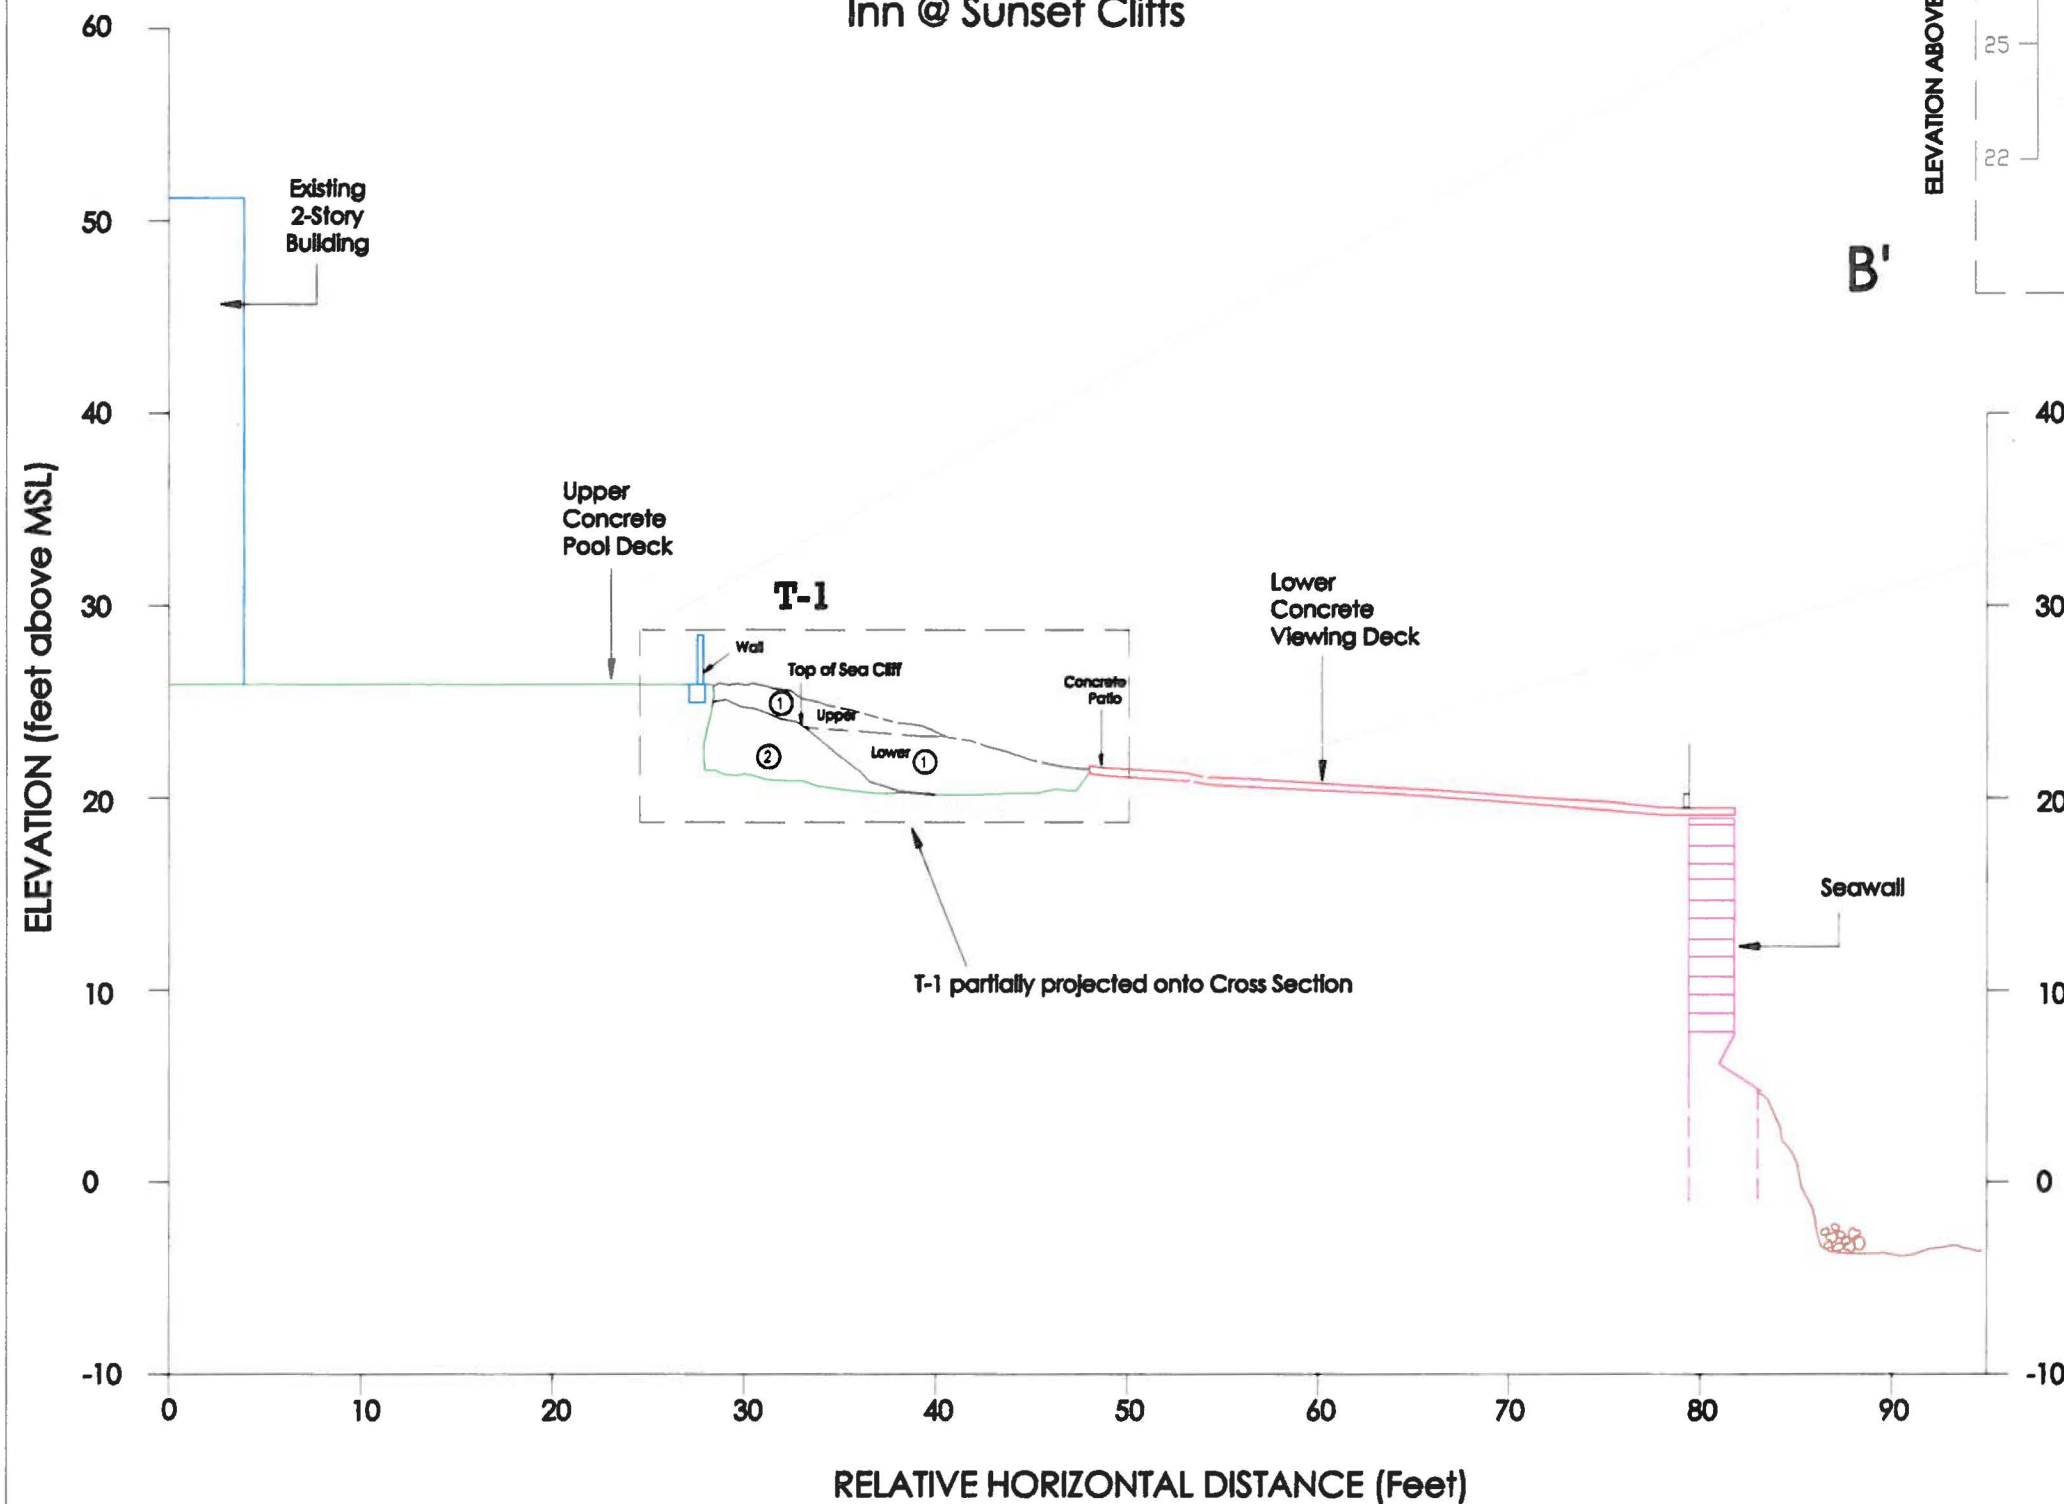
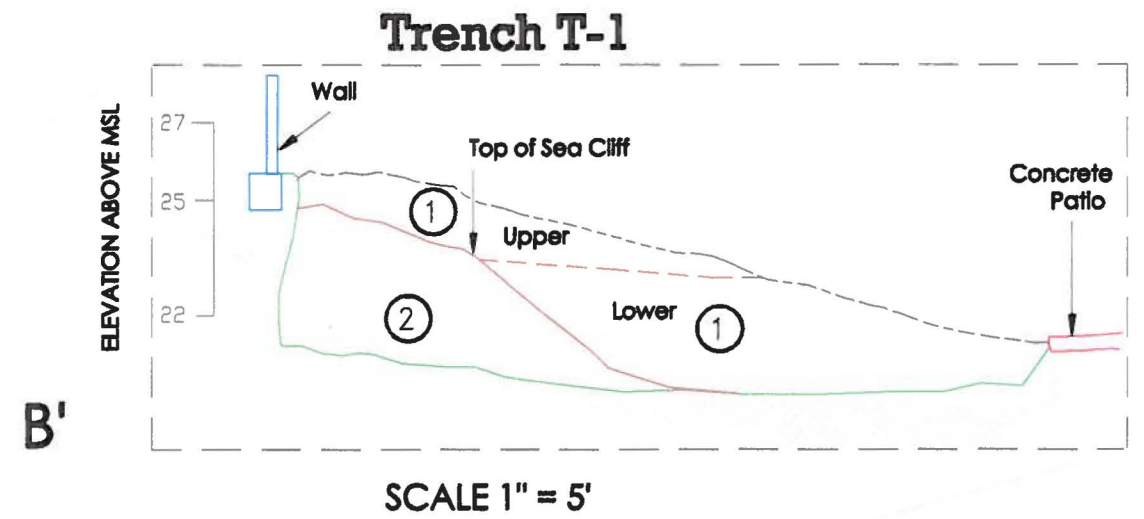
# CROSS SECTION B-B' Inn @ Sunset Cliffs

UNIT #	LOCATION	UNIT DESCRIPTION
<b>ARTIFICIAL FILL (Qaf)</b>		
①	<b>Upper Fill</b>	Gravelly Sand, loose, dry-damp, gray/brown/tan with mixed cobble-size angular concrete debris.
	<b>Lower Fill</b>	Fine to Medium Sand. Loose-medium dense, damp-moist, buff/pale brown/yellow white. "beach sand derived"
②	<b>TERRACE MATERIALS (Qbp)</b>	
	<b>Bay Point Formation</b>	Slightly Silty fine to medium sand, Medium dense, moist, brown/dark brown.
