**GEOTECHNICAL REPORT  
THE INN AT SUNSET CLIFFS  
SAN DIEGO, CALIFORNIA**

Prepared for  
**PROJECT DESIGN CONSULTANTS**  
San Diego, California

Prepared by  
**TERRACOSTA CONSULTING GROUP, INC.**  
San Diego, California

Project No. 2317-01  
December 24, 2020

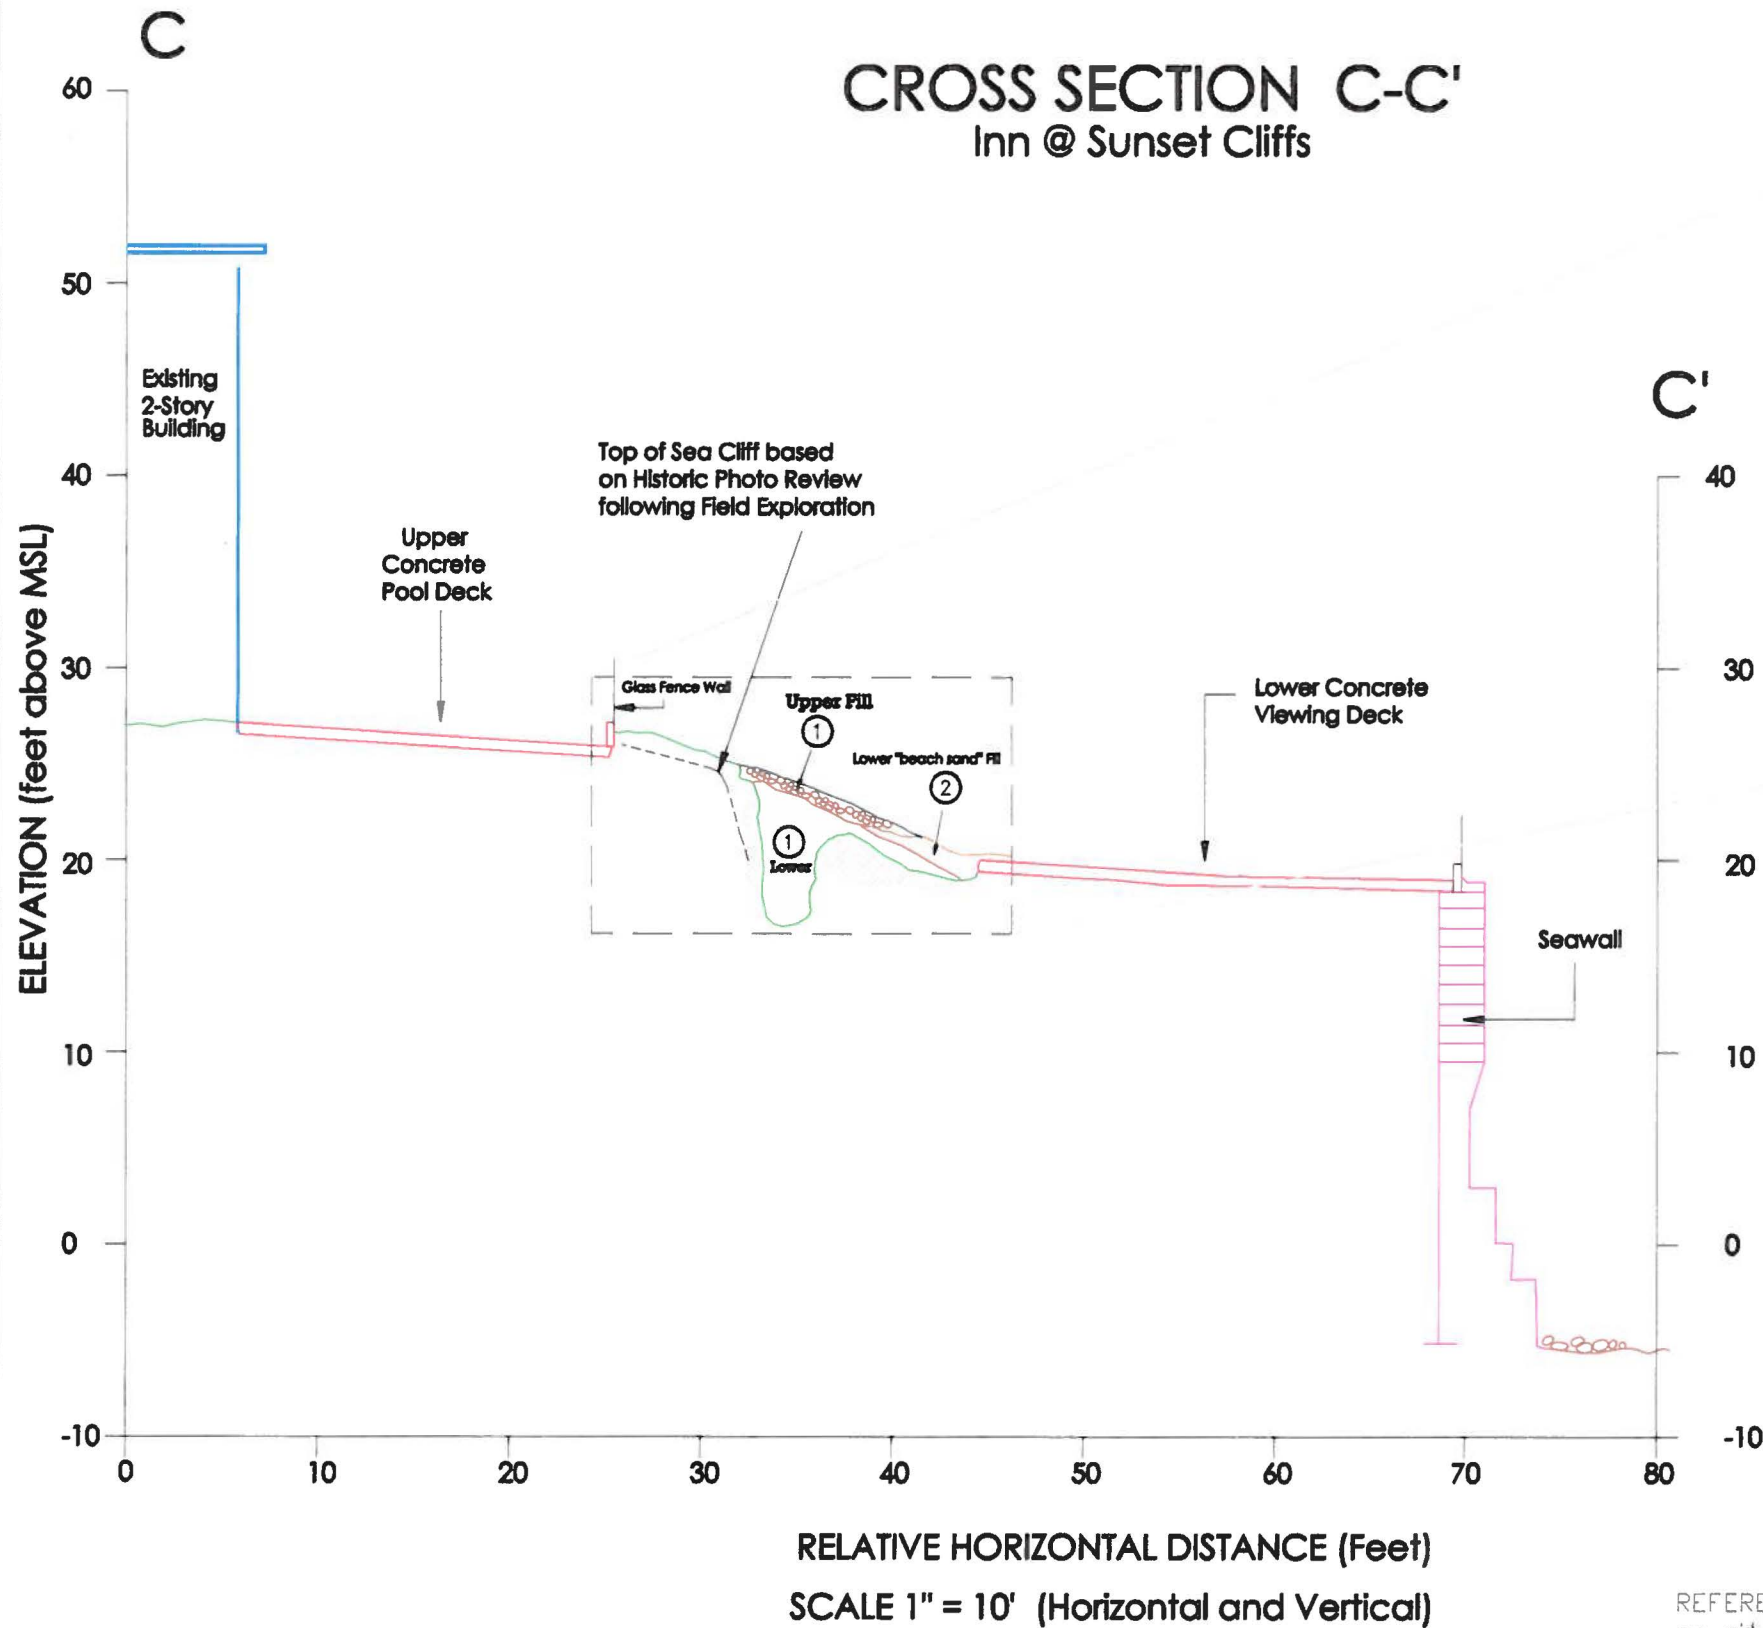
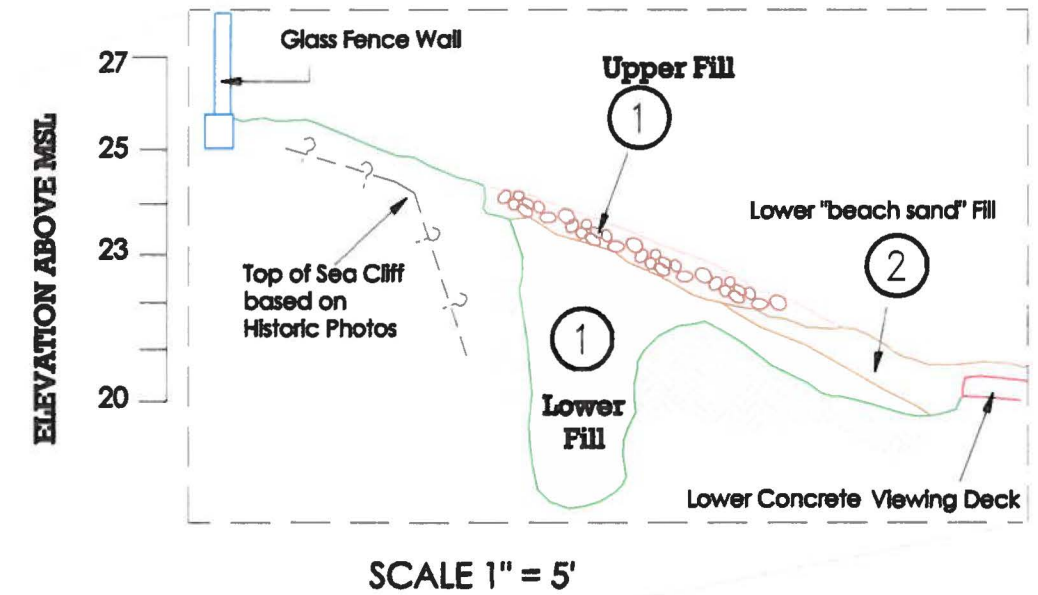
**Inn at Sunset Cliffs**  
**1370 Sunset Cliffs Boulevard**  
**San Diego, CA.**  
**Figure No. IvC**  
**Job No. 03-8530**

# CROSS SECTION C-C' Inn @ Sunset Cliffs

UNIT #	LOCATION	UNIT DESCRIPTION
<b>ARTIFICIAL FILL (Qaf)</b>		
①	Upper Fill	Silty Fine to Medium Sand. Loose-medium dense, damp, tan/brown/gray with angular gravel and angular cobble-boulder size, concrete debris.
②	Lower Fill	Fine to medium sand. Loose-medium dense, damp, brown with scattered angular concrete and brick debris.
	Lower "beach sand fill"	Fine to Medium Sand, Loose-medium dense, damp, pale tan/white/gold brown, "beach sand derived".

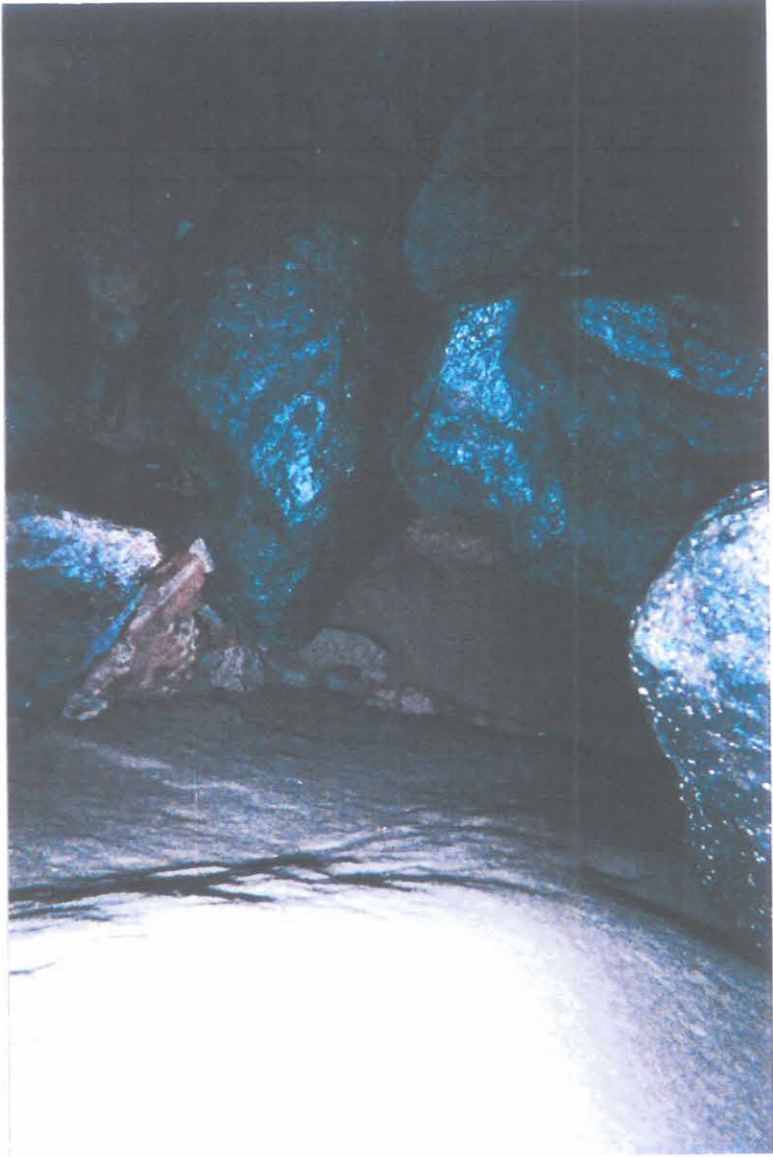
1

1. Point Loma Formation and rock infill observed below lower deck.
2. Shallow fill soils over Bay Point Formation in Trench T-5.
3. Concrete debris in fill soils, east end of Trench T-3.
4. Bioturbation in Bay Point Formation in Trench T-5.
- 5 & 6 Sublinear iron/manganese accumulations in Bay Point Formation in Trench T-5.
