**Appendix M. Geotechnical and Geological Hazards  
Technical Memorandum**

**To:** Jordan Moore, Senior Planner, City of San Diego  
**From:** Kelsey Hawkins, Project Manager, Harris & Associates  
**RE:** De Anza Natural Amendment to the Mission Bay Park Master Plan – Geotechnical and Geologic Hazard Evaluation  
**Date:** March 6, 2023  
**Att:** Figures; 1, 2019 Geotechnical and Geologic Hazard Evaluation

**PREPARED BY:**  
The Bodhi Group Inc.

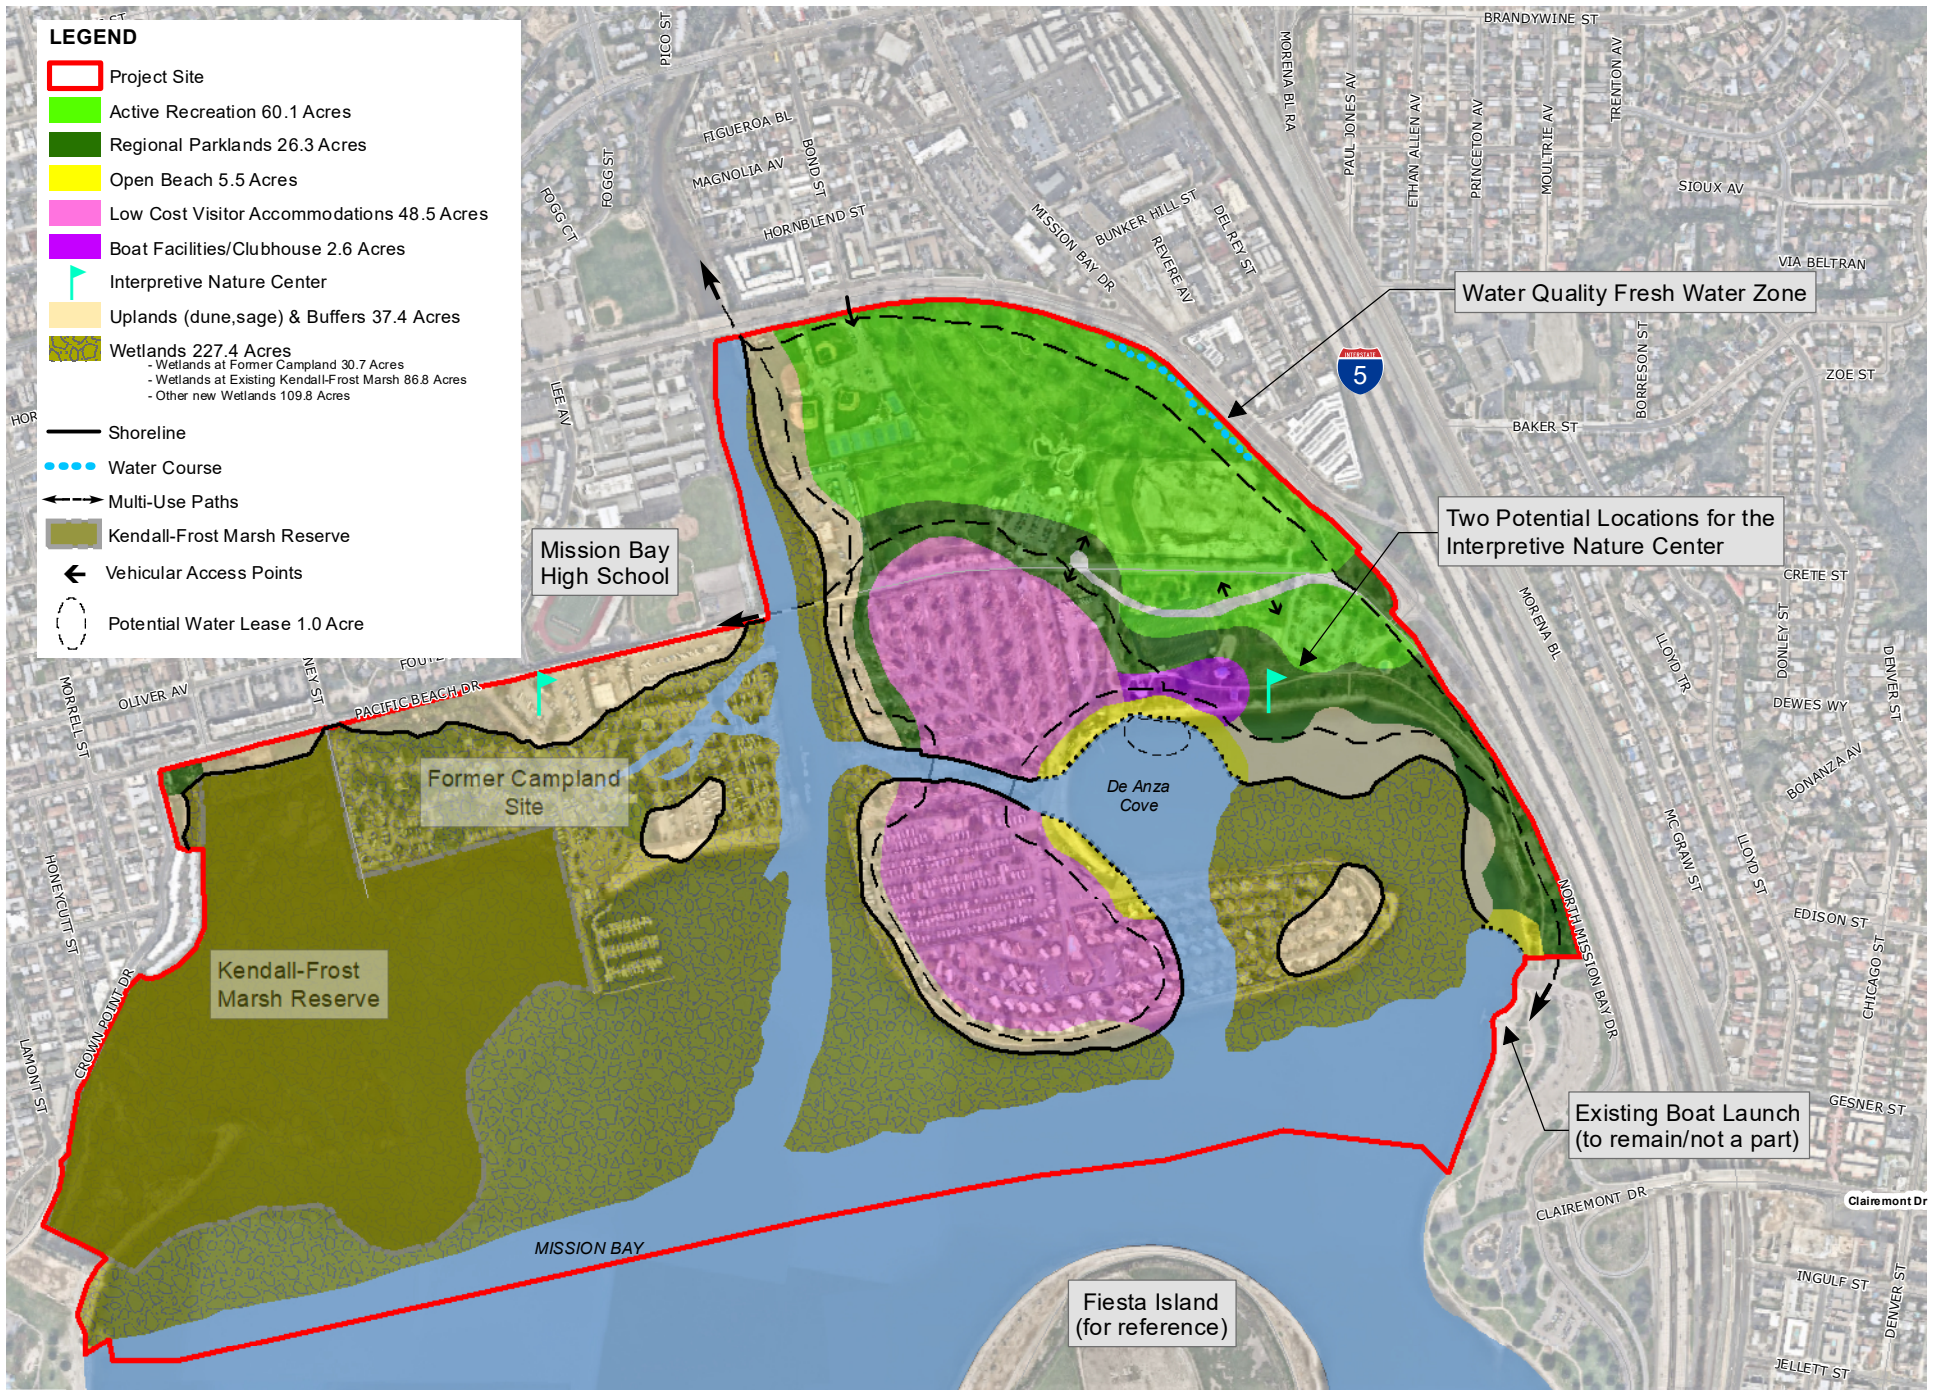
**Figure 3**  
Site Plan

Source: City of San Diego 2023.
