GEOTECHNICAL STUDY IN SUPPORT OF EIR

Carol Kimmelman Athletic and Academic Campus Carson, California

**23 April 2019
Langan Project No. 700060401**

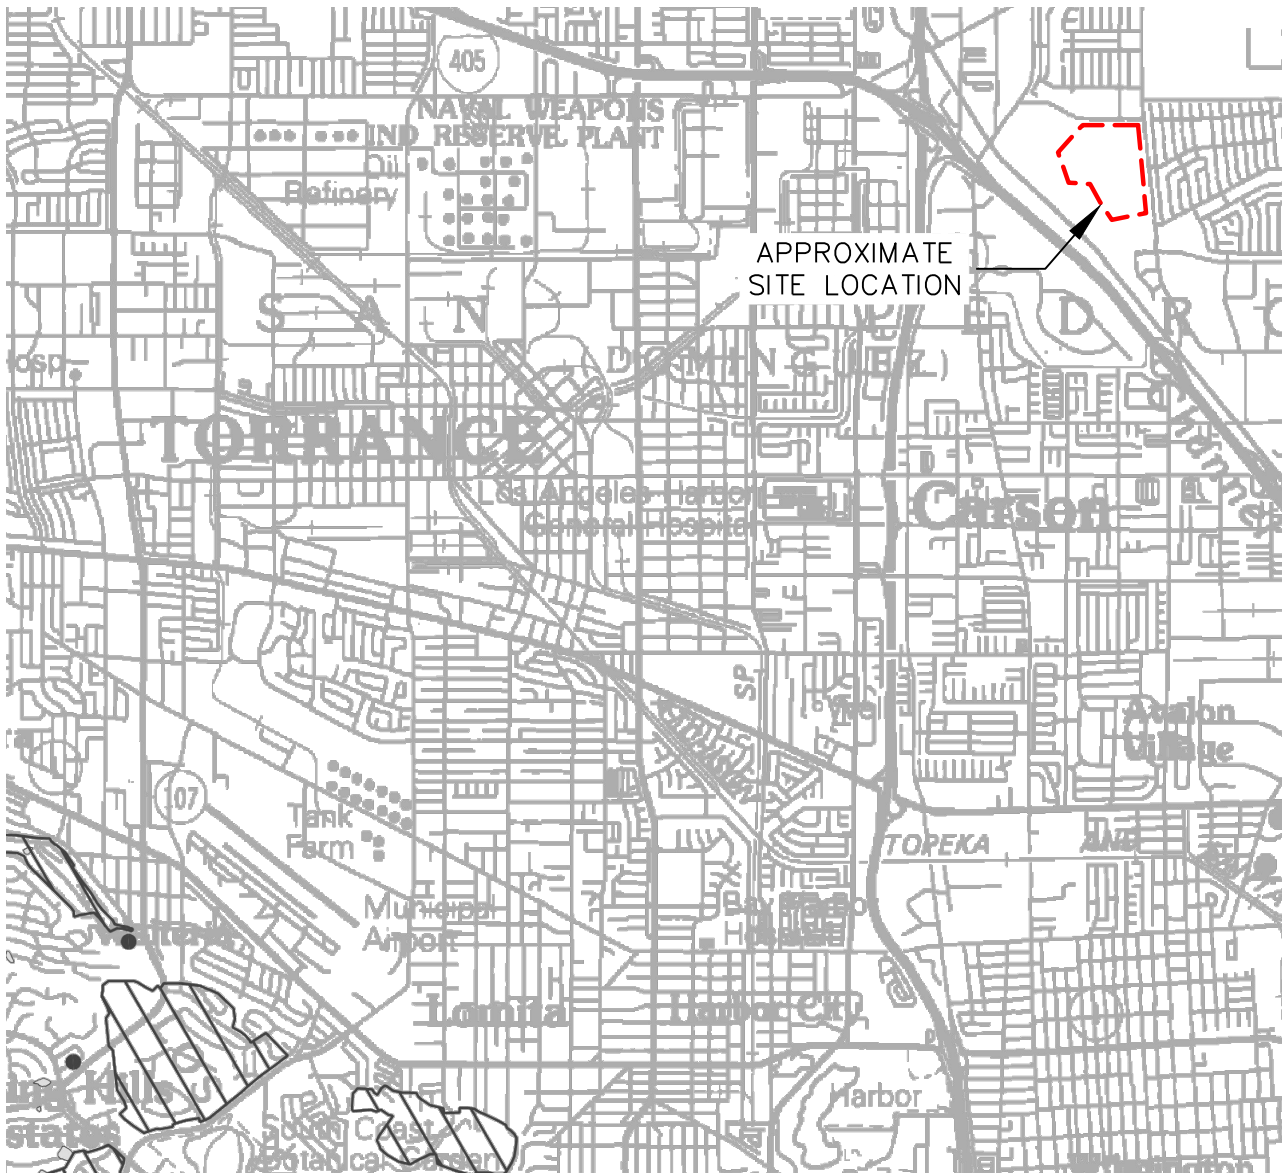
1. BACKGROUND REFERENCED FROM "SEISMIC HAZARD ZONE REPORT FOR THE TORRANCE 7.5-MINUTE QUADRANGLE, LOS ANGELES COUNTY, CALIFORNIA – PLATE 2.1," PREPARED BY STATE OF CALIFORNIA, DEPARTMENT OF CONSERVATION, DATED 1998.

515 South Flower Street, Suite 2860 Los Angeles, CA 90071 T: 213.314.8100 F: 213.314.8101 www.langan.com NEW JERSEY NEW YORK CONNECTICUT PENNSYLVANIA WASHINGTON DC VIRGINIA WEST VIRGINIA OHIO FLORIDA TEXAS ARIZONA CALIFORNIA ABU DHABI ATHENS DOHA DUBAI ISTANBUL LONDON PANAMA Langan Engineering & Environmental Services, Inc.	Project	Figure Title	Project No.	Figure No.	
	CAROL KIMMELMAN ATHLETIC AND ACADEMIC CAMPUS CARSON LOS ANGELES COUNTY CALIFORNIA	LANDSLIDE INVENTORY	700060401	5	
			Date		APRIL 2019
			Scale		1" = 5000'
			Drawn By	AJT

- Landslides – According to the CGS and SHZR 035 Landslide Inventory, the Site is not within a mapped Earthquake-Induced Landslide Hazard Zone or a mapped landslide area, as shown in Figure 5.

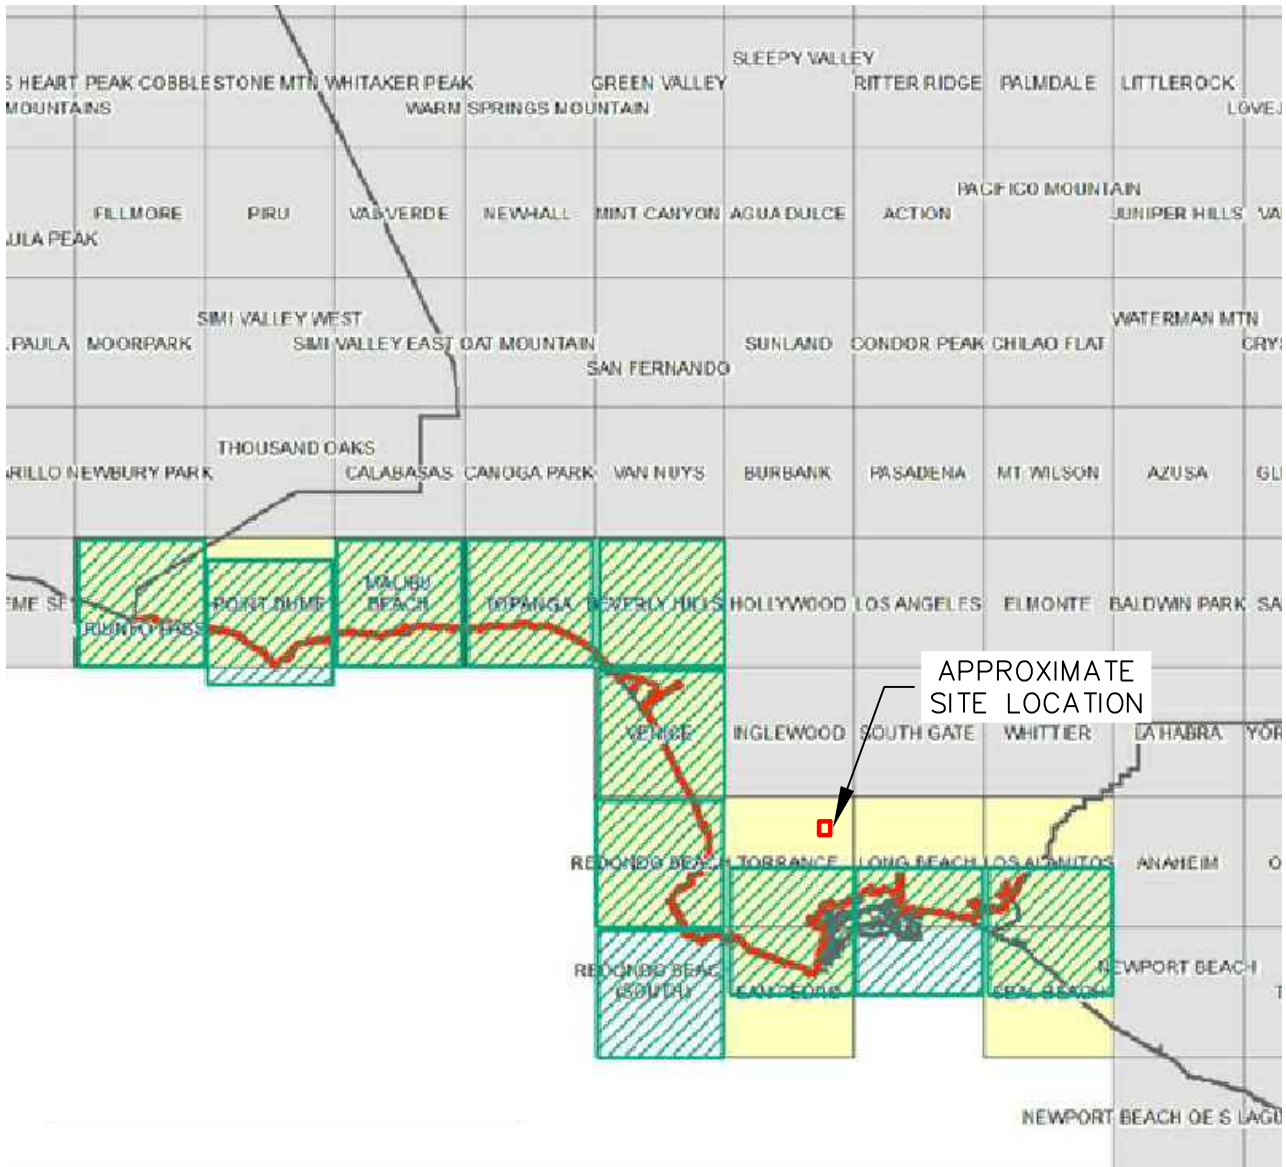
Project No.	Figure No.	700060401	8	Date	APRIL 2019	Scale	NOT TO SCALE	Drawn By		AJT	
	Project No.	Figure No.													
	700060401	8													
	Date														
APRIL 2019															
Scale															
NOT TO SCALE															
Drawn By															
AJT

1. BACKGROUND REFERENCED FROM "LOS ANGELES COUNTY TSUNAMI INUNDATION WITH USGS 24K QUADS," PREPARED BY STATE OF CALIFORNIA, DEPARTMENT OF CONSERVATION, DATED 1 MARCH 2009.

- Tsunami and Seiche – According to information and maps available from the California Department of Conservation, the Site is not within a mapped tsunami inundation- hazard zone, as shown in Figure 8.
